Field Demonstration of Electro-Scan Defect Location Technology for Condition Assessment of Wastewater Collection Systems

Mary Ellen Tuccillo, Ph.D./The Cadmus Group, Charles Wilmut/Burgess & Niple, Inc., Christopher Feeney/P.E./Louis Berger Group, Kathy Martel, P.E./The Cadmus Group, and Ariamalar Selvakumar, Ph.D./USEPA Office of Research and Development Watershed Management Branch

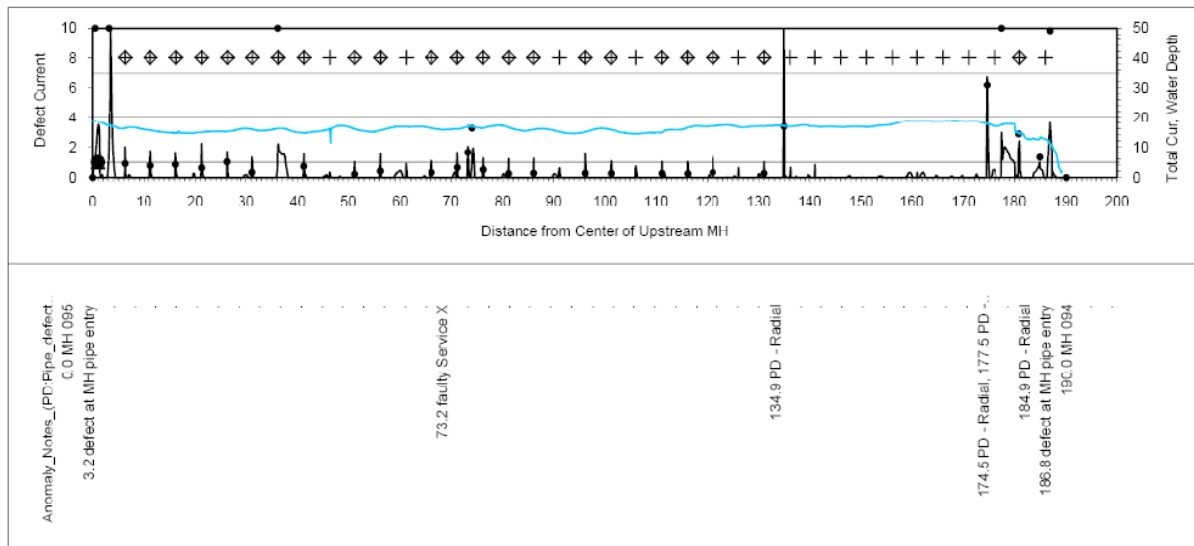
Figure 2. Electro-scanning results for the pipe segment MH 095 to MH 094.

defects (e.g., cracks in the pipe) or leaks at service connections. The categorization of the magnitude of the anomaly (e.g., small, medium, large) is based on a comparison of electro-scanning results with pressure testing results for pipe joints (Harris and Tasello, 2006). Anomalies with amplitude of 1 to 4 are classified as small defects while anomalies with amplitude of 4 to 7 and greater than 7 are classified as medium or large defects, respectively. Figure 2 shows the computer processed current trace for a pipe segment, with distance along the pipe on the horizontal axis and current level on the vertical axis. The line of crosses at the top represents joint locations. The graph displays numerous small joint defects (diamonds overlain on the crosses), as well as manhole entry defects, a faulty service connection at 73.2 ft, and a large pipe defect at 134.9 ft. The blue line shows total electric current.

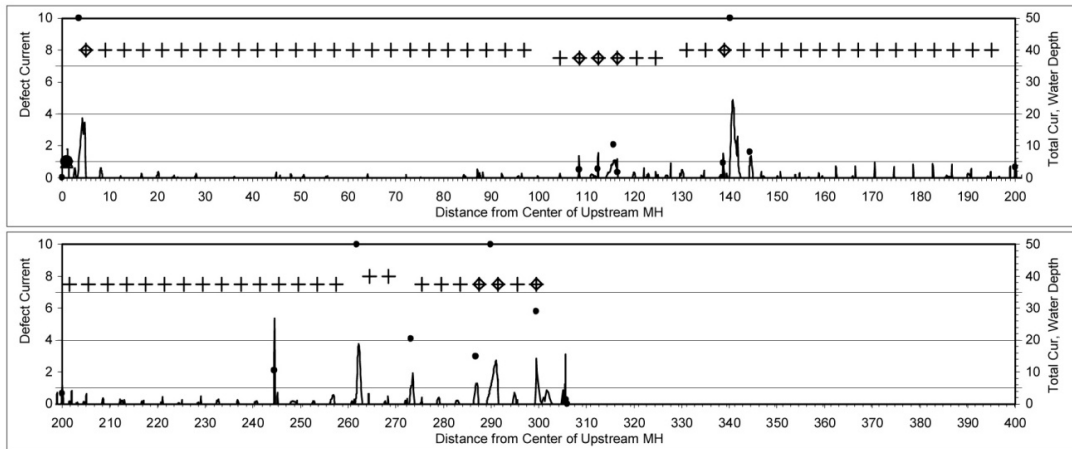
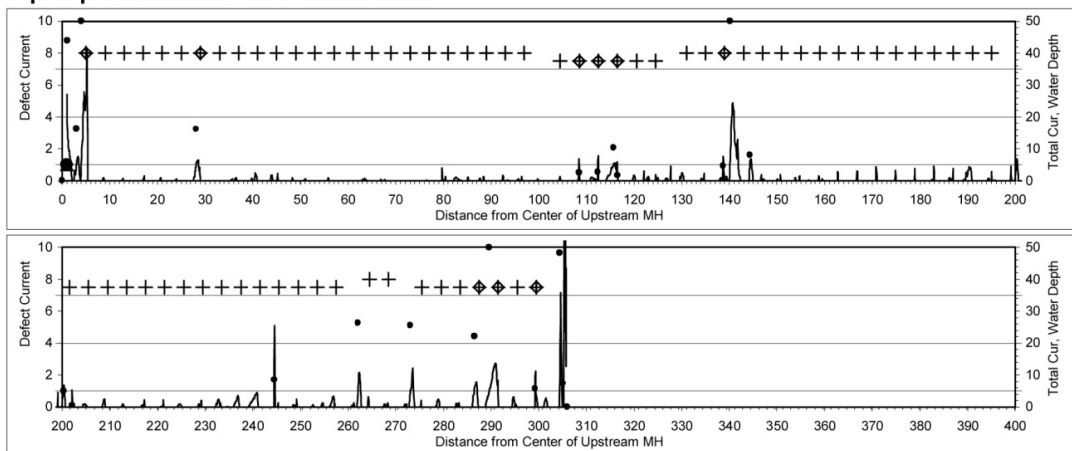
Figure 3. Duplicate electro-scans for pipe segment MH 101 to MH 100.

Scan A: Pipe segment 101 to 100 with ground stake 10 ft from manhole 101 on sewer line

Scan B: Pipe segment 101 to 100 with ground stake 30 ft from manhole perpendicular to sewer line

The two scans were very similar; scan B revealed only three more defects than scan A. The observed differences in results may be attributed to changes in the sonde's travel rate, which occurred at the start and end of the scan. The high current at the end of the second scan may have been caused by a steel pole used to move the probe into the middle of the downstream manhole. Although the ground stake placement varied between the two scans, it was not expected to affect the results.

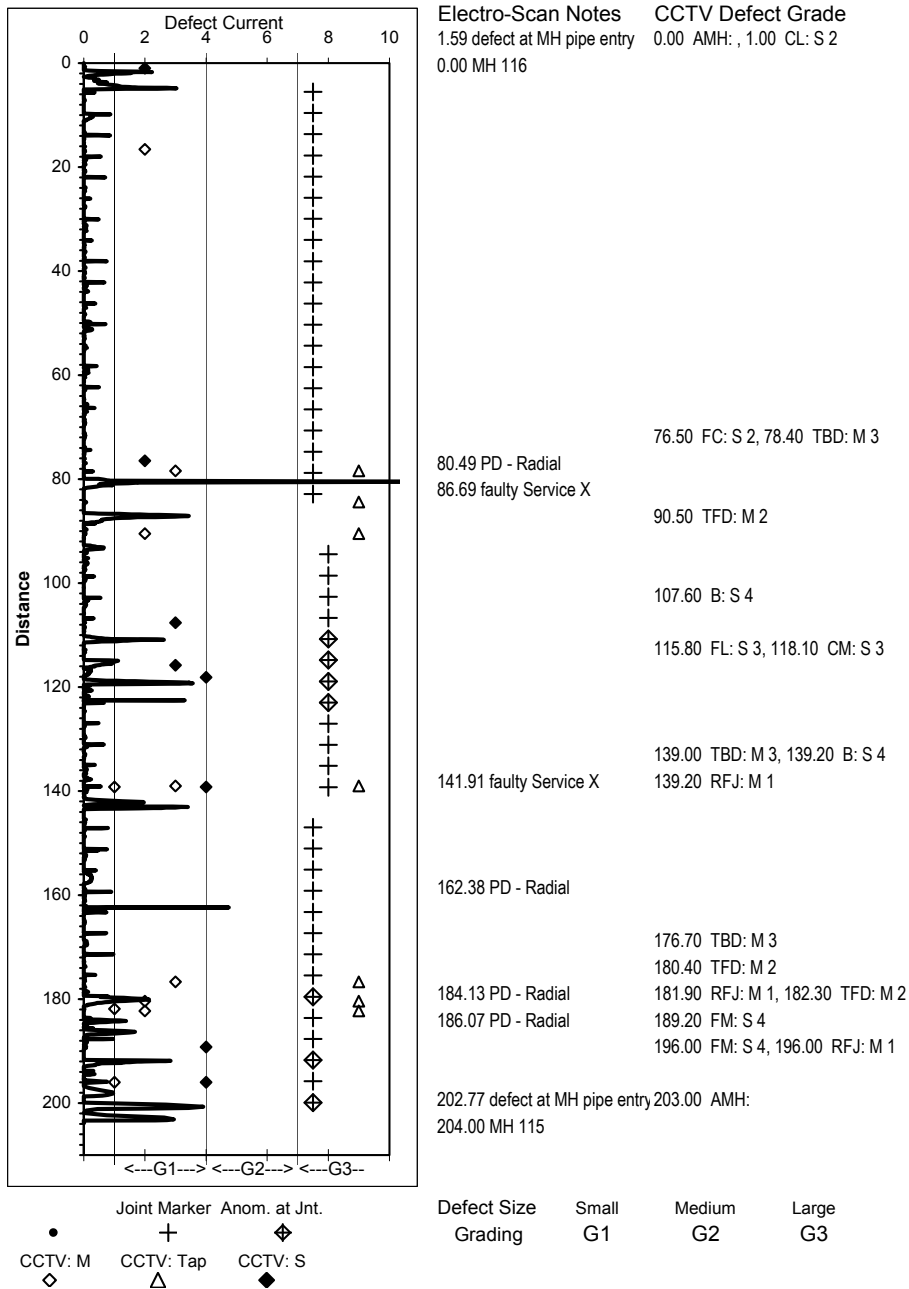
Figure 6. Comparison of CCTV and electro-scanning for pipe segment 116-115

Figures 4-9 show that electro-scanning anomalies generally coincide with CCTV defects and that electro-scanning is effective at detecting pipe locations with leak-related defects. These graphs also illustrate the ability of electro-scanning to find leakage potential that is not observed by CCTV. For example, anomalies occur at some taps that do not appear defective by CCTV (e.g., Figure 7, 47 ft and 124 ft; Figure 9, 24 ft). Among the 17 segments with data for both CCTV and electro-scanning, electro-scanning results showed 42 defective taps, and CCTV identified 45 defective taps (Table 1). If the total number of tap-related anomalies is expanded to include anomalies interpreted as pipe defects (PD) but that occur where CCTV identified a tap, then electro-scanning identified leak potential at 75 of 97 taps. In addition, some electro-scanning anomalies interpreted as pipe defects did not have corresponding CCTV crack defects (e.g., Figure 6, 162 ft; Figure 9, 137 ft).

Some pipe fractures identified by CCTV were not associated with electro-scanning anomalies (e.g., Figure 7, ~73-79 ft; Figure 6, 108 ft). These defects may represent areas where the pipe has deteriorated but is not yet leaking. In such cases, CCTV data are valuable for identifying emerging pipe defects that may become sources of leakage.
