## **Field Demonstration of Electro-Scan Defect Location Technology for Condition Assessment of Wastewater Collection Systems**

Mary Ellen Tuccillo, Ph.D./The Cadmus Group, Charles Wilmut/Burgess & Niple, Inc., Christopher Feeney/P.E./Louis Berger Group, Kathy Martel, P.E./The Cadmus Group, and Ariamalar Selvakumar, Ph.D./USEPA Office of Research and Development Watershed Management Branch

### **ABSTRACT**

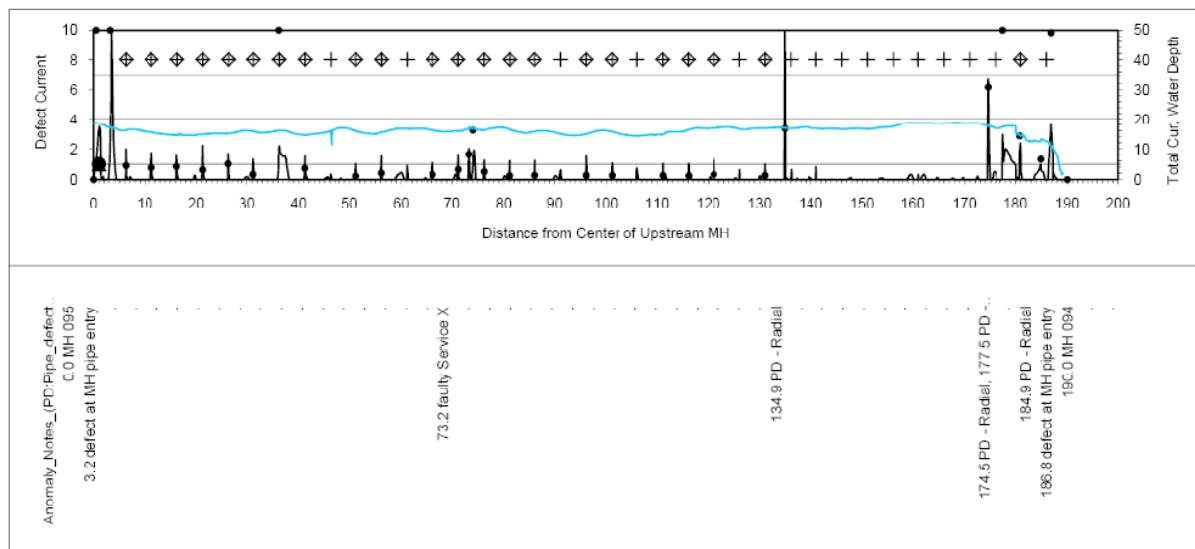
**Figure 2. Electro-scanning results for the pipe segment MH 095 to MH 094.**

Results of electro-scanning are graphed to show the electric current level (in units of 0.0001 Amp) plotted against the distance along the pipe. An example is shown in Figure 2. Levels of the measured electrical current greater than a threshold level are called anomalies and typically appear as spikes on the electro-scan. The shape and amplitude of these anomalies are interpreted to define the type and severity of each defect. Previous studies (e.g., Harris and Tasello, 2006) are used to distinguish between electrical currents that represent normal conditions (i.e., no defect) versus an anomaly (i.e., a potential pipe leak). For example, if pipe joint intervals are known and can be superimposed on the electrode current graph, anomalies that coincide with these joint locations would point to leaky joints. Anomalies that do not match joint locations may represent structural

defects (e.g., cracks in the pipe) or leaks at service connections. The categorization of the magnitude of the anomaly (e.g., small, medium, large) is based on a comparison of electro-scanning results with pressure testing results for pipe joints (Harris and Tasello, 2006). Anomalies with amplitude of 1 to 4 are classified as small defects while anomalies with amplitude of 4 to 7 and greater than 7 are classified as medium or large defects, respectively. Figure 2 shows the computer processed current trace for a pipe segment, with distance along the pipe on the horizontal axis and current level on the vertical axis. The line of crosses at the top represents joint locations. The graph displays numerous small joint defects (diamonds overlaid on the crosses), as well as manhole entry defects, a faulty service connection at 73.2 ft, and a large pipe defect at 134.9 ft. The blue line shows total electric current.

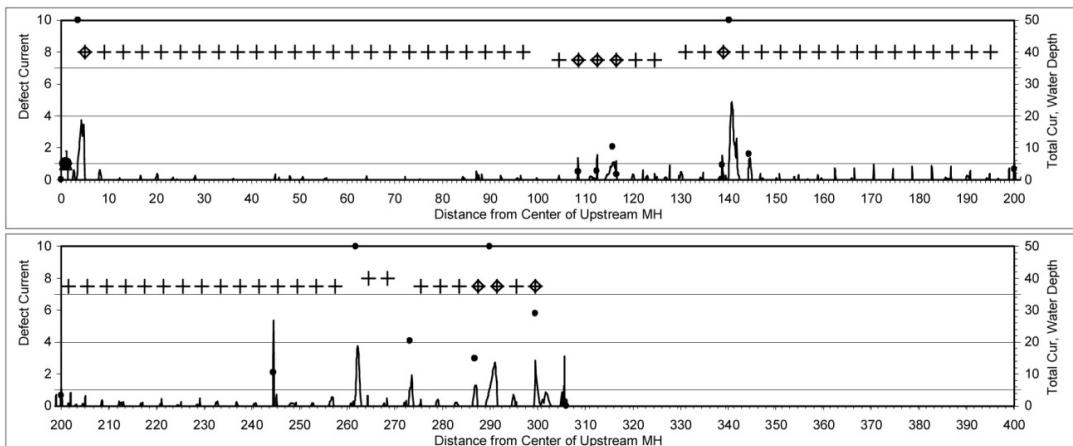
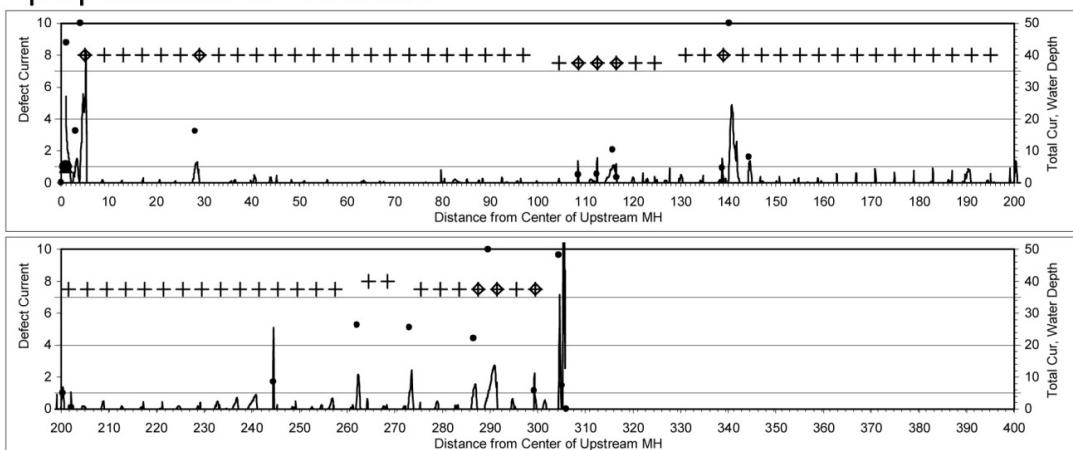
**Figure 3. Duplicate electro-scans for pipe segment MH 101 to MH 100.**

**Scan A: Pipe segment 101 to 100 with ground stake 10 ft from manhole 101 on sewer line**

**Scan B: Pipe segment 101 to 100 with ground stake 30 ft from manhole perpendicular to sewer line**

The two scans were very similar; scan B revealed only three more defects than scan A. The observed differences in results may be attributed to changes in the sonde's travel rate, which occurred at the start and end of the scan. The high current at the end of the second scan may have been caused by a steel pole used to move the probe into the middle of the downstream manhole. Although the ground stake placement varied between the two scans, it was not expected to affect the results.

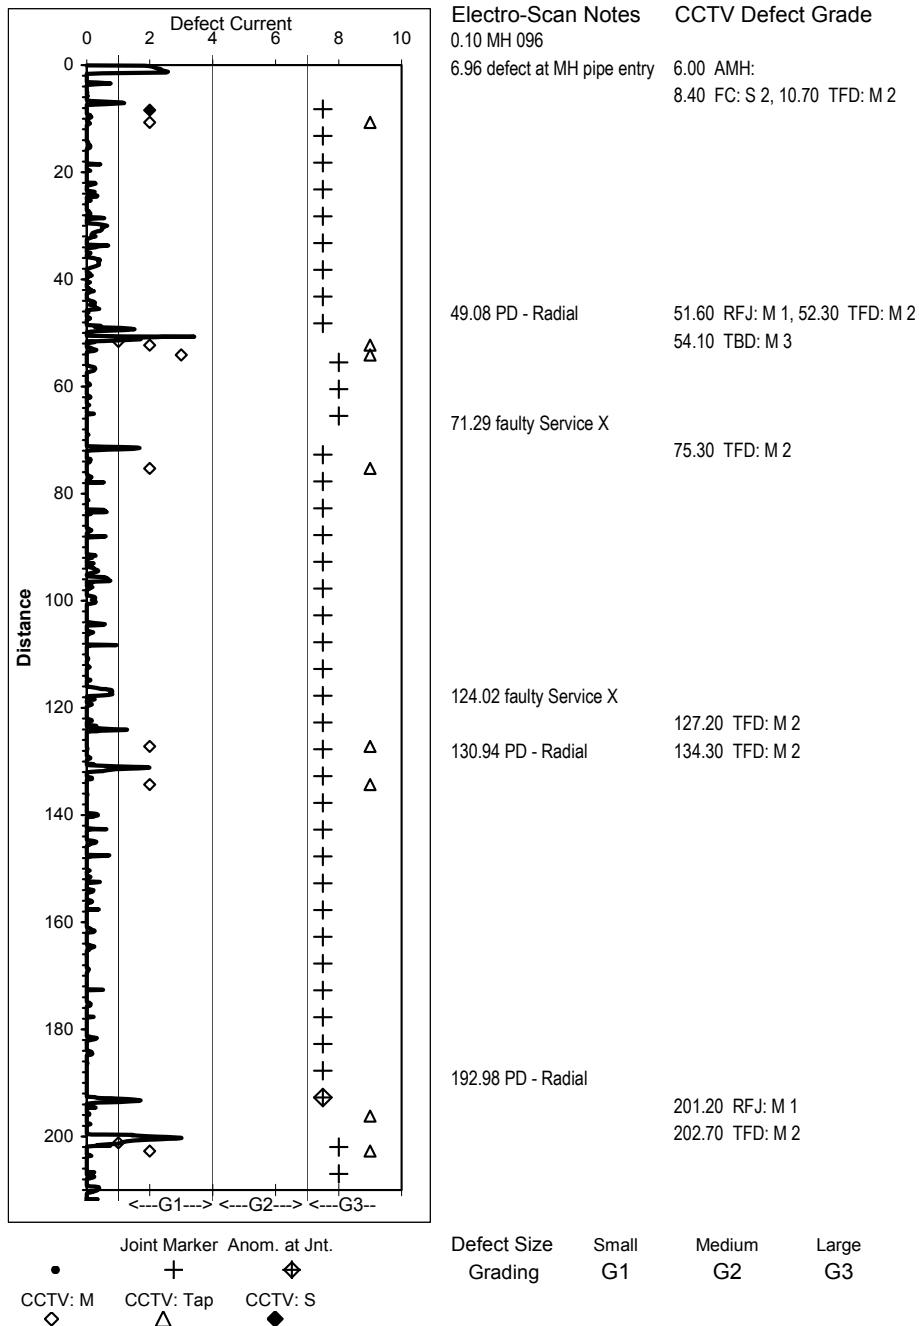
**Figure 4. Comparison of CCTV and electro-scanning for pipe segment 96-95**

**Pipe Segment: MH 096 to 095**

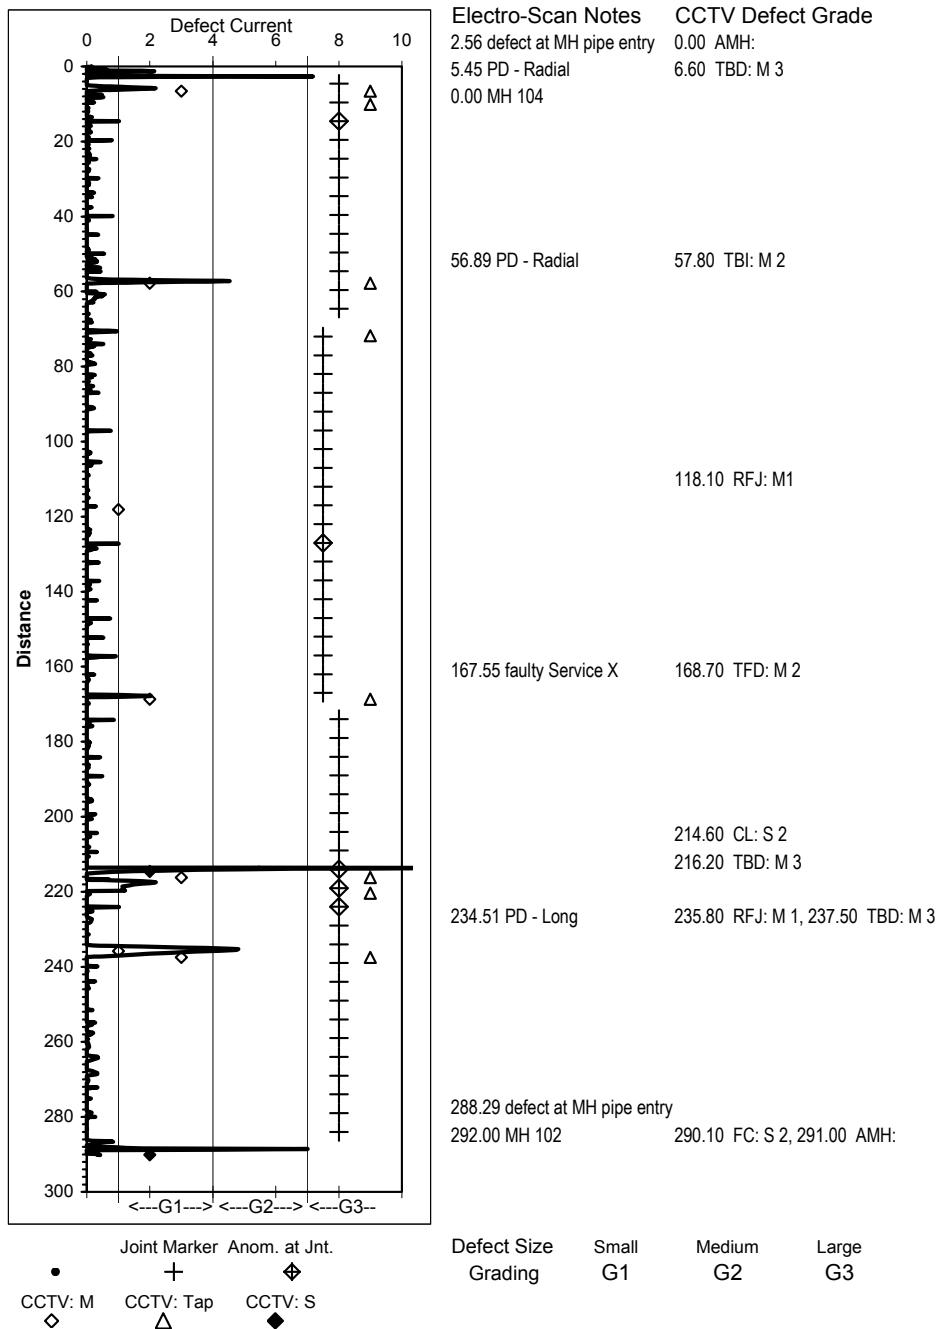
**Figure 5. Comparison of CCTV and electro-scanning for pipe segment 104-102**

**Pipe Segment: MH 104 to 102**

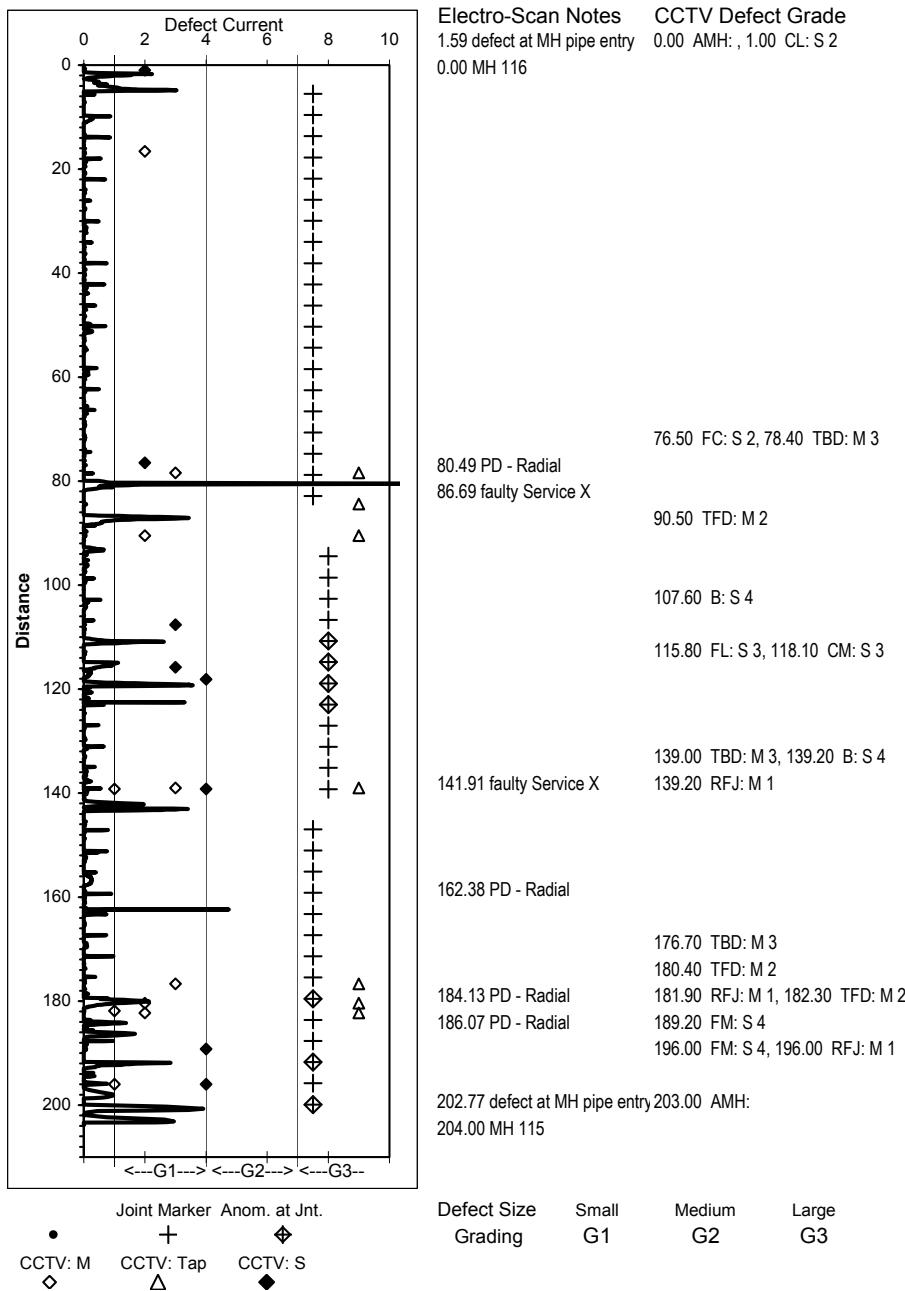
Figure 6. Comparison of CCTV and electro-scanning for pipe segment 116-115

## Pipe Segment: MH 116 to 115

Figures 4-9 show that electro-scanning anomalies generally coincide with CCTV defects and that electro-scanning is effective at detecting pipe locations with leak-related defects. These graphs also illustrate the ability of electro-scanning to find leakage potential that is not observed by CCTV. For example, anomalies occur at some taps that do not appear defective by CCTV (e.g., Figure 7, 47 ft and 124 ft; Figure 9, 24 ft). Among the 17 segments with data for both CCTV and electro-scanning, electro-scanning results showed 42 defective taps, and CCTV identified 45 defective taps (Table 1). If the total number of tap-related anomalies is expanded to include anomalies interpreted as pipe defects (PD) but that occur where CCTV identified a tap, then electro-scanning identified leak potential at 75 of 97 taps. In addition, some electro-scanning anomalies interpreted as pipe defects did not have corresponding CCTV crack defects (e.g., Figure 6, 162 ft; Figure 9, 137 ft).

Some pipe fractures identified by CCTV were not associated with electro-scanning anomalies (e.g., Figure 7, ~73-79 ft; Figure 6, 108 ft). These defects may represent areas where the pipe has deteriorated but is not yet leaking. In such cases, CCTV data are valuable for identifying emerging pipe defects that may become sources of leakage.

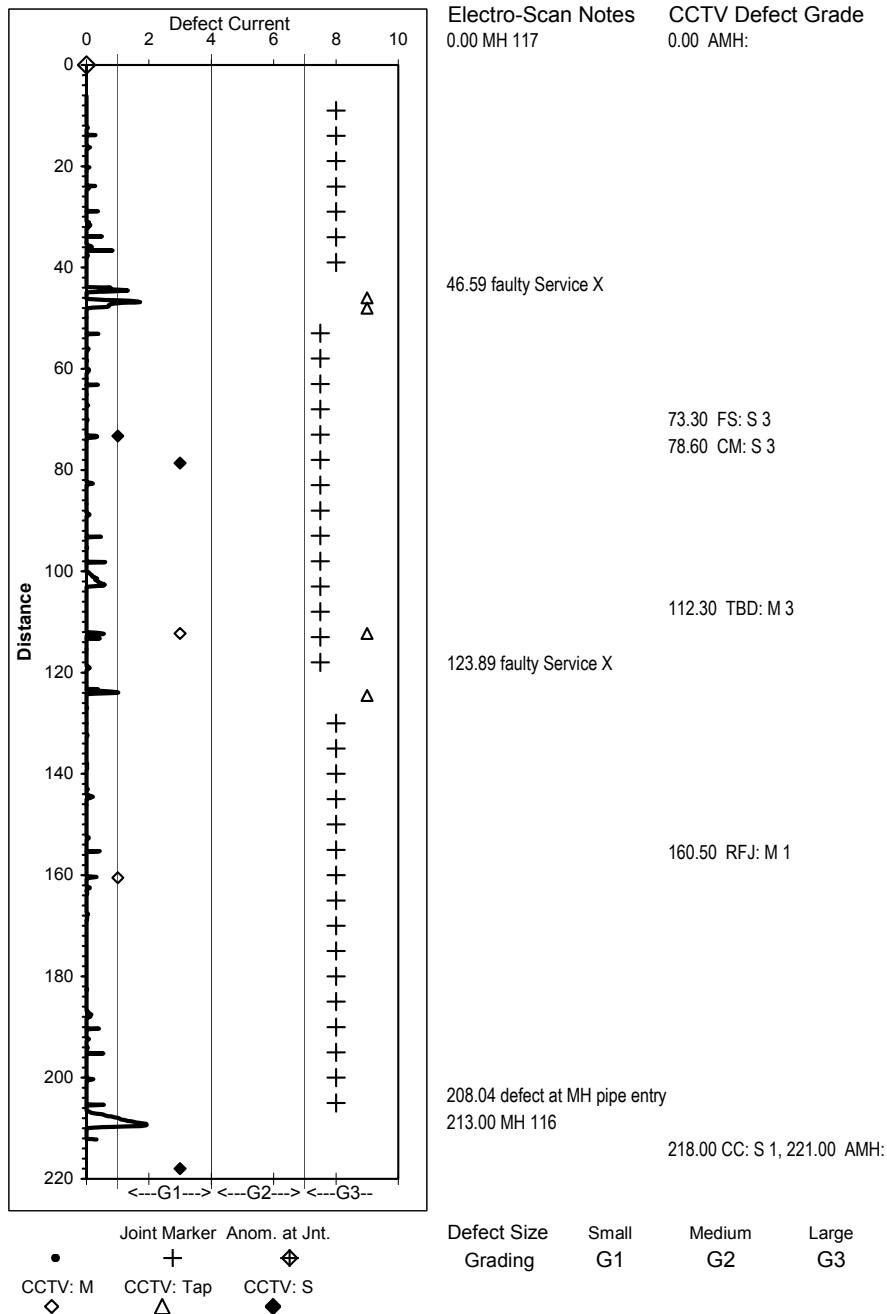
**Figure 7. Comparison of CCTV and electro-scanning for pipe segment 117-116**

**Pipe Segment: MH 117 to 116**

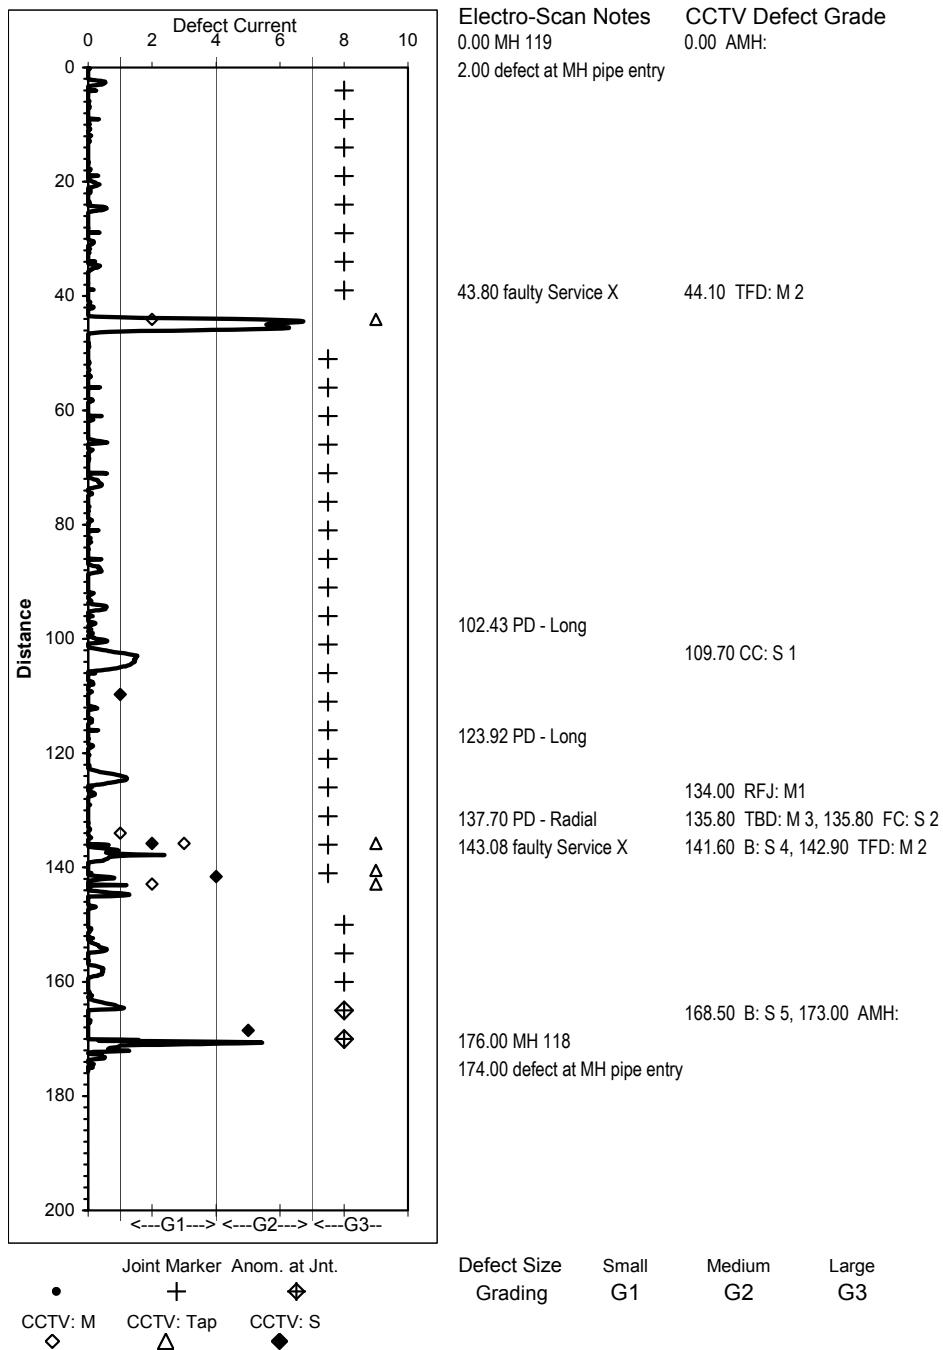
**Figure 8. Comparison of CCTV and electro-scanning for pipe segment 119-118**

**Pipe Segment: MH 119 to 118**

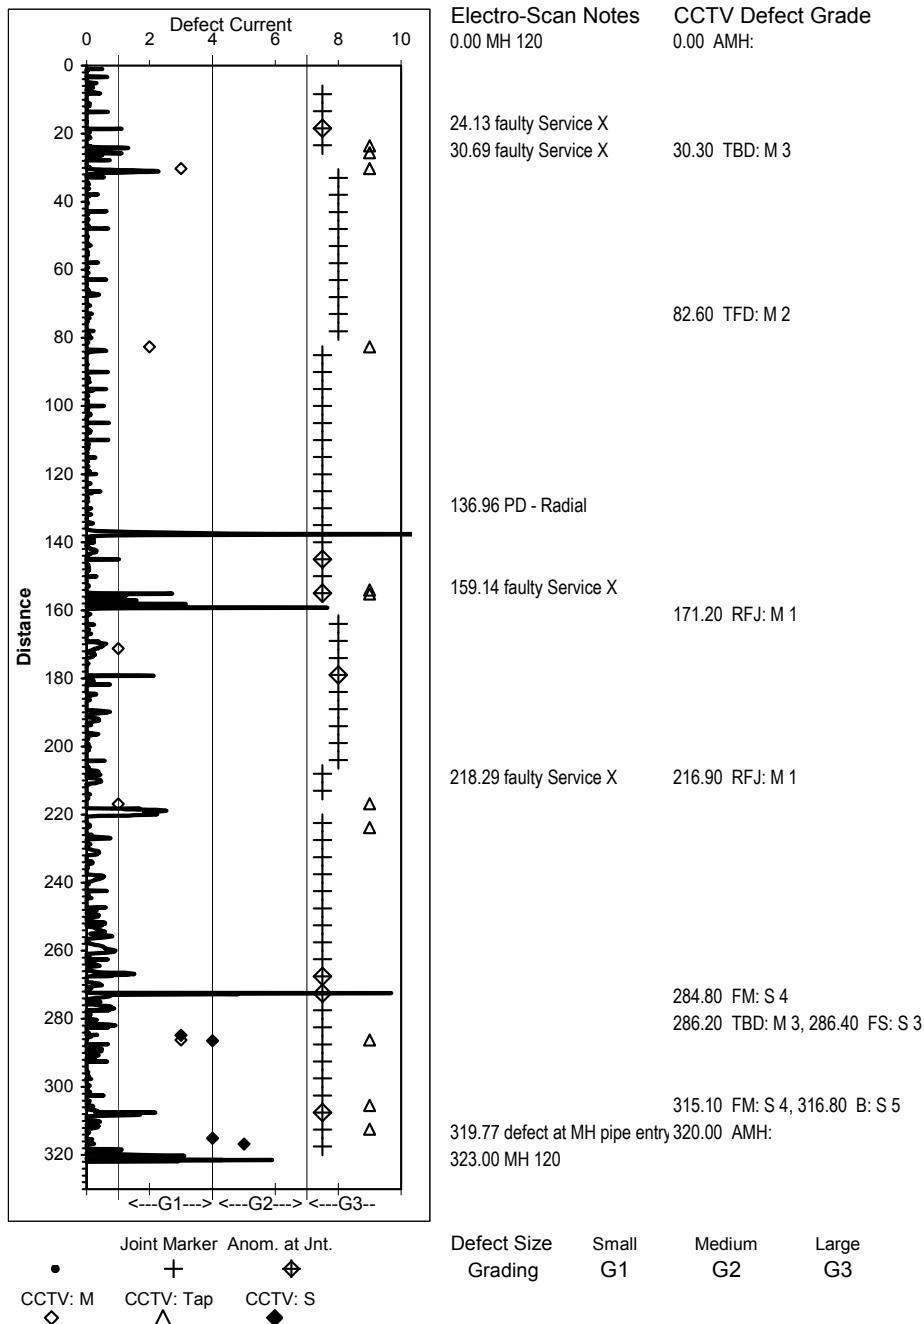
**Figure 9. Comparison of CCTV and electro-scanning for pipe segment 120-119**

**Pipe Segment: MH 120 to 119**
