# **Field Demonstration of Condition Assessment Technologies for Wastewater Collection Systems**

**Kathy Martel, P.E.  
The Cadmus Group, Inc.**

**Contract No. EP-C-05-058  
Task Order No. 59**

**National Risk Management Research Laboratory  
Office of Research and Development  
U.S. Environmental Protection Agency  
Cincinnati, Ohio 45268**

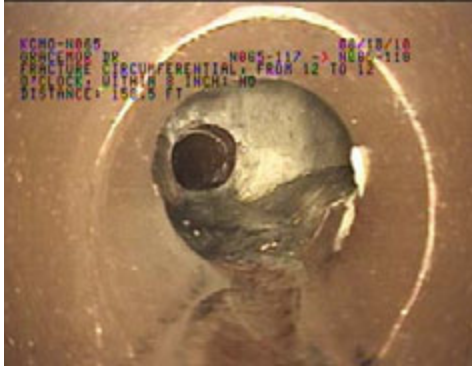
(a) Circumferential Fracture, Grade 2 Defect

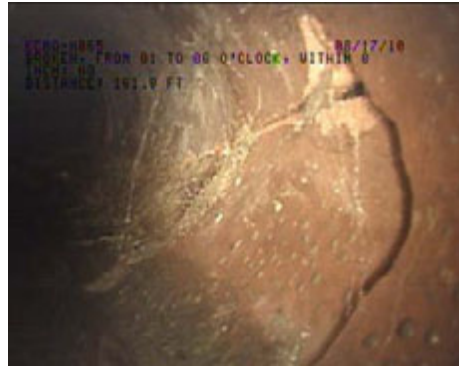
(b) Broken Pipe, Grade 5 Defect

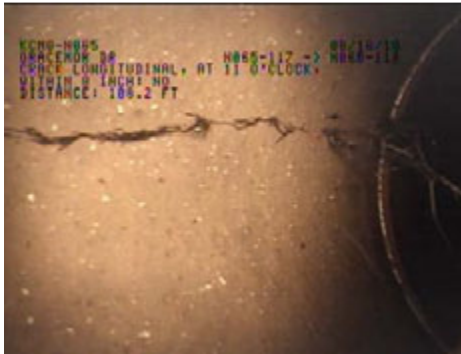
(c) Longitudinal Crack, Grade 2 Defect

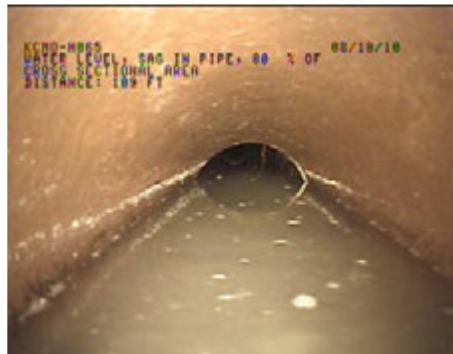
(d) Pipe Sag, Grade 5 Defect

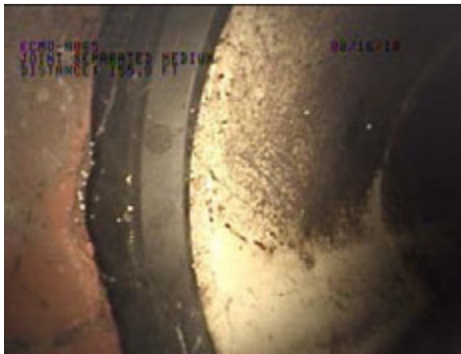
(e) Separated Joint, Grade 1 Defect

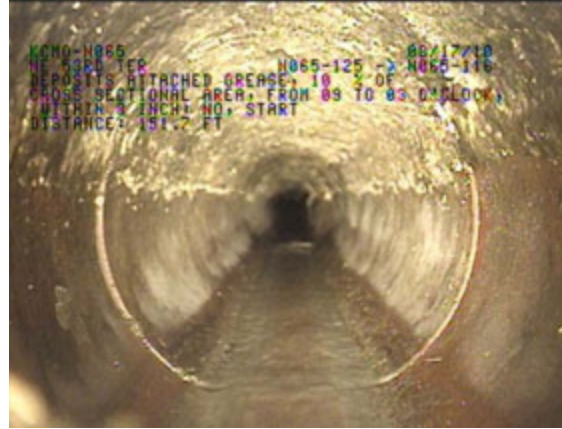
(b) Grease Deposit, Grade 2 Defect

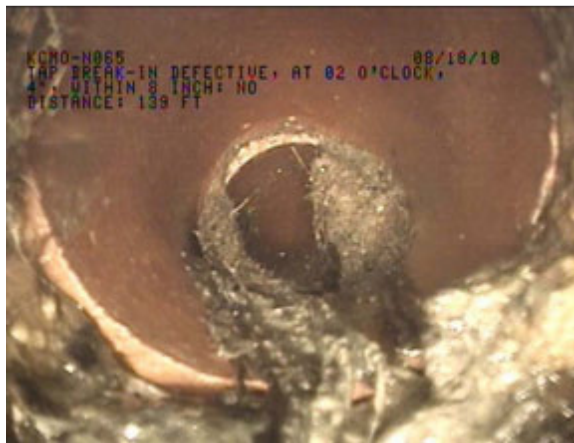
(c) Defective Tap, Grade 3 Defect

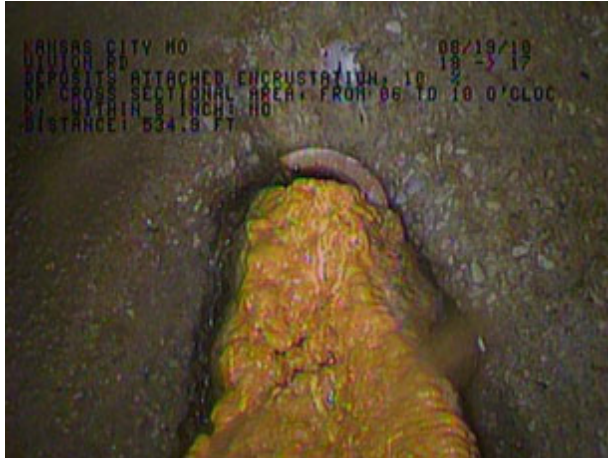
(a) Encrustation Grade 2 Defect

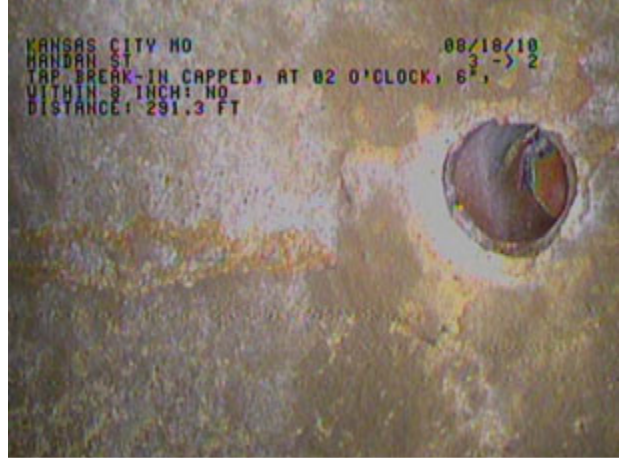
(b) Damaged Service Tap, Grade 2 Defect

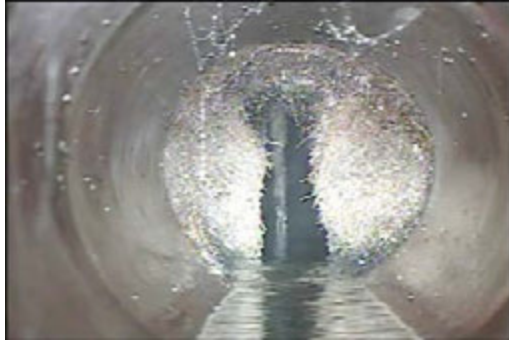
**Figure 5-4. Grade 4 Root Intrusion (Maintenance Defect) in MH 100-101 Identified from Zoom Camera Images in the Gracemor Area.**  
(Photos Courtesy of TREKK Design Group)

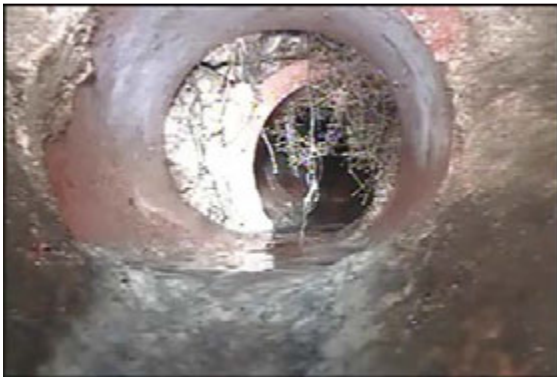
(a) Grade 2 Off-set joint in MH 136-137

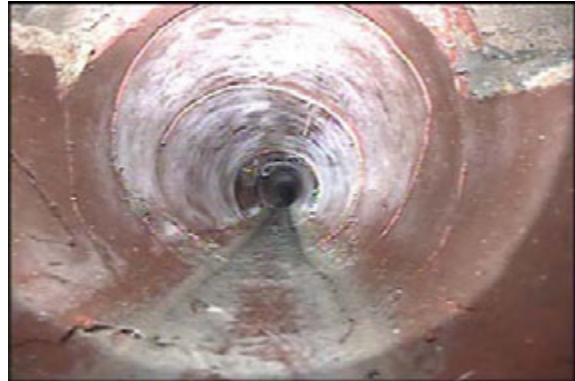
(b) Grade 2 Circumferential Fracture in MH 125-127

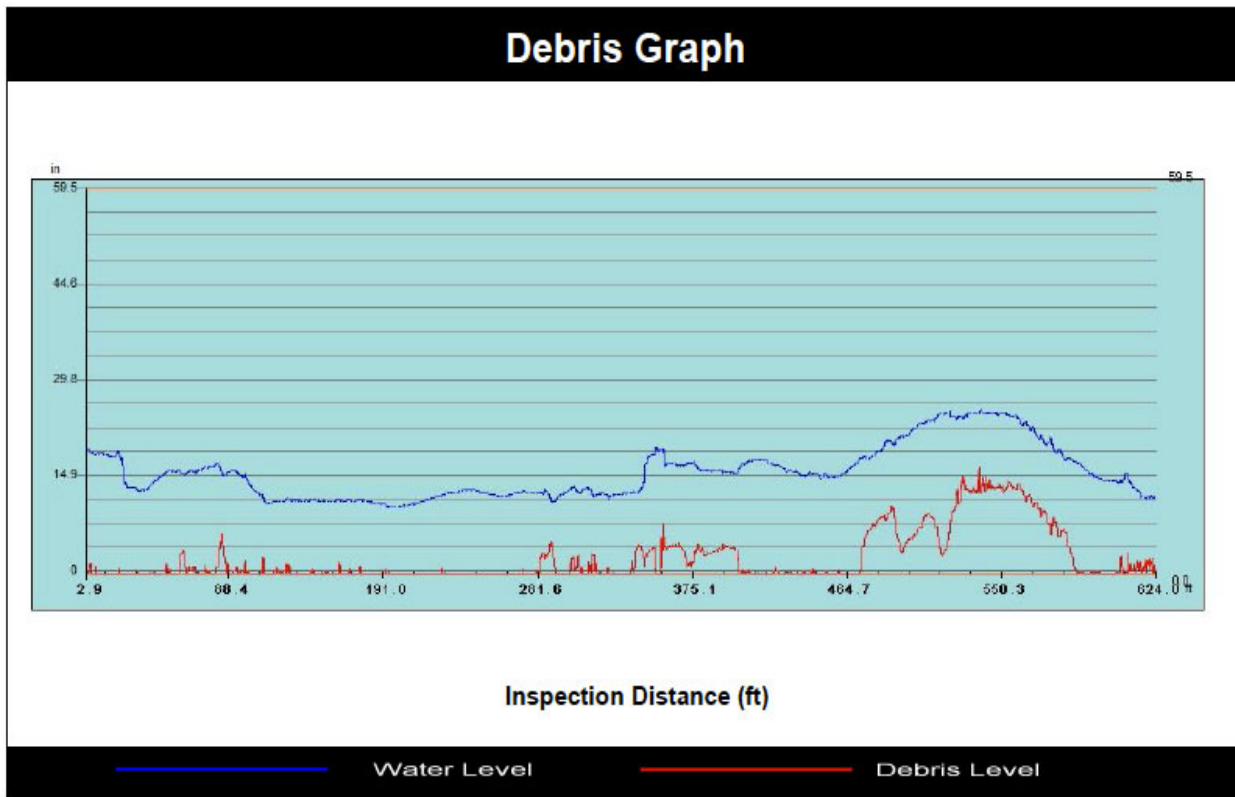
The sonar scan results provide information on the depth and location of debris (e.g., sediment) in the pipe. For example, in the pipe segment between SMH 3 and 2 (Figure 5-11), the deepest accumulation of debris appears to be located at a distance of 550-ft downstream of SMH 3. The debris graph provides information that aids the utility in soliciting accurate bids for pipe cleaning.

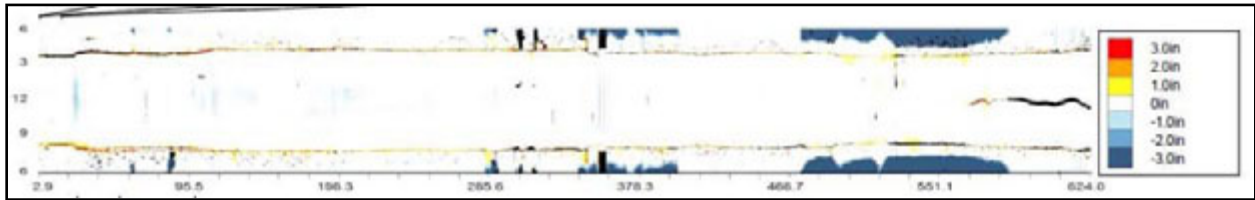
**Figure 5-12. Flat Graph™ for Pipe Segment from SMH 1- 18.**

Figure 5-12 provides an example of the Flat Graph™ for the pipe segment between SMH 1 and 18. The graph shows that debris, as denoted in dark blue, had accumulated to a thickness of 3-in. at the invert location (i.e., six o'clock) between 470-ft and 580-ft downstream of SMH 1. Figure 5-12 also shows that corrosion loss of approximately 1-in., denoted in yellow, occurred at the same location.

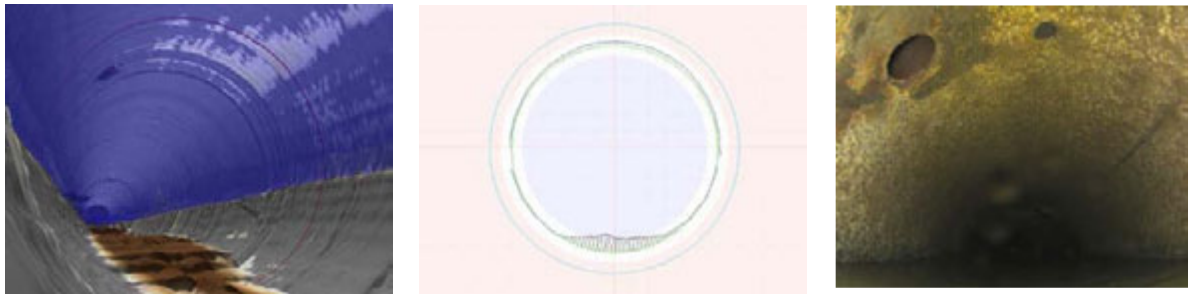
A more detailed view of the pipe cross-section is provided by three distinct images (Figure 5-13) at the same location along the pipe (approximately 516-ft to 518-ft downstream of SMH 1). Together, the images show location and cross-sectional area of debris and corrosion loss, and a service connection at the pipe crown.

(a) 3D image at 518.1-ft (b) cross-sectional graphic at 517-ft (c) HD image of the pipe crown at 516.5-ft.

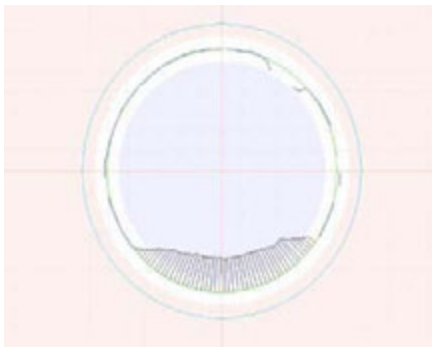
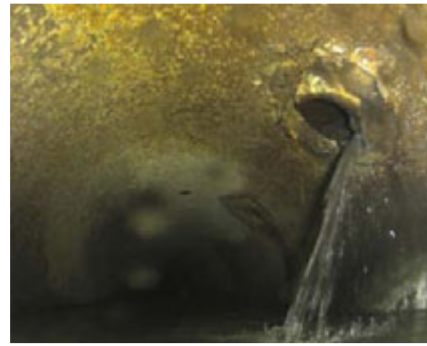
**Figure 5-14. Cross-Sectional and HD Images of 2.5-in. Protruding Lateral at 528.4-ft.**

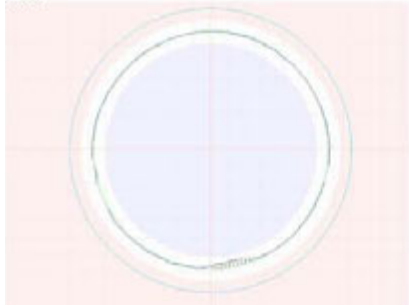
0ft General Observation - Corrosion to 0.5", Debris to 0.9"

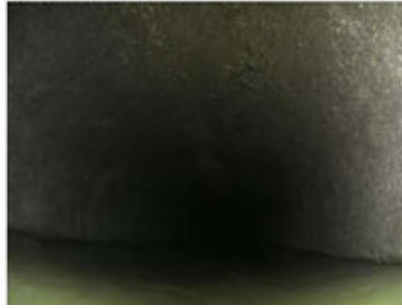
0ft General Observation - Debris to 0.9"

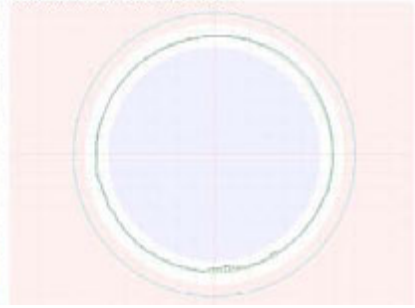
18.7ft Maximum Corrosion - To 0.8"

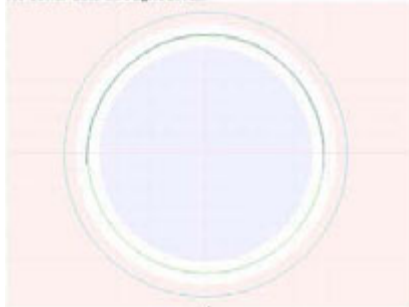
0ft General Observation - Corrosion to 0.5"  
No sonar data throughout run

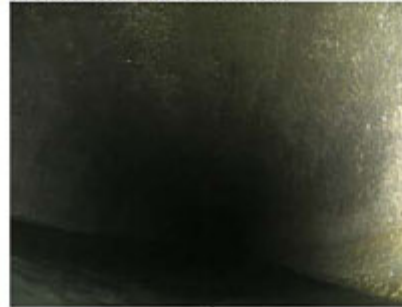
0ft General Observation - Corrosion to 0.5"

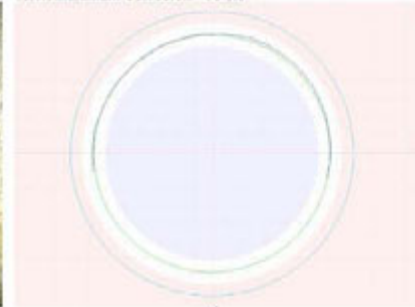
18.1ft Maximum Corrosion - To 0.8"

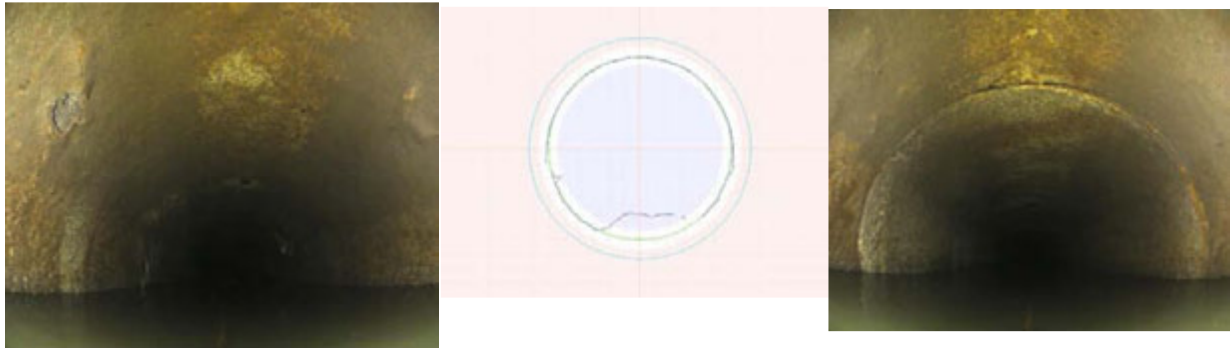
**Figure 6-14. Images from Multi-sensor Inspection 148-ft to 150-ft Downstream of MH 2 (left) Evidence of Delamination, (middle) Cross-Sectional View of Debris Accumulation; and (right) Corrosion at Pipe Crown.**

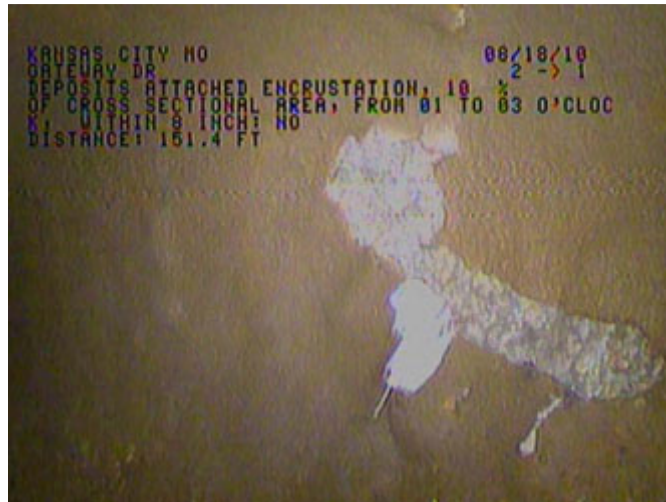
**Figure 6-15. CCTV Data 150-ft Downstream of MH 2 Showing Encrustation Deposit.**
