SEWER ELECTRO-SCAN  
CEDAR CREEK STREAM CROSSINGS  
CITY OF OLATHE  
KANSAS  
JULY 2011

CH2M HILL INC  
PO Box 241329  
Denver, CO 80224

LEAK BUSTERS, INC  
3157 Bentley Drive  
Rescue  
California, 95672  
Phone 530 558 5241

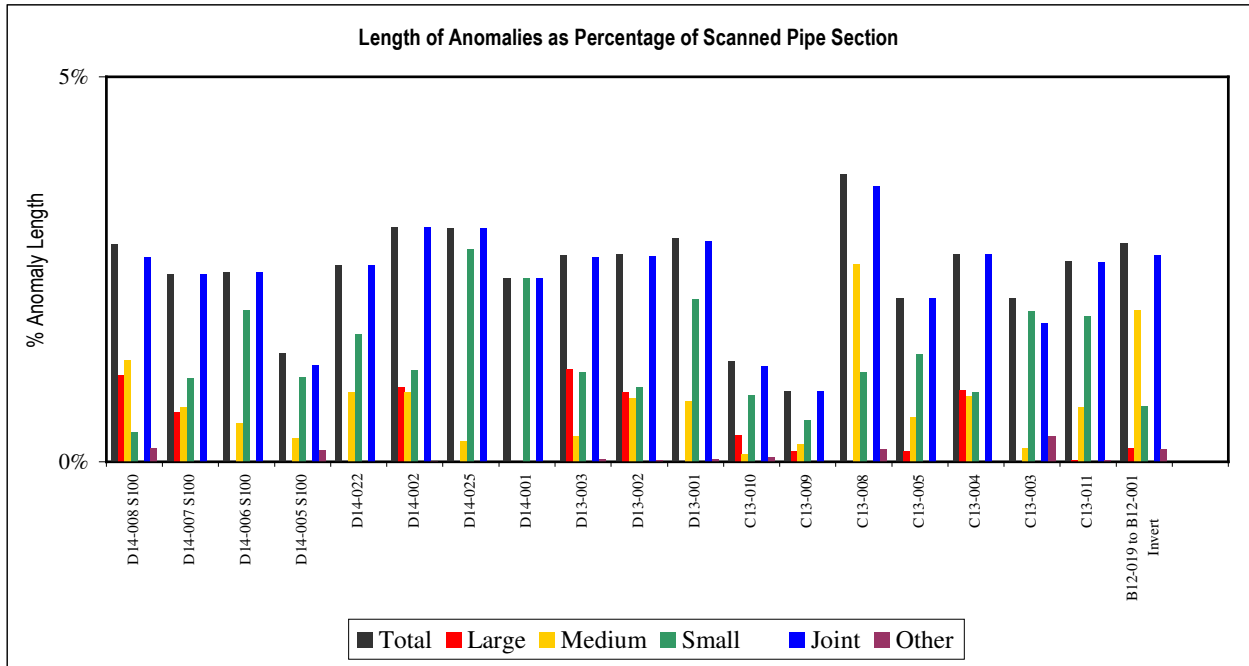
**Figure 3. Anomaly Graphic Summary**

The anomaly graphic summary using the “percentage of anomaly length per length of scanned pipe” shows at a glance the relative occurrence and size of the anomalies. From this information it is straight forward to make an assessment of the relative potential leakage for each pipe section electro-scanned and prioritize rehabilitation programs. The graphic summary also shows the distribution of the defects between joint defects and other faults such as pipe cracks. This analysis may assist the design of a rehabilitation program.

The anomaly analysis shows that pipe sections D14-008, D14-007, D14-002, D13-003, D13-002, C13-008, C13-004 and B12-019 to B12-001 have the largest leak potential. It is possible that the repair of these pipe sections would reduce infiltration to an acceptable level.

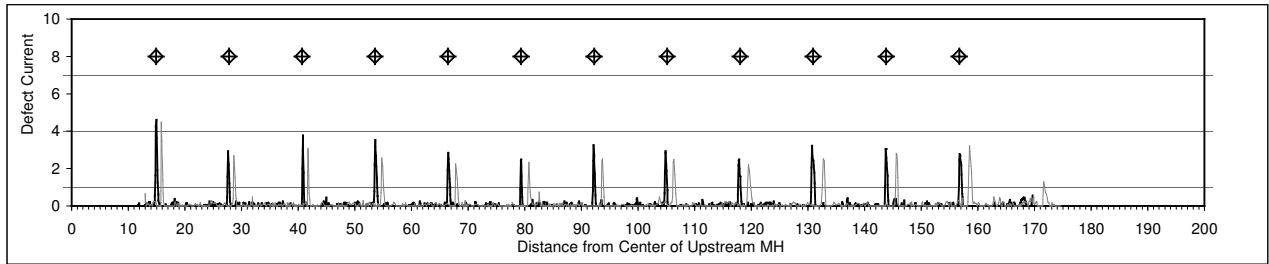
#### Electro-scans with the Pipe Full in Both Directions: Pipe Section D14-025

Note that the significant parameter on the scan is the maximum value of the anomalies. The scans show some small differences. This can be attributed to the speed at which the probe is pulled downstream by hand was not as closely controlled as when it is pulled upstream by the electric power winch. Also the measurement system records a value every 0.5 inch as the probe moves along the pipe. That is each measurement is not exactly at the same location for each of the scans. The location of the current measurement for each scan could vary by +/- 0.25 inch.

Taking into account these factors, the comparison of these electro-scans shows a high degree of repeatability of the electro-scan.

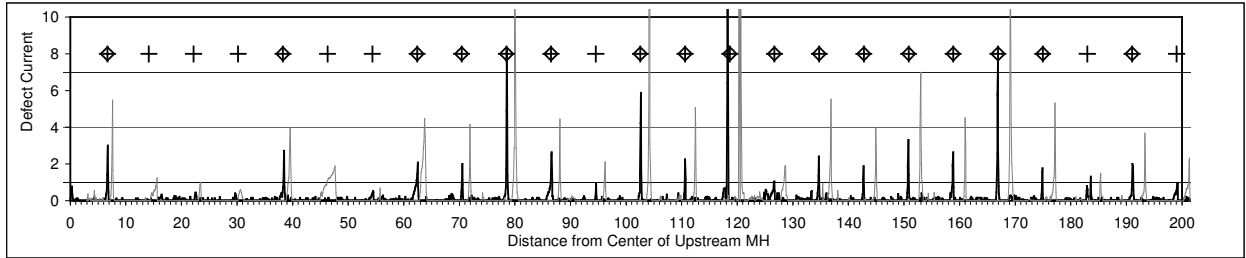
#### Electro-scans of Full and Part Full Pipe: Pipe Section C13-010

Note that the significant parameter on the scan is the maximum value of the anomalies. The most apparent difference is the significant number of larger anomalies on the part full pipe scans. This maybe due to the reduction of electrical current distribution density when the pipe is full. If this is the case then it is possible that the defects that show the larger anomalies are larger on the invert of the pipe than on the crown.

This comparison shows that for a pipe condition analysis involving a number of pipe sections it is not appropriate to compare electro-scans of full pipes with partly full pipes.

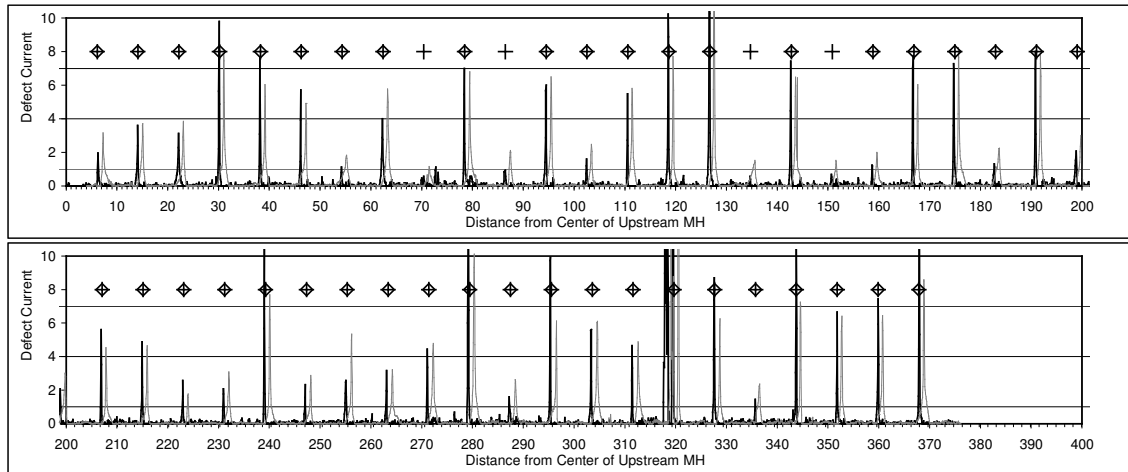
#### Comparison of Electro-Scans with S100 Probe and the S50 Probe: Pipe Section D14-008

Note that the significant parameter on the scan is the maximum value of the anomalies. The scans show that the S100 probe is slightly more effective at detecting the low level defects close to the Threshold. At higher defect current levels there are only minor differences where the maximum value of the anomalies measured by the S50 probe are sometimes slightly larger and sometimes slightly smaller than that measured by the S100 probe. This can be attributed to the measurement system that records a value every 0.5 inch as the sonde moves along the pipe. That is each measurement is not exactly at the same location for each of the scans. The location of the current measurement for each scan could vary by +/- 0.25 inch.

Failure of the electro-scan equipment due to an abraded cable and water leakage caused a field operations delay of one and half days and the use of the S50 probe instead of the S100 probe. A repeat electro-scan of pipe section D14-008 showed that this did not significantly degrade the results.

There were a number of anomalies with a maximum greater than 10 (off-scale); for example at 320-ft on pipe section D14-008. Targeted spot repair of these locations may also significantly reduce infiltration.

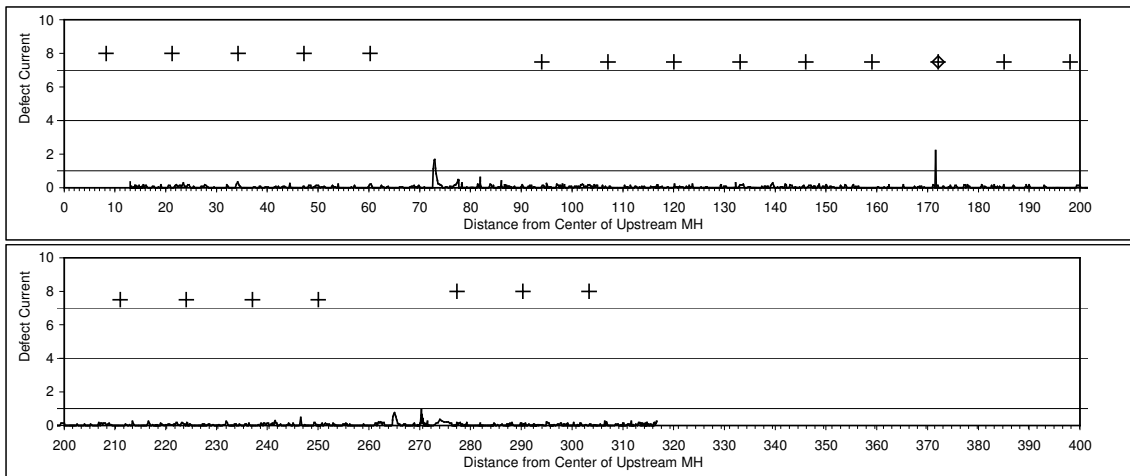
#### Electro-scan with Probe on Pipe Crown: Pipe Section B12-019 to B12-001

The crown electro-scan shows no joint anomalies except at 172-ft while the invert electro-scan shows anomalies at every joint. The only other anomaly shown by the crown electro-scan is at 73-ft. This corresponds with the manhole pipe entry and an anomaly on the invert electro-scan. There are two anomalies below the threshold each side of MH B12-018 at 269-ft on the crown electro-scan that correspond with anomalies on the invert electro-scan. This suggests that the defects associated with these manhole anomalies extend around the entire circumference of the pipe while the joint anomalies shown on the crown electro-scan only extend around part of the circumference.
