Sewer Leak Detection – Electro-Scan Adds a New Dimension

Abstract

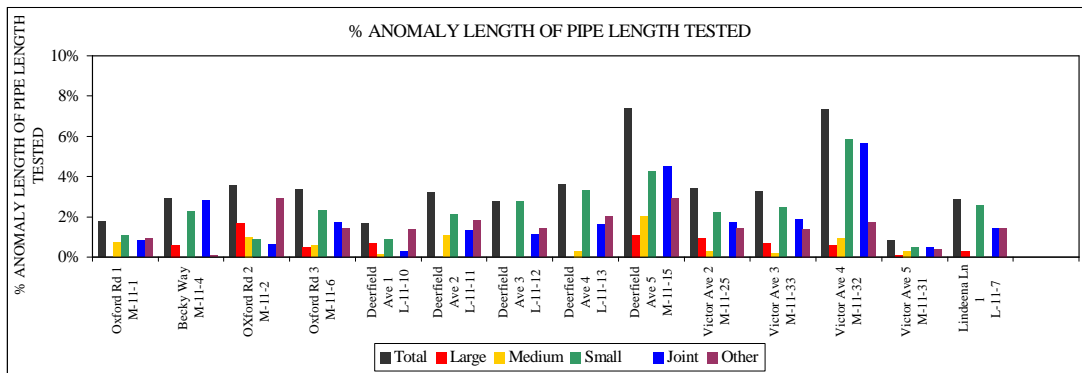
Figure 3. Electro-Scan Histogram Redding Pilot Study

Electro-scan Histograms were generated for all the electro-scan data collected. An example summarizing 14 pipe sections and about 4,200 ft of pipe is shown in Figure 3. It is observed that Victor Ave 4 and Deerfield Ave 5 have the greatest percentage of defects.

Oxford Rd 2, Deerfield Ave 1 and Lindeena Ln 1 also show a significant percentage of defects graded as large and other indicating that these pipe sections have a few large defects, possibly associated with service connections. It was considered likely that spot repairs might significantly reduce the infiltration volume from these pipe sections.

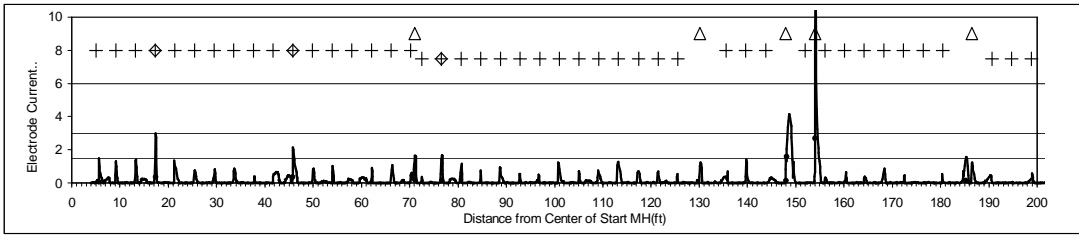
Figure 4. Electro-Scan: Lindeena Ln 1, Redding Pilot Study

Figure 4 is part of the Electro-Scan current trace of Lindeena Ln 1 This trace shows very small anomalies below the threshold level at most of the joints. There are small anomalies at three joints. The service connection locations are marked with “△”. The Electro-Scan shows that the most significant pipe defects occur at the service connections located at 45 m (149 ft) and 47 m (155 ft).

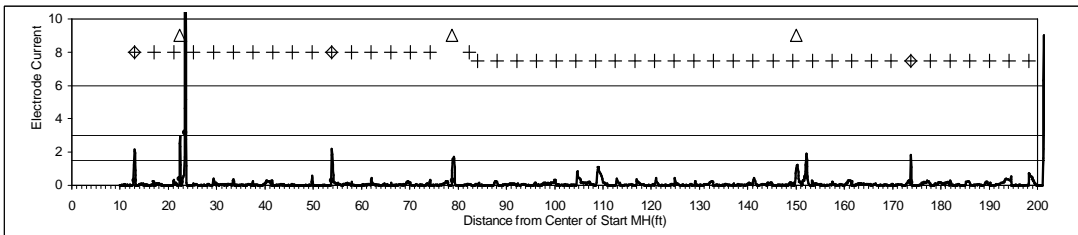
Figure 5. Electro-Scan: Deerfield Ave 1, Redding Pilot Study

Figure 5 is part of the Electro-Scan current trace of Deerfield Ave 1. This trace shows very small anomalies below the threshold level at many of the joints. There are small anomalies at three joints. The Electro-Scan shows that the most significant pipe defect occurs at the service connection located at 6.7 m (22 ft).

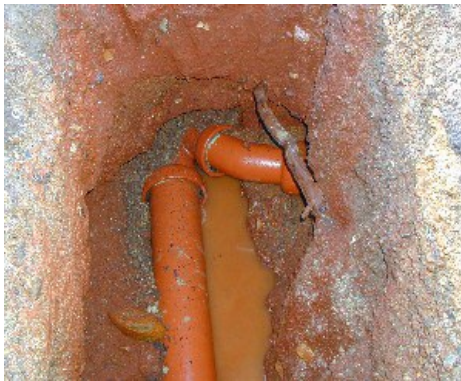
**Figure 6. Spot-Repair
Lindeena Ln 1**

Pipe defects were found and repaired at each of the selected locations. The position given by the electro-scan was accurate thus enabling the maintenance crews to make repairs efficiently. Figure 6 shows the faulty service connection joint at Lindeena Ln 1. Figure 7 shows the service connection at Deerfield Ave 1. This connection leaked because the steel bands were loose.
