## Benchmark Demonstration: Comparison of WRc-based CCTV Inspections v. Electro Scanning

Topsham, England  
8 November 2012

Presented in Cooperation with  
South West Water  
Pell Frischmann, and  
Electro Scan Inc.

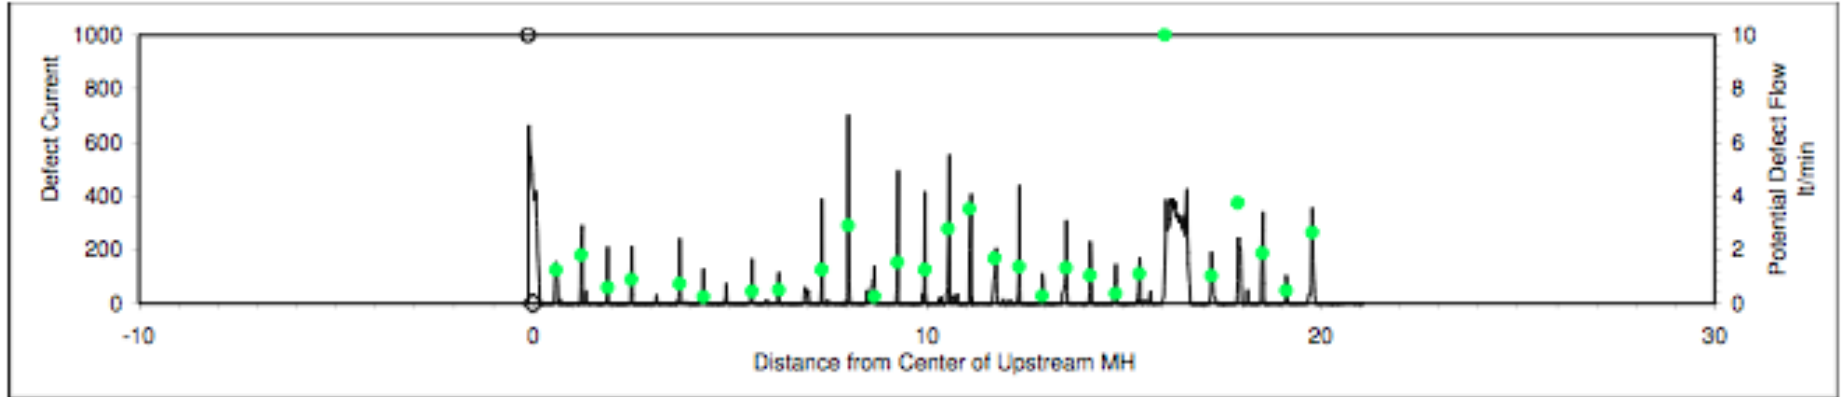
# Run 1 Analysis

**ANOMALY ANALYSIS**

Anomaly Picking Threshold	100.00	Grade Current Levels	Number	Length	% Length of Pipe Tested	% of Total Anomaly Length
Grade	Large	>700	1	0.0	0%	1%
	Medium	700 to 400	6	0.7	3%	72%
	Small	<400	21	0.3	1%	27%
	Total		28	1.0	5%	100%

Grade Flow Levels	Number	Flow It/min	Flow It/sec
>15	1	40.7	0.6783
15 to 5	0	0.0	0.0
<5	27	36.8	0.6133
<1	28	77.5	1.2916

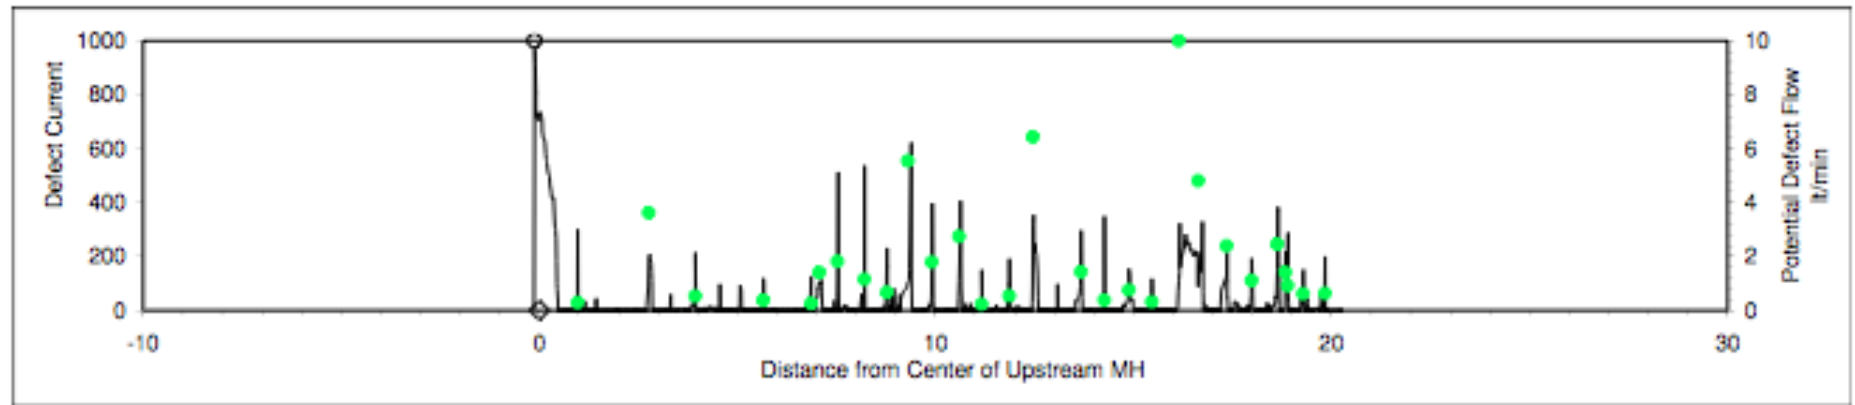
# Run 2 Analysis

ANOMALY ANALYSIS						
Anomaly Picking Threshold	100.00	Grade Current Levels	Number	Length	% Length of Pipe Tested	% of Total Anomaly Length
Grade	Large	>700	0	0.0	0%	0%
	Medium	700 to 400	4	0.2	1%	13%
	Small	<400	24	1.0	5%	87%
	Total		28	1.2	6%	100%

Grade Flow Levels	Number	Flow It/min	Flow It/sec
>15	1	23.0	0.3833
15 to 5	2	12.0	0.2000
<5	25	32.6	0.5433
<1	28	67.6	1.126

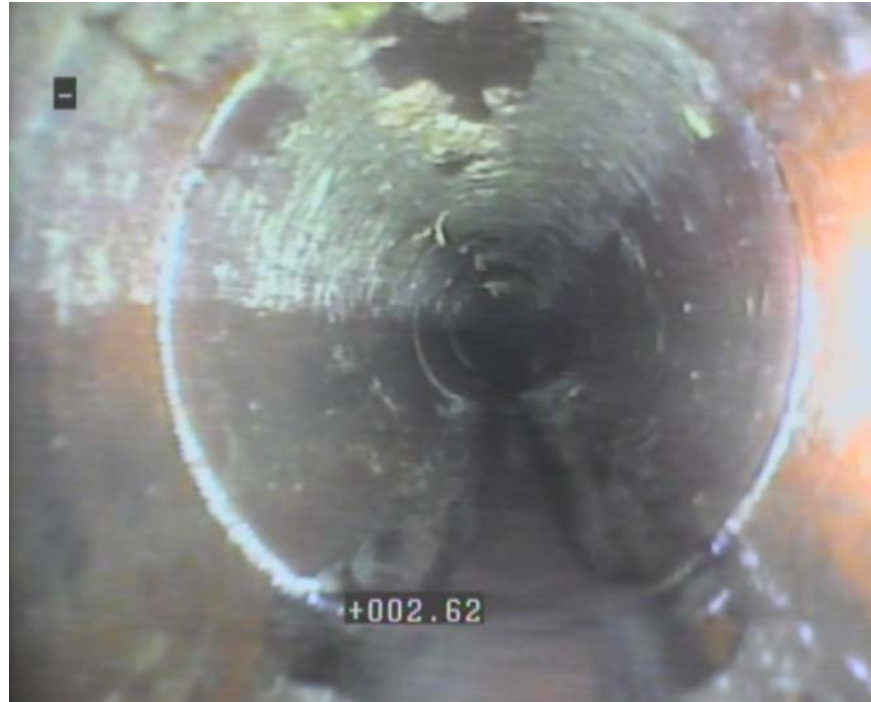
# Defect Identified: Joint Defect

CCTV Call Out: None

Defect Start (m)	Defect End (m)	Defect Length (mm)	Defect Max Current	Defect Severity
2.79	2.88	90	249	S

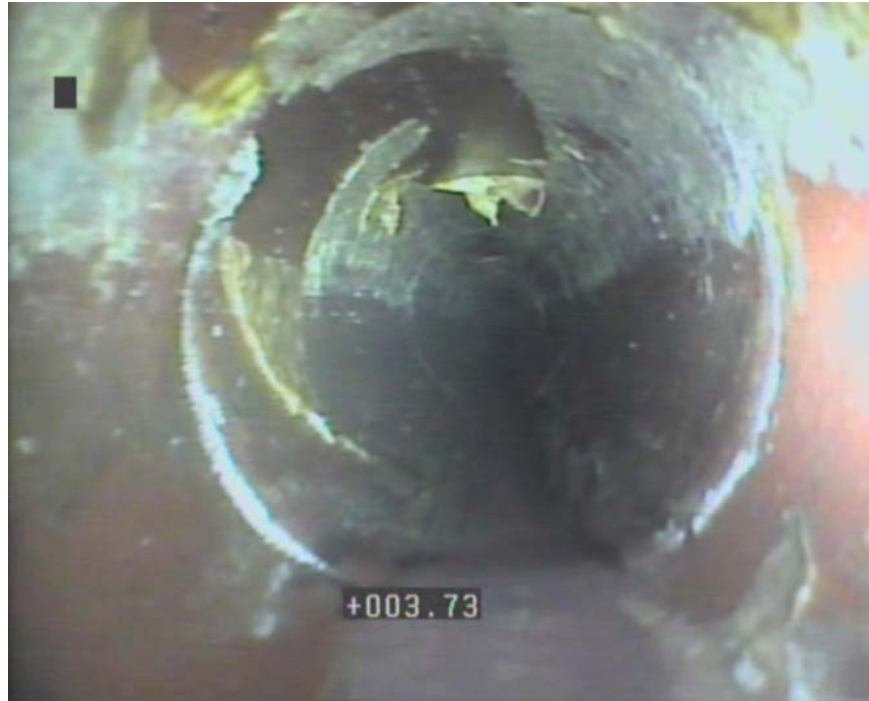
# Defect Identified: Joint Defect

CCTV Call Out: None

Defect Start (m)	Defect End (m)	Defect Length (mm)	Defect Max Current	Defect Severity
3.951	3.951	0	161	S

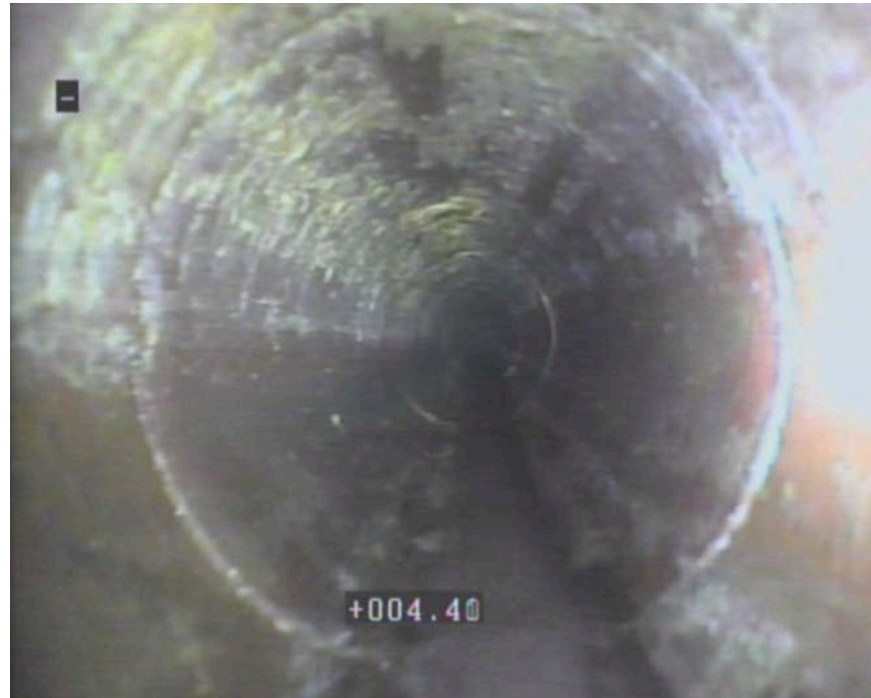
# Defect Identified: Joint Defect

CCTV Call Out: None

Defect Start (m)	Defect End (m)	Defect Length (mm)	Defect Max Current	Defect Severity
4.563	4.563	0	116	S

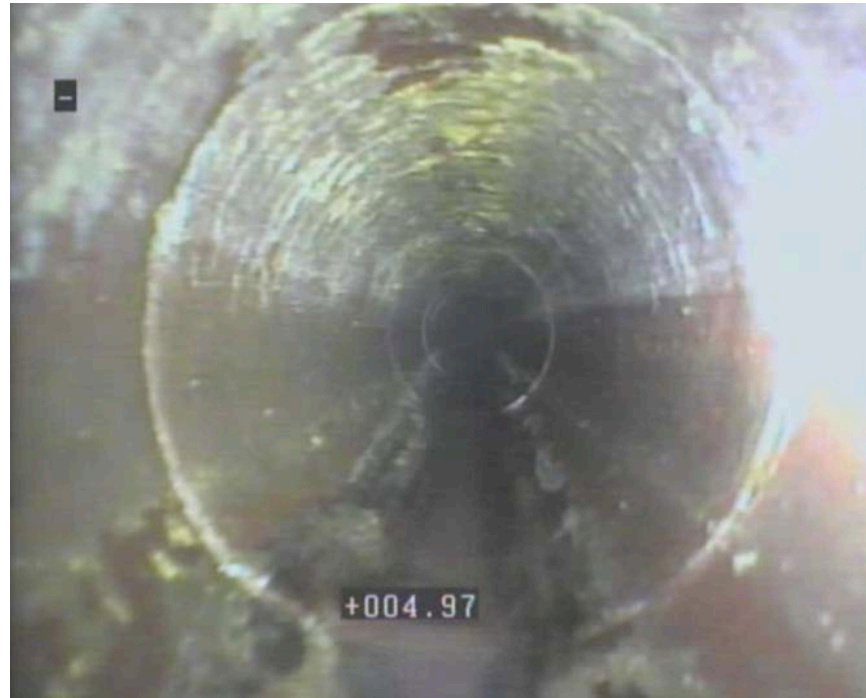
# Defect Identified: Joint Defect

CCTV Call Out: None

Defect Start (m)	Defect End (m)	Defect Length (mm)	Defect Max Current	Defect Severity
5.072	5.072	0	112	S

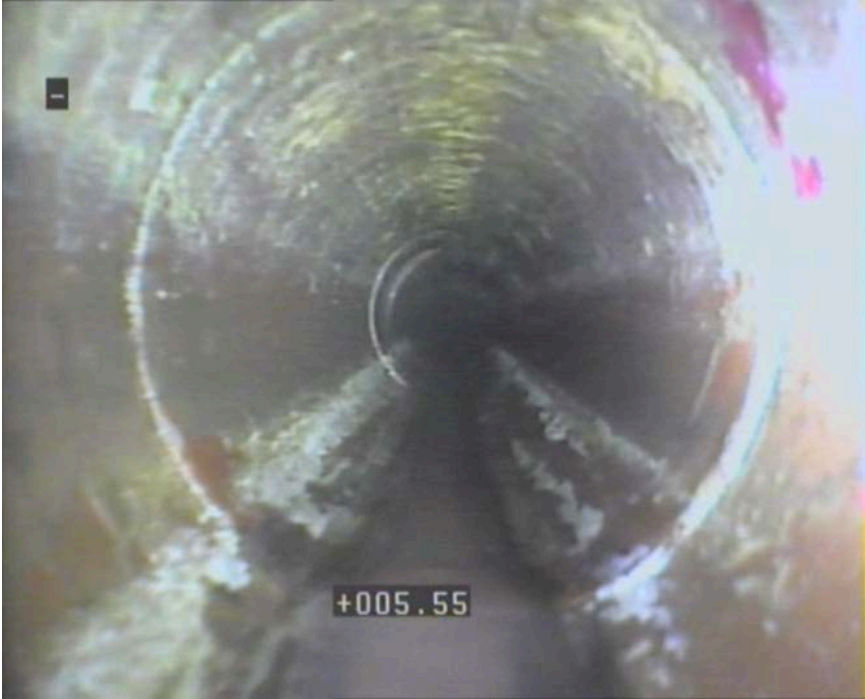
# Defect Identified: Joint Defect

CCTV Call Out: None

Defect Start (m)	Defect End (m)	Defect Length (mm)	Defect Max Current	Defect Severity
5.664	5.664	0	132	S

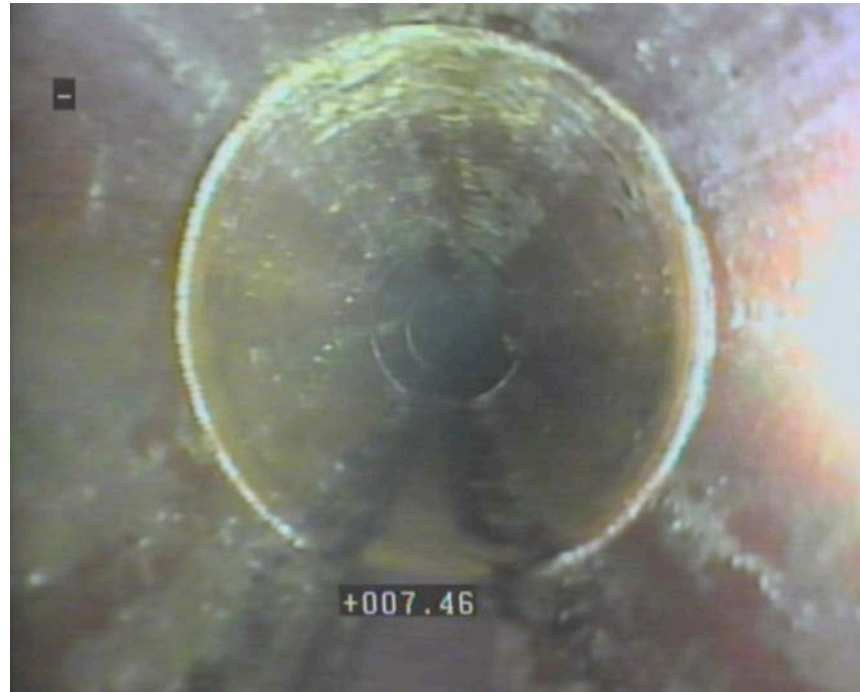
# Defect Identified: Joint Defect

CCTV Call Out: None

Defect Start (m)	Defect End (m)	Defect Length (mm)	Defect Max Current	Defect Severity
7.542	7.564	22	581	M

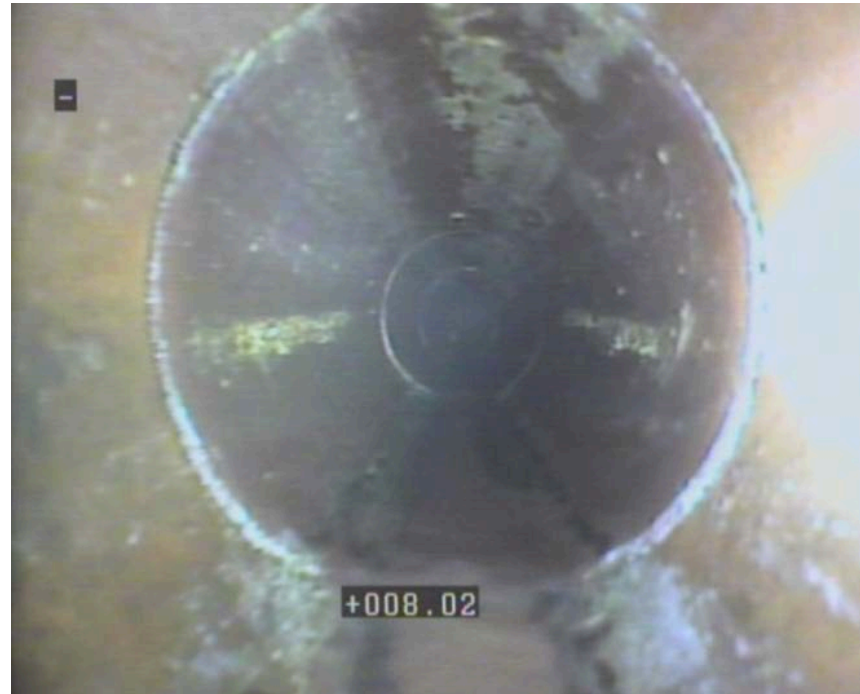
# Defect Identified: Joint Defect

CCTV Call Out: None

Defect Start (m)	Defect End (m)	Defect Length (mm)	Defect Max Current	Defect Severity
8.221	8.221	0	113	S

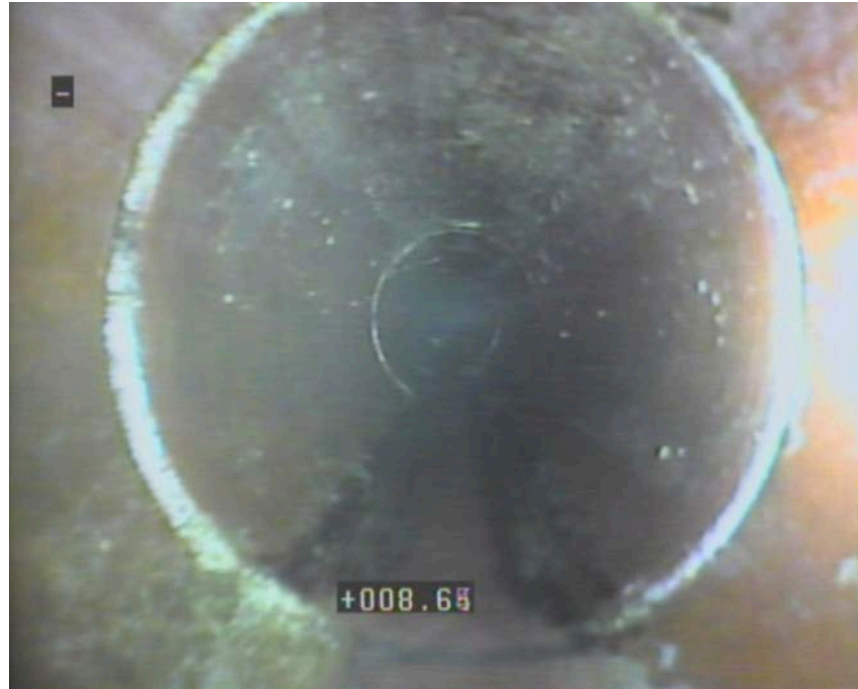
# Defect Identified: Joint Defect

CCTV Call Out: None

Defect Start (m)	Defect End (m)	Defect Length (mm)	Defect Max Current	Defect Severity
8.778	8.778	0	238	S

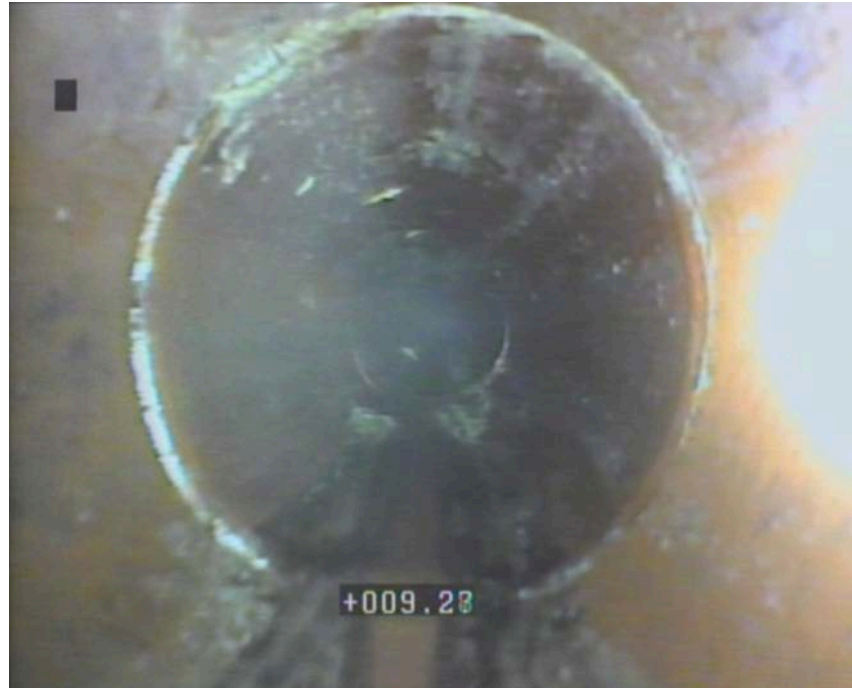
# Defect Identified: Joint Defect

CCTV Call Out: None

Defect Start (m)	Defect End (m)	Defect Length (mm)	Defect Max Current	Defect Severity
9.388	9.676	288	695	M

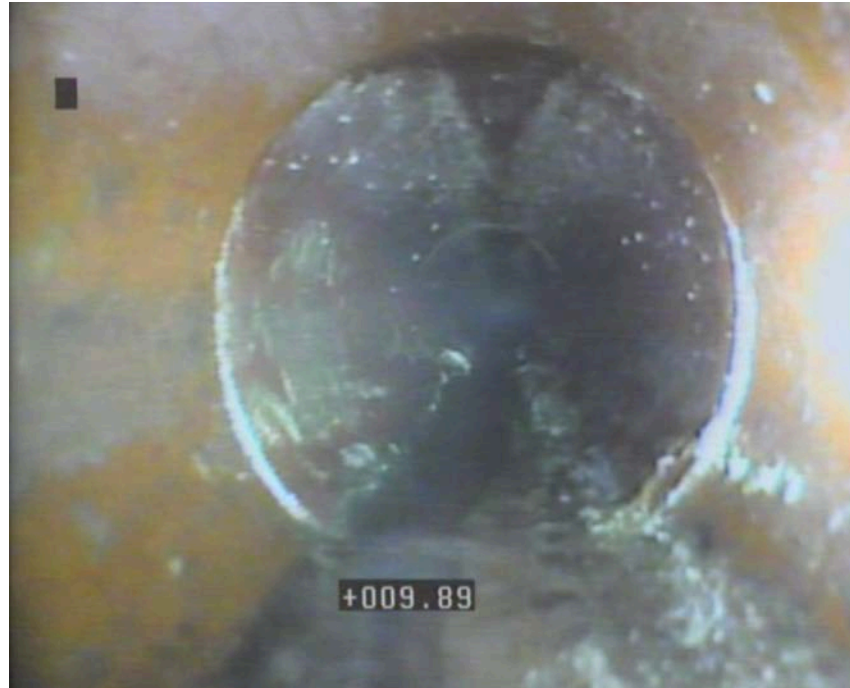
# Defect Identified: Joint Defect

CCTV Call Out: None

Defect Start (m)	Defect End (m)	Defect Length (mm)	Defect Max Current	Defect Severity
9.93	9.947	17	422	M

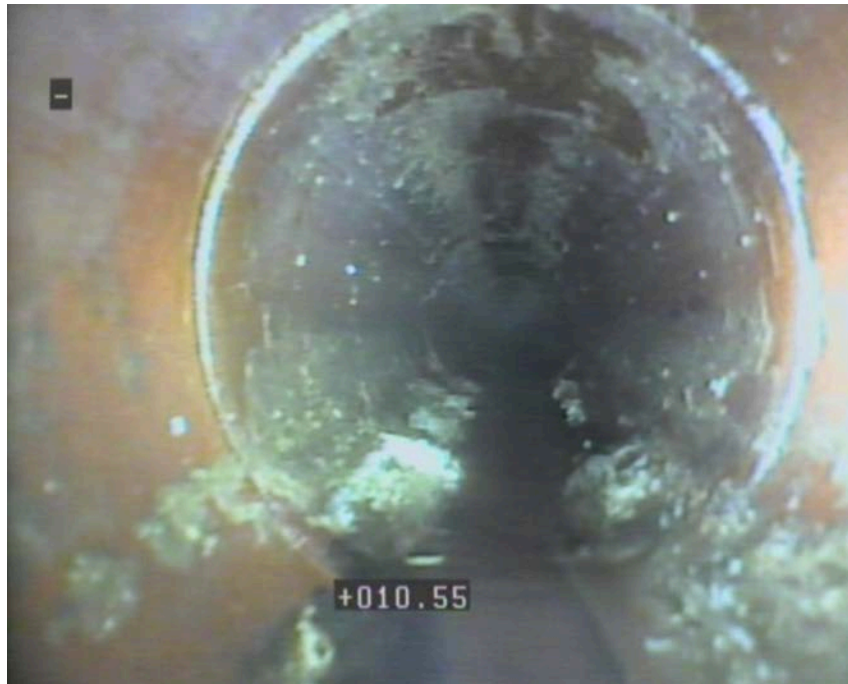
# Defect Identified: Joint Defect

CCTV Call Out: None

Defect Start (m)	Defect End (m)	Defect Length (mm)	Defect Max Current	Defect Severity
10.637	10.689	52	423	M

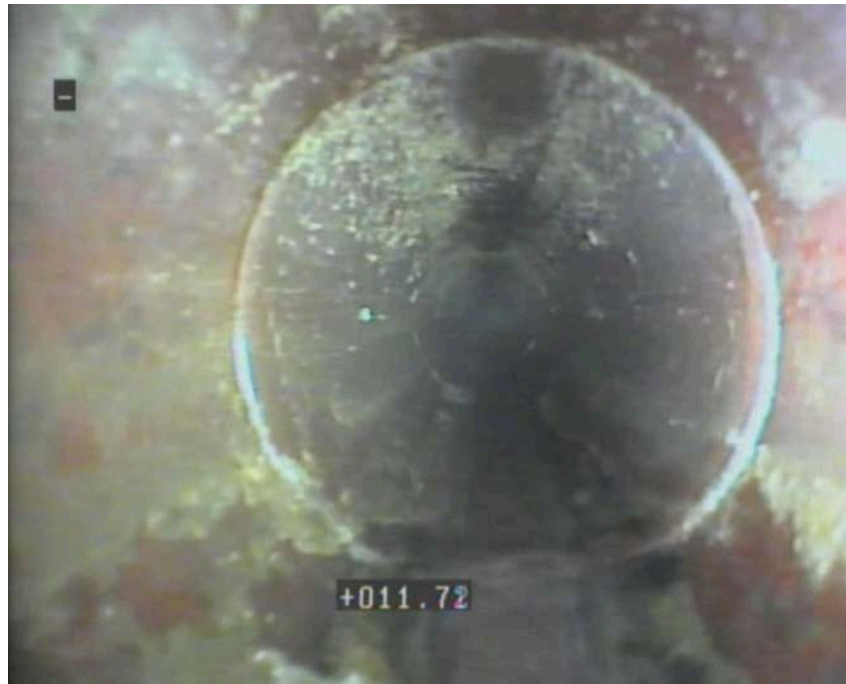
# Defect Identified: Joint Defect

CCTV Call Out: None

Defect Start (m)	Defect End (m)	Defect Length (mm)	Defect Max Current	Defect Severity
11.869	11.869	0	191	S

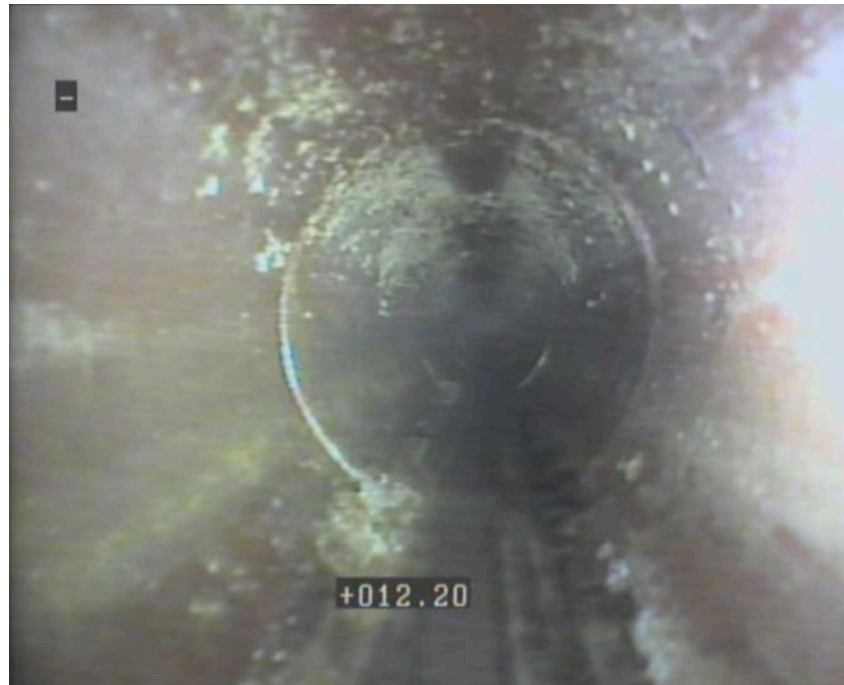
# Defect Identified: Small Longitudinal Defect

CCTV Call Out: None

Notes: Evidence of minor cracking @ 5 o'clock

Defect Start (m)	Defect End (m)	Defect Length (mm)	Defect Max Current	Defect Severity
12.398	12.424	26	128	S

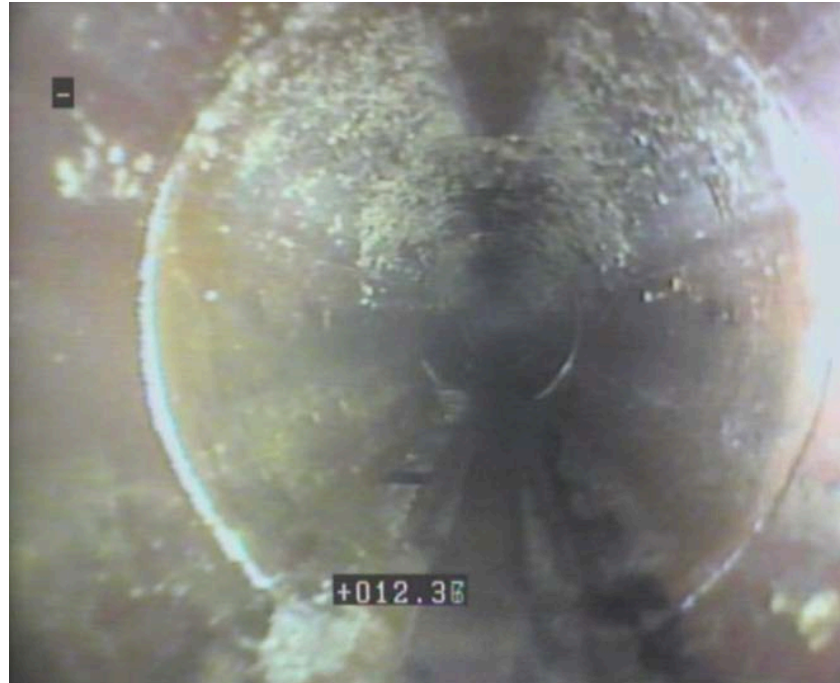
# Defect Identified: Joint Defect

CCTV Call Out: None

Notes: Evidence of minor cracking @ 5 o'clock continuing on from joint.

Defect Start (m)	Defect End (m)	Defect Length (mm)	Defect Max Current	Defect Severity
12.48	12.649	169	479	M

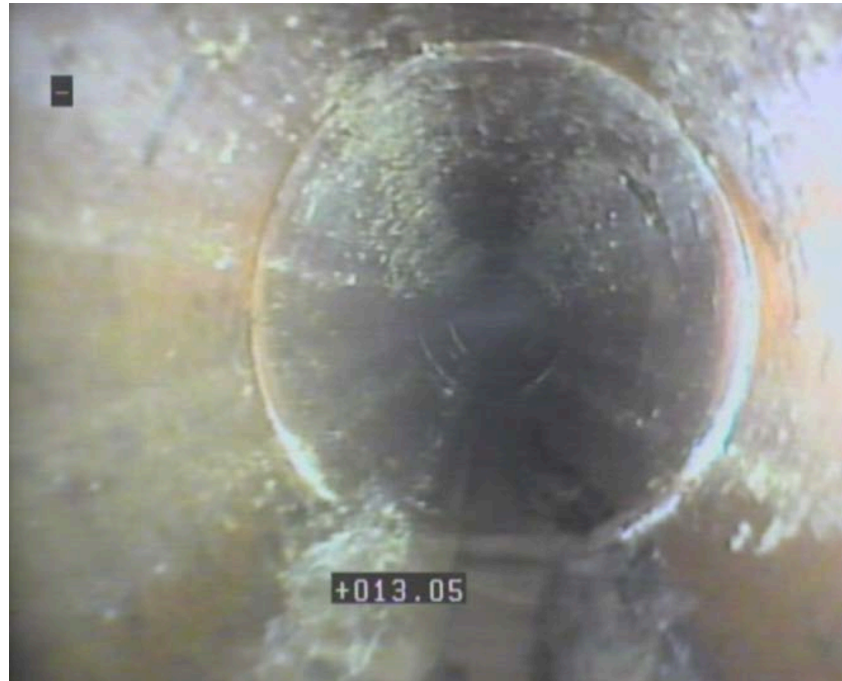
# Defect Identified: Joint Defect

CCTV Call Out: None

Defect Start (m)	Defect End (m)	Defect Length (mm)	Defect Max Current	Defect Severity
13.079	13.079	0	132	S

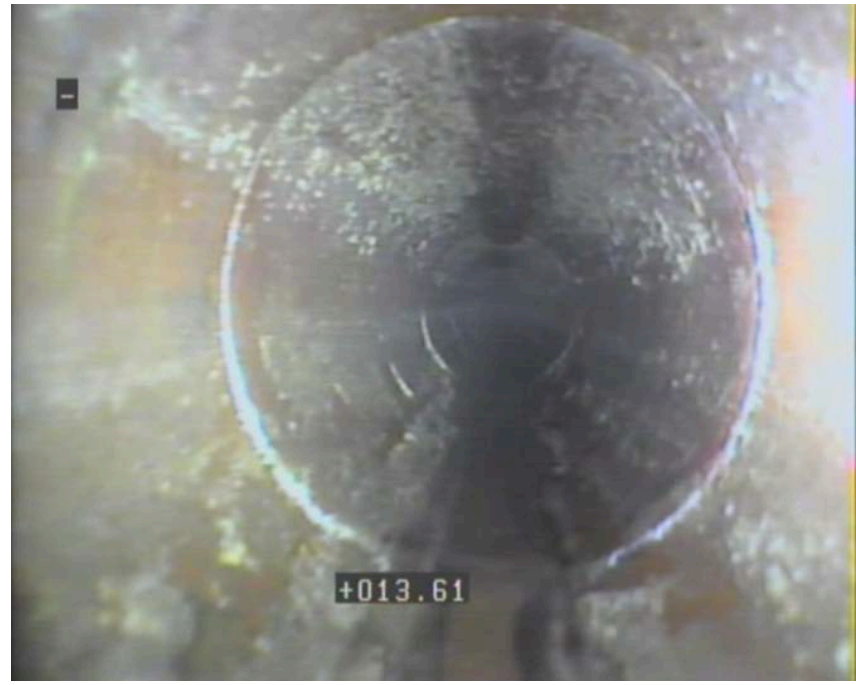
# Defect Identified: Joint Defect

CCTV Call Out: None

Defect Start (m)	Defect End (m)	Defect Length (mm)	Defect Max Current	Defect Severity
13.676	13.707	31	317	S

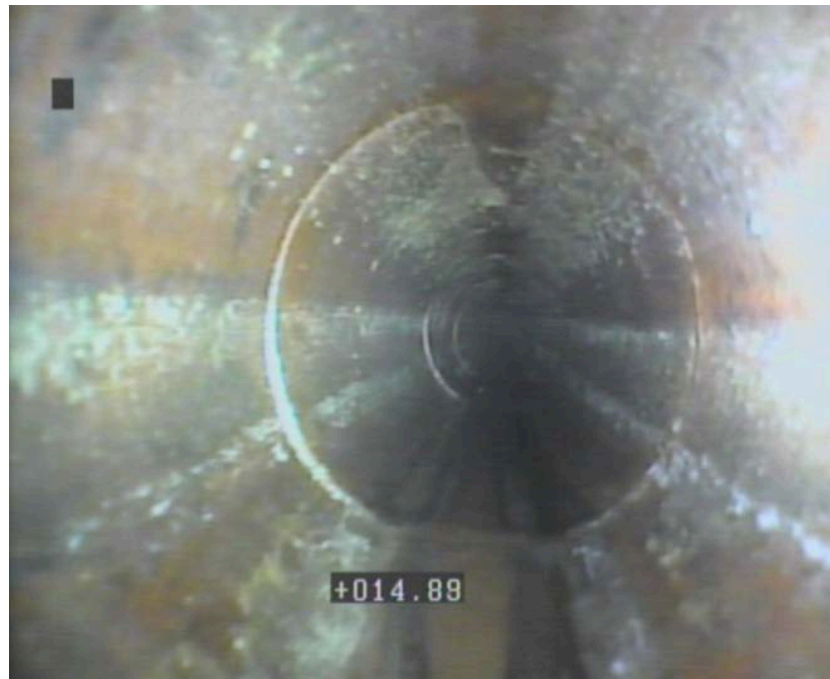
# Defect Identified: Joint Defect

CCTV Call Out: None

Defect Start (m)	Defect End (m)	Defect Length (mm)	Defect Max Current	Defect Severity
14.901	14.901	0	116	S

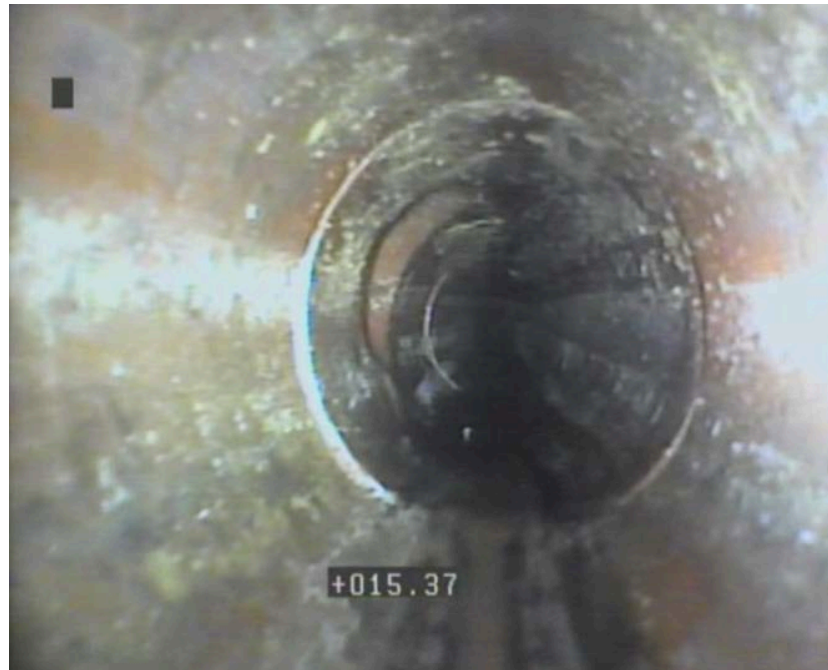
# Defect Identified: Joint Defect

CCTV Call Out: None

Defect Start (m)	Defect End (m)	Defect Length (mm)	Defect Max Current	Defect Severity
15.462	15.462	0	117	S

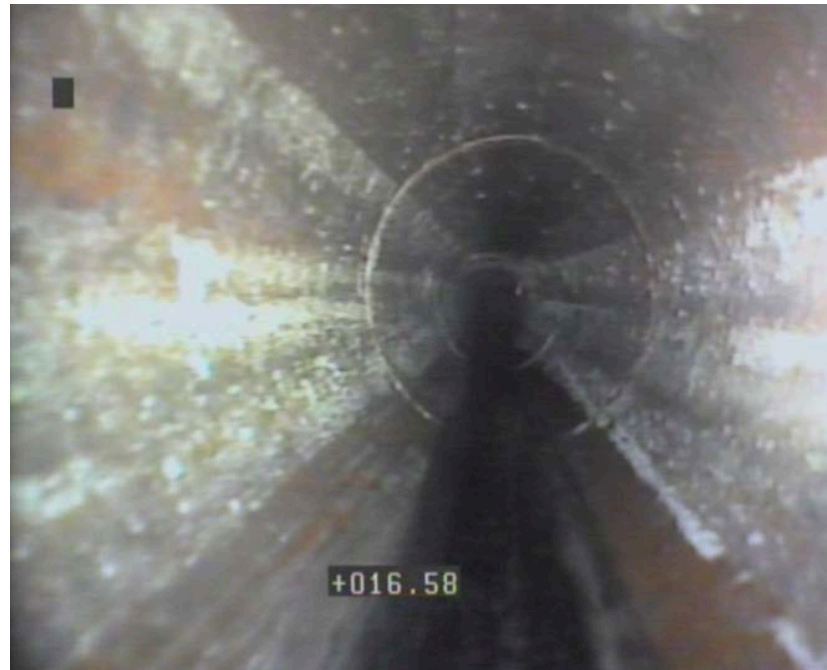
# Defect Identified: Small Longitudinal Defect

CCTV Call Out: None

Notes: Evidence of minor cracking @ 9 o'clock.

Defect Start (m)	Defect End (m)	Defect Length (mm)	Defect Max Current	Defect Severity
16.68	16.68	0	130	S

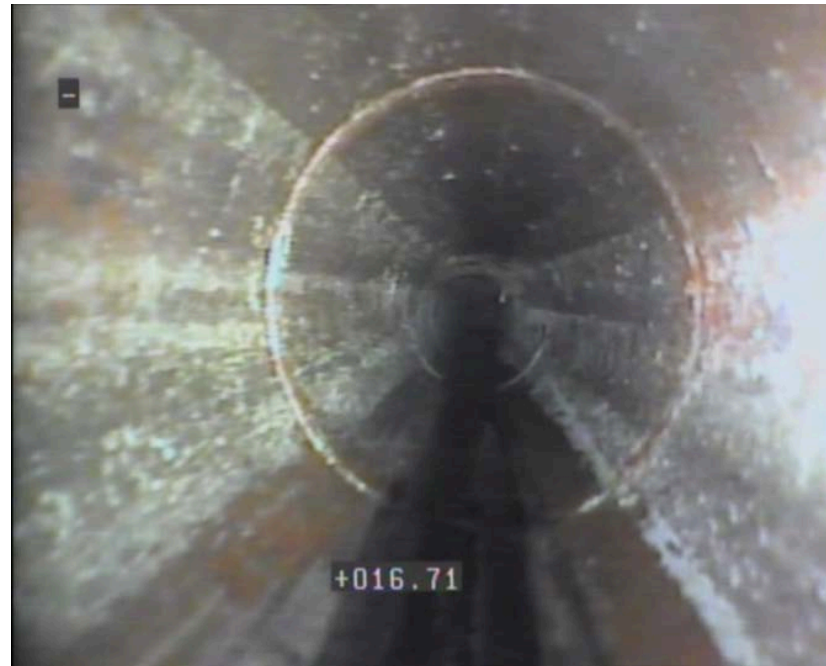
# Defect Identified: Joint Defect

CCTV Call Out: None

Defect Start (m)	Defect End (m)	Defect Length (mm)	Defect Max Current	Defect Severity
16.743	16.76	17	242	S

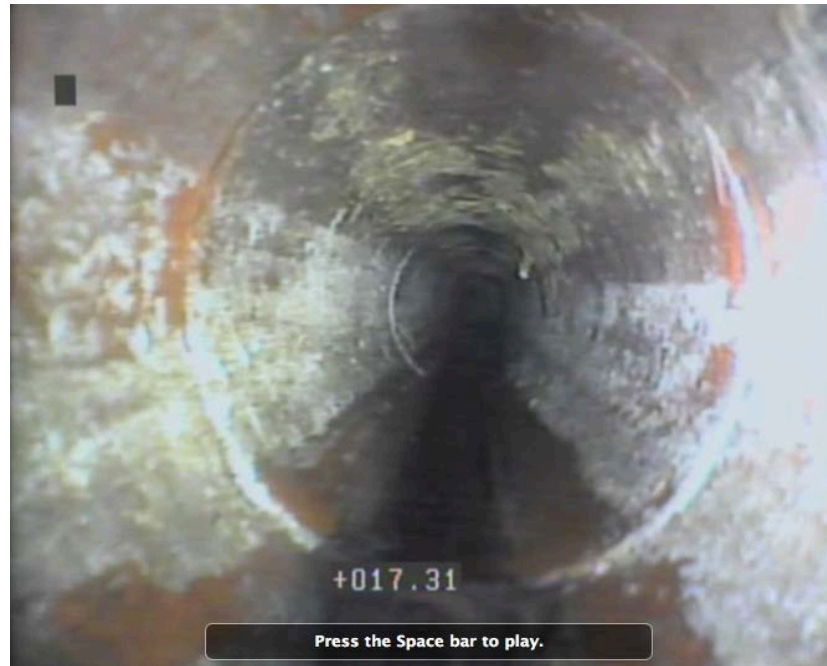
# Defect Identified: Joint Defect

CCTV Call Out: None

Defect Start (m)	Defect End (m)	Defect Length (mm)	Defect Max Current	Defect Severity
17.355	17.369	14	138	S

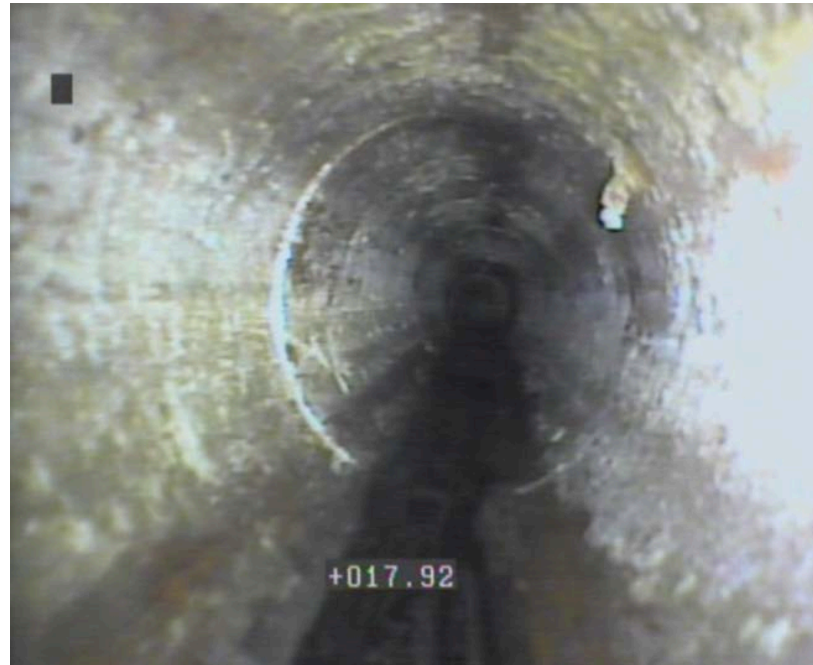
# Defect Identified: Joint Defect

CCTV Call Out: None

Defect Start (m)	Defect End (m)	Defect Length (mm)	Defect Max Current	Defect Severity
17.981	17.992	11	202	S

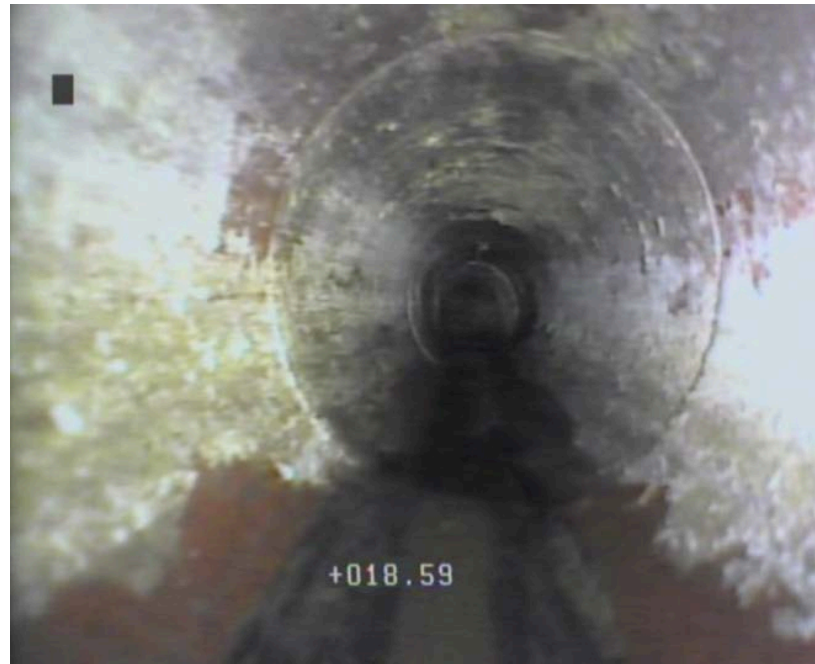
# Defect Identified: Joint Defect

CCTV Call Out: None

Defect Start (m)	Defect End (m)	Defect Length (mm)	Defect Max Current	Defect Severity
18.642	18.667	25	385	S

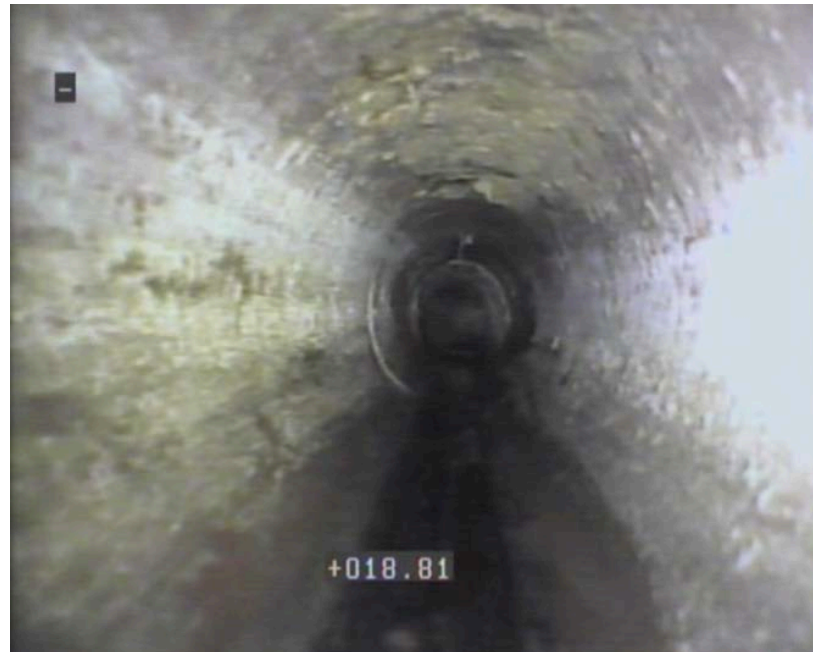
# Defect Identified: Small Longitudinal Defect

CCTV Call Out: None

Notes: Evidence of minor cracking @ 9 o'clock.

Defect Start (m)	Defect End (m)	Defect Length (mm)	Defect Max Current	Defect Severity
18.851	18.883	32	168	S
18.901	18.912	11	284	S

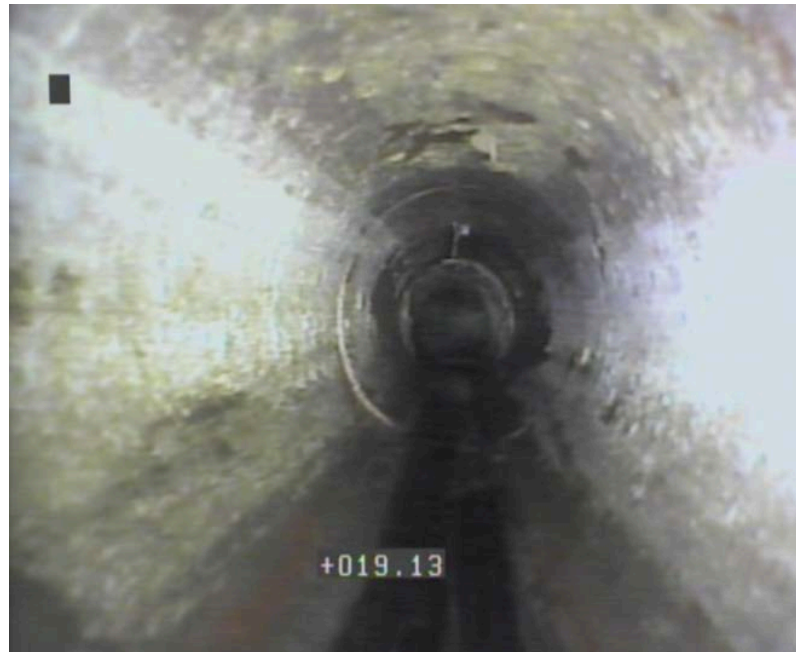
# Defect Identified: Small Longitudinal Defect

CCTV Call Out: None

Notes: Evidence of minor cracking @ 9 o'clock.

Defect Start (m)	Defect End (m)	Defect Length (mm)	Defect Max Current	Defect Severity
19.296	19.32	24	188	S

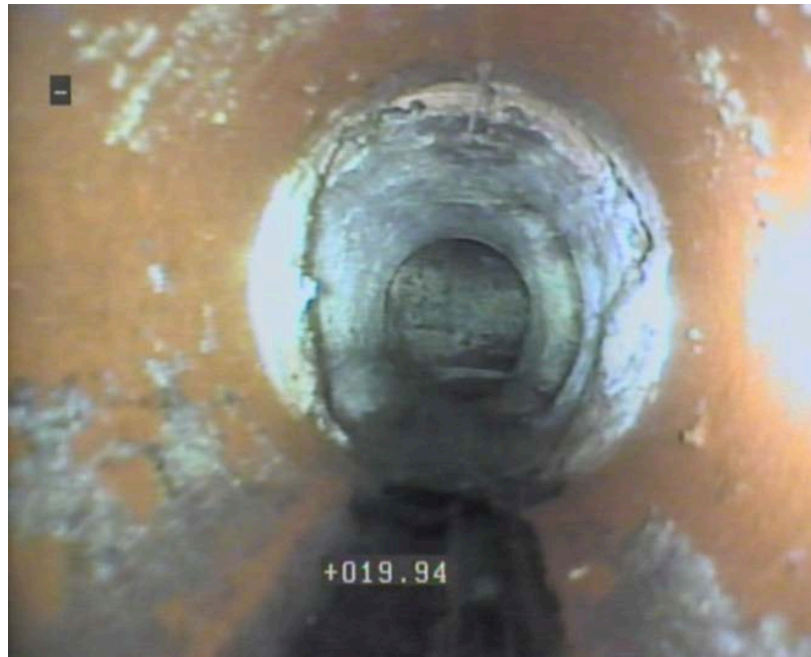
# Defect Identified: Joint Defect

CCTV Call Out: OJM – Open Joint Medium

Defect Start (m)	Defect End (m)	Defect Length (mm)	Defect Max Current	Defect Severity
19.836	19.836	0	200	S
