**North American Society for Trenchless Technology (NASTT)  
NASTT's 2013 No-Dig Show**

**Update from Christchurch on Condition Assessment of Sewer Drains**

Chuck Hansen, Electro Scan Inc., Sacramento, California  
Email: [chuck@electroscan.com](mailto:chuck@electroscan.com)

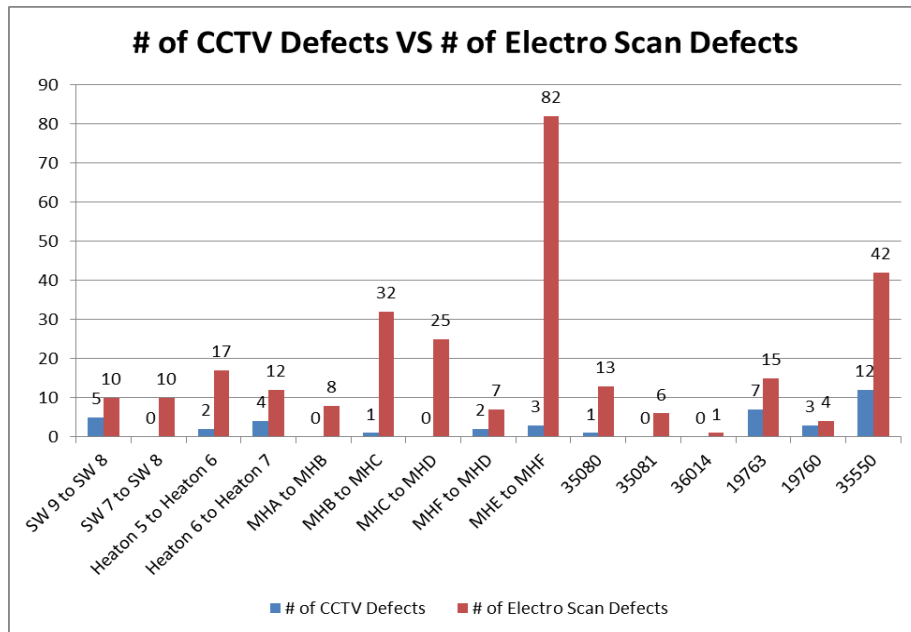
Figure 6 – Number of CCTV and Electro Scan Defects Identified per Pipe Section

- For example, in pipe section 19760 Electro Scan identified only 33% more defects (one additional defect). In this case Electro Scan confirmed the CCTV hypothesis that this pipe was in relatively good condition. With only 2.4 liters per minute of infiltration potential, it was the second best condition pipe identified in the study by Electro Scan standards.

- However, in one case – pipe section MHE to MHF in Selwyn – Electro Scan identified 2733% more defects than CCTV (79 additional defects). This asbestos cement pipe had significant areas of visually non-obvious corrosion as well as a multitude of seemingly minor structural cracks that added up to contribute to the second largest infiltration potential of the project, measured at 50 liters per minute. Since the sub-basin containing this pipe section was immediately adjacent to a large river it is likely that under peak flow conditions this single 82 meter section of pipe was contributing an extra 72,000 liters per day of groundwater infiltration to the system. As is apparent in Figure 6 below, under a standard CCTV inspection program this pipe section would not have been classified as a high priority for rehabilitation with only 3 defects identified.

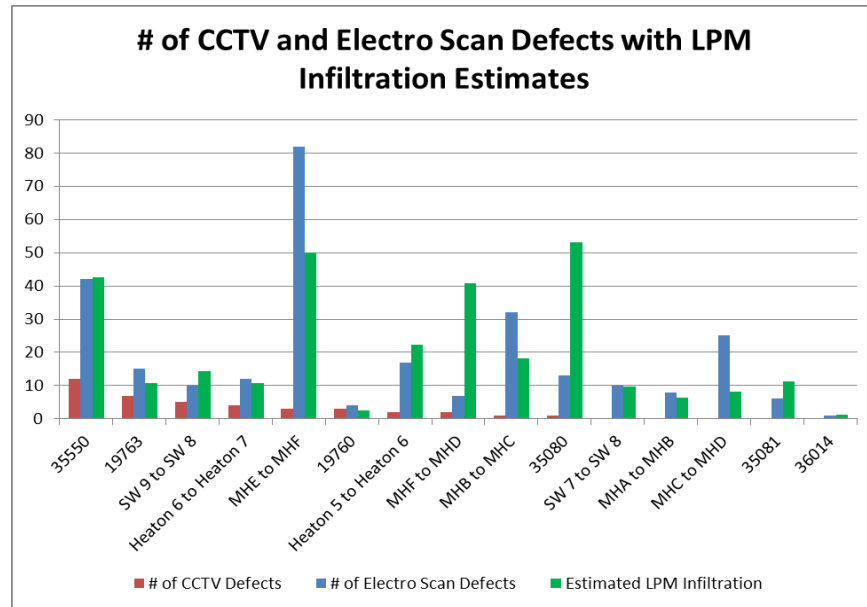
Figure 7: Number of CCTV and Electro Scan Defects and LPM Infiltration Estimates

This figure is sorted by how rehabilitation would be prioritized by CCTV alone. By this standard the pipe with the highest potential infiltration (section 35080) would be very low priority for rehabilitation with only a single minor defect identified visually. Since this pipe section is in a tidal zone, a regular 53.1 liters per minute of infiltration potential would be systematically overlooked.
