SW 199th Terrace and SW 81st Court
Cutler Bay, FL

Thursday, February 21, 2013

Miami-Dade Water and Sewer
3071 SW 38th Avenue
Miami, Florida 33146
www.miamidade.gov/water

SW 199th Terrace Electro Scan Demo – Scan 1

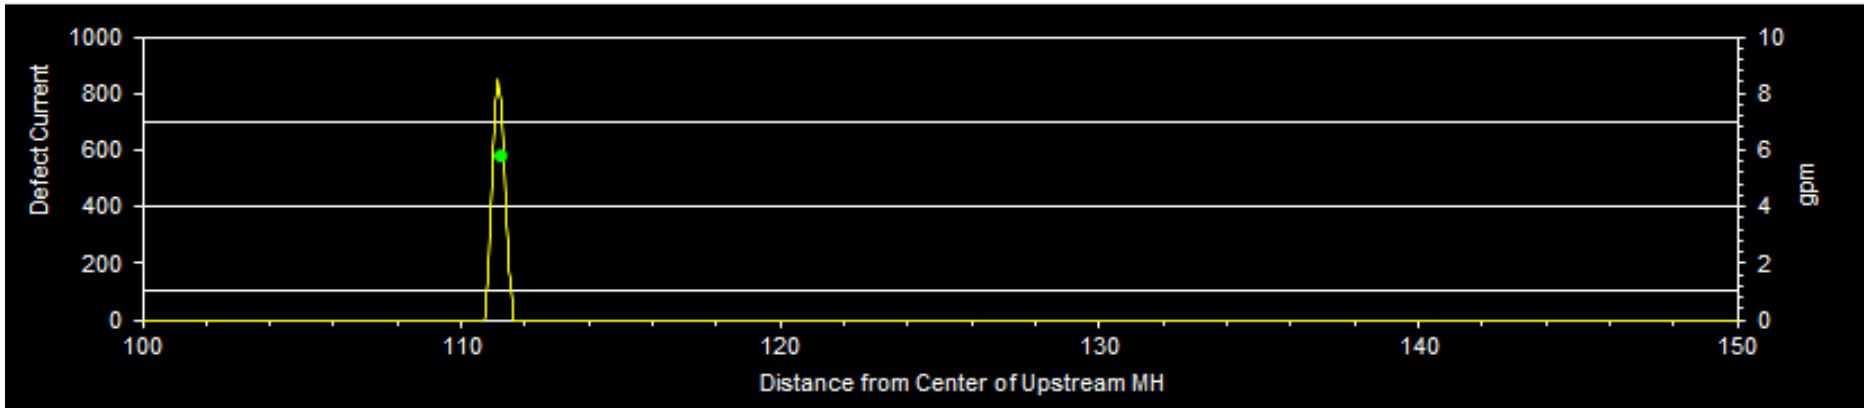
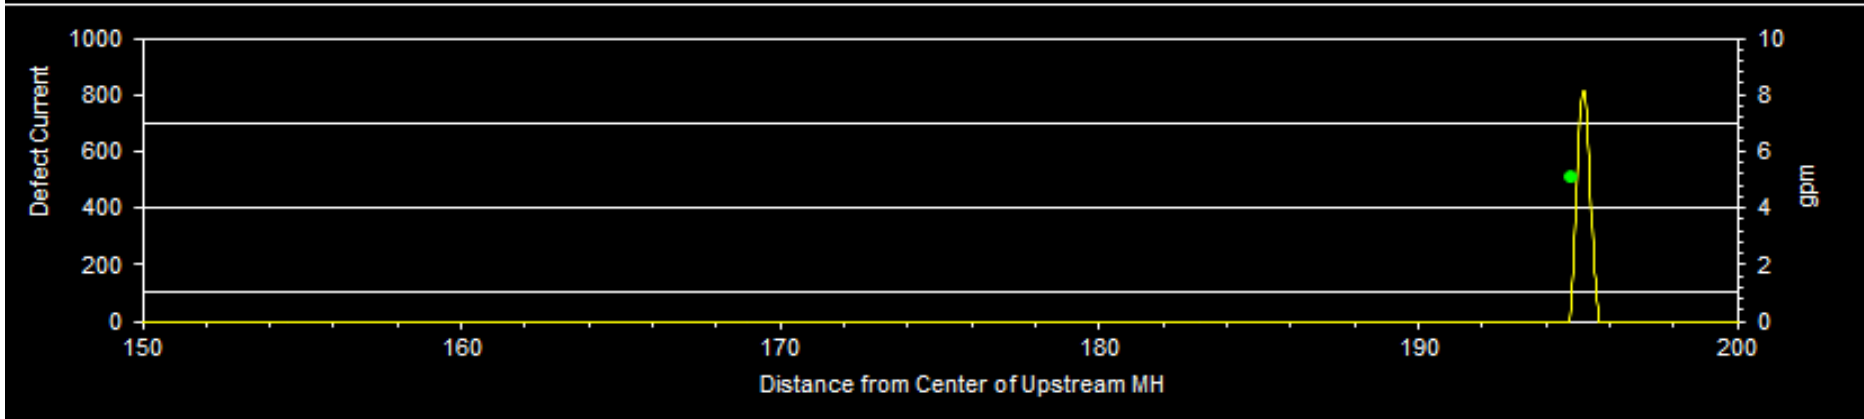
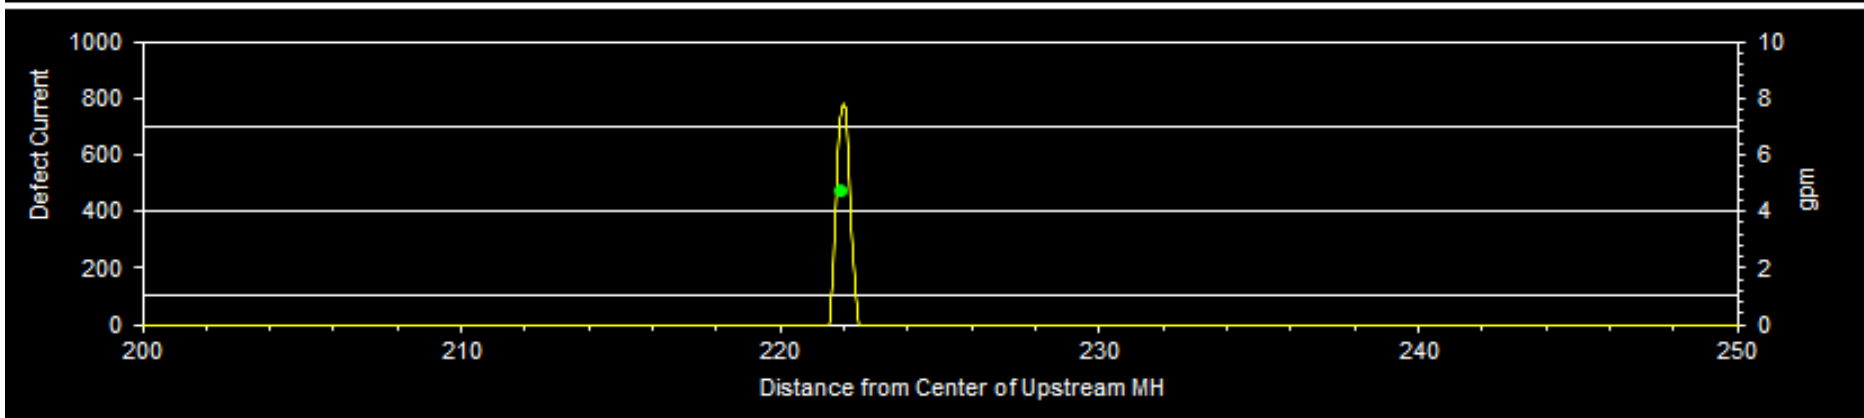
SW 199th Terrace (Scan 1) Defect Graph

Electro Scan located **3** total defects – all of them large. Based on the size and quantity of those defects, it is estimated that this pipe length could infiltrate **15.6 gallons per minute**.

The defects appear to correspond to lateral connections. In reviewing the CCTV video, no lateral or connection lining or sealing method had been used. The Electro Scan results reveal that all three service connections are faulty and are a source for infiltration into the newly lined pipe. Because of these unaddressed connections, this pipe has the possibility of infiltrating about 22,464 gallons per day.

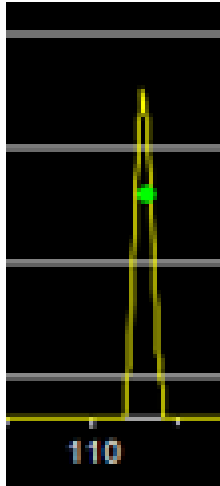
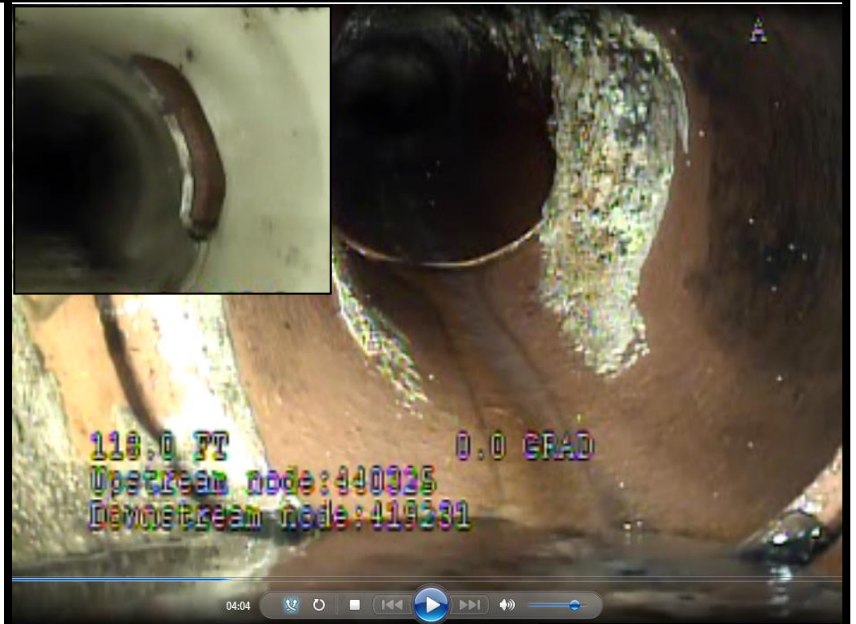
116.0'
(CCTV)

All defects are at lateral connections. Of the three (3) defects that have the potential to infiltrate, only one of them had any CCTV callout that would have identified that location as defective. Comparing the same pipe length that was Electro Scanned with that same length that was CCTV'd, Electro Scan located three (3) total defects that could cause infiltration, while CCTV only identified one (1) of those lateral connections as infiltrating, and listing the other two just as “active taps” (not defective).

111.2'
(ES)

Estimated
Infiltration
Flow:
5.8 GPM

CCTV Callout: <None>

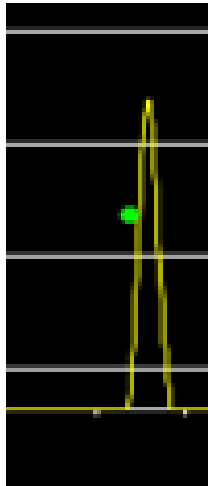
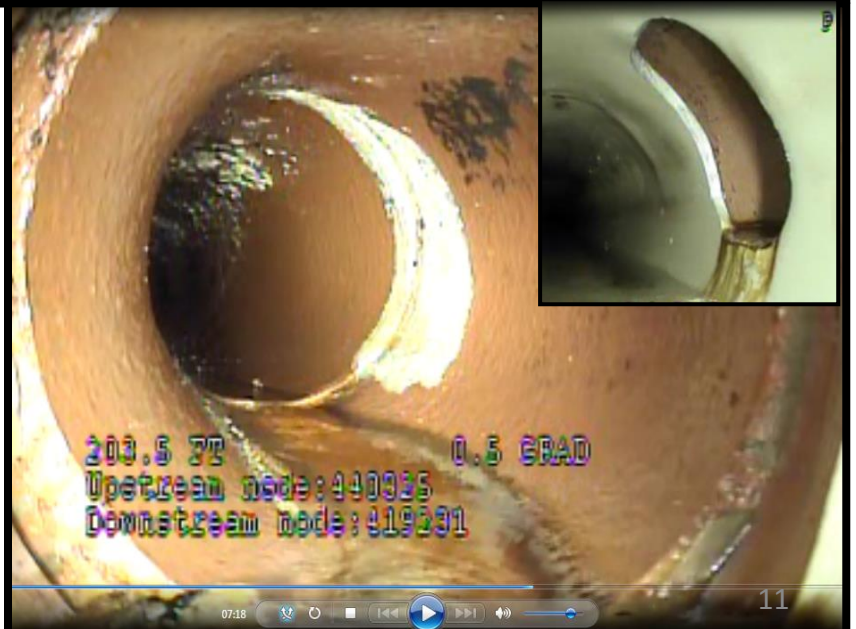
202.3'
(CCTV)

194.8'
(ES)

Estimated
Infiltration
Flow:
5.0 GPM

CCTV Callout: <None>

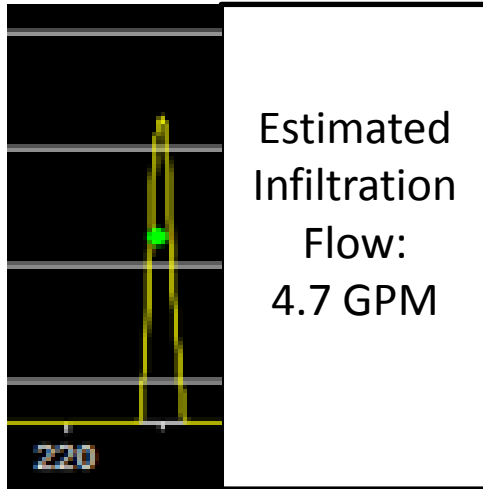
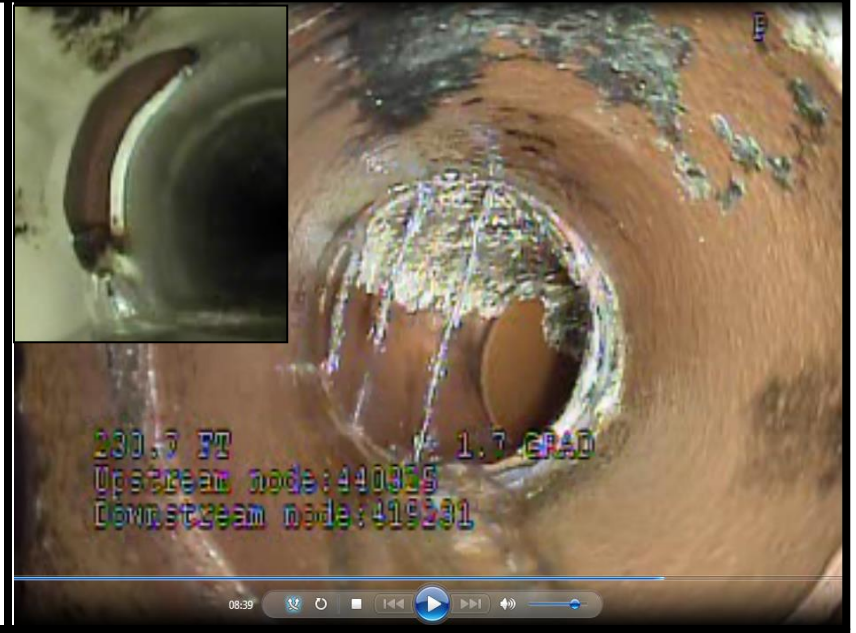
230.7'
(CCTV)

221.9'
(ES)

CCTV Callout: <None>

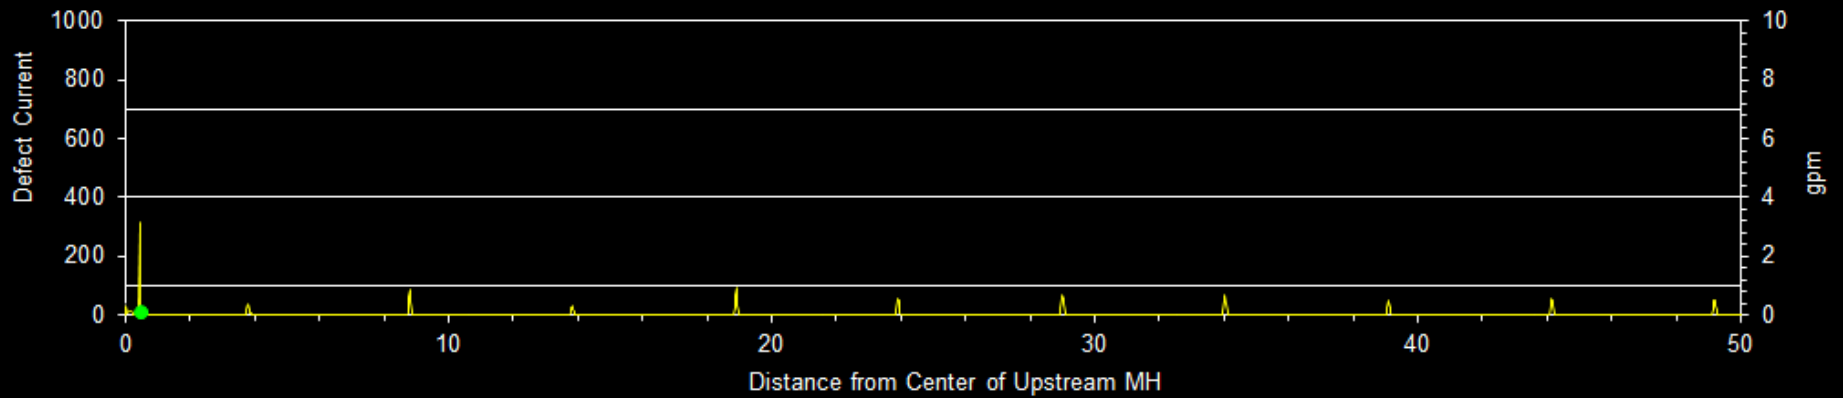
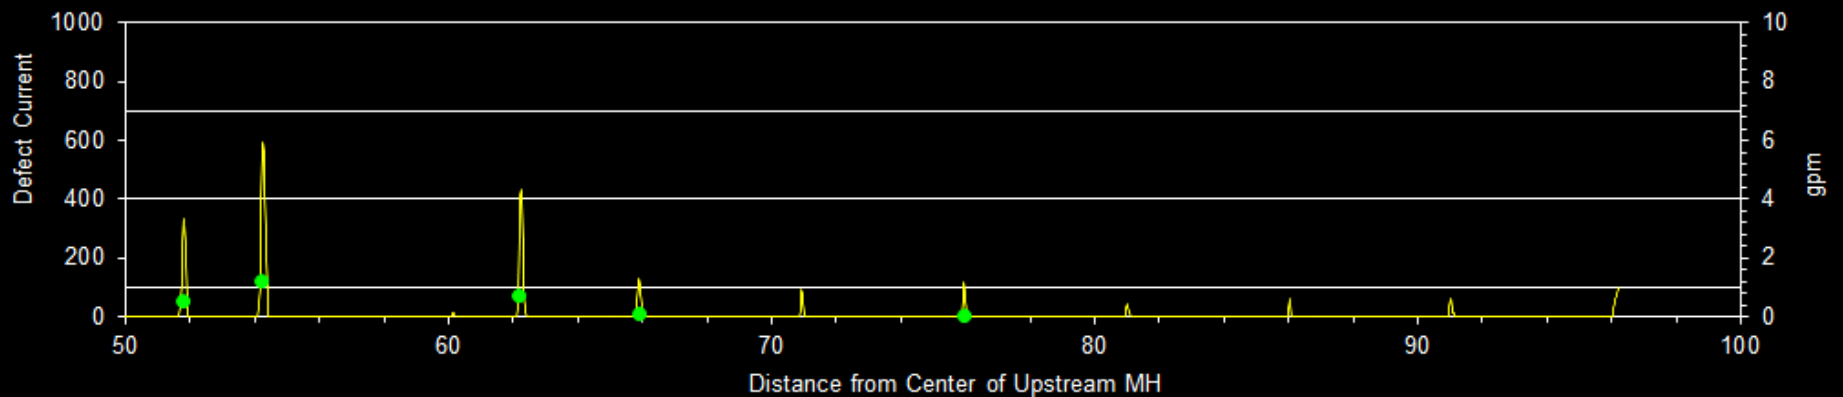
SW 81st Ct. (Scan 2) Defect Graph

Electro Scan located **6** total defects – 4 small and 2 medium. Based on the size and quantity of those defects, it is estimated that this pipe length could infiltrate **2.9 gallons per minute**.

The majority of this pipe (including most joints) are in good shape. From the graph and chart, almost all the infiltration is occurring in a 15' section between the 51 foot and 66 foot marks – where the spot repair and new lateral tie-in occurred. Correcting that area could prevent almost 4200 extra gallons per day.

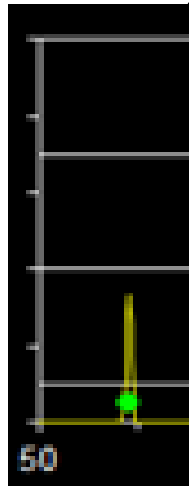
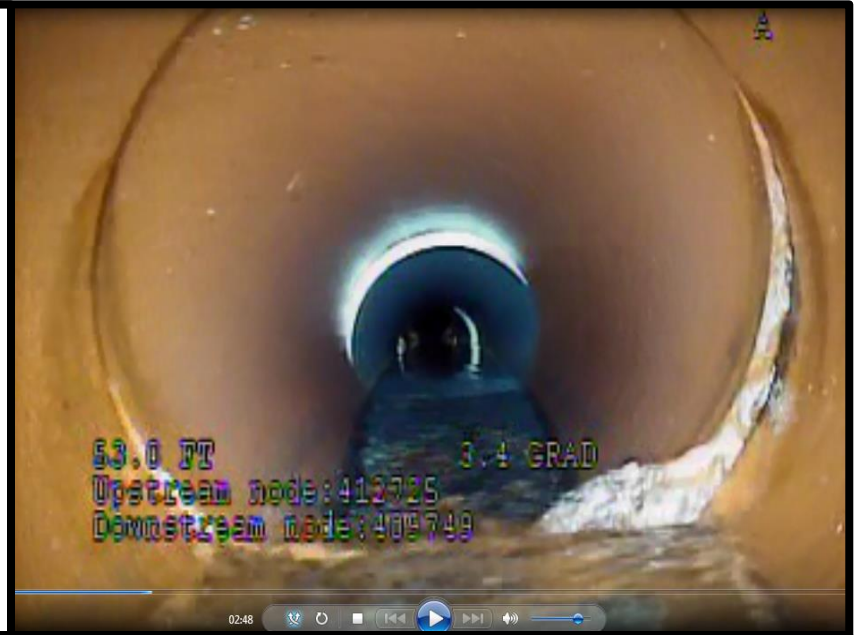
54.0'
(CCTV)

51.7'
(ES)

Estimated
Infiltration
Flow:
0.59 GPM

CCTV Callout: <Crack, Infiltration>

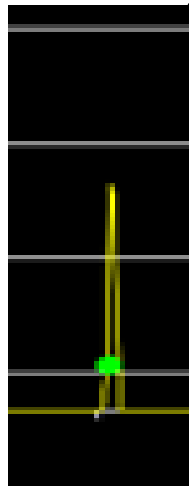
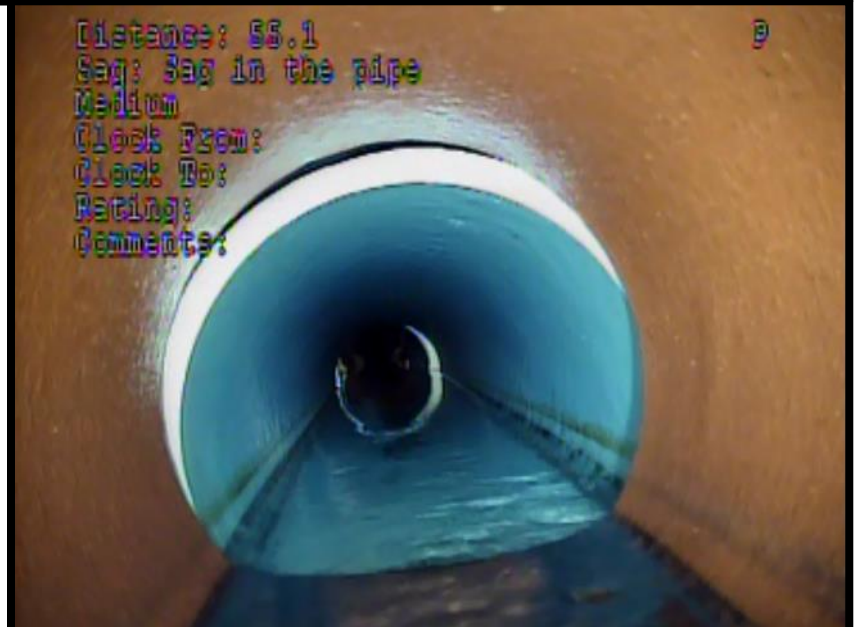
56.6'
(CCTV)

54.2'
(ES)

Estimated
Infiltration
Flow:
1.25 GPM

CCTV Callout: <Sag, Material Change>

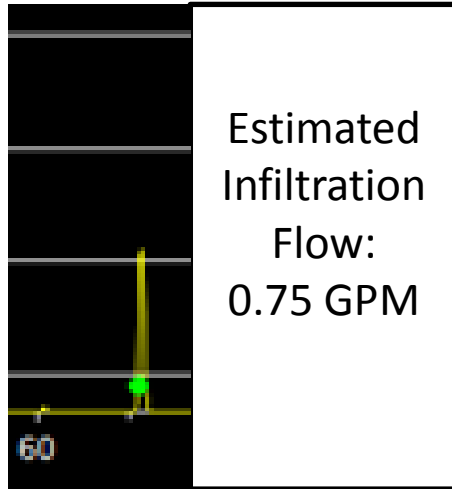
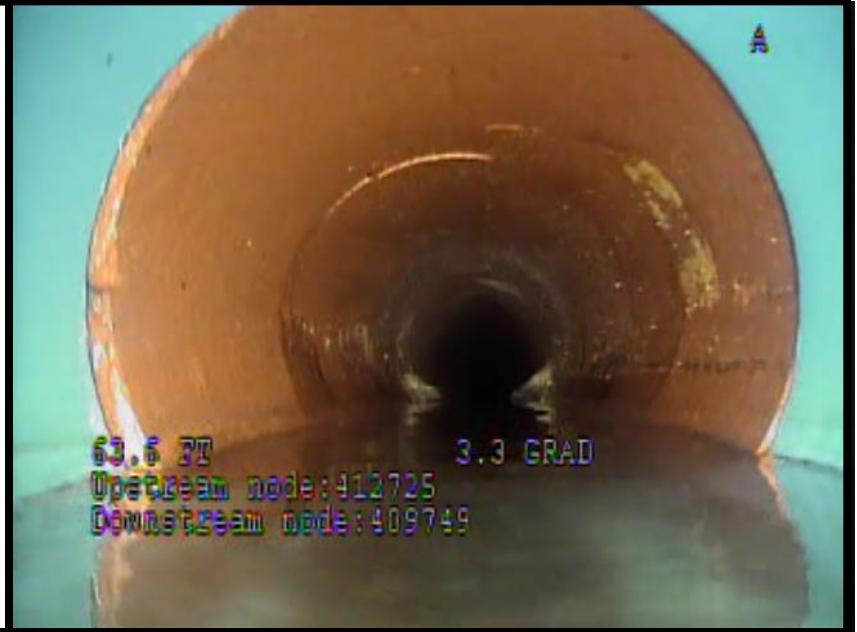
64.6'
(CCTV)

62.2'
(ES)

CCTV Callout: <Material Change>

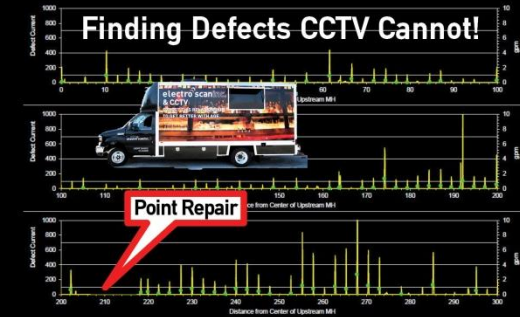
(Above) Sewer agency used CCTV to locate a defect that was determined to require a Point Repair at 210 feet. A Point Repair was completed and the Contractor used CCTV to certify the repair. Then, the pipe was **Electro Scanned**.

Good News: The Point Repair was successful -- no electrical readings!
Bad News: The Sewer Pipe had numerous other defects not seen by CCTV.
