**North American Society for Trenchless Technology (NASTT)
NASTT's 2015 No-Dig Show**

MA-T1-01

**Small Agency, Big Ambition - How a Pennsylvania Township
Authority Chose New Technology to Begin Addressing Their
Infiltration Issues**

Mark Grabowski, Electro Scan, Inc., Sacramento, CA
Sharon Purnell, Hamilton Township Municipal Authority, Chambersburg, PA

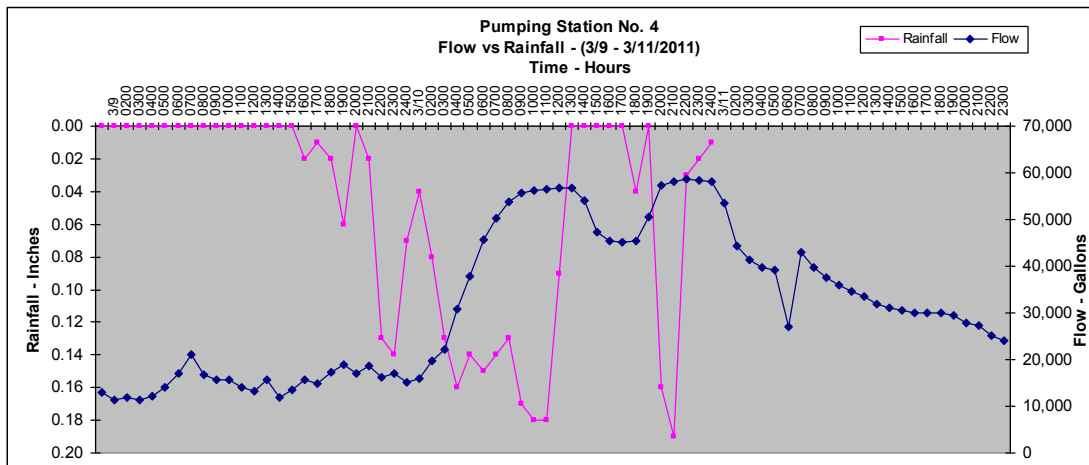
Figure 3.Hydrograph of Pump Station 4 hourly flows and rainfall, pre-Electro Scan

The second section of pipe that was to be examined as part of the mini-project is also an interceptor that runs to a pump station, except this line is 10" PVC. These four (4) sections of pipe run adjacent to a small creek, and are located within the flood plain of the creek. Data from the pump station and creek level observations indicate that flow rates and pump run times increase in tandem with adjacent creek levels. During extreme wet weather conditions the pump station cannot keep up with the incoming flow and is pumping more than 60,000 gallons per hour with metering data recording flows of nearly 1.1 mgd. Again, due to constant flows, the Authority has been unable to assess this section of pipe via CCTV. Historically, there have not been any repairs made to this section of pipe.

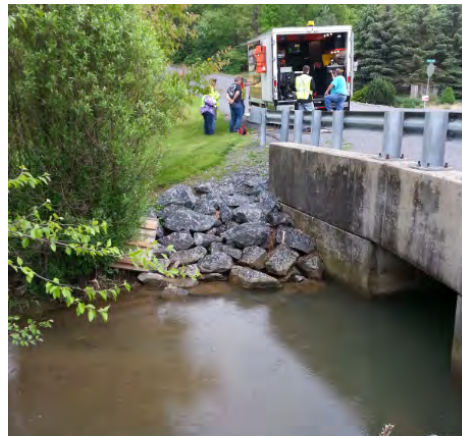
Figure 5: Scanning the PVC pipes adjacent to the creek, which was suspected to be the cause of the pipe infiltration.

As mentioned earlier in the report, whenever the creek adjacent to this pipe flooded, the lift station saw significant increases that corresponded almost directly with the water levels. This section of pipes, although suspected of being significant contributors of infiltration to the system, were shown by Electro Scan be in good shape overall with low levels of potential infiltration (Table 3). With the Electro Scan results ruling out significant infiltration, the focus (and rehabilitation money) of these segments can now be directed fully at addressing what is likely the issue with these pipes – inflow – without spending additional money on other inspections, such as CCTV (Table 4).

With only one pipe (P04A04 to P04A03) showing any signs of defects, these pipes were placed low on the list of pipes to receive rehabilitation attention. If it is decided to address these sources, spot repair methods will probably suffice. HTMA will continue to monitor this section as it utilizes Electro Scan to compile additional sewer condition assessments in this area before prioritizing defects and developing and implementing a progressive I&I repair program.

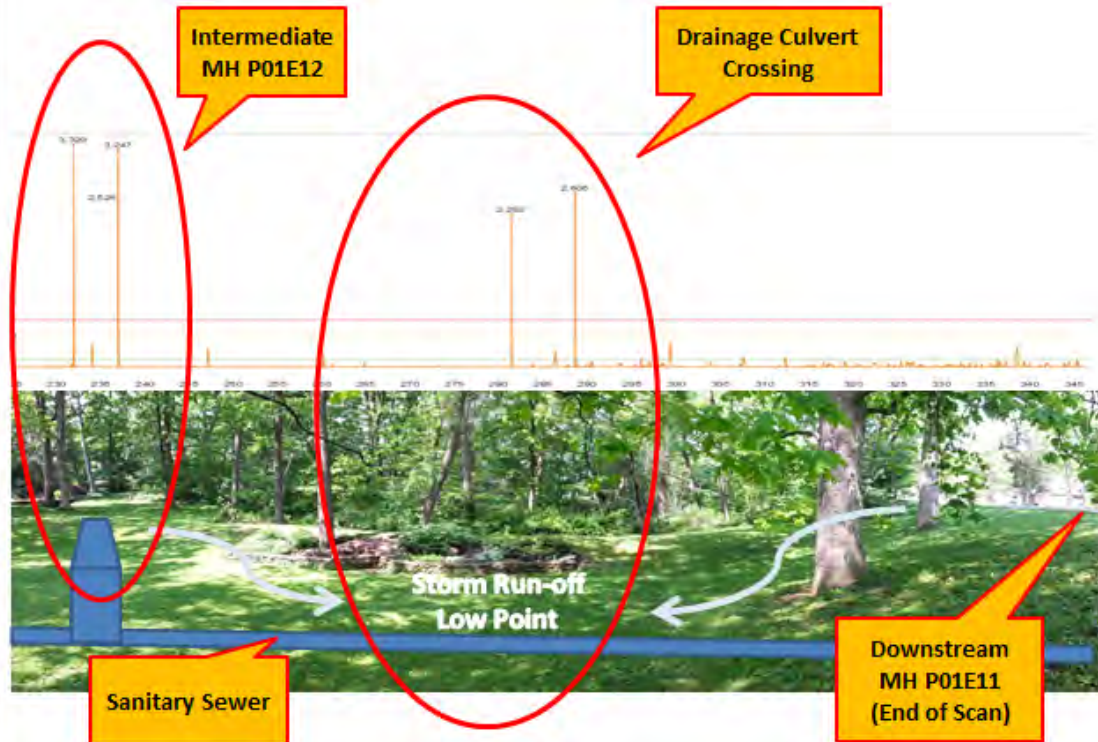
With the results from these two sections of pipe, plus a third section of pipe that showed severe leakage, below a storm swale (see Figure 6), HTMA decided to invest in both an ES-620 Electro Scan system, which would integrate into their UEMSI CCTV system, and an ES-38 system for lateral investigations.

Figure7: Scan graph for third section of pipe showing large leaks located directly below a drainage swale.

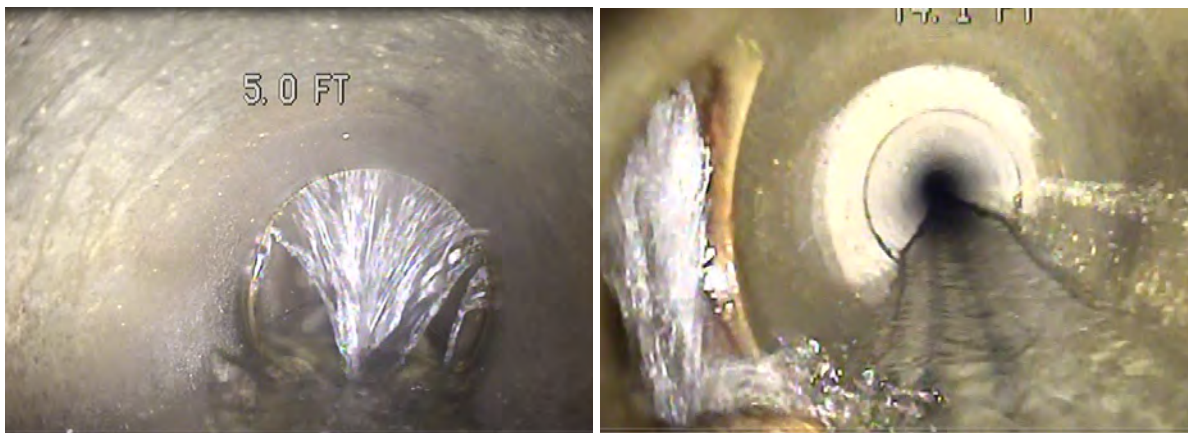
In the 3-month time frame that HTMA has been using their ES-620 system the Authority has discovered several situations that caused their pre-Electro Scan rehabilitation decisions to be revisited. One, in particular, was an 8” AC pipe that had defects that were previously discovered with CCTV and repaired by making four (4) point repairs (two leaking joints and two leaking wye connections). HTMA repaired what could be physically seen and identified in a wet weather event of nearly 1” of rain. Figure 8 shows CCTV pictures of two of the four leaks that were repaired.

Figure 8: CCTV screenshots of two leaks identified and repaired by digging and replacing

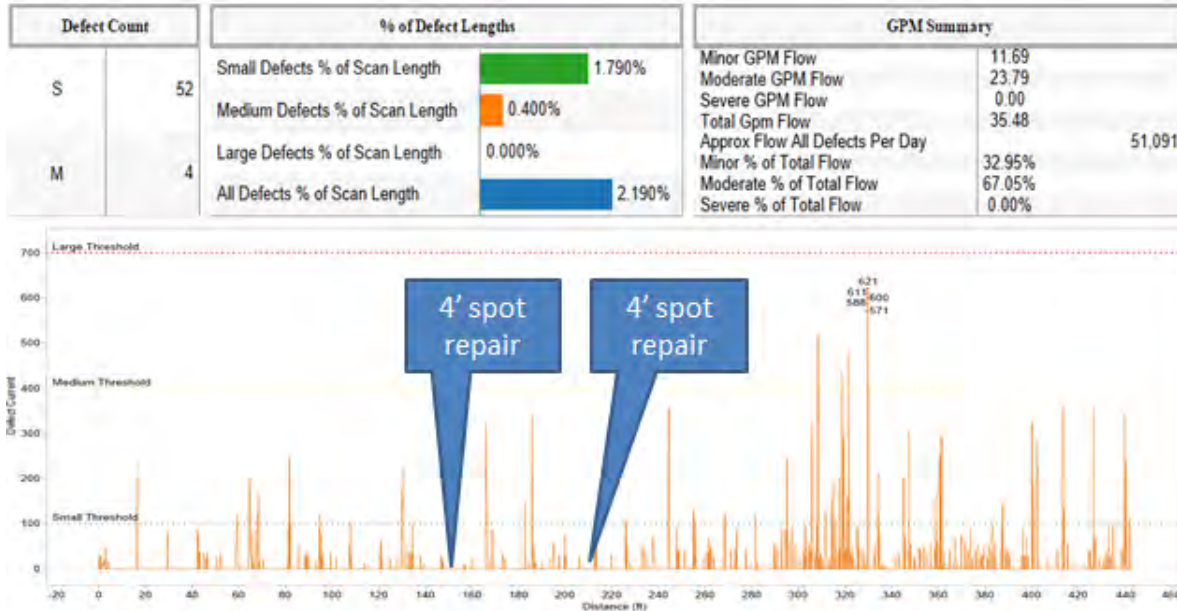
However, as a post-evaluation inspection, HTMA electro scanned the two sections of pipe where point repairs had been made by in-house crews. It was revealed that although the spot repairs had been effective, the remainder of the pipe was in poor condition and in need of rehabilitation, as shown in Figure 9. In addition to 3 ½ days labor and materials to make the repairs, the cost for road restoration work alone amounted to \$7,970. HTMA believes that if

Figure 9: Scan graph showing the effectiveness of the spot repairs, but leaks in the pipe beyond the repairs.

the Agency had purchased and utilized Electro Scan before these repairs were made, the Electro Scan technology would have allowed the Authority to make better educated decisions, both structurally and financially. HTMA Management feels that in hindsight, owing to the Electro Scan results, a better approach would have been to CIPP line these two sections of pipe; this approach would have undoubtedly yielded better post-scan evaluation results. HTMA repaired what could physically be seen and identified during the major storm event.
