CASE STUDY

# A Midwest Municipal Sewer Agency

## 5,500 LF Project

### Pre-Rehabilitation Assessment, Nov 11 & 12, 2015

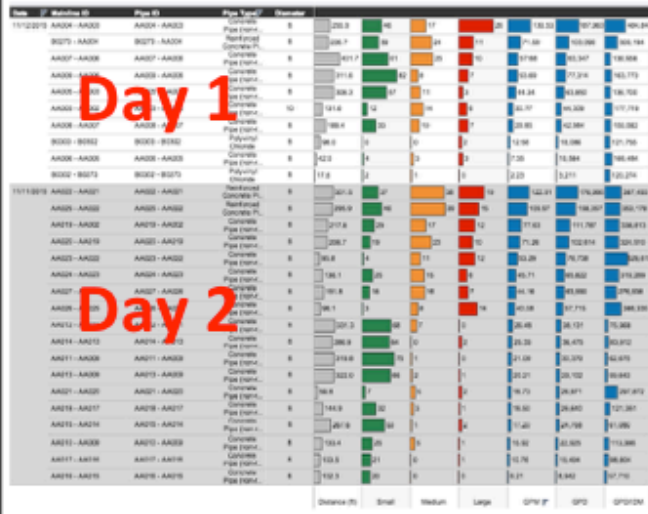
## Pre-Rehabilitation

Total Feet: 5,559      1,708,171 GPD  
 Total Segments: 28

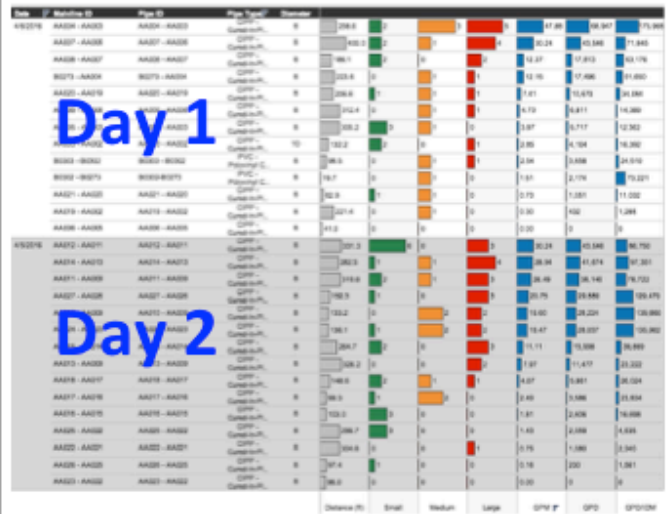
## Post-Rehabilitation

Total Feet: 5,563      434,822 GPD  
 Total Segments: 28

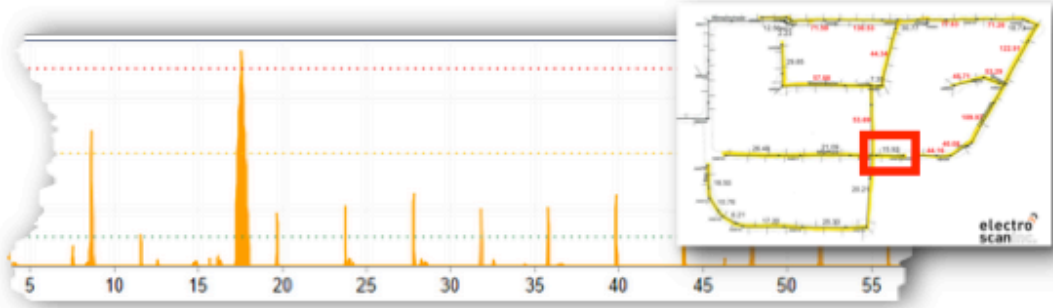
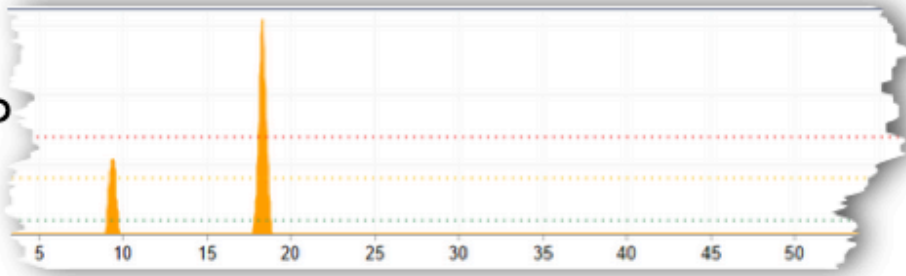
AA010 – AA009

## Post-CIPP Flow Worse Than Pre-CIPP

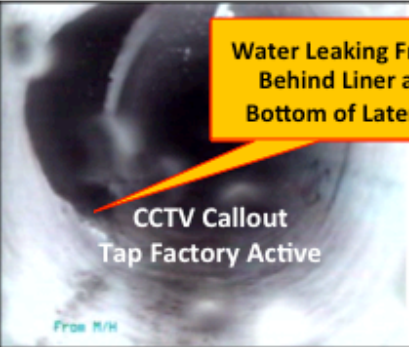
<p><b>1</b> Bad Service Connection</p>	<p>electroscaninc.

Estimated Infiltration Flow: 10.00 GPM</p>	<p>Water Leaking From Behind Liner at Bottom of Lateral CCTV Callout Tap Factory Active</p>

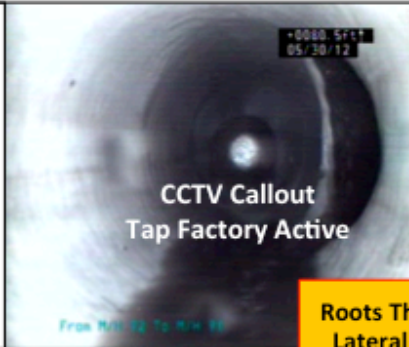
<p><b>2</b> Liner Cuts Causing Roots</p>	<p>electroscaninc.

Estimated Infiltration Flow: 10.00 GPM</p>	<p>0888 5111 05/30/12 CCTV Callout Tap Factory Active</p>

<p>Roots Through Lateral Liner</p>

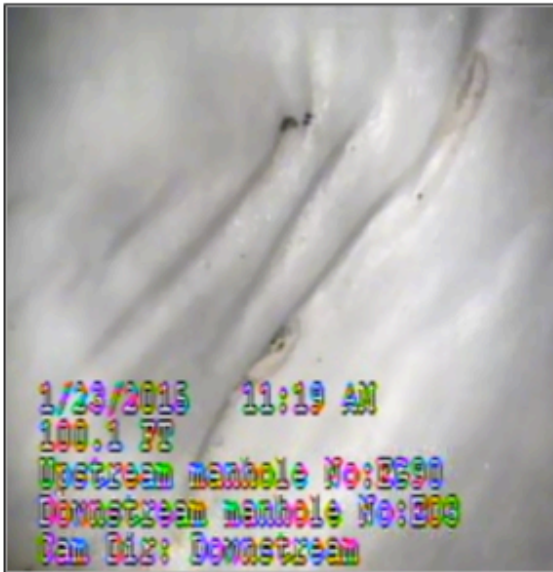
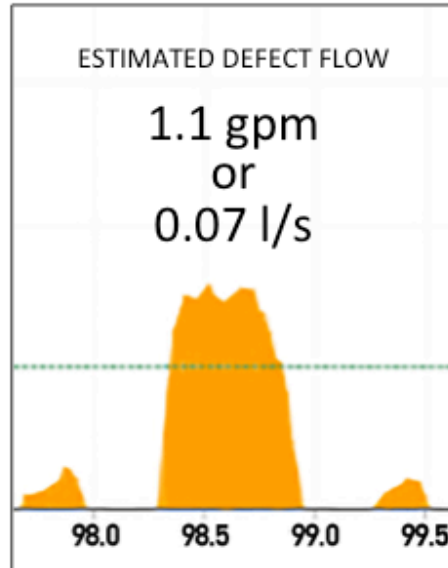
### 3 Wrinkles

WRINKLES HAVE NOW BEEN FOUND TO LEAK!

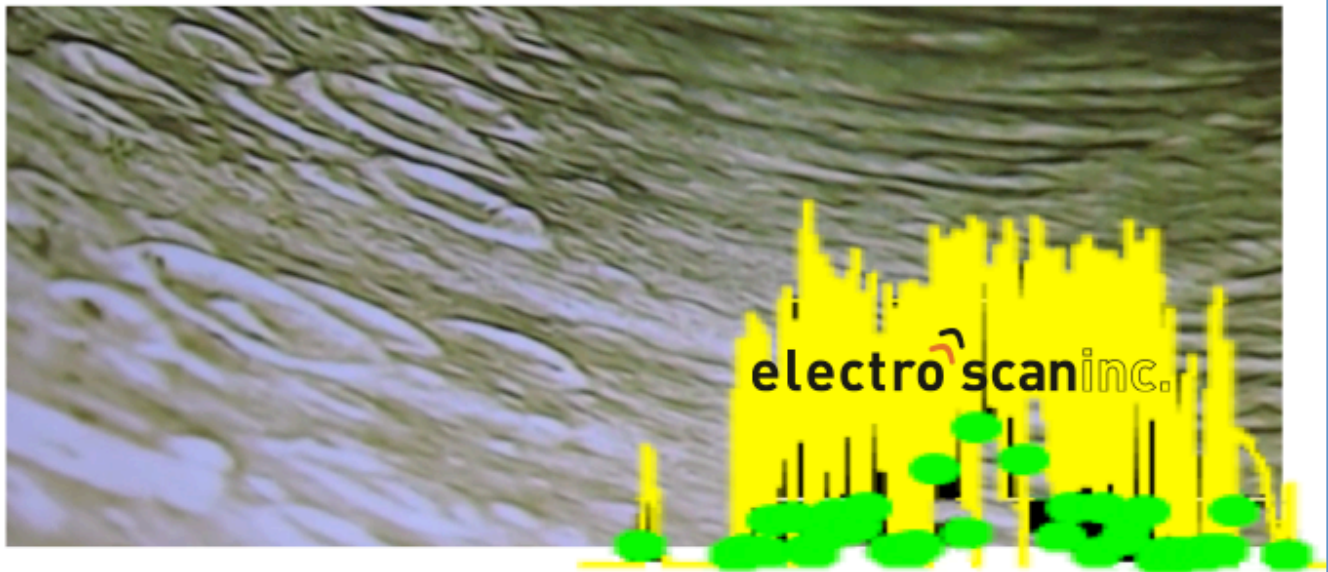
### 4 Over-Cooking a Liner *Also Referred to as Spotting or Pocking*

CCTV May 'See' It, But Has No Way of Assessing Leakage Risk
