Tri-Cities North Regional Wastewater Authority

Electro Scan Field Demonstration

Friday, March 22, 2013

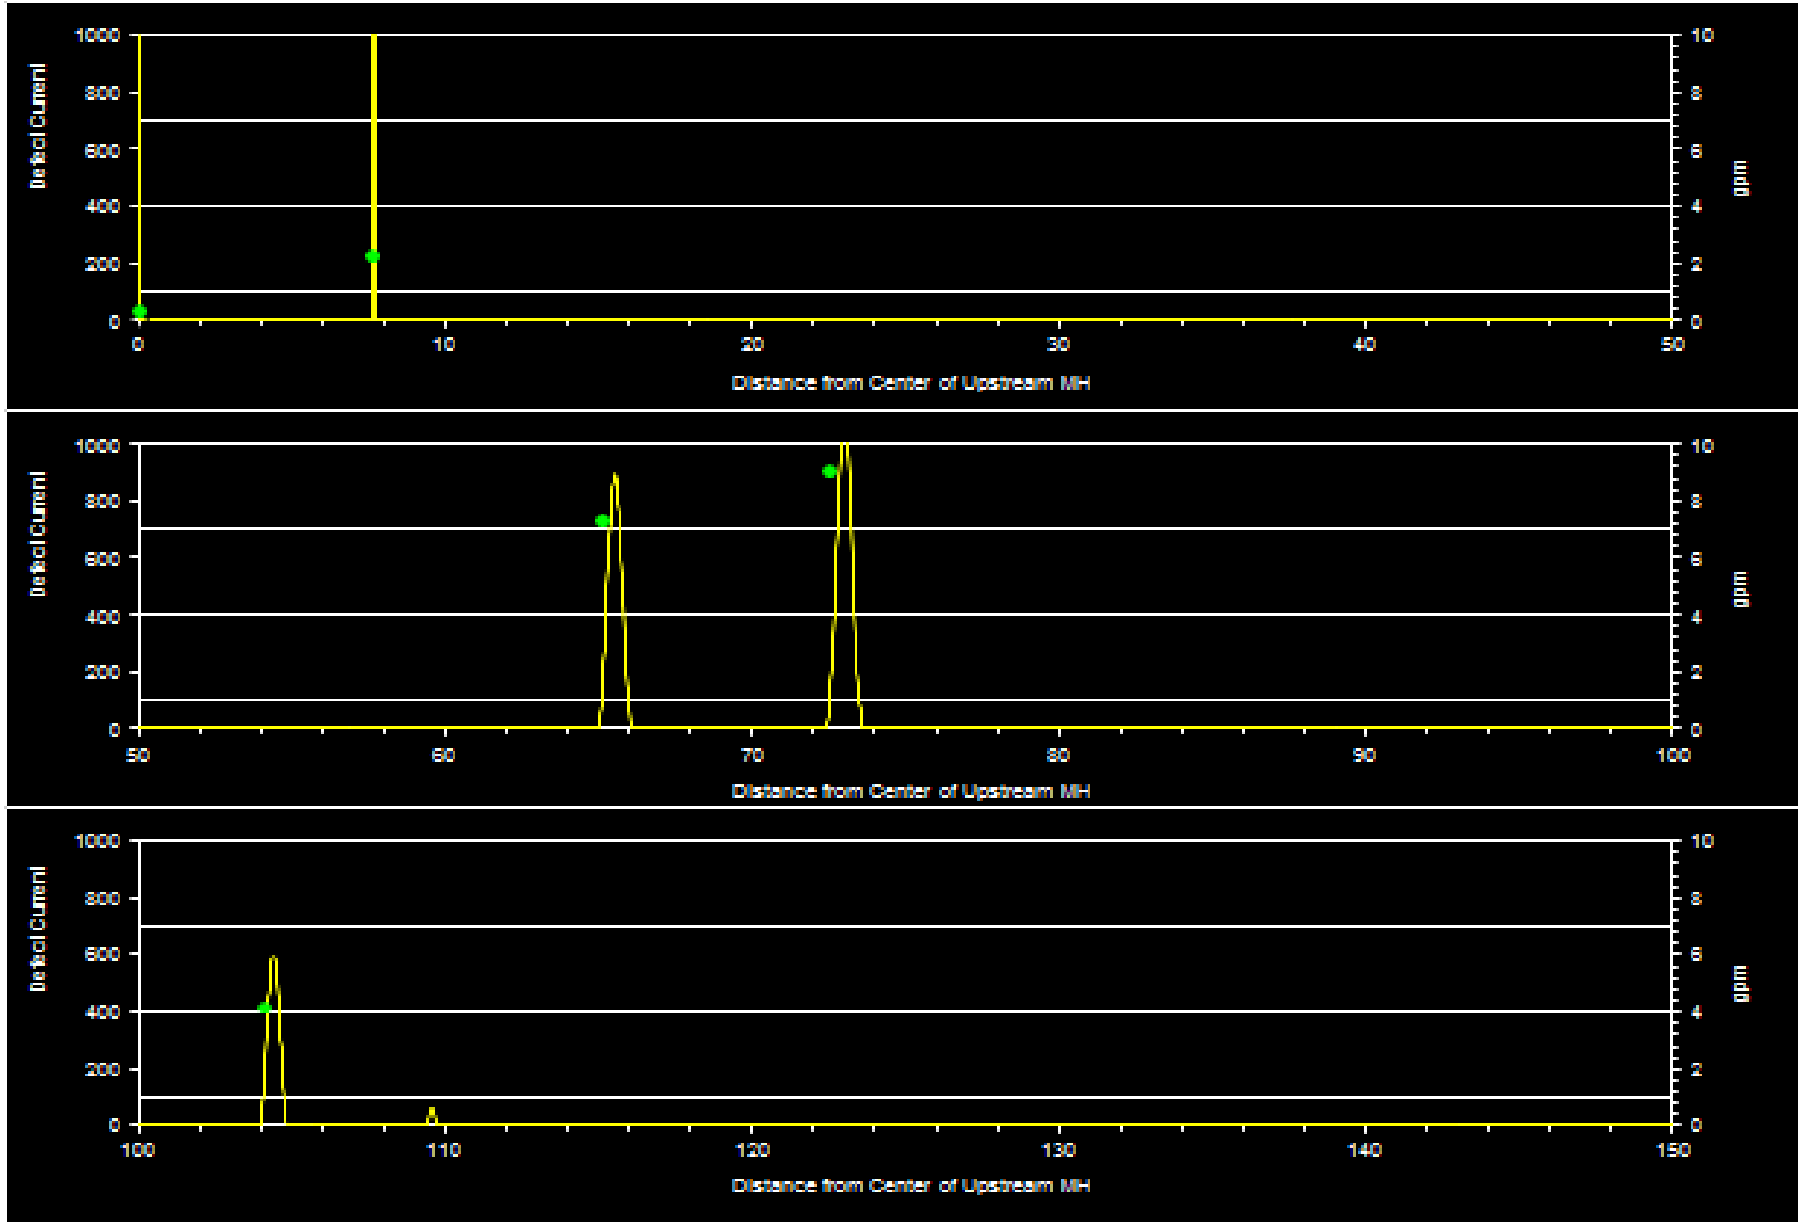
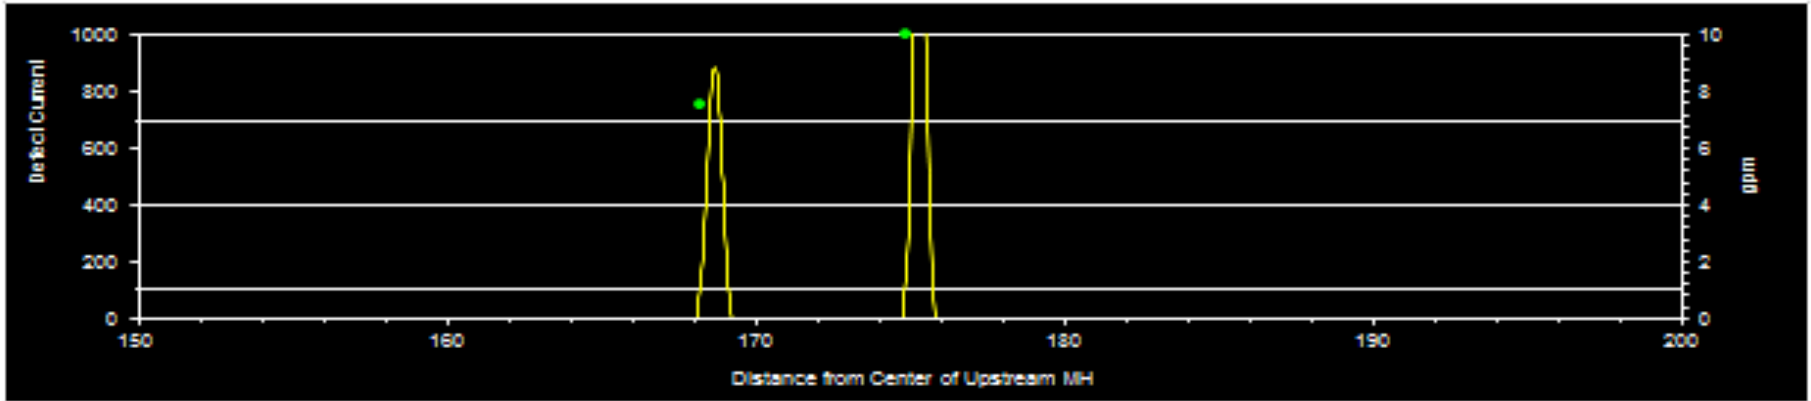
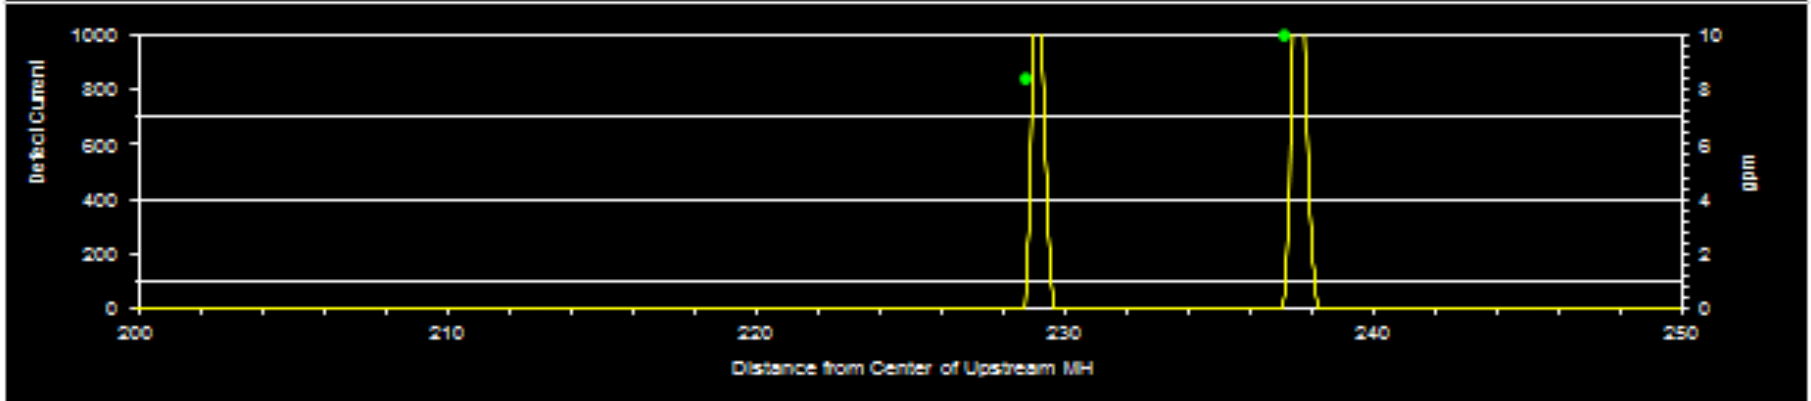
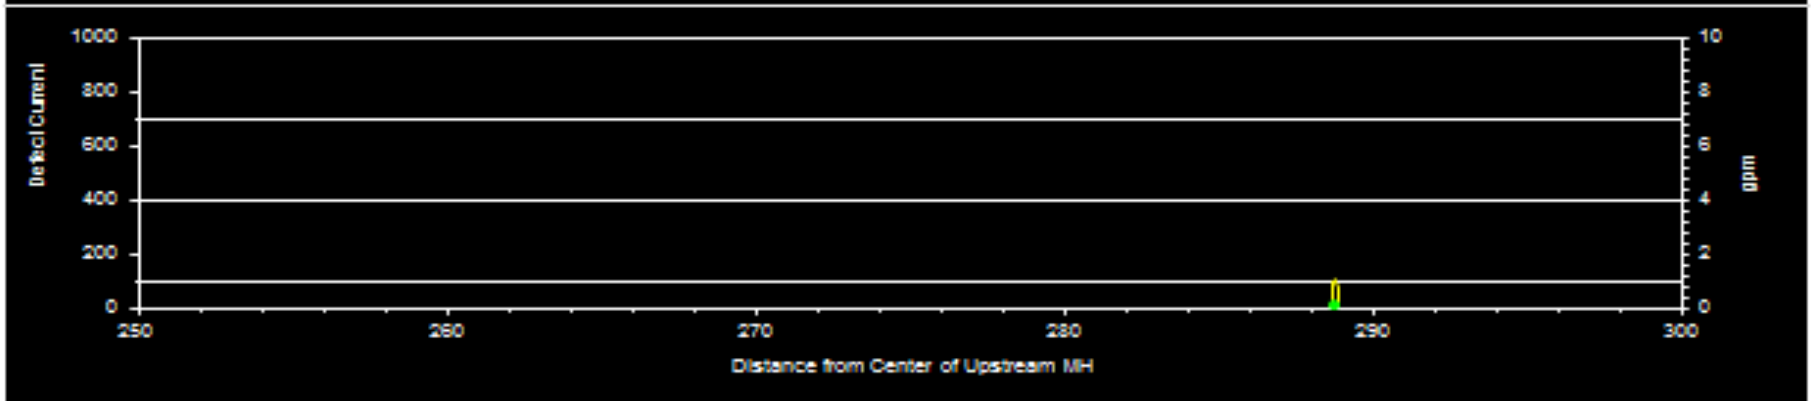
Scan #1 - Marview Avenue - Defect Graph

Electro Scan located **10** total defects – one (1) small, one (1) medium, and eight (8) large. Based on the size and quantity of those defects, it is estimated that this pipe length could infiltrate **62.1 gallons per minute**.

The defects appear to correspond to lateral connections. According to information Electro Scan and MTech received, no lateral or connection lining or sealing method had been used. This pipe has the possibility of infiltrating as much as 89,424 gallons per day. Given that this pipe was relined with CIPP, it is still a very significant potential source of infiltration. Almost 100% of the potential infiltration of this pipe is from the lateral re-instatement connections.

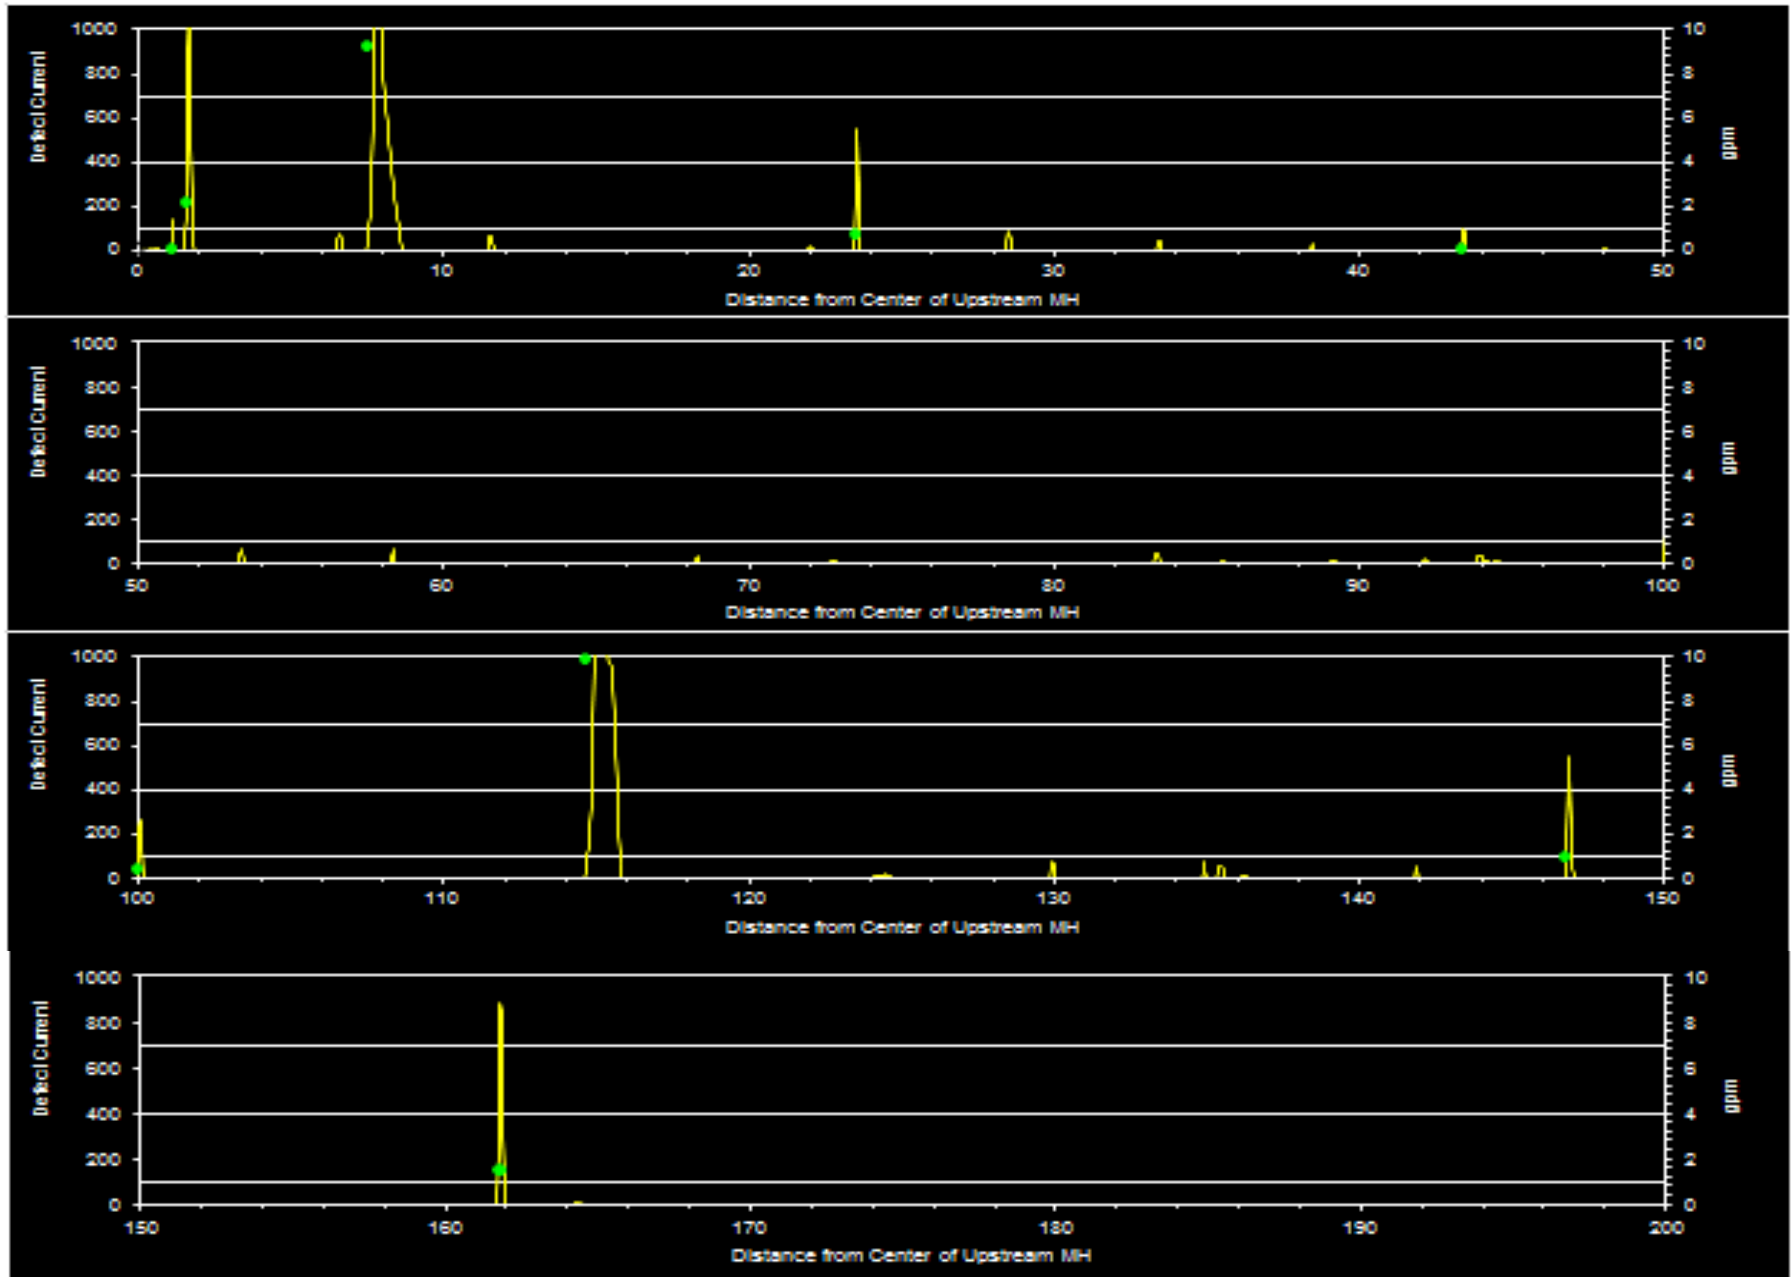
Scan #2 - Cassel Rd. - Defect Graph

Electro Scan located **9** total defects – three (3) small, two (2) medium, and four (4) large. Based on the size and quantity of those defects, it is estimated that this pipe length could infiltrate **29.9 gallons per minute**.

The majority of this pipe (including most joints) are in good shape. However, from the graph and chart, you can almost all the potential infiltration is occurring at the four large and two medium defects. The one defect alone at 115' accounts for 50% of the potential infiltration. Because of these handful of defects, this pipe has the potential to infiltrate 43,056 gallons per day.

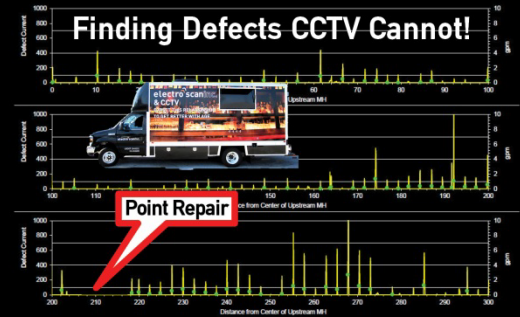
(Above) Sewer agency used CCTV to locate a defect that was determined to require a Point Repair at 210 feet. A Point Repair was completed and the Contractor used CCTV to certify the repair. Then, the pipe was **Electro Scanned**.

Good News: The Point Repair was successful -- no electrical readings!
Bad News: The Sewer Pipe had numerous other defects not seen by CCTV.
