## Using Electro Scan to certify Post-CIPP Lining Projects.

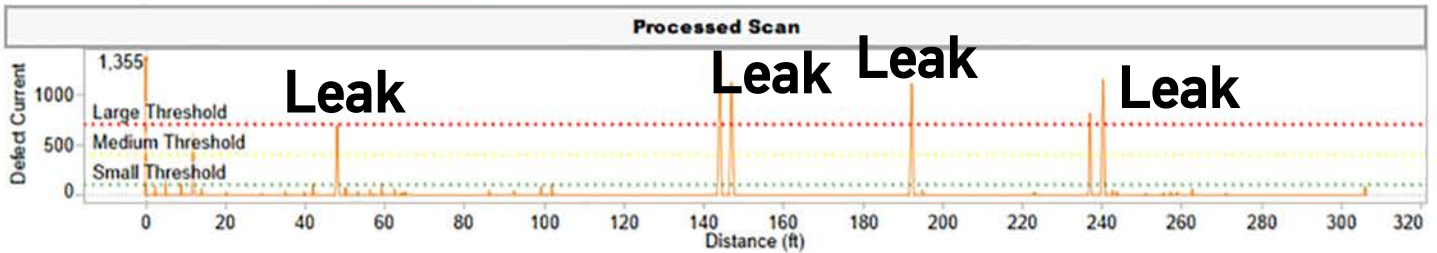
### 1 CIPP Lining

Defect Count		Defects % of Scan Length		GPM Summary	
S	5	Small Defects	0.080%	Minor GPM Flow	1.21
M	2	Medium Defects	0.450%	Moderate GPM Flow	0.00
L	6	Large Defects	1.610%	Severe GPM Flow	55.11
		All Defects	2.140%	Total Gpm Flow	56.32
				Approx Flow All Defects Per Day	81,101
				Minor % of Total Flow	1.97%
				Moderate % of Total Flow	0.00%
				Severe % of Total Flow	98.03%

**NOTE:**  
Out of eleven (11) reinstated laterals, seven (7) appear to have substantial potential for infiltration.

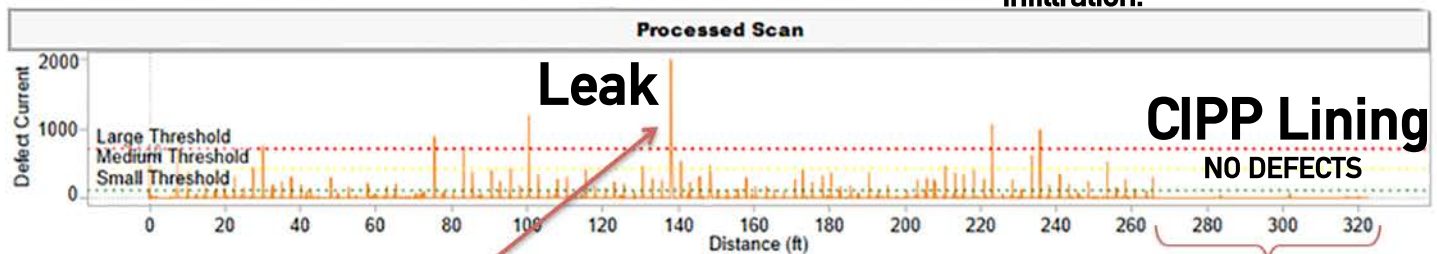
### 2 Vitrified Clay Pipe with CIPP Repair

Defect Count		Defects % of Scan Length		GPM Summary	
S	70	Small Defects	2.530%	Minor GPM Flow	29.91
M	12	Medium Defects	0.710%	Moderate GPM Flow	24.63
L	8	Large Defects	0.900%	Severe GPM Flow	9.76
		All Defects	4.140%	Total Gpm Flow	64.30
				Approx Flow All Defects Per Day	92,592
				Minor % of Total Flow	46.52%
				Moderate % of Total Flow	38.30%
				Severe % of Total Flow	15.18%

**NOTE:**  
While initial CCTV indicated only a portion of this main needed repair, which appears water tight, the remaining portion of the pipe has substantial potential for infiltration.
