37TH INTERNATIONAL
NO - DIG
FLORENCE 2019

**A case study in successful sewer network rehabilitation
with UV cured CIPP & traditional/non-traditional survey technologies.**

- Wastewater Network in Ras Al Khaimah, U.A.E. -

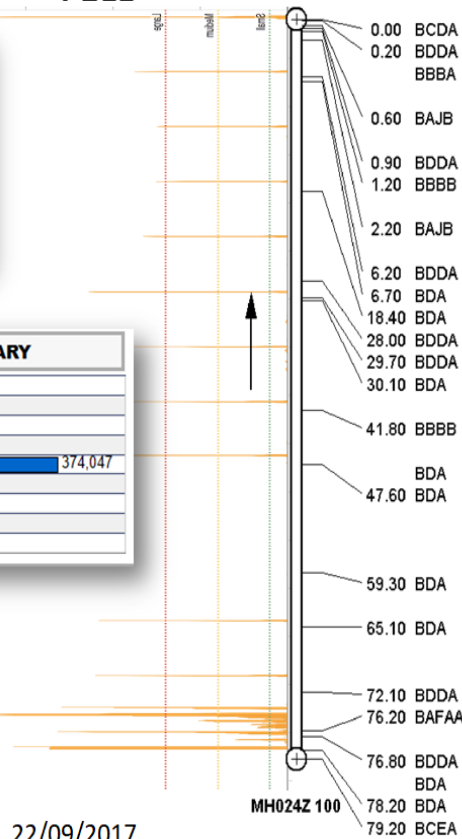
MH024Z 100A

DEFECTS	
Small	6
Medium	4
Large	15
All Defects	25

LPS SUMMARY	
Minor	
Moderate	1.83
Severe	2.40
Total LPS	4.33
LPD	374,047
LPD IDM	31,271
Minor %	1.90%
Moderate %	35.14%
Severe %	62.96%

25 Total Leaks

- 0.00 BCDA Start node type, manhole; Cl.: 1
- 0.20 BDDA Water level, clear effluent, Height = 5%; Cl.: 2
- BBBA Psn: 9; Attached deposits, encrustation, reduction of cross-section = 1%; Cl.: 1

- 0.60 BAJB Psn: 12 - 11; Displaced joint, radial Distance = 21mm; Cl.: 4
- 0.90 BDDA Water level, clear effluent, Height = 10%; Cl.: 3
- 1.20 BBBB (A) (1); Psn: 8 - 4; Attached deposits, grease, reduction of cross-section = 1%; Cl.: 1

- 2.20 BAJB Psn: 5 - 8; Displaced joint, radial Distance = 23mm; Cl.: 3
- 6.20 BDDA Water level, clear effluent, Height = 5%; Cl.: 2
- 6.70 BDA Psn: 12; General photograph; Cl.: 1

- 76.20 BAFAA Psn: 12; Surface damage, increased roughness, mechanical damage; Cl.: 3
- 76.80 BDDA Water level, clear effluent, Height = 5%; Cl.: 2
- BDA Psn: 12; General photograph; Cl.: 1

2 Displaced Joints

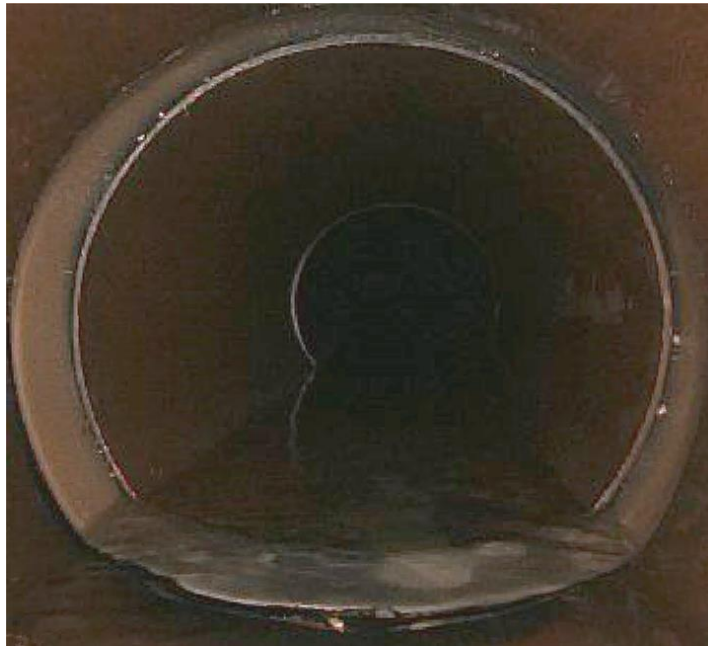
Example: MH024Z/99 – MH024Z/98

B
E
F
O
R
E

9	MH024Z/97 - MH024Z/98	PVC	200	76.60	9 patches @13.72m, 25.40m, 31.27m, 37.0 m, 43.0, 48.85 m, 66.2m, 72.2m & 74.7 m as per FELL. CIPP due to number of patches exceeding 5
10	MH024Z/99B - MH024Z/100	PVC	200	39.30	CIPP as per FELL(5 points @1.45m, 7.95m, 10.74m, 16.8m, 30.3m, 37.95m & 38 m) and CCTV (0.6m, 38.70m) exceeded limits of patches.
