Use of Low Voltage Conductivity to Conduct a 10km (30,461 LF) Inspection of Legacy Cured-In-Place Pipe (CIPP) for a Leak Assessment Project

Chuck Hansen¹

¹ Chairman, Electro Scan Inc., United States

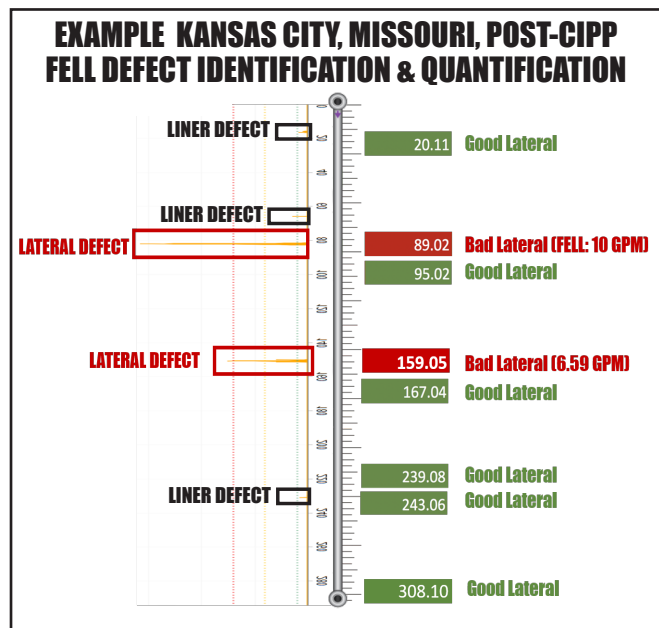
Figure 12: CIPP Liner vs. Lateral Connection Defects

(Above) Certified CCTV operator identified all 'Lateral Connections' as Tap Factory Active (TFA), i.e. no defects or leakage.

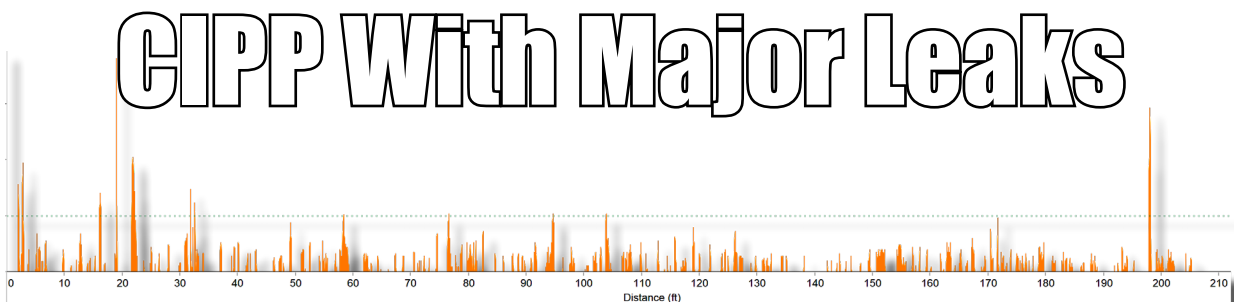
Figure 13: Example FELL Survey of a Severely Defective CIPP Liner

In addition to finding multiple defects at lateral re-connections, a number of liner defects were located and measured in liner walls as a single sewer main is illustrated in Figure 13.

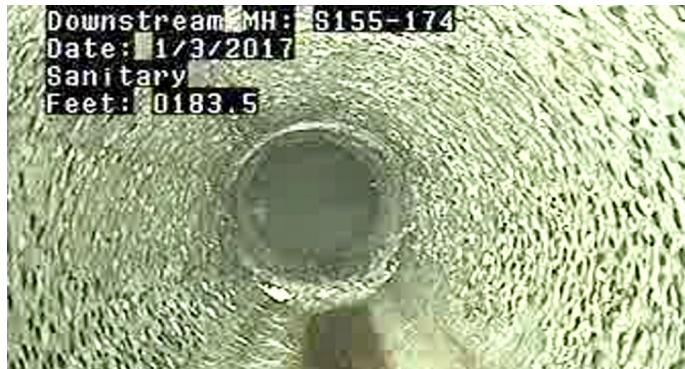
Figure 14: Example KCMO CIPP Pinholes

Pinhole leaks were a key goal of assessing for KCMO and may be caused by a number of factors including, but not limited to, lower resin-to-felt mixtures, low quality resin material, uneven heating or curing, accidental cuts, liner stretching, use of inappropriate tire treads on mobile CCTV camera, contractor mechanical equipment entering, and/or improperly applied cleaning equipment.

Contrary to CIPP suppliers and installation contractors, pinholes *are not* self-healing, will get worse not better over time, and may severely reduce the useful life and structural integrity of CIPP. While pinholes may not be visually seen by initial Post-CIPP televising, infiltration stains, i.e. where water has seeped through the liner, may show defect locations.

As shown in Figures 14, 15, and 16, a number of pinhole defects were identified by FELL, with many confirmed by visual inspection. While large holes are included in gpm calculations, smaller defects, i.e. below 0.1 GPM can be included in defect flow calculations.

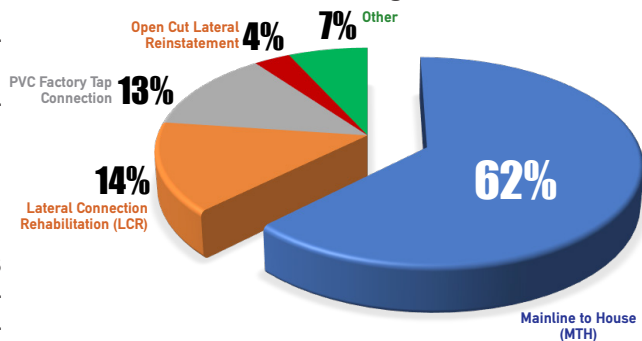
Figure 17: KCMO CIPP Defects By Lateral Connection Relining Method

While CIPP suppliers and contractors have often stated elimination of infiltration as the reason to rehabilitate laterals, FELL testing found defects at both lateral connections and T-liner connections as part of the KCMO CIPP survey.

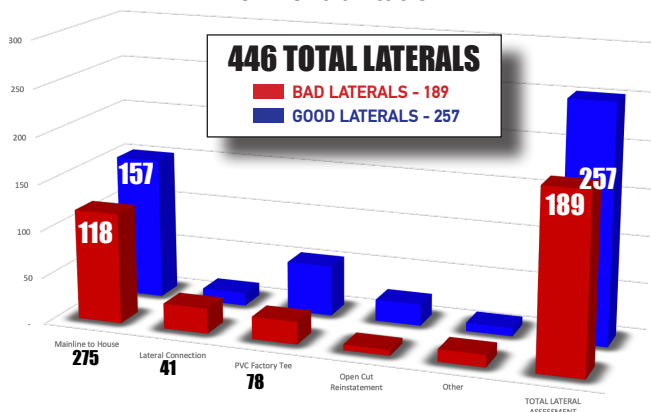
Figure 18: KCMO Defects By Type of Lateral Liner Rehabilitation

Based on FELL assessment, 118 of 275 or forty-three percent (43%) of MTH lateral rehabilitation were found with measurable FELL Defect Flows, indicating less than satisfactory reductions in flow. The next most popular method of rehabilitation was PVC factory tee solutions, representing eighteen percent (18%) of total lateral rehabilitation.

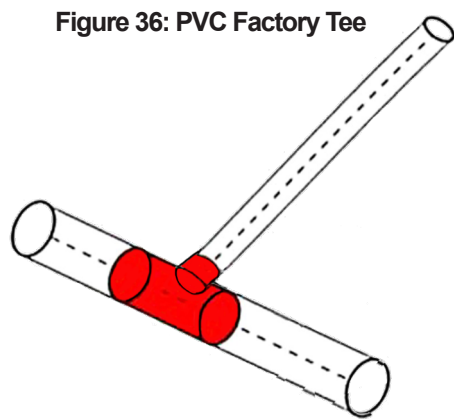
Figure 36: PVC Factory Tee

Factory tap PVC-based lateral connections or factory tees, as shown in Figures 36 and 27, resulted in 24 of 78 or 31% defective laterals found by FELL. A sample of defective PVC factory laterals with FELL leaks are shown in Figure 38.

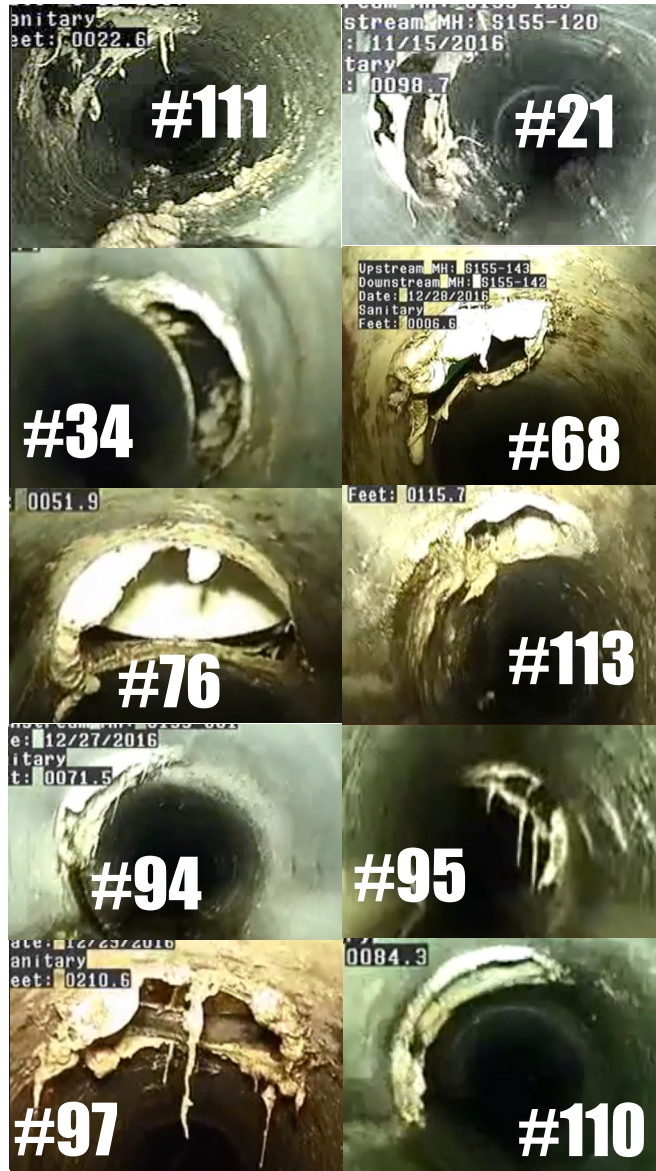
Figure 38: KCMO FELL Defects at PVC Connections

As illustrated in Figure 38 (Above), while CIPP may eliminate a significant amount of infiltration from sewer mains, poor lateral reinstatements may risk defect flows being greater *after* CIPP rehabilitation, than *before* rehabilitation.

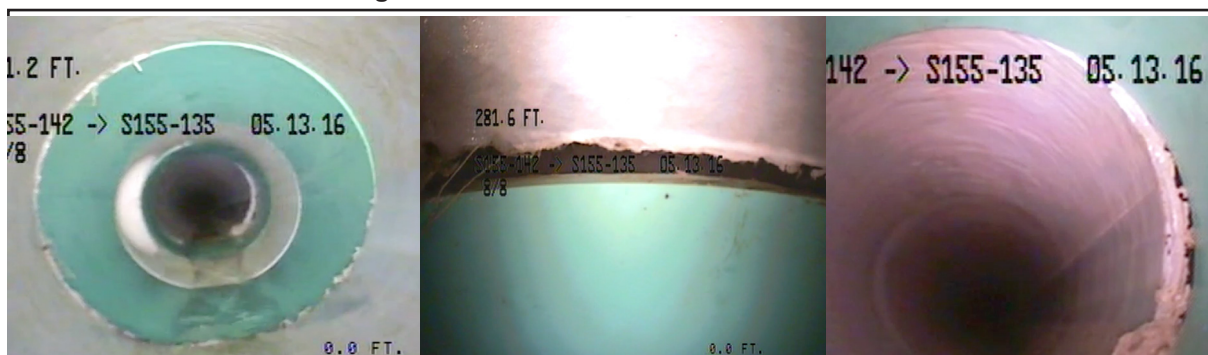
Figure 37: KCMO PVC Tee Mainline Defects

PVC connection defects are not limited to laterals, but may also include defects related to end-points of their mainline T-connection. Often called out by CCTV operators, these defects should have been identified as defective 'Material Changes' but no observations were noted as part of reviews of CCTV records.
