## **The Use of New Condition Assessment Technologies for Selecting Trenchless Rehabilitation of Wastewater Networks in Ras Al Khaimah, UAE**

Abdul Qadir Malik<sup>1</sup>

<sup>1</sup> Head of Capital Projects, Ras Al Khaimah Wastewater Agency, UAE

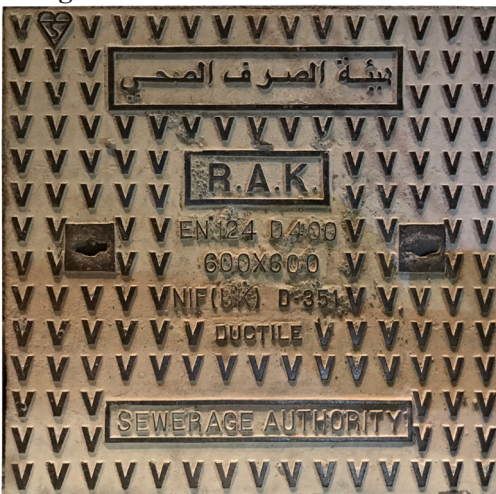
Figure 2. RAKWA Manhole Cover

RAKWA engineers had noticed numerous sections of the ‘new’ network were experiencing high levels of infiltration, illustrated in Figures 2 & 3, initially approved by high resolution CCTV cameras. Located in close proximity to the Arabian Sea, tidal infiltration is a constant threat for infiltration and exfiltration.

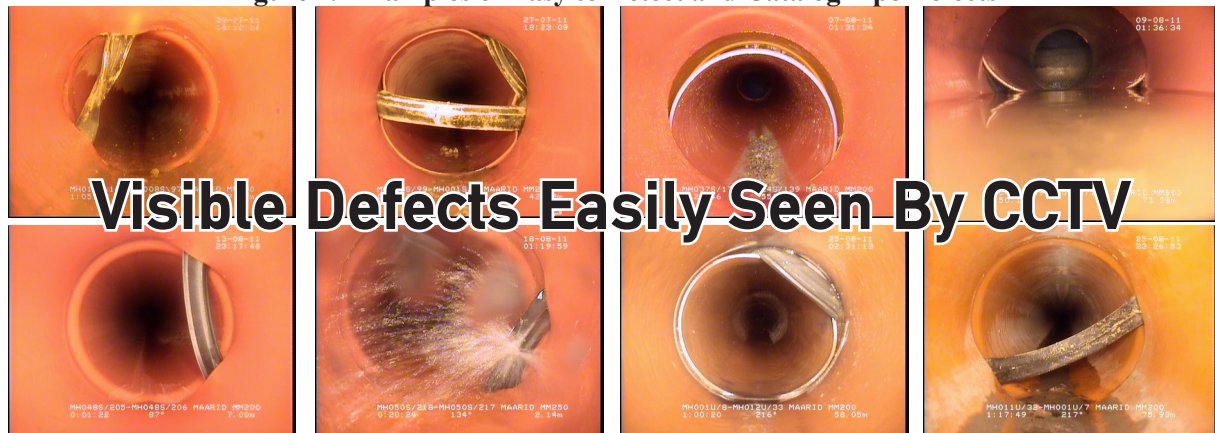
**Figure 7. Examples of Easy to Detect and Catalog Pipe Defects**

**Easy to Detect 'Visual' Problems.** A detailed review of Post-Installation / Pre-Commission of PVC sewer pipes can show obvious problems that should not be identified months or years after installation. Improperly sealed joints, poorly placed gaskets, and collapsed pipes should never be accepted if properly evaluated prior to acceptance, as shown in Figure 7 (Below).

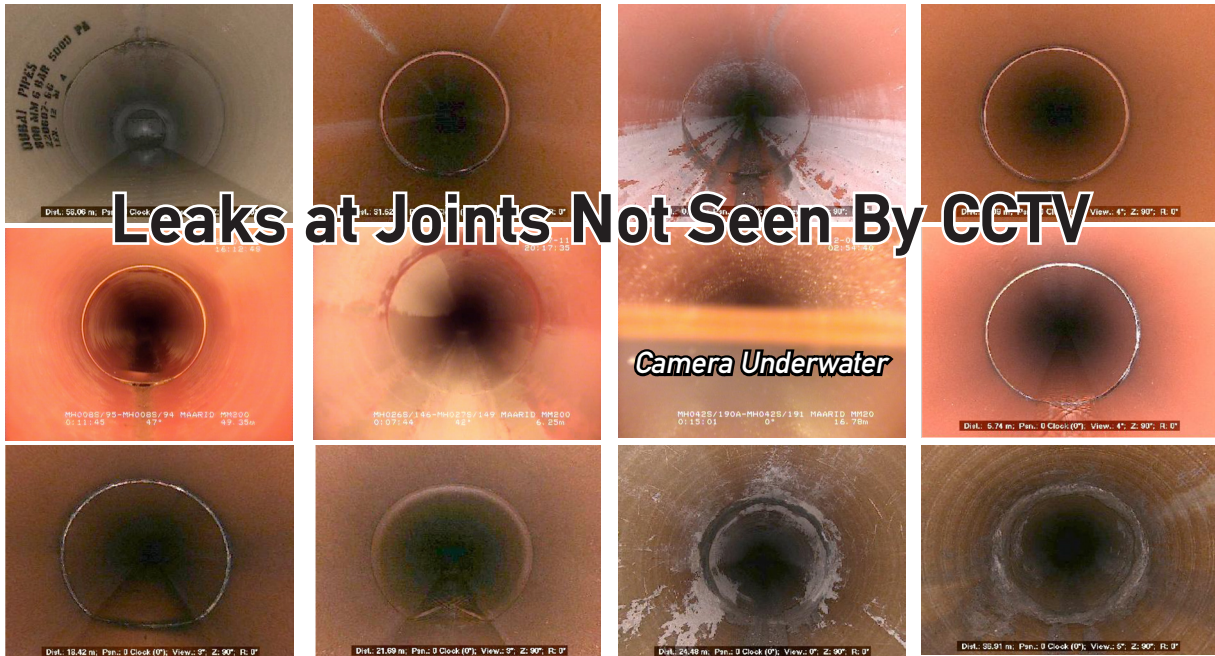
**Figure 8. Examples of Difficult to Detect and Catalog Pipe Defects**

**'Invisible Sources' of Pipe Leakage Missed By Closed-Circuit Television (CCTV) Inspection.** A key finding of the RAKWA condition assessment project was the confirmation of 'invisible' defects, i.e. defects at joints not readily observed by CCTV operators, QA/QC personnel or consulting engineers, as shown in Figure 8 (Below).

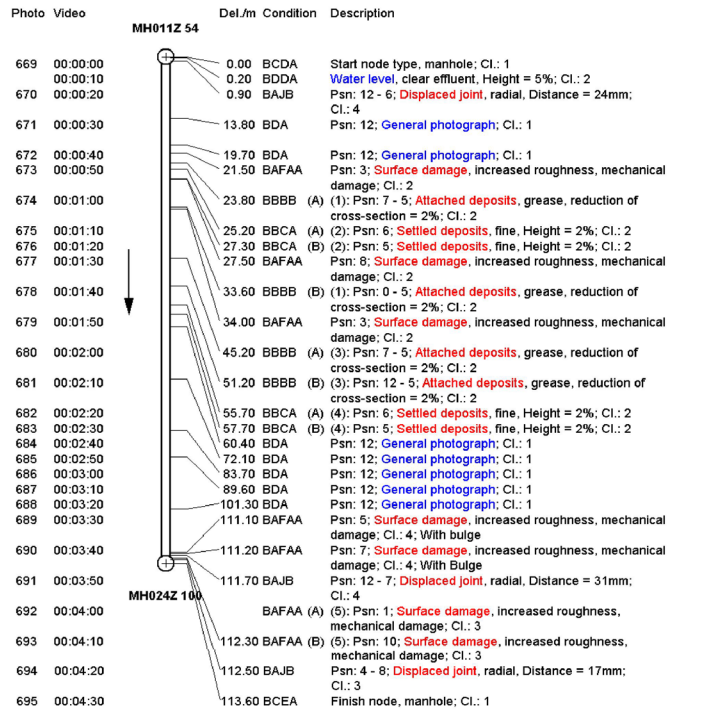
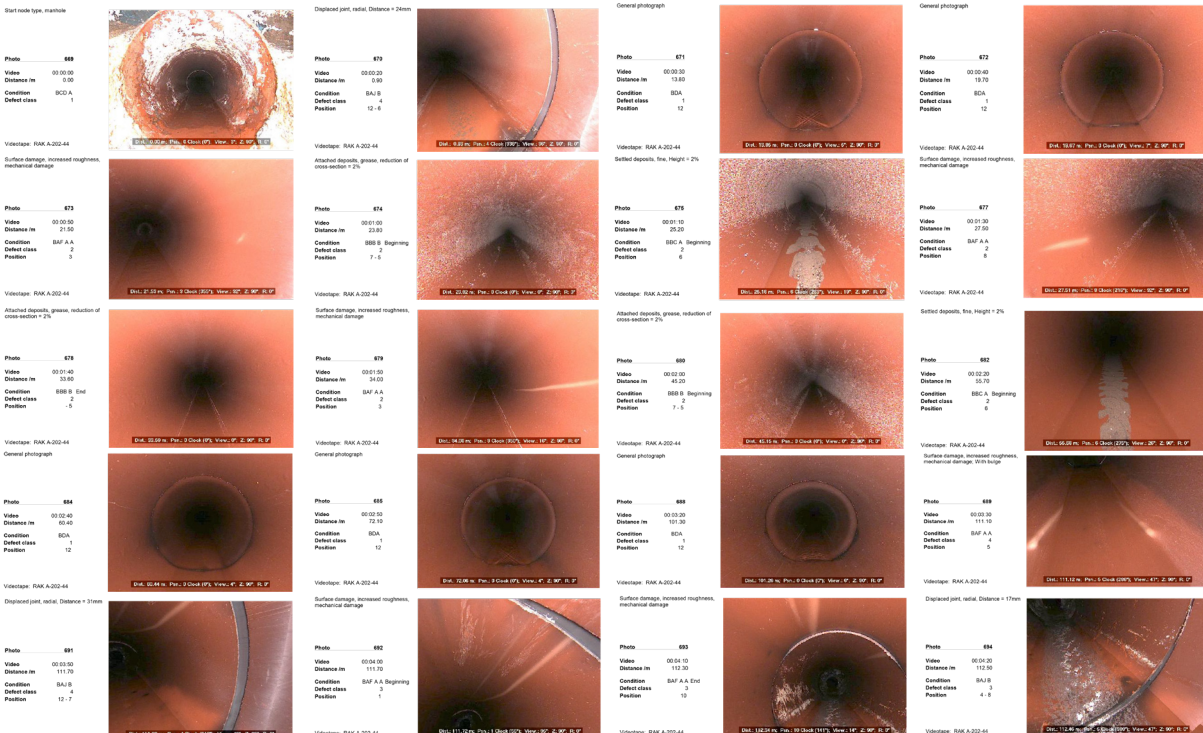
Figure 9. Example CCTV Inspection Results Using iBAK Panorama Camera

Photo	Video	Dist./m	G	Condition	C	Description
669	00:00:00	0.00	BCD	A		Start node type, manhole
	00:00:10	0.20	BDD	A		Water level, clear effluent, Height = 5%
670	00:00:20	0.90	BAJ	B		Pos: 12- 6; Displaced joint, radial, Distance = 24mm
671	00:00:30	13.80	BDA	A		Pos: 12; General photograph
672	00:00:40	19.70	BDA	A		Pos: 12; General photograph
673	00:00:50	21.50	BAFAA	A		Pos: 3; Surface damage, increased roughness, mechanical damage
674	00:01:00	23.80	BBBB	B		Beginning > Pos: 7- 5; Attached deposits, grease, reduction of cross-section = 2%
675	00:01:10	25.20	BBCA	A		Beginning > Pos: 6; Settled deposits, fine, Height = 2%
676	00:01:20	27.30	BBCA	A		End > Pos: 5; Settled deposits, fine, Height = 2%
677	00:01:30	27.50	BAFAA	A		Pos: 8; Surface damage, increased roughness, mechanical damage
678	00:01:40	33.60	BBBB	B		End > - 5; Attached deposits, grease, reduction of cross-section = 2%
679	00:01:50	34.00	BAFAA	A		Pos: 3; Surface damage, increased roughness, mechanical damage

680	00:02:00	45.20	BBBB	B		Beginning > Pos: 7- 5; Attached deposits, grease, reduction of cross-section = 2%
681	00:02:10	51.20	BBBB	B		End > Pos: 12- 5; Attached deposits, grease, reduction of cross-section = 2%
682	00:02:20	55.70	BBCA	A		Beginning > Pos: 6; Settled deposits, fine, Height = 2%
683	00:02:30	57.70	BBCA	A		End > Pos: 5; Settled deposits, fine, Height = 2%
684	00:02:40	60.40	BDA	A		Pos: 12; General photograph
685	00:02:50	72.10	BDA	A		Pos: 12; General photograph
686	00:03:00	83.70	BDA	A		Pos: 12; General photograph
687	00:03:10	89.60	BDA	A		Pos: 12; General photograph
688	00:03:20	101.30	BDA	A		Pos: 12; General photograph
689	00:03:30	111.10	BAFAA	A		Pos: 5; Surface damage, increased roughness, mechanical damage; With bulge
690	00:03:40	111.20	BAFAA	A		Pos: 7; Surface damage, increased roughness, mechanical damage; With bulge
691	00:03:50	111.70	BAJB	B		Pos: 12- 7; Displaced joint, radial, Distance = 31mm

692	00:04:00	111.70	BAFAA	A		Beginning > Pos: 1; Surface damage, increased roughness, mechanical damage
693	00:04:10	112.30	BAFAA	A		End > Pos: 10; Surface damage, increased roughness, mechanical damage
694	00:04:20	112.50	BAJB	B		Pos: 4- 8; Displaced joint, radial, Distance = 17mm
695	00:04:30	113.60	BCEA	A		Finish node, manhole

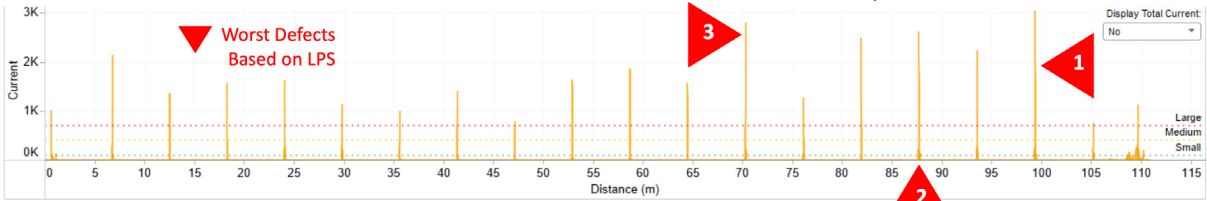
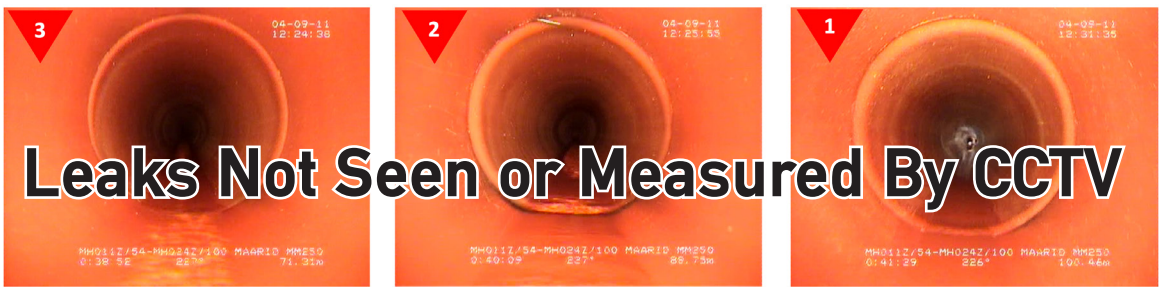
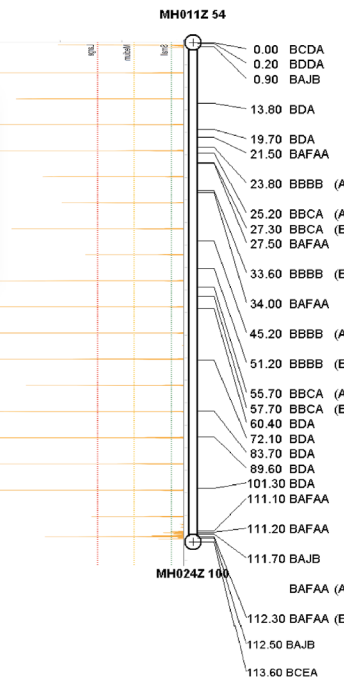
Figure 10. Example FELL Inspection Results Using Electro Scan Inc. Machine-Intelligent Probe

DEFECT BY LOCATION								
Mainline ID: MH011Z/54 - MH024Z/100 Pipe ID: MH011Z/54 - MH024Z/100 Diameter: 250 inches Pipe Type: PVC Soil Type: Sand Ground Condition: Dry								
Defect Grade	Defect Start	Defect End	Defect Length	LPS	% of LPS	LPD	LPD IDM	
L	99,389	99,595	206	0.58	0.11	50,367	2,948	
L	87,738	87,960	222	0.53	0.10	45,897	2,686	
L	70,326	70,486	160	0.45	0.08	38,811	2,271	
L	81,947	82,070	123	0.34	0.06	29,054	1,700	
L	93,575	93,698	123	0.32	0.06	28,073	1,643	
L	6,795	6,925	130	0.31	0.06	26,383	1,544	
L	58,731	58,862	131	0.29	0.05	24,693	1,445	
L	24,077	24,230	153	0.27	0.05	23,003	1,346	
L	109,700	109,861	161	0.26	0.05	22,131	1,295	
L	52,940	53,078	138	0.25	0.05	21,967	1,286	
L	84,511	84,620	109	0.23	0.04	19,957	1,168	
L	48,746	48,855	109	0.22	0.04	18,697	1,094	
L	29,845	30,006	161	0.22	0.04	18,697	1,094

**Worst 9 Defects = 56% of Estimated Defect Flow**

**Leaks Not Seen or Measured By CCTV**

LPS SUMMARY	
Minor LPS	0.11
Moderate LPS	1.68
Severe LPS	3.59
Total LPS	5.39
LPD	465,297
LPD IDM	27,230
Minor LPS %	2.10%
Moderate LPS %	31.20%
Severe LPS %	66.71%

**25 Total Leaks**  
FELL Survey Date  
21/09/2017

**3 Displaced Joints**  
CCTV Date  
06/09/2017
