## A CAUTIONARY CASE STUDY: MINNEAPOLIS, MINNESOTA, USA

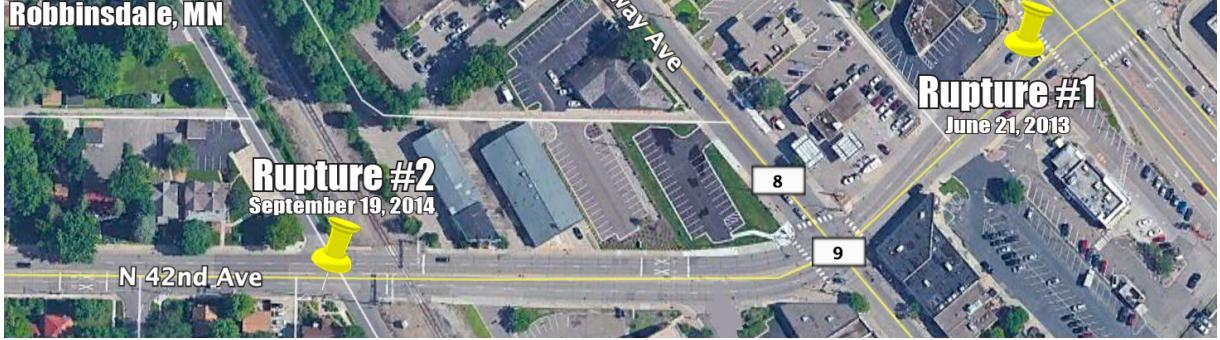
Investor-owned & municipal utilities may experience catastrophic damage if it relies on Untethered Acoustic Ball technology to locate leaks. As shown below, the inspection of a 10,000-feet (3km) of 36-inch (913mm) diameter Prestressed Concrete Cylinder Pipe (PCCP), gave a clean-bill-of-health with '**NO LEAKS**' using a leading vendor's Untethered Acoustic Ball technology. Eighteen (18) months later, separate pipe ruptures occurred. First, on June 21, 2013 (Rupture #1) causing a 30ft-wide by 15ft-deep hole, followed by a second rupture on September 19, 2014 (Rupture #2), located nearby the first ruptured pipe. Not disclosed to local media, both pipe failures had '**NO LEAKS**' identified using sensitive listening devices equipped with acoustic sensors sent through the pipe a caught in netting downstream from its insertion point.

Figure 1 – Two Separate Rupture Locations Shown After Untethered Acoustic Balls Detected 'NO LEAKS'.

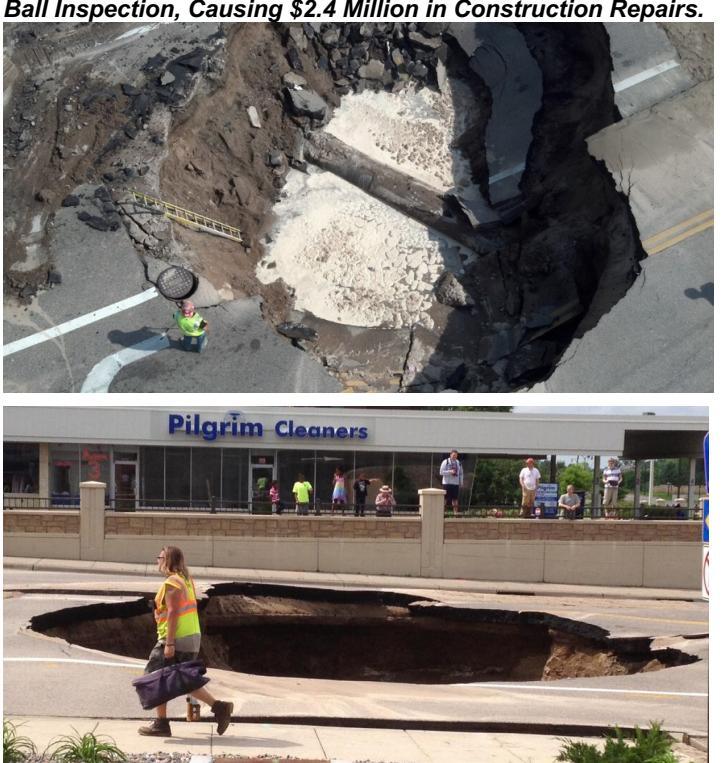
Both ruptures cost over \$2 million, each, to repair, excluding damages to local businesses that were flooded due to the rupture of both pipes. As shown in Figure 2 (Below), the five-lane roadway underwent severe damage, located in a high traffic area in front of a McDonalds restaurant.

Figure 2 – Rupture #1, One-Year after Untethered Acoustic Ball Inspection, Causing \$2.4 Million in Construction Repairs.

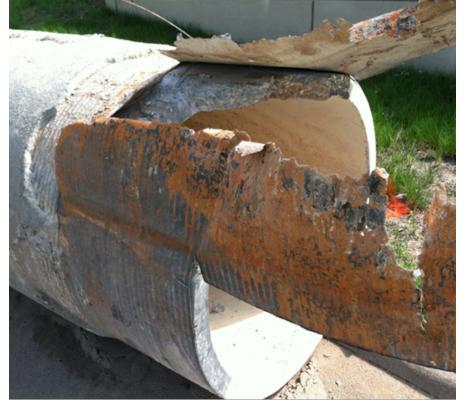
Figures 3 shows the exhumed pipe from Rupture #1, where pre-existing cracks and pipe deterioration indicated constant and ongoing leakage that was not detected up by the Untethered Acoustic Ball contractor, that also supplied its own technology licensed from a UK water organization.

Figure 3 - Exhumed PCCP section.

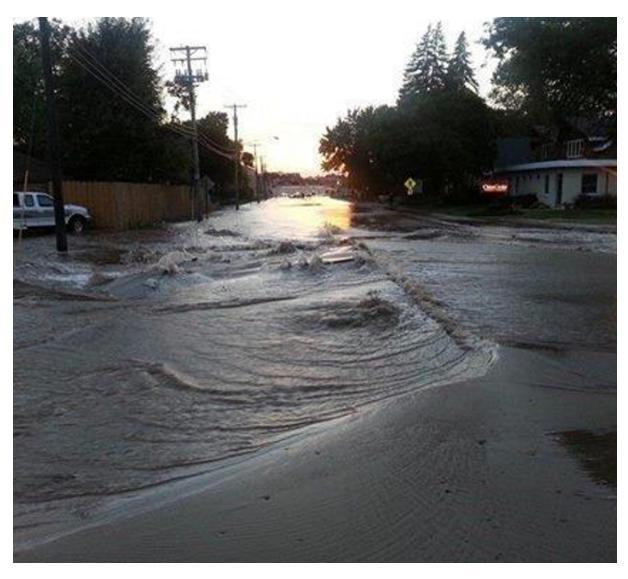
Fifteen (15) months later, a second rupture occurred less than 3,000 feet (1km) away from the first location. As shown in Figure 4, the second segment of the 36-inch (914mm) diameter pipe also ruptured under the same five-lane arterial collector roadway in the same business area – in front of an office and apartment building – where no leaks were found using an Untethered Acoustic Ball.

## Figure 4 - Pipe Location of Rupture #2.

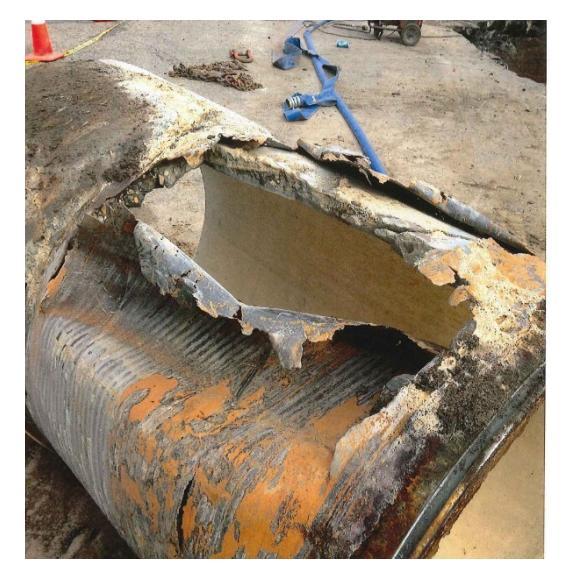
The second rupture measured 1,300 ft (0.4m) and dewatered for repairs. Upon further investigation to determine the cause, the owner responsible for the pipeline entered into a second contract with the same Untethered Acoustic Ball supplier to insert an electro-magnetic scanner, as shown in Figure 6, at an additional cost of \$137 per meter, to assess the damaged pipe. Again, the exhumed pipe responsible for Rupture #2 showed clear and unambiguous evidence of cracks and leakage, Figure 5, not detected by untethered acoustic ball technology.

Figure 5 – Exhumed damage #2.

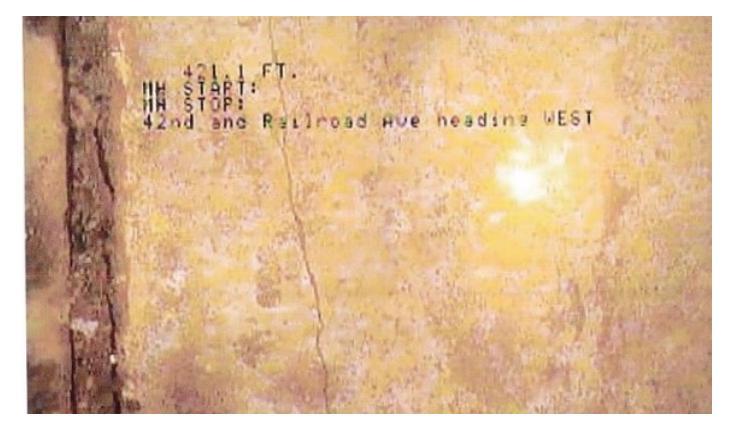
During that electro-magnetic scan, supported by humanentry, cracks and other defects were found in the pipe wall and photographed, shown in Figure 7.

Figure 7 – Hairline Crack in the Pipe Wall (Right of the Pipe Joint) Missed by Untethered Acoustic Ball, Found During Human-Entry.
