CRITICAL SEWER AND WATER CHRONICLES

AN ELECTRO SCAN PUBLICATION. ALL RIGHTS RESERVED. ISSUE No. 4, SEPTEMBER 2014

ELECTRO SCAN TRANSFORMS PIPE ASSESSMENT MARKET

Electro Scan Finds Defects Not Found By CCTV; Estimates Defects in Gallons Per Minute*

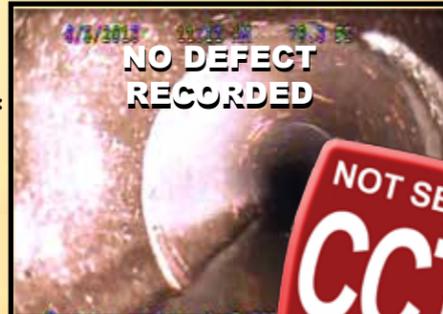
NOT SEEN ON
CCTV

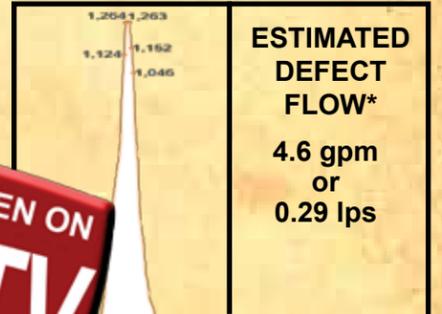
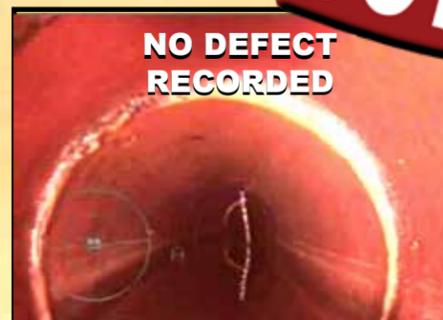
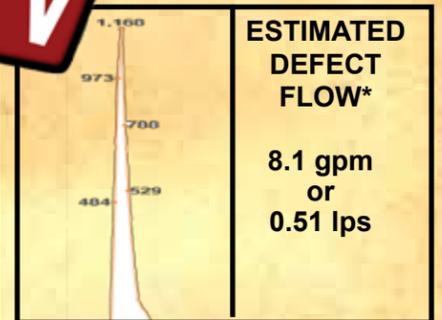
* Gallons per Minute (GPM) and Litres per Second (LPS) of Defect Flow assumes a 1ft (300mm) head and 1% pipe gradient with ±40% accuracy.

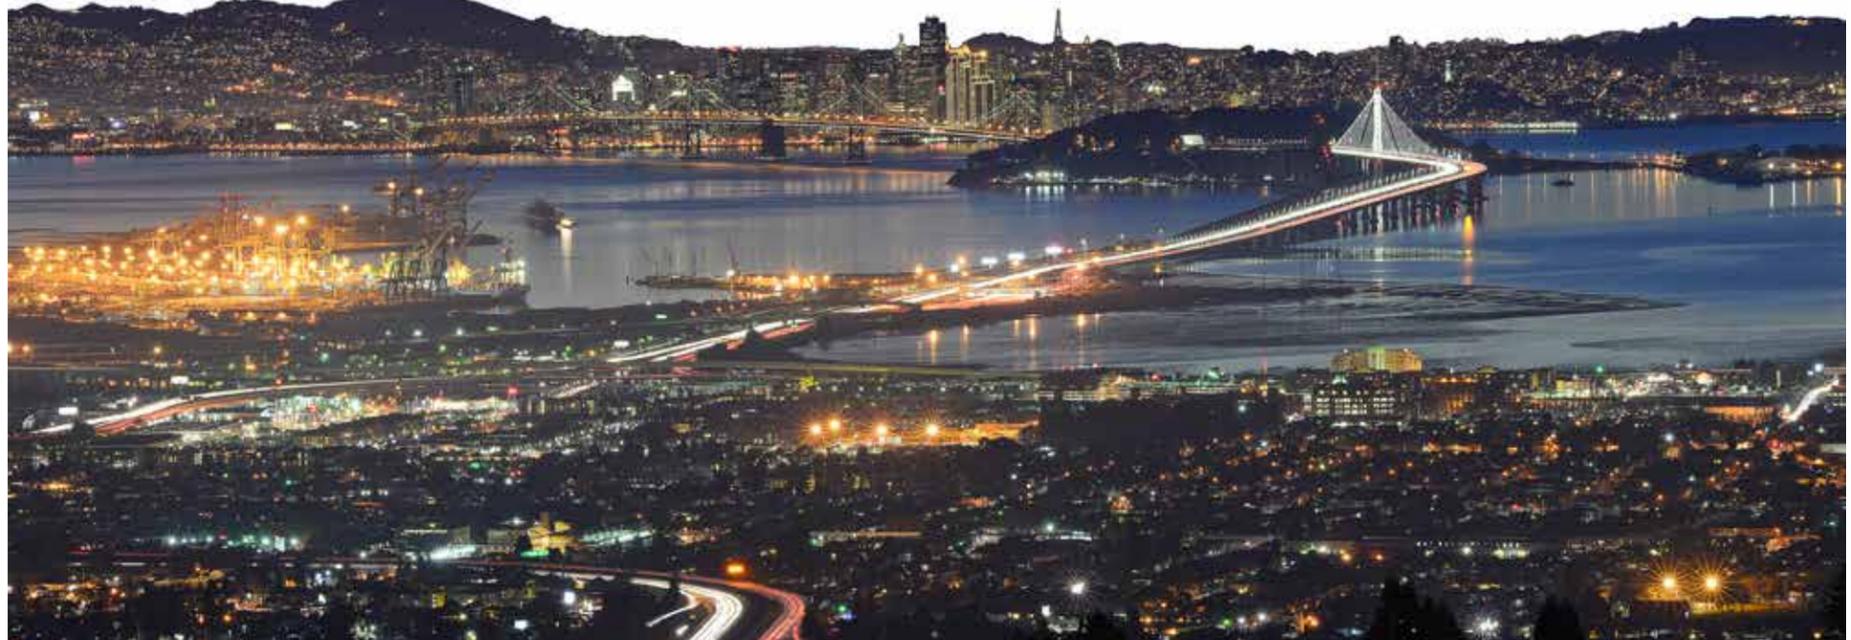
Scan Graph

Source: Critical Sewers® Cloud Application, Electro Scan Inc., 2014

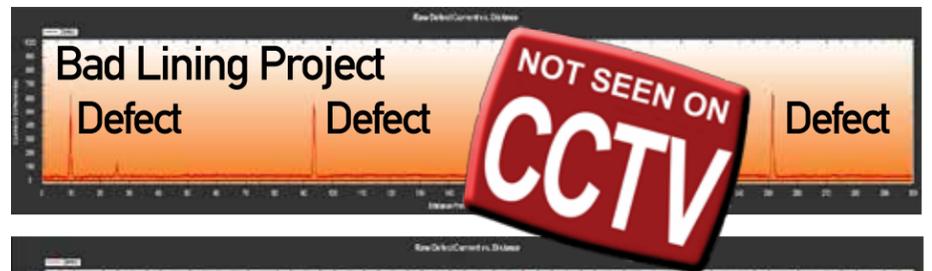
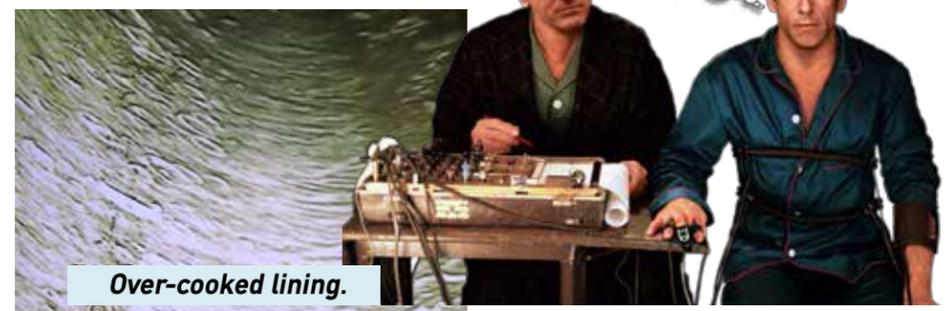
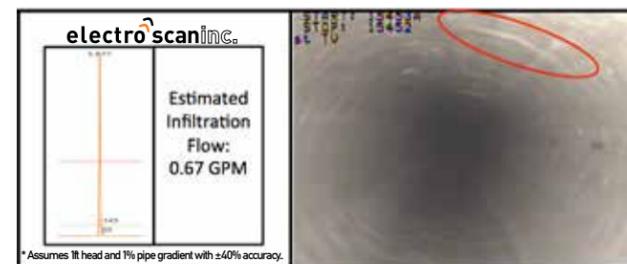
COMMON CIPP LINING DEFECTS
Tears, Rips, Ribs, Cracks, Over-Heating, Defective Service Reconnections, Lifts, Buckling, Ruptures, Fins, Wrinkles, and Pinholes
Often Missed by CCTV, but Identified and Measured by Electro Scan (F2550-13).

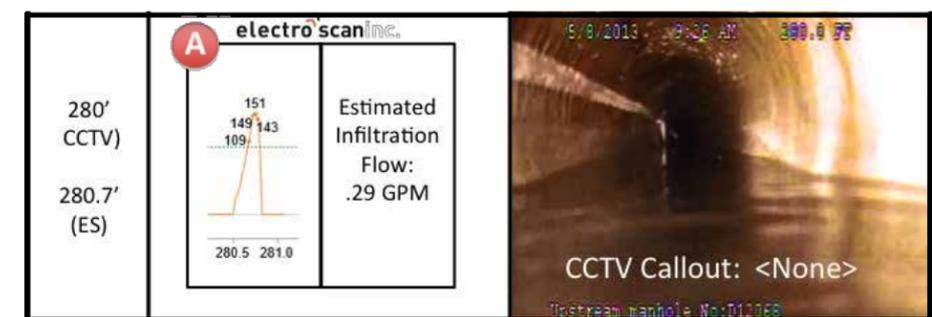
Electro Scan finds defects in bad CIPP lining projects missed by CCTV Inspection.

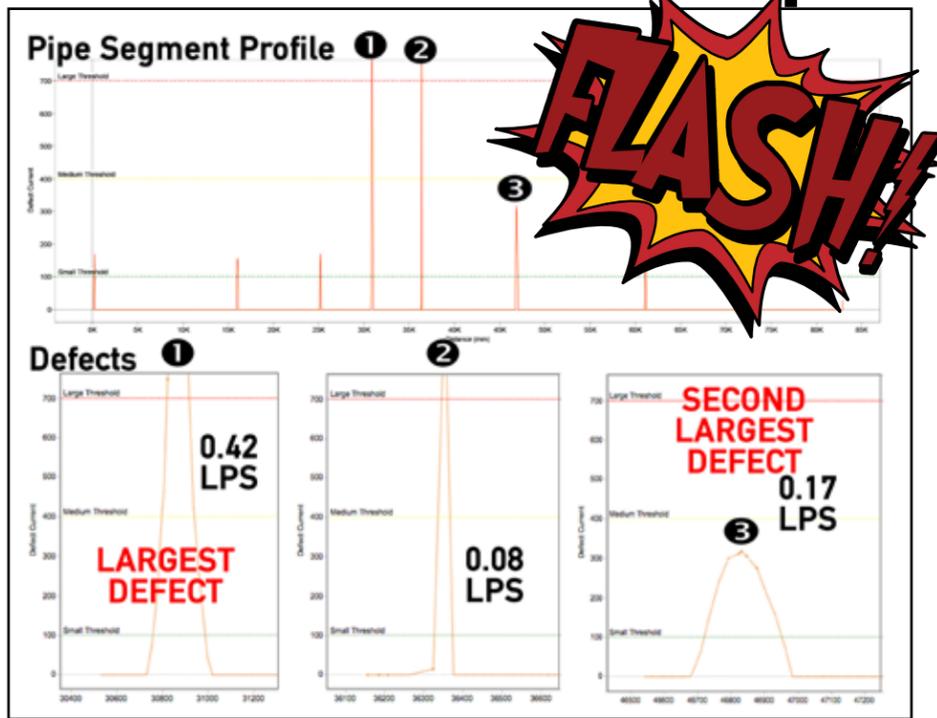
CIPP Pipe Segment #6.

As shown above, pipe segment showed seven (7) defects, representing 2 Large and 5 Small Defects, with three of the worst defects highlighted. As described in the 2013 WERF/EPA Milwaukee Metro Electro Scan Revisited Study, an advantage is to not only measure the Height of each defect, but the Width (including Start and End Points). It should be noted that while the highest defect currents are noted in Defects 1 and 2, Defect 3 actually contributes the second highest defect flow as shown by its larger calculated area.

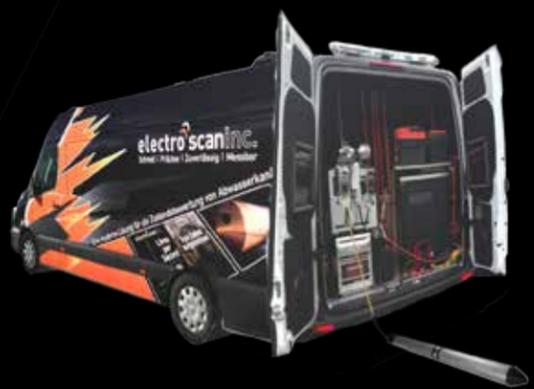
Switch from CCTV to Electro Scan, and back again - in the field - in less than 10 minutes.

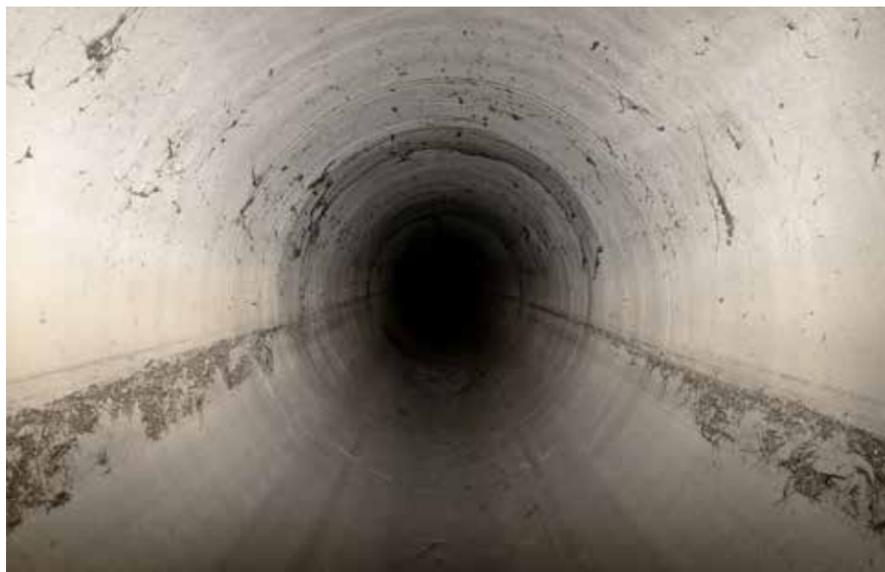
(Above) A dewatered water main undergoes TV inspection to attempt to locate leaks.

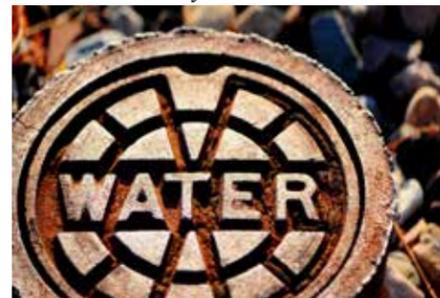
Source: AWWA Water Audits and Loss Control Programs, Manual of Water Supply Practices, M36, 2009.

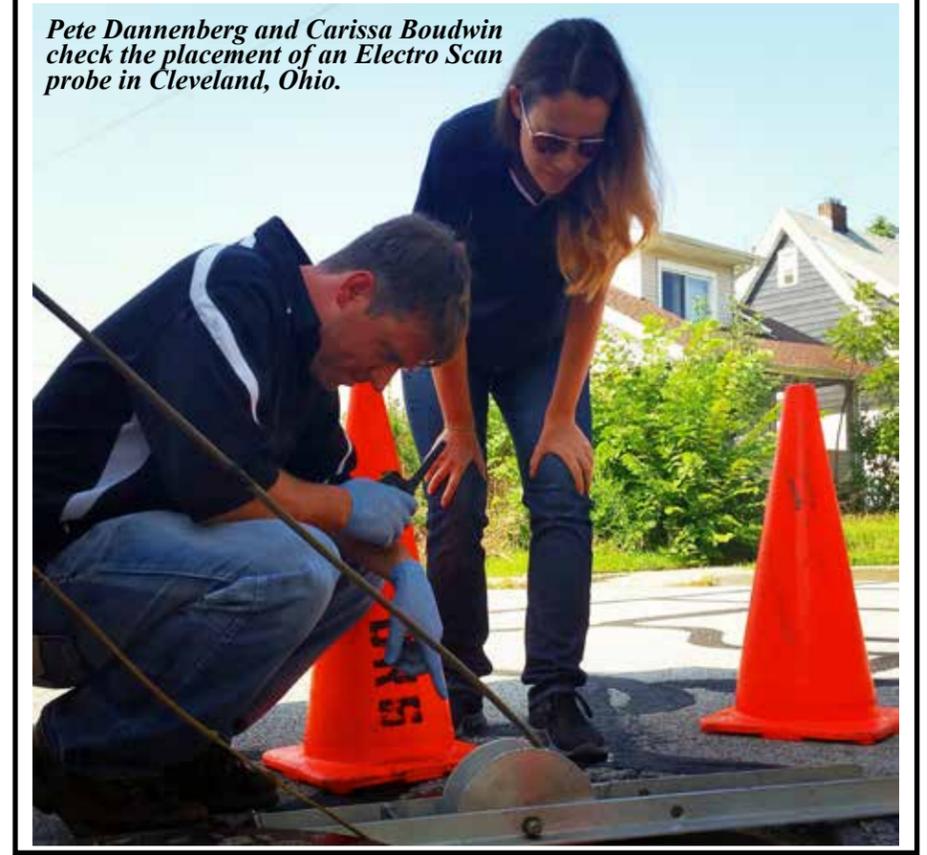
Pete Dannenberg and Carissa Boudwin check the placement of an Electro Scan probe in Cleveland, Ohio.

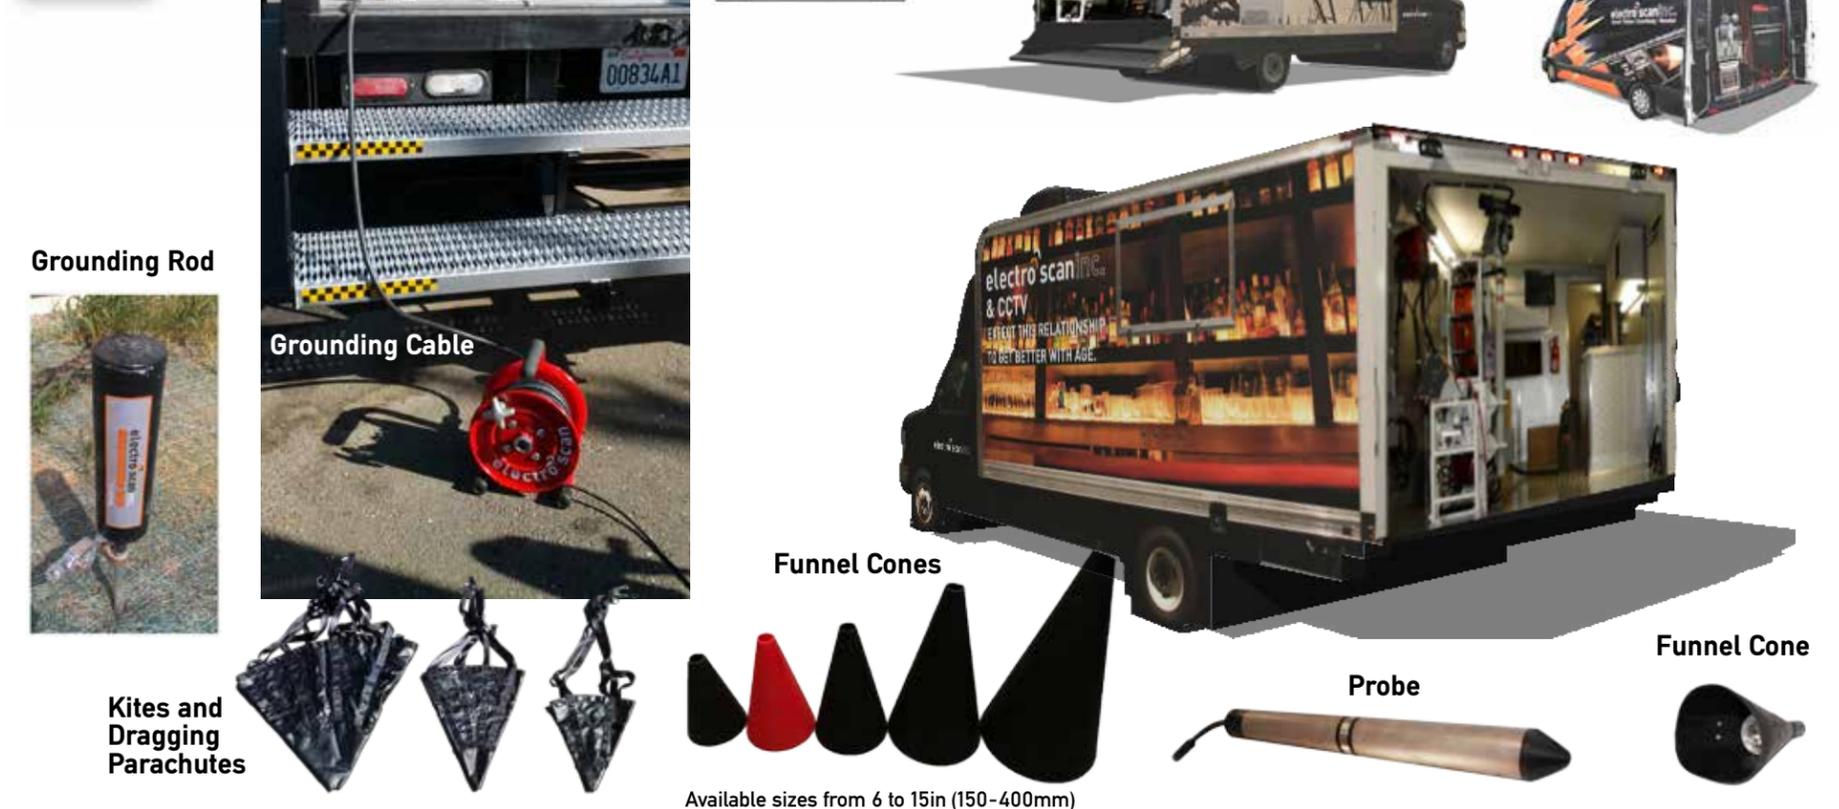
Electro Scan Field Guide

| b. Turn on Electro Scan Controller | | | | d. Operator Login | | d. Sample Funnel Plug | d. Fill until over MH Bench | | |

| | | | | e. Sewer Agency | | | | | |

| ELECTRO SCANNING | | | | GEAR REMOVAL & CLEAN-UP | REPORTING | | |
|---|---|--|--|--|---|---|--|
| a. Layout Probe | a. Connection Check | a. Water 'Too High' & Probe 'Too Slow' | a. Scan (In Process) | a. Raw Defect | a. Stop Retraction When Funnel in Downstream MH | a. Clean-Up Equipment b. Pack-Up Tools | a. www.CriticalSewers.com |
| b. Insert Probe | b. Connection Check | b. Probe Speed 'Too Fast' | c. Save Scan | b. Total Defect | b. Carefully Pull Probe Into Downstream Manhole | | b. Data Display; Subject To Licensing |
| | | 205.7 94.3 | | Shows Operator that there is adequate current flowing through the probe to obtain an effective scan. This is important because the Raw Defect Current may show low values and very little variation (good pipe) and this is the only way the operator can be sure that the system is running properly. | | | |
| d. Side Wedge Pulley OPTIONAL | 1. Total Current 2. Defect Current 3. Battery Volts 4. Probe Volts | d. All Readings 'Good' | e. Display Scan Data? | c. Data Integrity | d. Pull Probe & Rope Back Through Pipe | | Shows Operator that Probe is moving at a speed that enables the system to collect data every 10mm (0.394 inch). Plotted data represents distance (i.e. Data separation) between each defect current measurement. If the speed is too fast, the scan loses data fidelity (i.e. integrity) and will miss pipe defects. If the speed is too slow then too much time is taken to carry out the scan. |

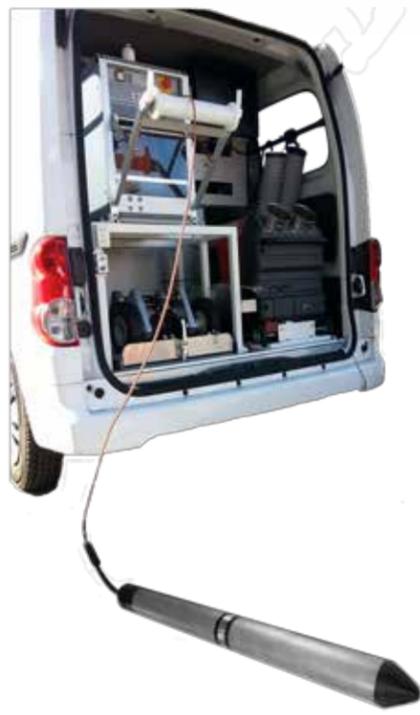
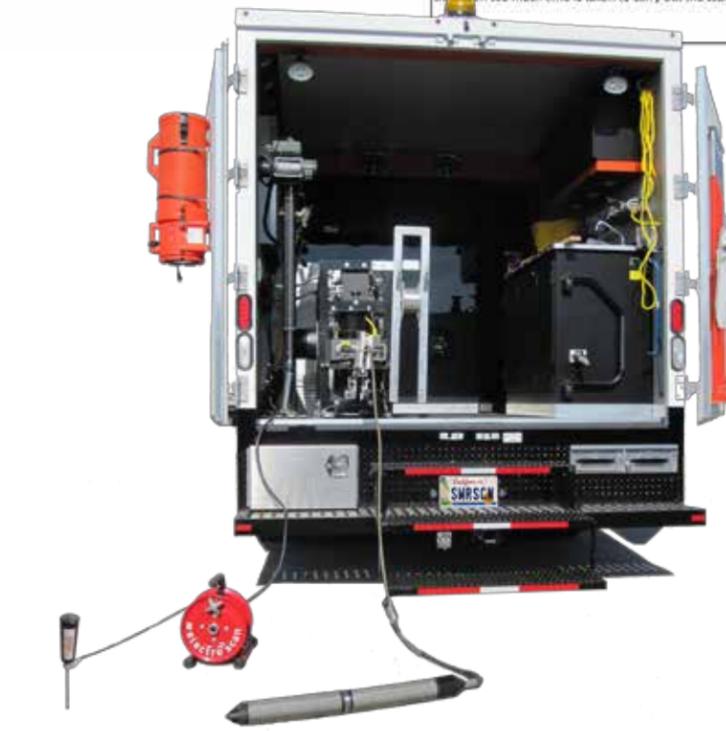
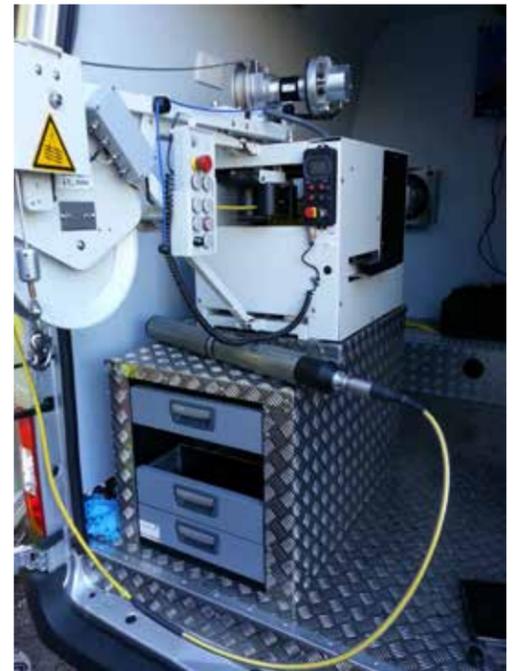
| ELECTRO SCANNING | | | | GEAR REMOVAL & CLEAN-UP | REPORTING | | |
|---|---|--|--|--|---|---|--|
| | | 205.7 94.3 | | Shows Operator that scan is being recorded. Provides information on possible pipe defects. | | | |

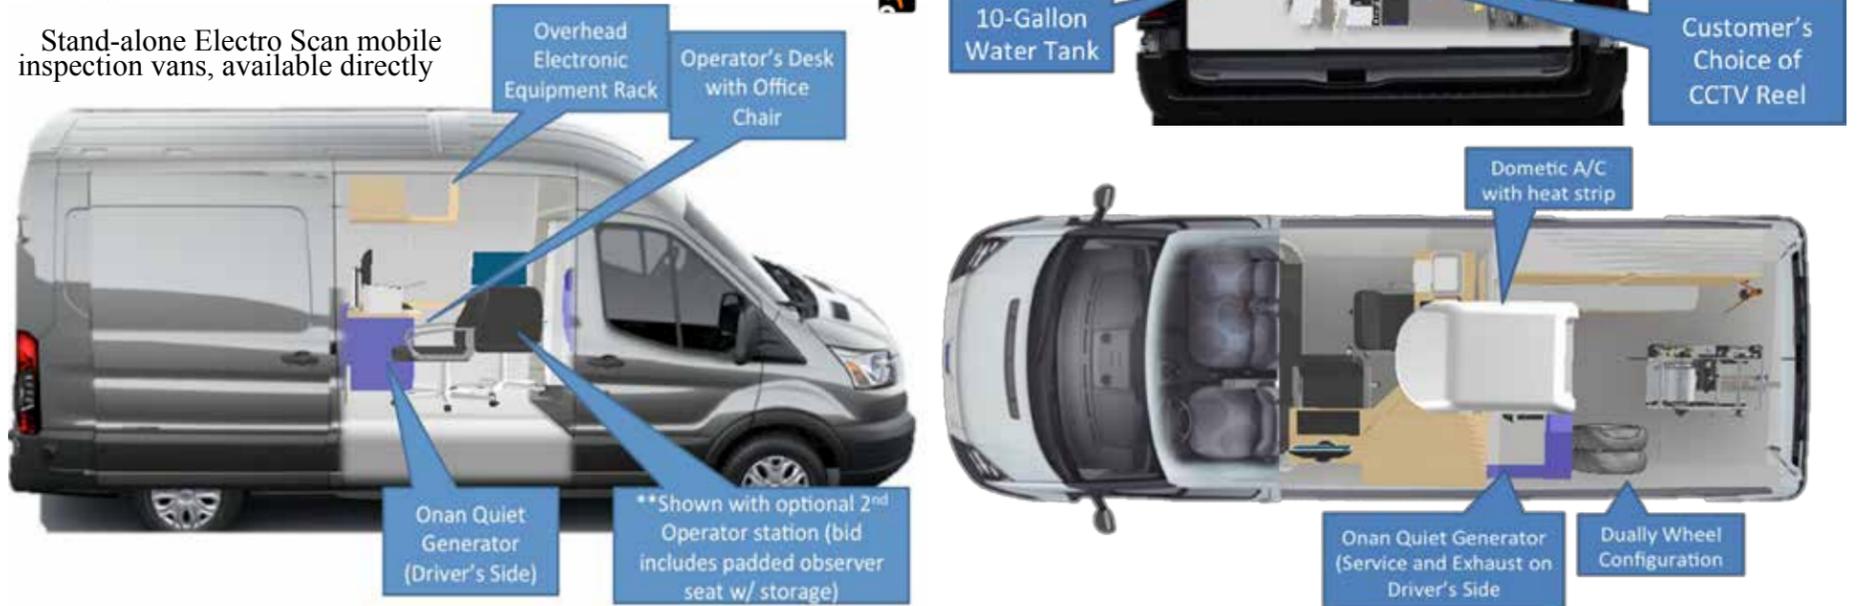
Electro Scan Releases Specification For Standalone Mobile Inspection Van

from Electro Scan Inc. are outfitted with modern mobile command centers including: customer defined cable and reel infrastructure, rear-mounted operator consoles, and wifi connectivity. From any Electro Scan Van, anywhere on the globe, results are automatically transmitted to the company's award-winning Critical Sewers® or Critical Water® cloud application.

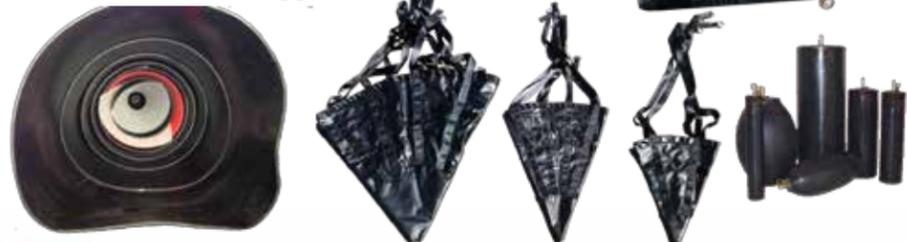
Assorted Cones, Kites, Parachutes & Plugs

While 6" to 15" funnel cones are typically used for smaller diameter pipes, other devices like kites and plugs are recommended for larger diameter pipes to temporarily encompass a pipe to conduct electrical current to the pipe wall.

Easy; by using the right funnel cone, kite, parachute, or plug as field conditions warrant. Sewer operators have been blocking, plugging, and dragging things through sewers and storm drains for centuries. But, with Electro Scan, we only need to surround the middle of our probe with water, so

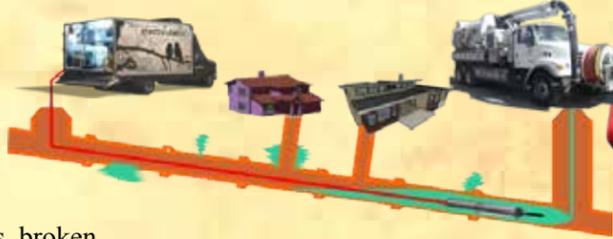
Electro Scan May Record From 12,000 To 20,000 Data Points, In Less Than 10 Minutes, For An Average 300 Foot, 8 Inch Diameter Sewer

close its circuit and return to its grounding source. But, if there is the slightest opening, fracture, or crack, Electro Scan's international patent-pending technology will register the Start, End, and Defect Current Height to precisely measure its location and estimated defect flow, often generating from 12,000 to 20,000 data points," states Chuck Hansen, Chairman, Electro Scan Inc.

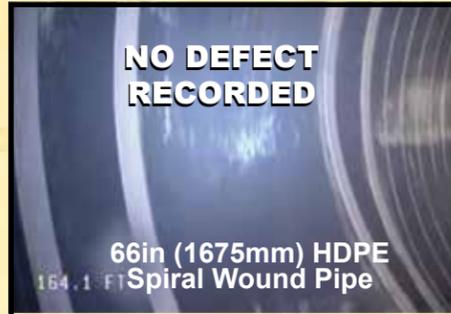
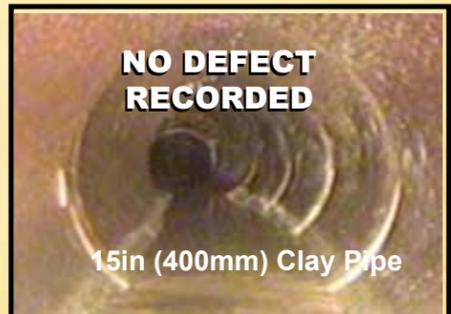
Not Seen By CCTV or Heard By Acoustics

*GPM and LPS calculation assumes a 1ft water head and 1% pipe gradient with ±40% accuracy.

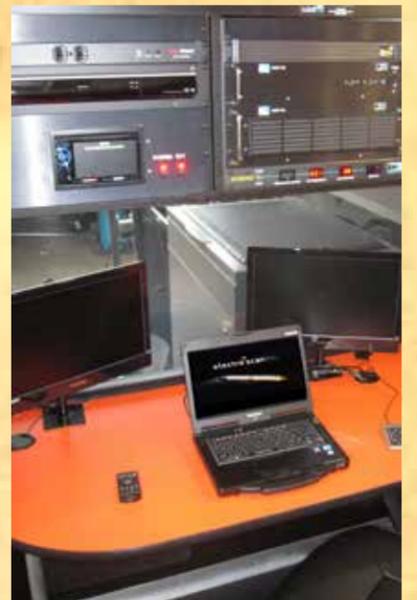
Electro Scan Laptop PC Console Application.
