CRITICAL SEWERS™ CHRONICLES

AN ELECTRO SCAN PUBLICATION. ALL RIGHTS AND PRIVILEGES RESERVED. ISSUE No. 2, OCTOBER 2013

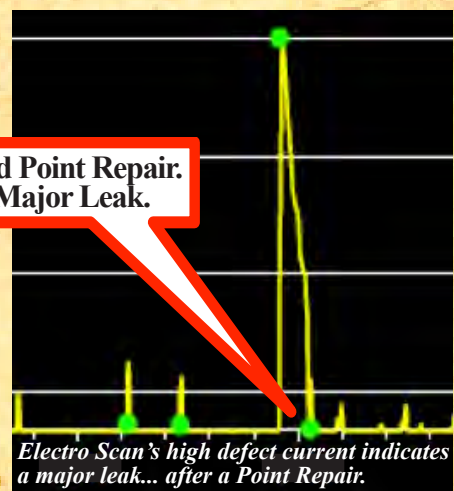
Bad Point Repair. Major Leak.

Electro Scan's high defect current indicates a major leak... after a Point Repair.

(Above) Electro Scan finds a major leak precisely where a point repair had been recently completed. (Below) A point repair was fixed, but other major defects remain.

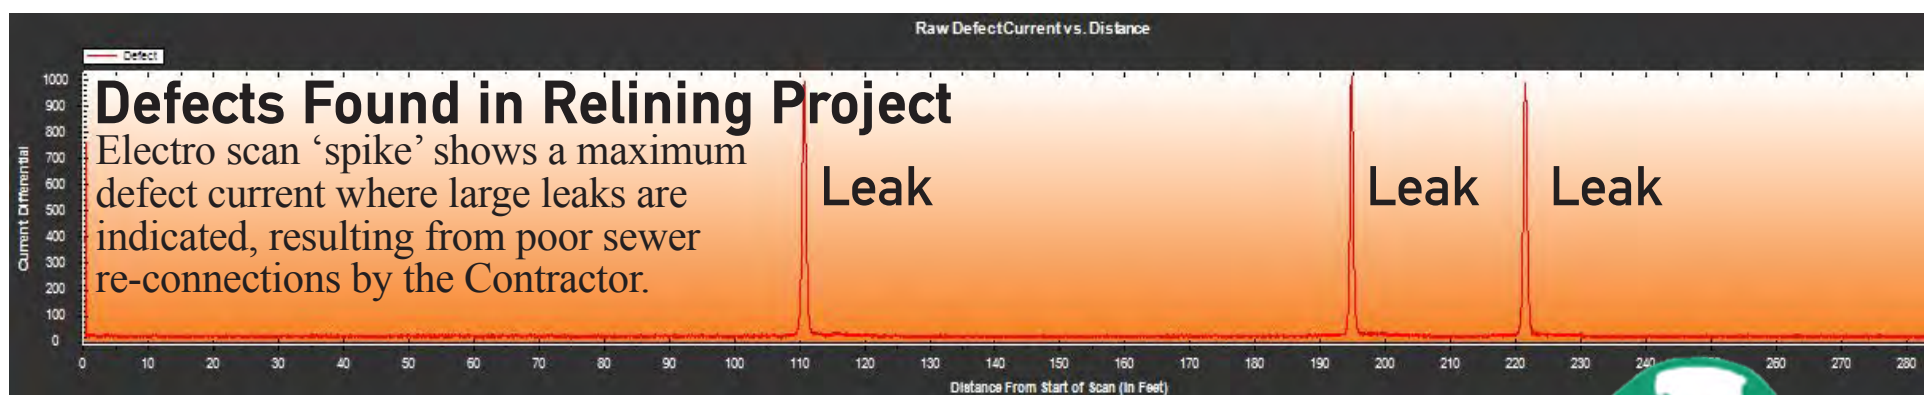
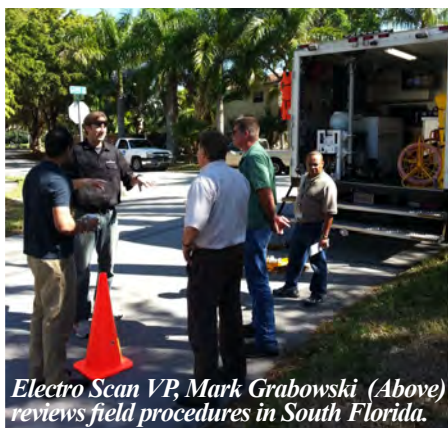
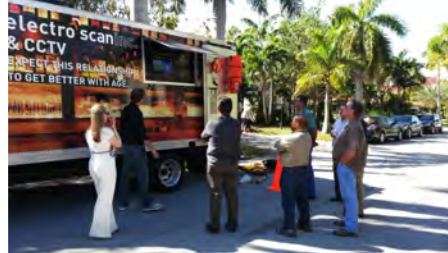
Electro Scan readings taken March 2013, compared to CCTV images taken in January 2013.

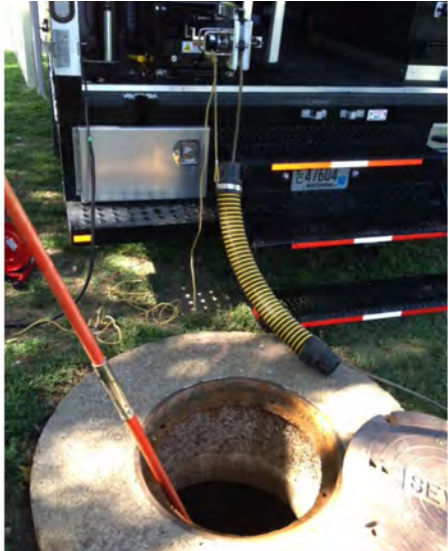
Without the need for external water, given the existing flow, an electro scan test was conducted with Electro Scan locating 197 Total Defects, including 112 Small, 34 Medium, and 51 Large defects.

But ASTM F2550 and Electro Scan do not simply recommend looking at the total number of defects in a pipe. Instead, the ASTM & Electro Scan’s technology displays both a Maximum Defect Current (i.e. for Small, Medium, and Large readings) **AND** an estimated Defect Flow based on the Defect Area *for each defect* -- as defined by the electric current sustained over an Area. The longer or wider the reading, the worse the leak.

In some cases, sewer mains may be renewed with a single point repair. Unfortunately, this is not one of those cases. Electro Scan shows that defects are consistent throughout the pipe, making it a prime candidate for relining.

Based on the size and quantity of all defects, it was estimated that McKinney’s pipe could infiltrate 290.5 gallons per minute.

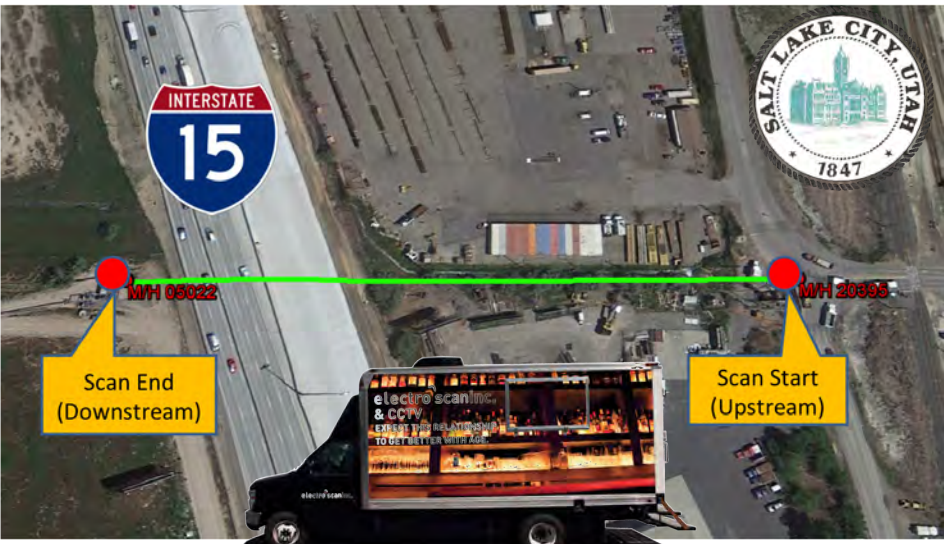
(Right) Side-by-side comparisons of Electro Scan defects and CCTV images. In each case, no CCTV callouts were recorded that corresponded to defects found by Electro Scan.

Electro Scan recorded over 45,000 data points as part of its pipe scan, finding 35 Total Defects representing 52 Gallons of Minute (i.e. 75,000 GPD) of estimated infiltration.

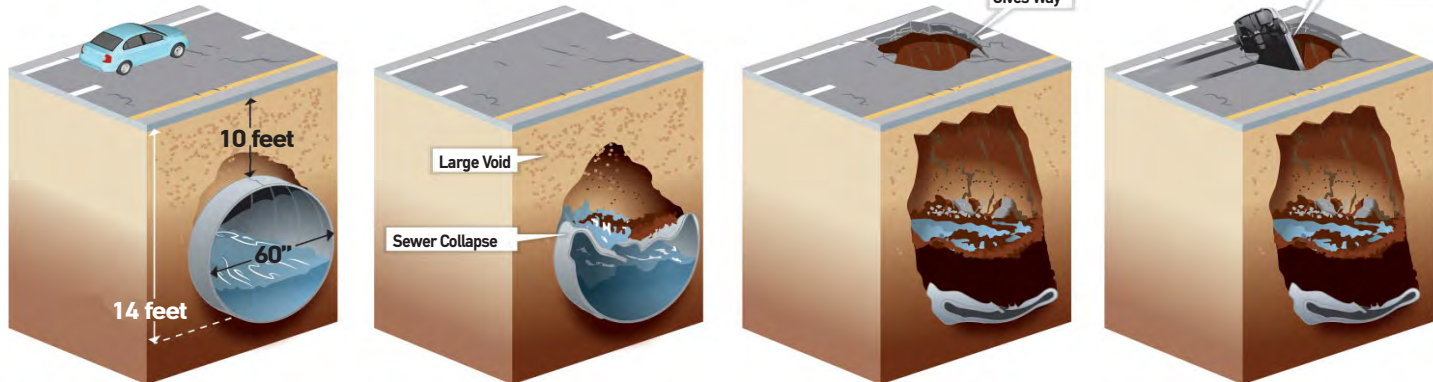
How Do Sewer Sinkholes Happen?

An aging sewer... allows soil to leak through bad joints creating a void... so the pavement gives way... & swallows a car.

A 50-year old sewer has been televised multiple times in the past 20 years, with no visible defects. Defective joints, not seen by CCTV inspection, periodically surcharge and systematically liquifies soil above the sewer pipe, creating a void. City crews have a PM to remove silt, without knowing that a void is being created. Without a base under it, the pavement collapses, opening a hole wide enough and deep enough to swallow a car. An unsuspecting car plunges into the sinkhole as the hole continues to widen.

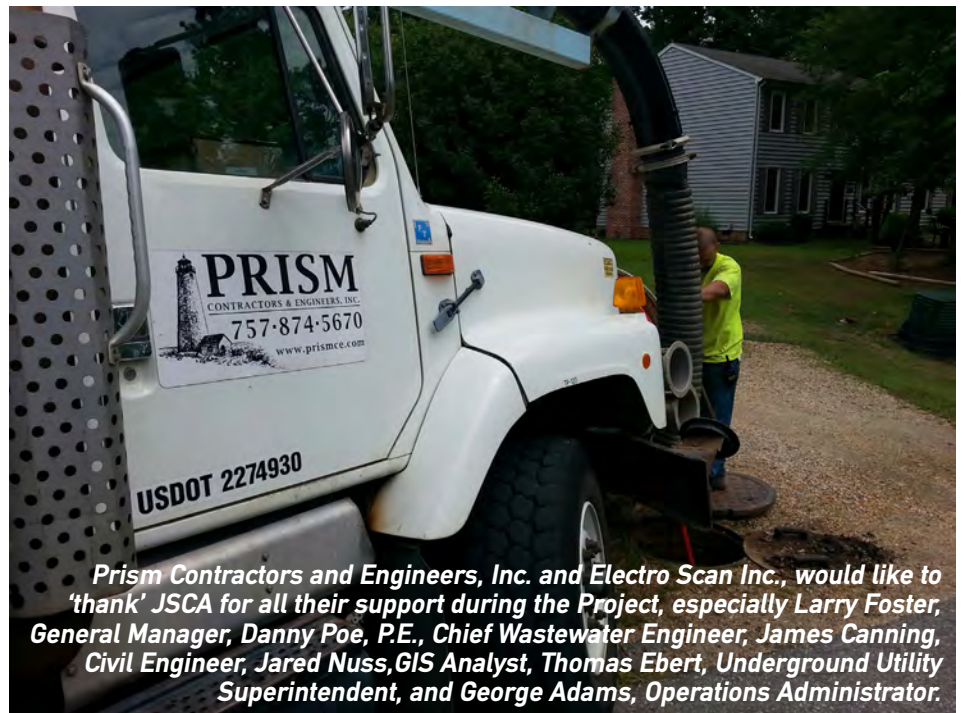
(Above) Prism Contractors & Engineers, guides water into sewer main to surround Electro Scan's moving funnel plug.

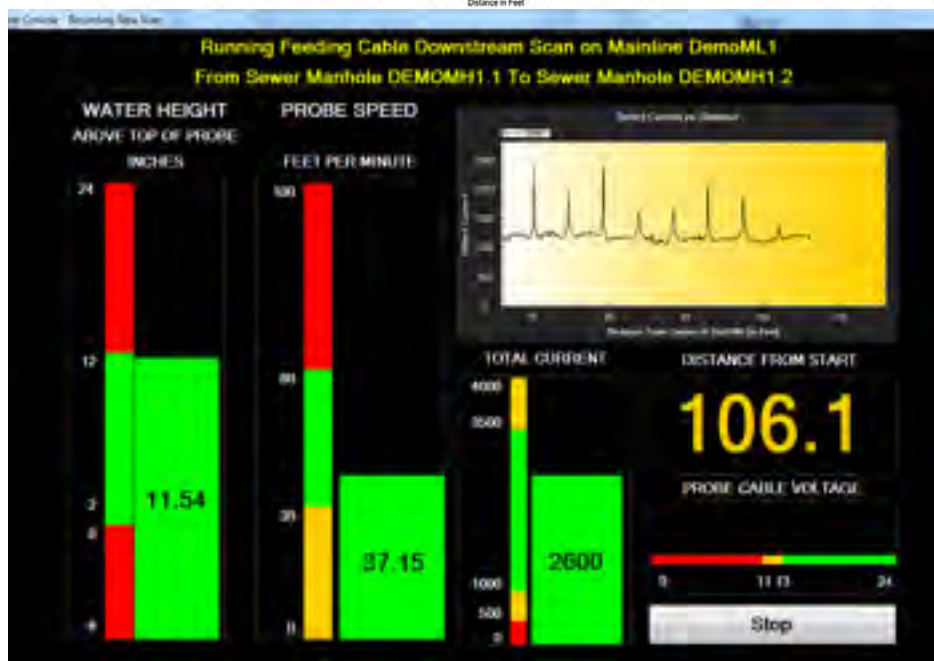
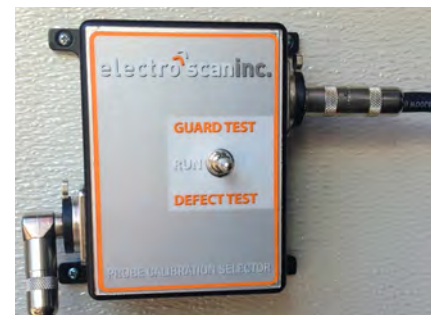
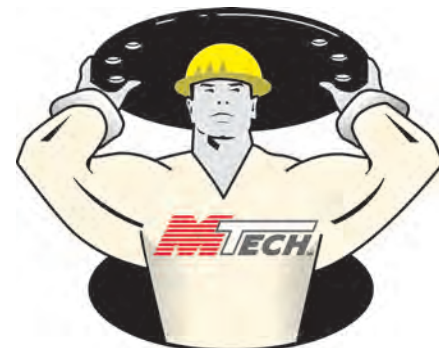
(Above & Below) Add-on products to convert CCTV for electro scanning in less than 5 minutes.

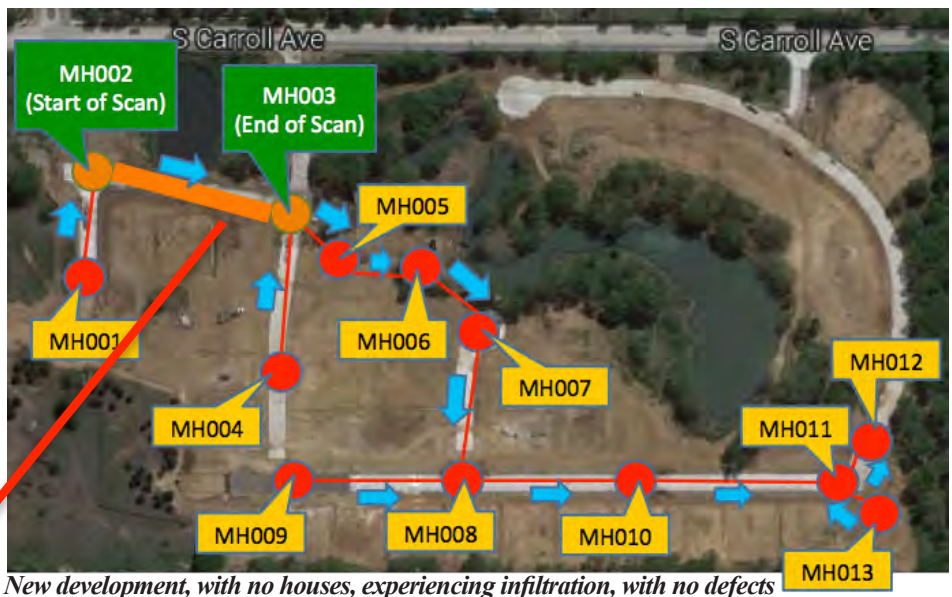
New development, with no houses, experiencing infiltration, with no defects found on CCTV inspections. City asked Electro Scan to find defects.

GPM	From	To	Date	Defects
17.36	002	003	8/8/2013	2
11.11	002	003	8/8/2013	1
4.08	009	008	8/8/2013	3
3.87	006	007	8/8/2013	1
1.22	001	002	8/8/2013	1
0.07	007	008	8/8/2013	1
0.78	003	005	8/8/2013	1
0.6	013	011	8/8/2013	1
0.54	011	012	8/8/2013	1
0.31	010	011	8/8/2013	1
0.24	004	002	8/8/2013	1

Mainline	Pipe Length	Small Defects	Medium Defects	Large Defects	Total Defects	Gallons Per Day	% of Total Infiltration
001_002	178	3	0	1	4	1,757	4%
002_003	330	10	2	2	14	22,277	54%
004_003	292	2	0	0	2	346	1%
003_005	49	2	0	0	2	1,094	3%
005_006	193	0	0	0	0	-	0%
006_007	129	0	0	1	1	5,717	14%
007_008	300	4	0	1	5	1,757	4%
009_008	425	13	1	1	15	5,846	14%
008_010	379	0	0	0	0	-	0%
010_011	327	1	0	0	1	446	1%
011_012	145	2	0	1	3	778	2%
012_013	56	0	0	1	1	864	2%
TOTAL	2,803	37	3	8	48	40,882	100%

Worst 3 Pipes, Total GPM as a % of Total Subdivision 83%
Worst 3 Pipes, Total Length as a % of Total Subdivision 32%

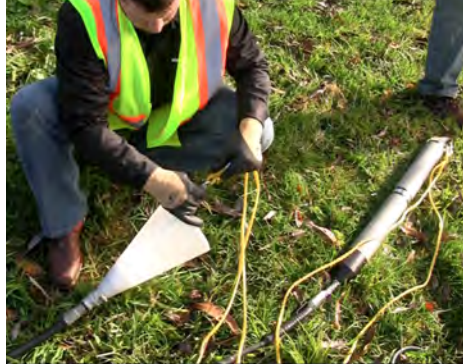
Field Tech, Macy Grubbs, attaches a Funnel Cone to Jet Hose and Electro Scan Probe.

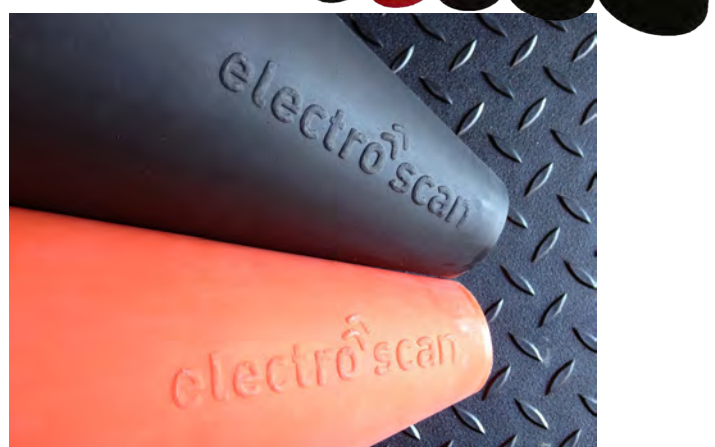
Electro Scan Funnel Cones*
Ranging from 6" to 15" Diameter Pipes

Since Electro Scan requires water to surround its probe -- allowing for a defect current to conduct to the wall of the pipe -- a moving reservoir of water is created through the pipe using a *funnel cone*.

While water (technically) is only needed to surround its middle electrode, a 3-to-6 foot column of water is recommended behind the probe to allow water to partially surcharge up each lateral. Since Electro Scan finds all leaks where water rises, a complete scan of the service connection, including and first 18-24 inches up the lateral, can be accomplished.

* Initial set of funnel cones, up to 12" pipe diameter are provided with the purchase of all ES-620 for Sewer Mains™.

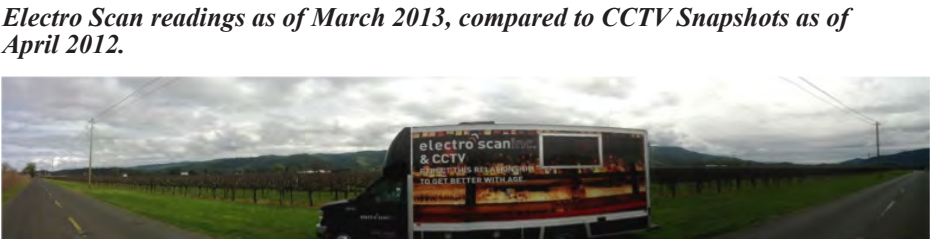
82.0' (C CTV) 81.9' (ES)	 Estimated Infiltration Flow: 2.76 GPM	 CCTV Callout: None
96.0' (C CTV) 96.1' (ES)	 Estimated Infiltration Flow: 2.16 GPM	 CCTV Callout: None
203.4' (CCTV) 203.2' (ES)	 Estimated Infiltration Flow: 2.56 GPM	 CCTV Callout: None

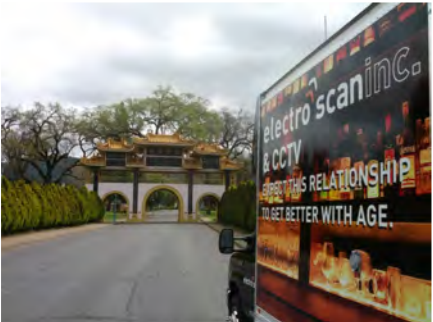
Objective: Determine if Electro Scan can identify any defects and compare to previous CCTV inspections. As shown in the pipe scan below Electro Scan identified each defect, displaying a potential to infiltrate estimated of 2 gpm or more.

Of the five (5) defects that have the potential to infiltrate 2 or more gpm, none had shown any defects from previous CCTV inspections.

Electro Scan located 148 Total defects, compared with ‘No Defects’ identified by a PACP-certified CCTV operator. A majority of defects identified by Electro Scan were at each joint, showing that its independent TV operator was unable to visually see any visible defects.

Anomaly Picking Threshold	100.00	Grade Current Levels	Number	Length	% Length of Pipe Tested	% of Total Anomaly Length	Grade Flow Levels	Number	Flow gpm	Flow per 100ft of pipe	% of Total Flow
Grade	Large	>700	18	4.1	1%	17%	>4	0	0.0	0.0	0%
	Medium	700 to 400	34	6.8	2%	29%	4 to 1	37	55.4	18.0	49%
	Small	<400	96	12.3	4%	53%	<1	111	56.7	18.4	51%
Total			148	23.2	8%	100%	<1	148	112.1	36.3	100%

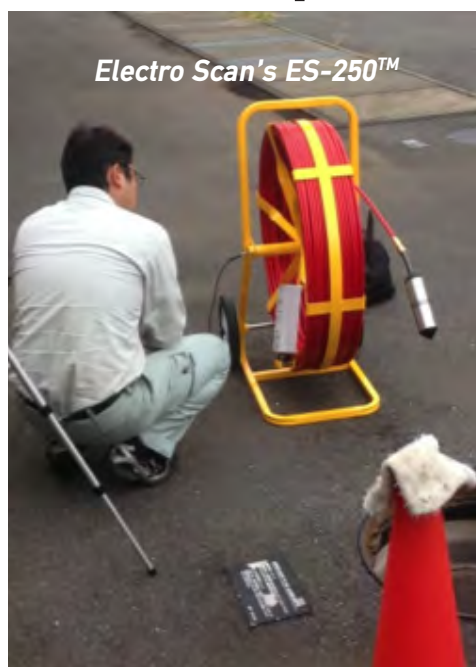
(Above) Set-up of Electro Scan's ES-250™ for trials at JASCOMA's Pipe Conduit Training Center in Asaka, Japan.
