Electrical Resistance Testing & Swab Testing of Insertion Probes Brings Next-Level Lead Pipe Risk Profiling

by Chuck Hansen¹, Mike App², Matt Campos³, Sean Blottie⁴, Shandon Baker⁵, and Bansari Doshi⁶

Abstract

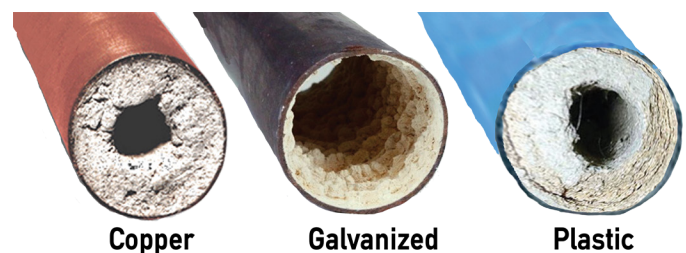
Figure 2. Scaling in Copper, Galvanized, and Plastic pipes.

Copper piping systems are particularly susceptible to surface deposition because corrosion scales—composed of copper oxides, carbonates, and orthophosphate precipitates—provide sorptive sites where lead can accumulate. When orthophosphate is used for corrosion control, lead-phosphate compounds may deposit within scale layers on copper interiors, effectively masking but not eliminating contamination potential. Hydraulic changes, construction disturbance, meter replacement, or partial lead service line replacement can destabilize these deposits and release particulates lead downstream.

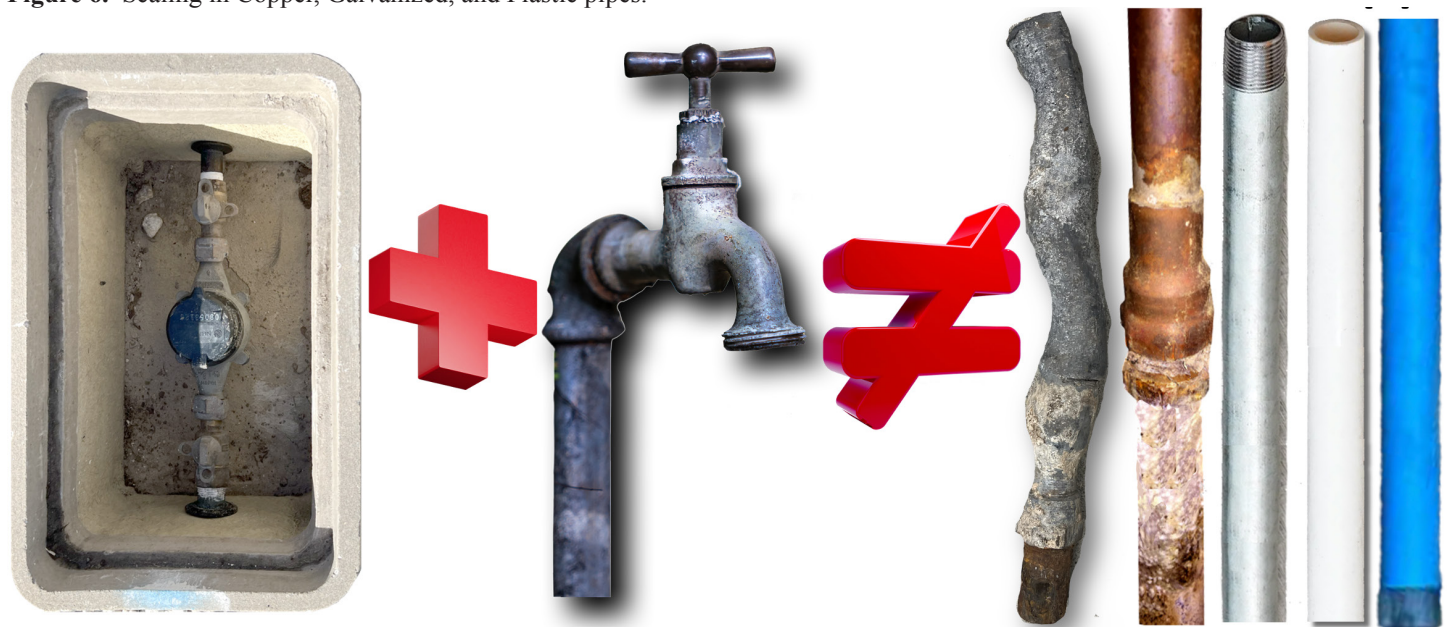
Figure 6. Scaling in Copper, Galvanized, and Plastic pipes.

When used as the sole verification method, it does not provide full-length material confirmation and may not produce a complete or defensible service line inventory. Comprehensive below-ground assessment—whether through excavation, in-pipe diagnostics, or other validated technologies—is necessary to reliably confirm non-lead conditions and reduce uncertainty in regulatory reporting, Figure 6.

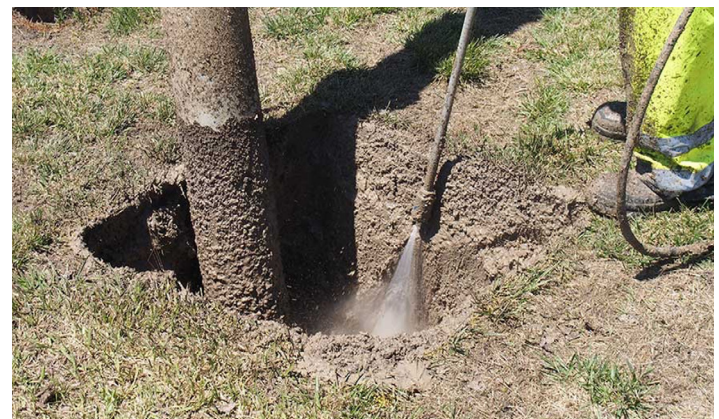
Figure 8. Removing topsoil using hydro-excavation.

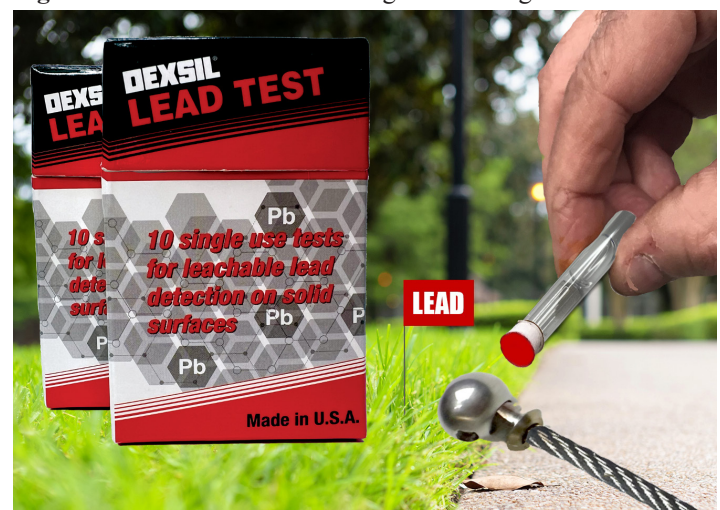
Figure 12. Commercial lead testing swab testing.

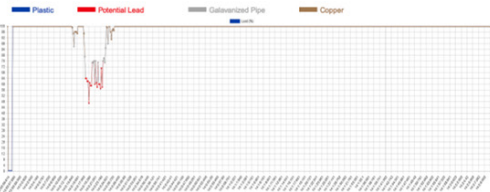
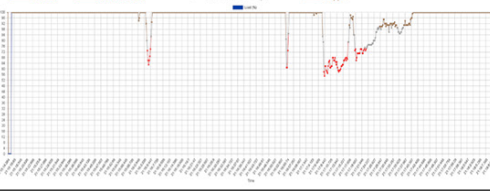
Figure 13. Lead ERT + Swab Test Results

| Electrical Resistance Testing | Lead Swab Testing of ERT Probe | Follow-Up Action(s) |
|---|---|---|
| <p>+ ERT POSITIVE LEAD</p> | <p>+ SWAB POSITIVE LEAD</p> | <p>LEAD. Most likely ERT scan found a lead or brass fitting to be replaced in this Copper pipe.</p> |
| <p>+ ERT POSITIVE LEAD</p> | <p>- SWAB NEGATIVE LEAD</p> | <p>LEAD. Despite a Negative Swab Test, ERT confirms lead pipe. Orthophosphates or PO₄ commonly used to coat lead may cause a False: Negative Swab Test.</p> |

This combination confirms both material hazard and surface exposure condition, Figure 13.

- Effective orthophosphate corrosion control forming a protective coating;
- Stable mineral scale encapsulating the lead substrate;
- Limited accessible particulate at the specific contact point;
- Sampling location variability.

Orthophosphate and PO₄-based, i.e. phosphate ion (PO₄³⁻), corrosion inhibitors are specifically designed to create insoluble lead-phosphate layers that reduce surface solubility and particulate release. These coatings can produce a negative swab result even though the pipe itself is lead.

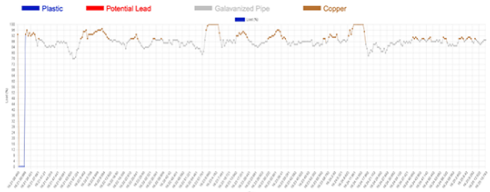
Figure 14. Galvanized ERT + Swab Test Results

| Electrical Resistance Testing | Lead Swab Testing of ERT Probe | Follow-Up Action(s) |
|---|---|--|
| <p>+ ERT POSITIVE GALVANIZED</p> | <p>+ SWAB POSITIVE LEAD</p> | <p>GALVANIZED. Re-testing not Recommended. Categorized as Galvanized Requiring Replacement (GRR).</p> |
| <p>+ ERT POSITIVE GALVANIZED</p> | <p>- SWAB NEGATIVE LEAD</p> | <p>GALVANIZED. If no lead can be located in close proximity upstream from the pipe, then based on a Negative Swab Test, pipe may be inventoried as Non-Lead Pipe, not requiring replacement.</p> |

ERT Positive GALVANIZED + Swab Positive LEAD
Galvanized Requiring Replacement (GRR). This finding is consistent with EPA’s GRR classification.

Galvanized steel, when historically connected to upstream lead components, can accumulate lead within corrosion scale. Over time, scale can release particulate lead, often-times by change in pressure, water hammer events, valve exercising activities, and water shut-offs and turn-ons.

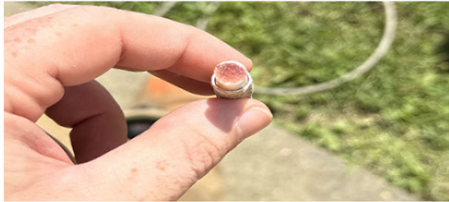
Figure 17. Plastic ERT + Swab Test Results

| Electrical Resistance Testing | Lead Swab Testing of ERT Probe | Follow-Up Action(s) |
|--|---|--|
| <p>+ ERT POSITIVE PLASTIC</p> | <p>+ SWAB POSITIVE LEAD</p> | <p>PLASTIC. Requires re-testing due to Positive Swab Test. If addl. flushing does not eliminate Positive Swab Test, then recommended for replacement.</p> |
| <p>+ ERT POSITIVE PLASTIC</p> | <p>- SWAB NEGATIVE LEAD</p> | <p>PLASTIC. Good scan. No action.</p> |

Plastic pipes are non-conductive and inert with respect to corrosion. However, biofilm formation and particulate migration can result in surface-bound lead deposition.
