EPA/600/R-12/004 | January 2012 | www.epa.gov /nrmrl

A Retrospective Evaluation of Cured-in-Place Pipe (CIPP) Used in Municipal Gravity Sewers

Office of Research and Development
National Risk Management Research Laboratory - Water Supply and Water Resources Division

September 2011

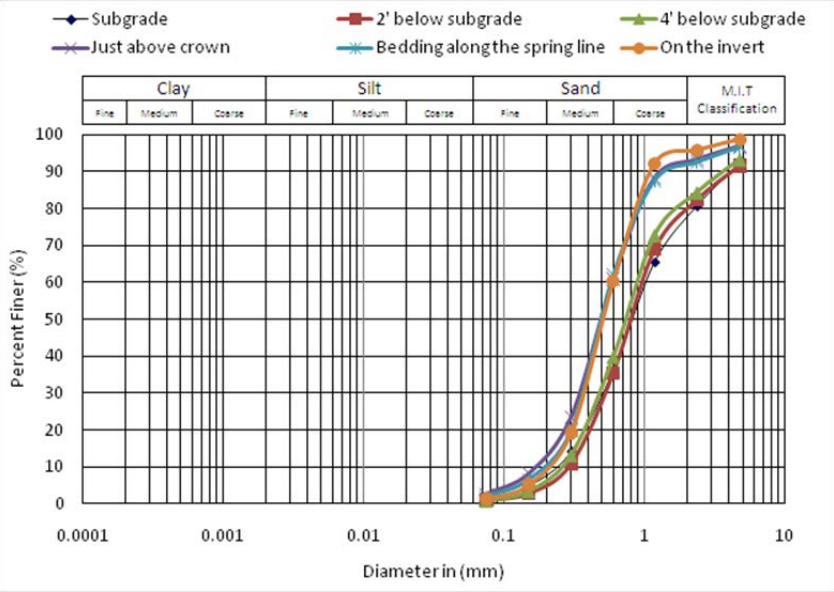
Figure 4-4. Soil Grain Size Distribution (Denver 8-in. Site)

4.2.5.1 Particle Size Distribution. ASTM C136, a standard testing method used for performing sieve analysis on geological material, was followed for the particle size distribution analysis. Based on visual inspection, soil samples were categorized as fine aggregates. For this analysis, 500 g of soil material was taken from each of the six soil samples and placed on a No. 4 sieve. For all samples, more than 90% of the particles passed through a No. 4 (4.76 mm) sieve, suggesting that the analysis procedure for fine aggregates should be followed. The resulting gradation curves are shown in Figure 4-4.

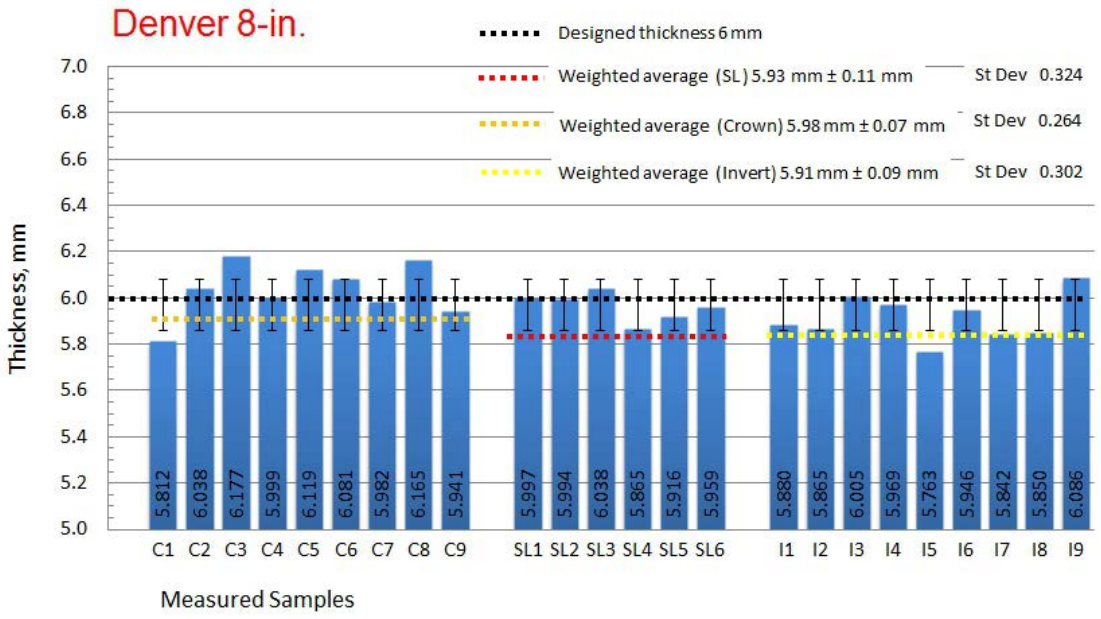
Figure 4-6. Average Thickness at Different Locations on the Liner

4.2.8 Liner Thickness. A total of 72 readings were taken to measure the thickness at different locations around the pipe circumference. These readings were taken using a caliper with a resolution of ±0.0001 in. The average thickness of the liner is shown in Figure 4-6. The thickness of the liner was found to vary slightly around the circumference of the liner with the maximum thickness at the crown (5.98 mm ± 0.07 mm) and slightly lower values at the spring line (5.93 mm ± 0.11 mm) and the invert (5.91 mm ± 0.09 mm). This was attributed mostly to the erosion of the polyurethane coating layer (approximately 0.38 mm thick), originally placed on the internal surface of the liner, at the invert zone. The average measured thicknesses after 25 years in service were all slightly lower than the designed thickness of the liner (6 mm) although some individual readings were higher. No ultrasonic field measurements of liner thickness were possible in the field and when attempted in the laboratory the measurements were not successful. A discussion of this issue is provided in Section 6.

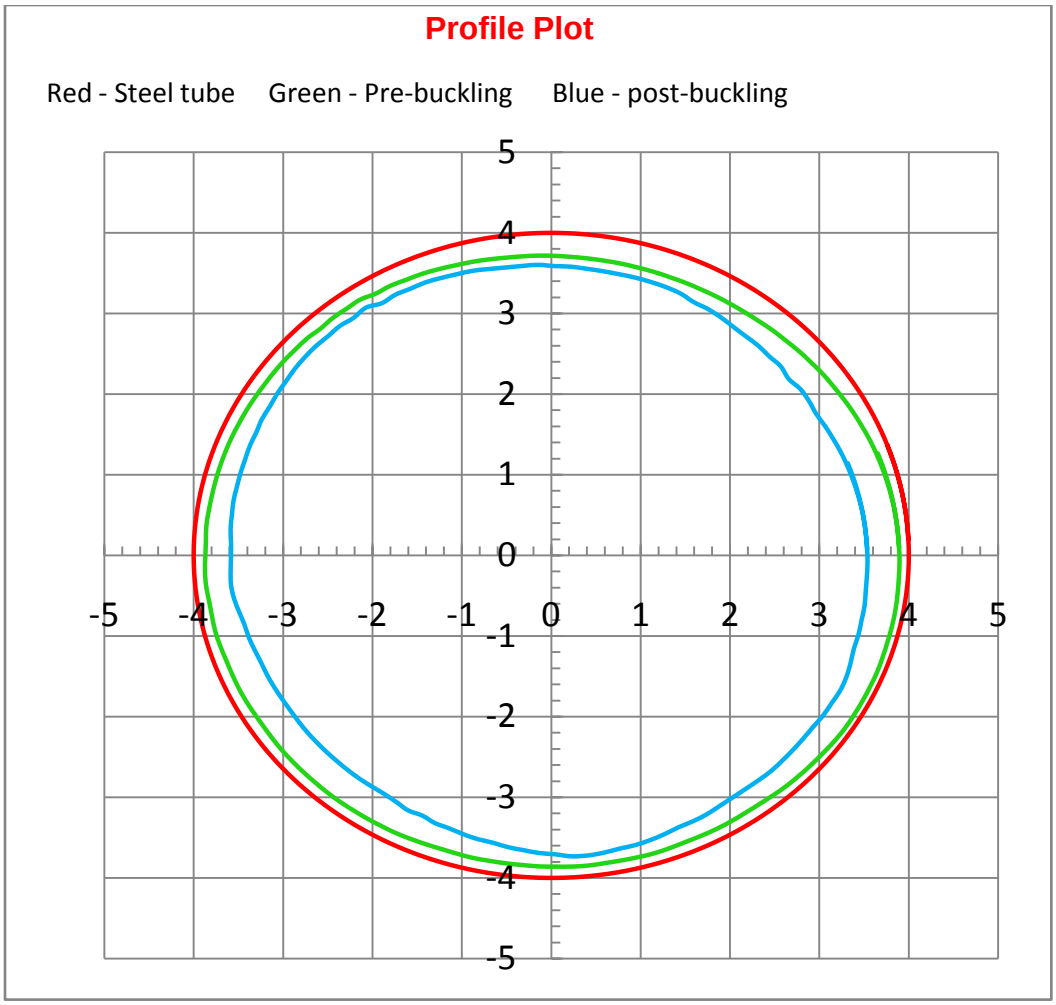
The liner was placed inside a circular polyvinyl chloride (PVC) tube, as if it was inside a host pipe, and careful measurements were taken to ensure that the liner center was aligned with the measuring device. Next, the profile plotter was aligned with the center of the CIPP liner tube. Continuous readings were taken around the circumference of three cross-sections spaced 1 in. apart and averaged. The liner was found to be approximately circular with reference to its center (green line in Figure 4-8). On the spring line to spring line plane, the liner had a slightly larger diameter than on the crown-invert plane, most likely due to geometrical imperfections in the original host pipe. The percent ovality based on the ovality definition in ASTM F1216 is 5.07%. The red and blue lines are shown in connection with the liner buckling test that was carried out on this liner and which is described in Section 4.2.12. When a host and/or liner are oval in shape, the larger radius of curvature in the flatter section of the oval liner reduces the ability of the liner to resist external buckling pressures. This is taken into account in the design equations for the liner in ASTM F1216. When pipe ovality exceeds 5%, the structural impact on liner strength becomes more significant.

Figure 4-8. Ovality of the Denver 8-in. Liner (Average of Three Cross-Sections Spaced 1 in. Apart)

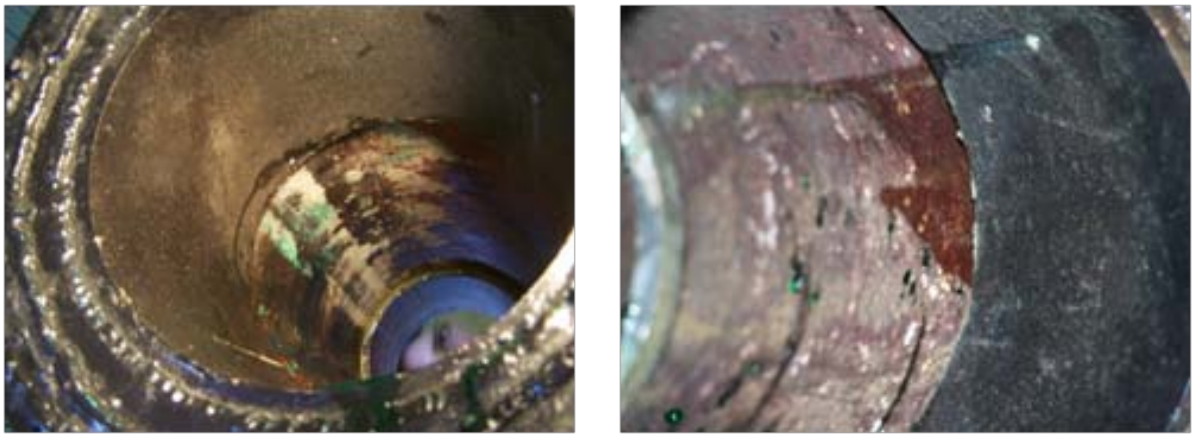
Figure 4-22. Localized Leak on the Liner – Green Spots Due to Green Food Color

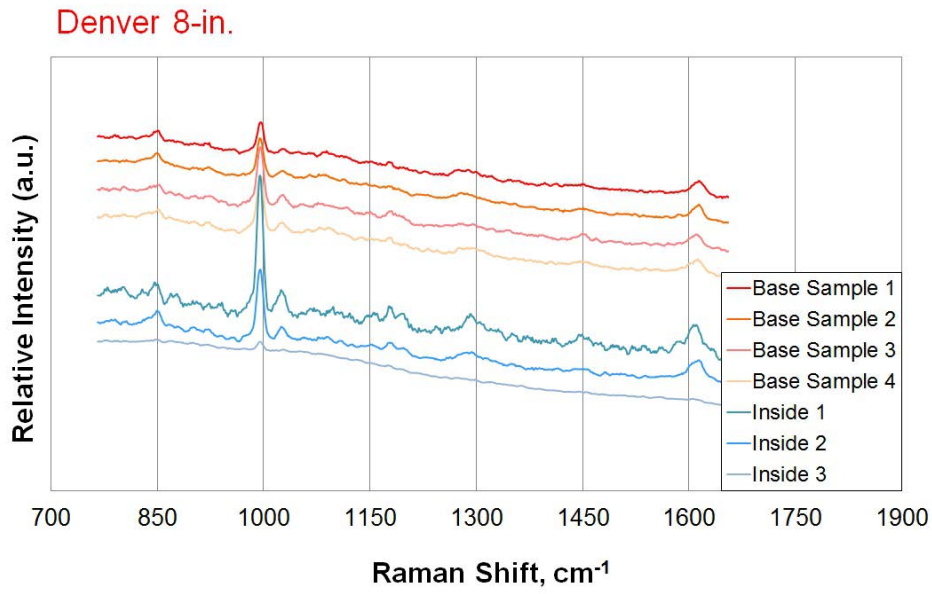
The plots are nearly identical for the base resin and liner used for 25 years, with no significant change in the intensity of the peaks or region shift, indicating high chemical stability. Additional tests were carried out on the exterior surface of the liner, but no significant changes from the spectra shown in Figure 4-25 were detected.

Figure 4-25. Raman Spectra (Denver 8-in. Liner)

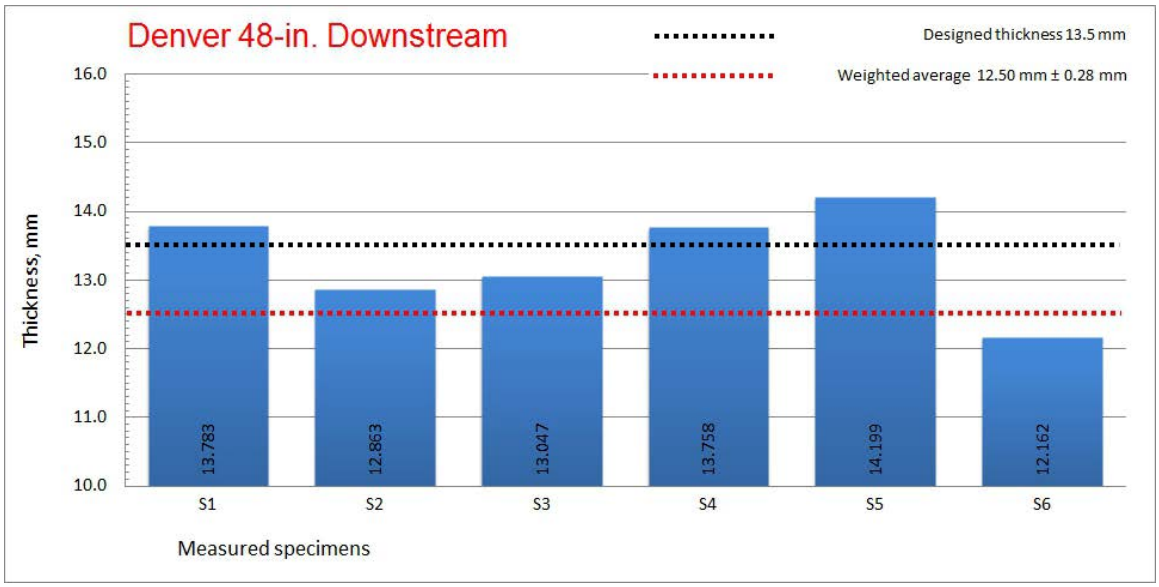
Figure 4-28. Thickness for Denver 48-in. Downstream Sample

4.3.5.1 Downstream Sample. For determining the liner thickness of the downstream sample, 10 readings were taken at six different locations around the sample (a total of 60 readings) using a micrometer with a resolution of ±0.0001 in. The average calculated values and their standard deviations are shown in Figure 4-28. The weighted average for the sample thickness measurements was calculated to be 13.9 mm and the weighted error ±0.3 mm.

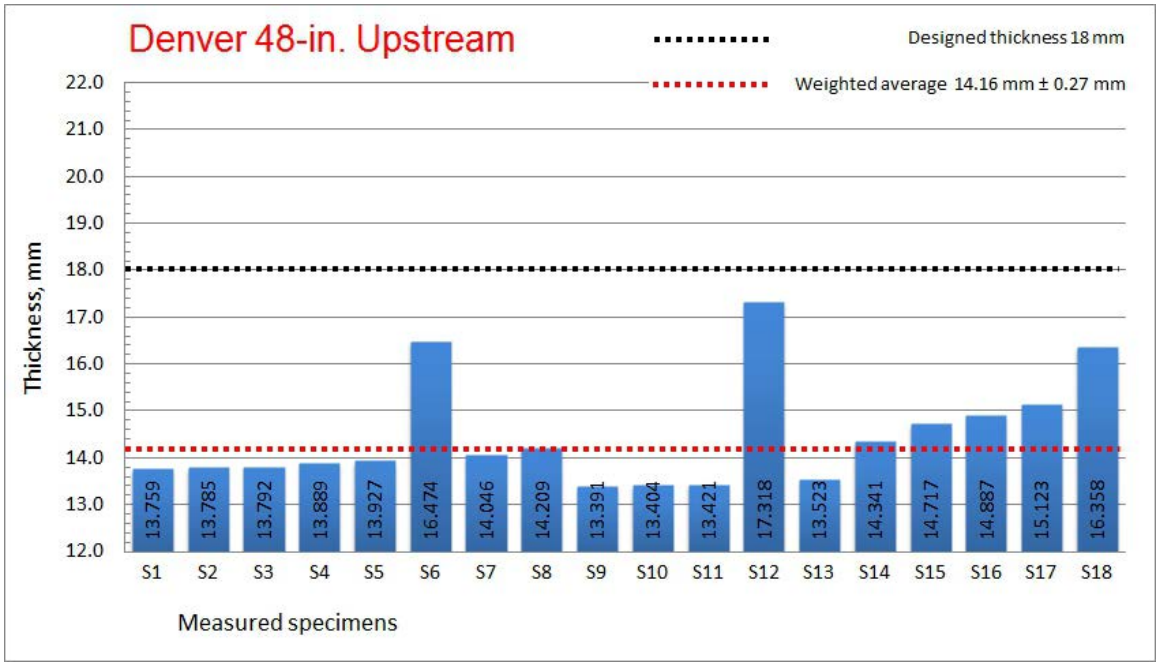
Figure 4-29. Thickness for Denver 48-in. Upstream Sample

4.3.5.2 Upstream Sample. For determining the liner thickness of the upstream sample, an 18 in. × 18 in. panel was cut into nine squares (6 in. × 6 in.) and thickness was measured along the edges. Three 'inner' squares were next cut into four squares each, and again thickness was measured along the edges. In summary, a total of 18 sets of readings were taken, where each set contained 10 readings, amounting to a total of 180 readings. The average calculated values and their standard deviations are shown in Figure 4-29. The weighted average for the sample thickness measurements was calculated to be 14.2 mm and the weighted error ±0.2 mm.

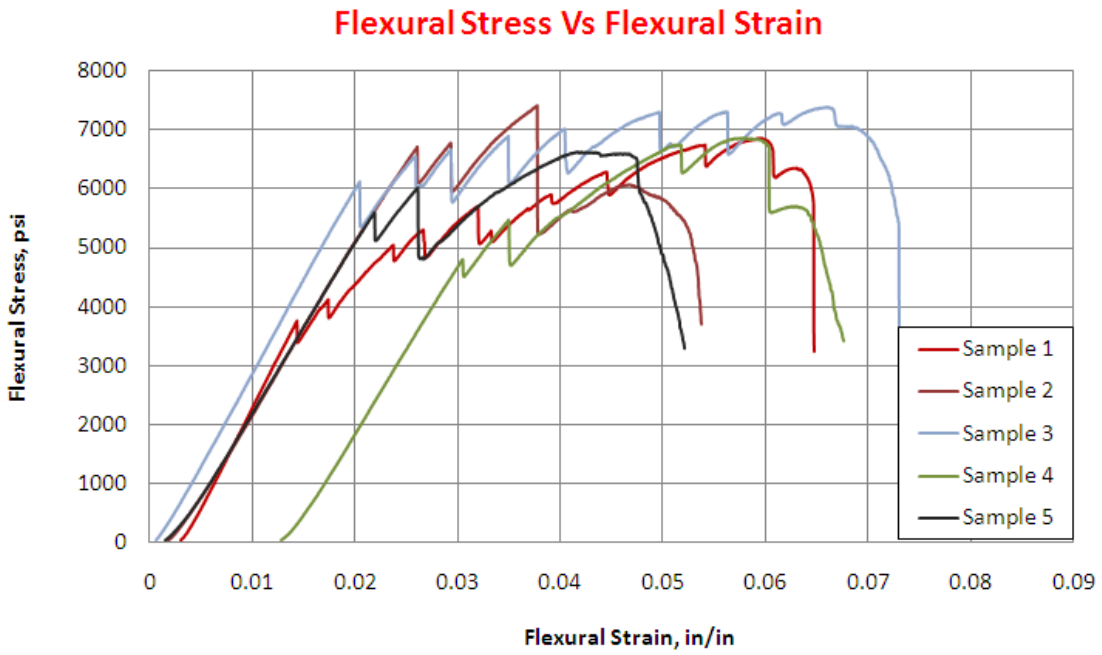
Figure 4-34. Flexural Stress-Strain Curves for Denver 48-in. Downstream Sample

4.3.7.1 Downstream Sample. Specimens were cut from the retrieved downstream CIPP liner sample in accordance with ASTM D790 for measuring the liner's flexural strength and flexural modulus of elasticity. A total of five specimens were prepared and tested. The sides of the specimens were smoothed using a grinder and a table router. The water jet cutter could not be used due to curvature of the liner. Testing was performed using an ADMET eXpert 2611 Universal Testing Machine (UTM) as shown in Figure 4-33. Table 4-14 lists the dimensions and moment of inertia for all specimens. Table 4-15 and Figure 4-34 summarize the flexural test results for the Denver 48-in. downstream sample.

Location on Pipe	Peak Load (lb)	Peak Bending Stress (psi)	Peak Shear Stress (psi)	Flexural Modulus (psi)
1	155	6,873	599	340,145
2	158	7,418	618	290,124
3	154	7,371	614	314,932
4	161	6,867	609	282,343
5	150	6,628	567	287,254
Average and Std. Dev.	-	7,031±346	601±21	302,960±24,303

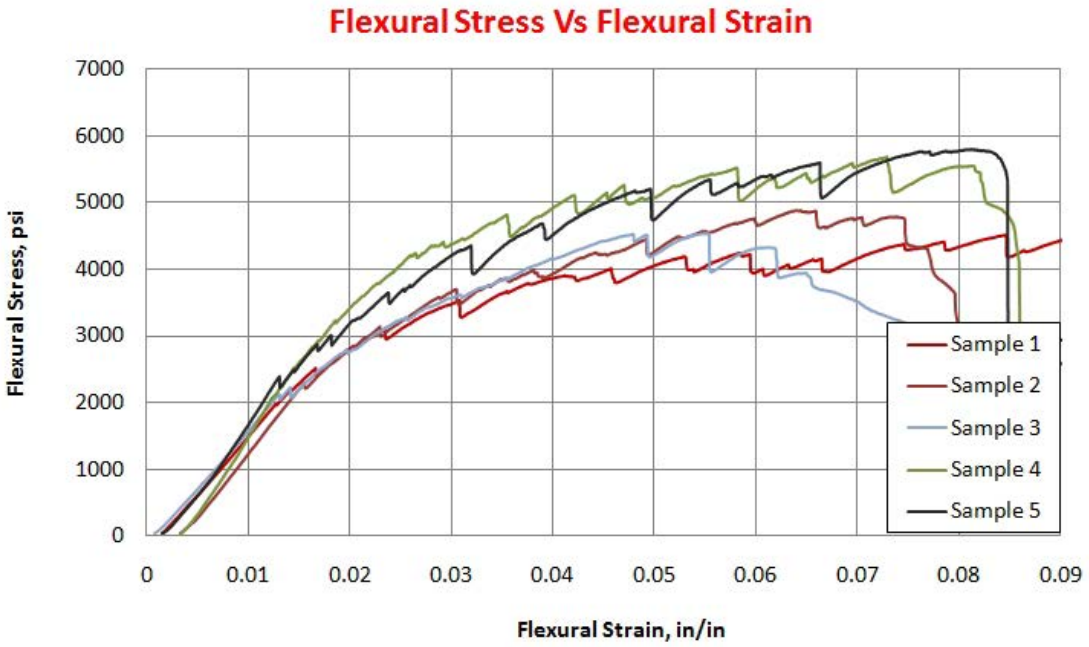
Figure 4-35. Flexural Stress-Strain Curves for the Denver 48-in. Upstream Liner (Set 1)

For this particular set of samples, the flexural test results, particularly the flexural modulus, were unusually low compared to the other samples tested in this project. It was decided to repeat a new set of five samples to see if an error in the testing procedures or a localized weak spot in the liner might have caused the low values. The original test results are termed "Set 1" and the repeated tests are termed "Set 2". It can be seen that there is a significant difference between the two sets of results with the second set meeting all of the ASTM minimum values for a new liner and the first set meeting the peak bending stress value, but falling significantly below on the flexural modulus. It appears most likely that the area of the liner used for the first set of tests was of poorer quality than for the second set of tests. The interpretation of these results in comparison with the test results for all the retrospective sites is discussed in Section 6.

Location on Pipe	Peak Load (lb)	Peak Bending Stress (psi)	Peak Shear Stress (psi)	Flexural Modulus (psi)
1	107.56	4,517	407	169,445
2	105.26	4,608	415	168,437
3	112.76	4,546	423	167,678
4	156.45	5,686	527	221,749
5	161.59	5,801	549	185,801
Average and Std. Dev.	-	5,032±652	464±68	182,622±23,126

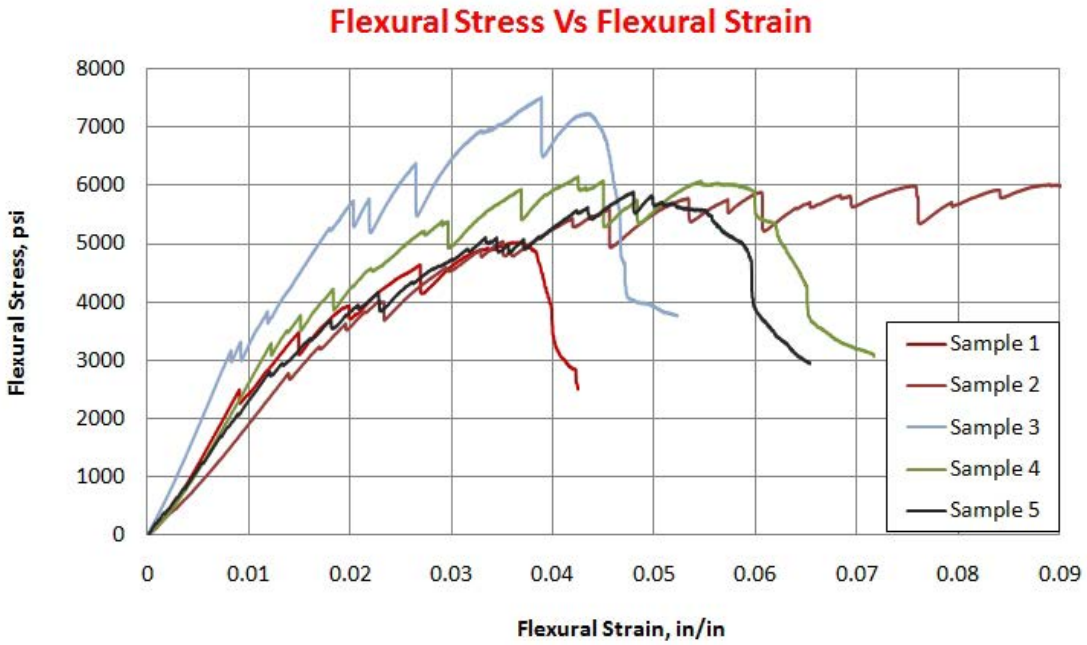
Figure 4-36. Flexural Stress-Strain Curves for Denver 48-in. Upstream Liner (Set 2)

Location on Pipe	Peak Load (lb)	Peak Bending Stress (psi)	Peak Shear Stress (psi)	Flexural Modulus (psi)
1	139	5,012	476	276,920
2	156	6,027	559	187,218
3	149	7,486	589	369,998
4	162	6,159	541	270,265
5	167	5,900	540	214,134
Average and Std. Dev.	-	6,117±888	541±41	263,707±70,398

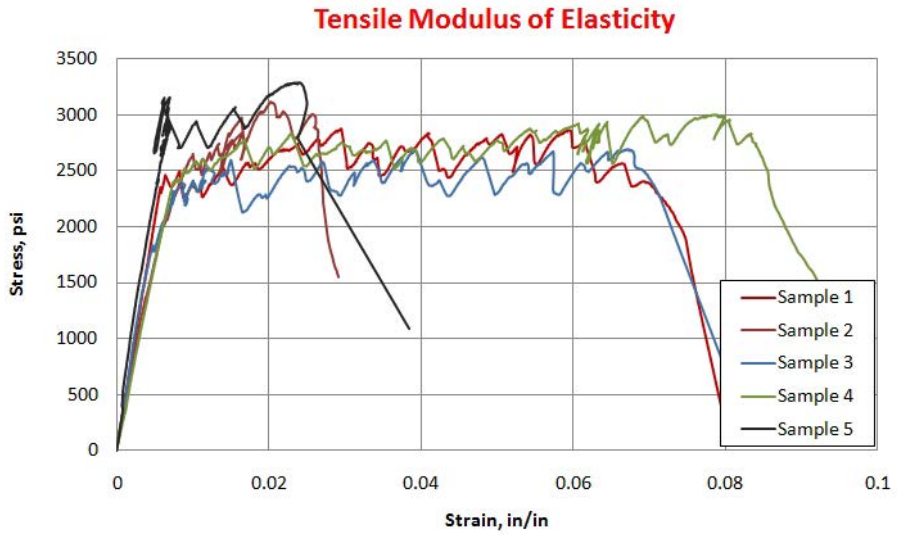
Figure 4-38. Stress-Strain Curves from Tensile Testing for Denver 48-in. Downstream Sample

Location on Pipe	Area ($in.^2$)	Peak Load (lb)	Peak Stress (psi)	Tensile Modulus (psi)
1	0.2733	785.36	2,874	405,345
2	0.2611	813.76	3,117	364,283
3	0.3203	862.47	2,693	405,639
4	0.2888	867.73	3,005	288,786
5	0.3467	1139.19	3,286	448,047
Average and Std. Dev.	-	-	**2,995±227**	**382,420±60,141**

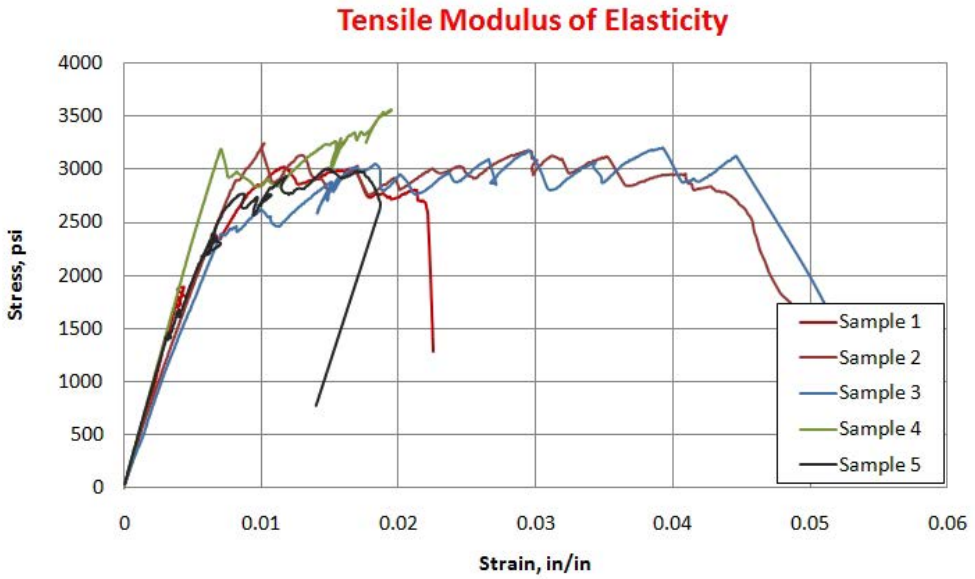
Figure 4-39. Stress-Strain Curves from Tensile Testing of Denver 48-in. Upstream Samples

Location on Pipe	Area ($in.^2$)	Peak Load (lb)	Peak Stress (psi)	Tensile Modulus (psi)
1	0.3052	923	3,023	451,779
2	0.2641	858	3,250	431,712
3	0.2822	904	3,203	324,920
4	0.2991	1064	3,557	466,379
5	0.2846	856	3,009	459,145
Average	-	-	**3,208±222**	**426,787±58,396**

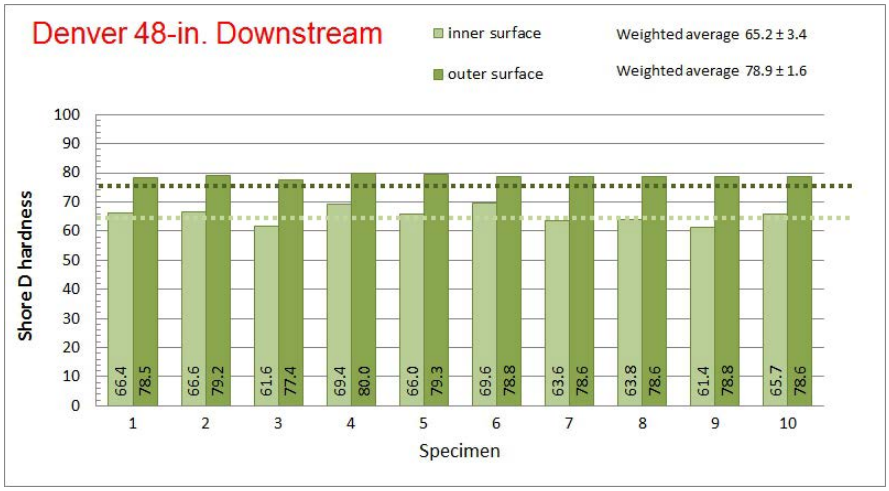
Figure 4-40. Shore D Hardness for Denver 48-in. Downstream Sample

4.3.9.2 Downstream Sample. Specimens measuring approximately 1 in. × 1 in. were cut from the retrieved downstream sample of the CIPP liner using a band saw. A total of 10 specimens were prepared and tested. A total of 36 tests were conducted on each sample: 18 tests on the inner surfaces and 18 tests on the outer surfaces. The average calculated values and their standard deviations are shown in Figure 4-40. The average and standard deviation of the Shore D hardness for the sample inner surface was calculated to be 65±3 and for the outer surface 79±2. The differences between the inner and outer surfaces of the liner follow the same pattern as the reading for the Denver 8-in. liner. The outer side of the liner enclosed by the host pipe was neither in contact with the soil nor with the waste stream. The significance of this result is explored in Section 6.

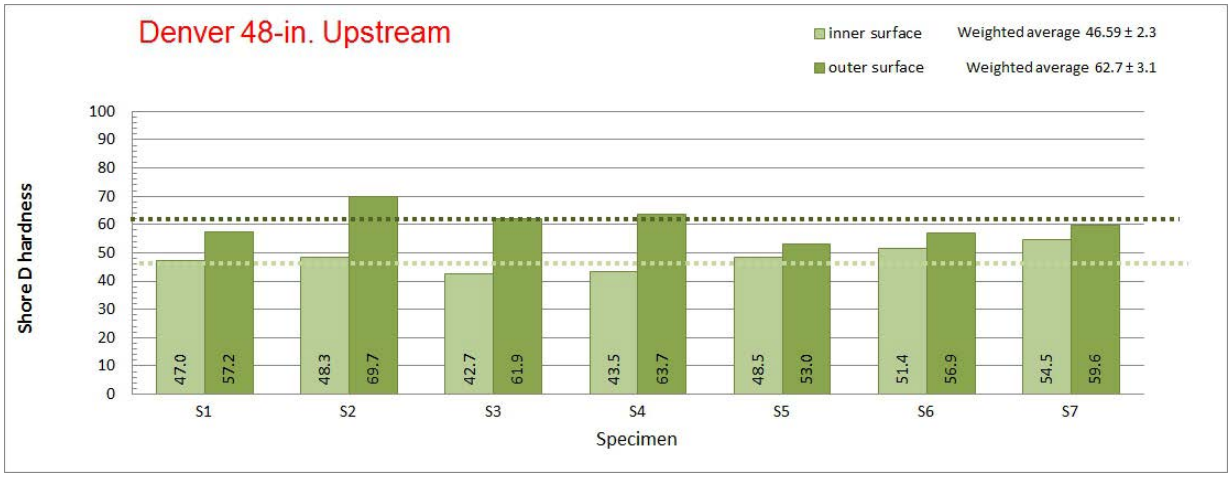
Figure 4-41. Shore D Hardness for Denver 48-in. Upstream Sample

4.3.9.3 Upstream Sample. A total of seven specimens were prepared and tested. A total of 50 tests were conducted on each sample: 25 tests on the inner surfaces and 25 tests on the outer surfaces. The average calculated values and their standard deviations are shown in Figure 4-41. An average of 25 readings at both the inner and outer surface of each of seven specimens is shown. The weighted average and standard deviation of the Shore D hardness for the sample inner surface was calculated to be 47±2 and for the outer surface 63±3.

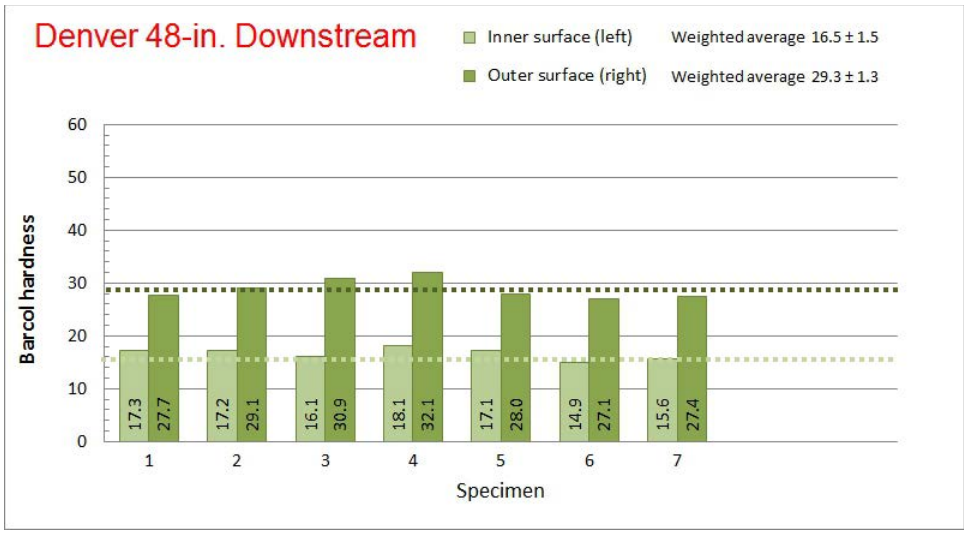
Figure 4-46. Barcol Hardness of Denver 48-in. Downstream Sample

For each specimen a total of 30 readings were taken: 15 on the outer surface and 15 on the inner surface. Similarly to the durometer (Shore D) hardness test, it was found that the measured inner surface hardness values were lower than those measured on the outer surface.

The average calculated values and their standard deviations are shown in Figure 4-46. The weighted average of Barcol hardness for the sample inner surface was calculated to be 16.5 and the weighted error ±1.5, and for the outer surface 29.3 ±1.3.

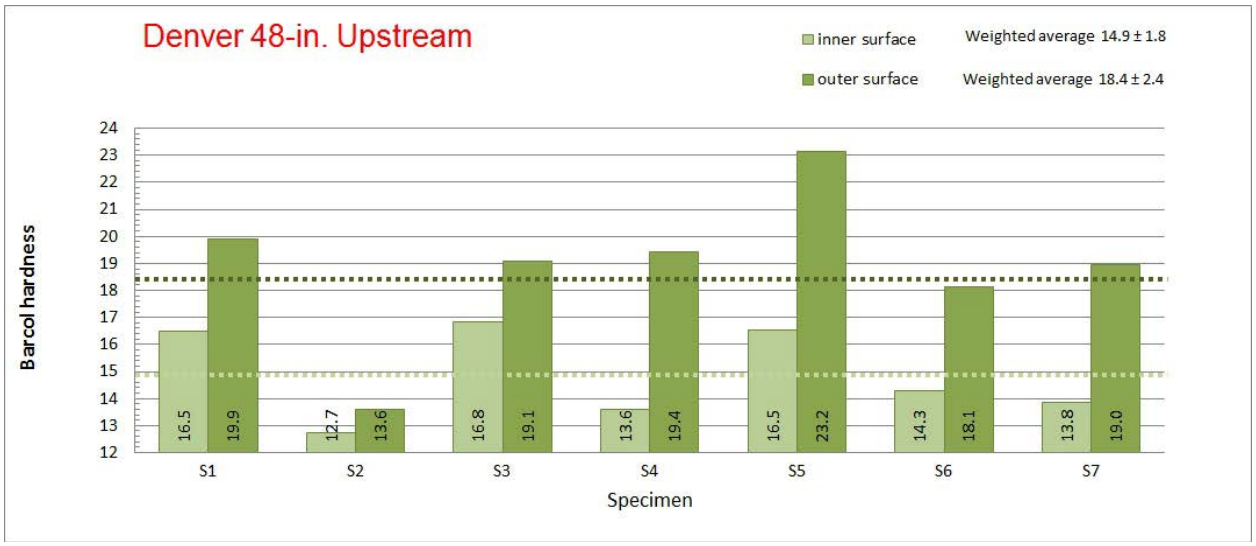
Figure 4-47. Barcol Hardness of Denver 48-in. Upstream Sample

4.3.10.2 Upstream Sample. Twenty-five hardness readings on the inner and outer side of seven samples were taken. The average calculated values and their standard deviations are shown in Figure 4-47. An average of 25 readings at both the inner and outer surface of each of seven specimens is shown. The weighted average and standard deviation of the Barcol hardness for the sample inner surface was calculated to be 14.9±1.8 and for the outer surface 18.4 ±2.4.

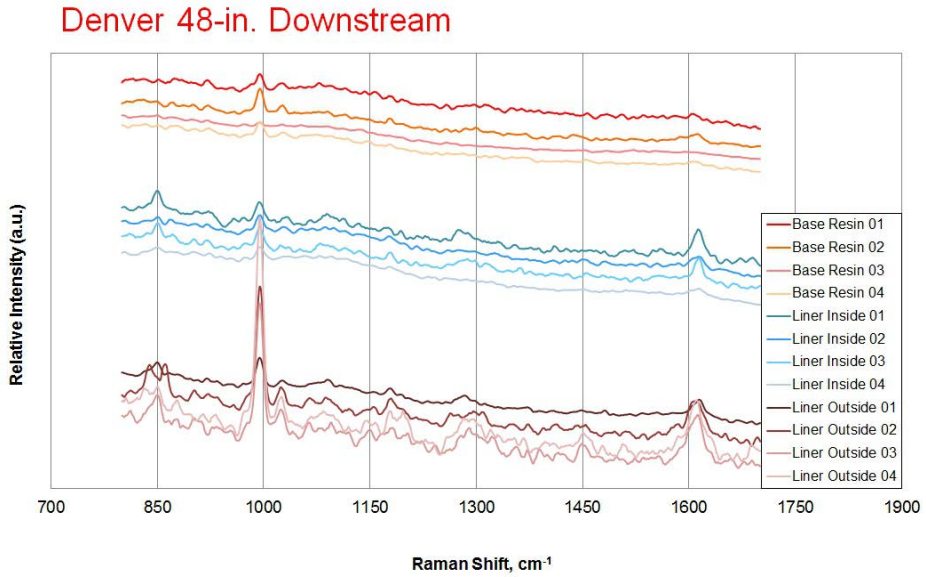
Figure 4-48. Raman Spectroscopy Plots (Denver 48-in. Downstream)

4.3.11.2 Downstream Sample. The Raman spectroscopy plots for the Denver 48-in. downstream sample are shown in Figure 4-48. Four plots are shown for each of the virgin resin, inside liner surface, and exterior liner surface. The location of peaks is generally the same for the plots for each location with the exterior surface exhibiting the most variability. A discussion of the possibilities for using Raman spectroscopy for liner evaluation is given in Section 6.

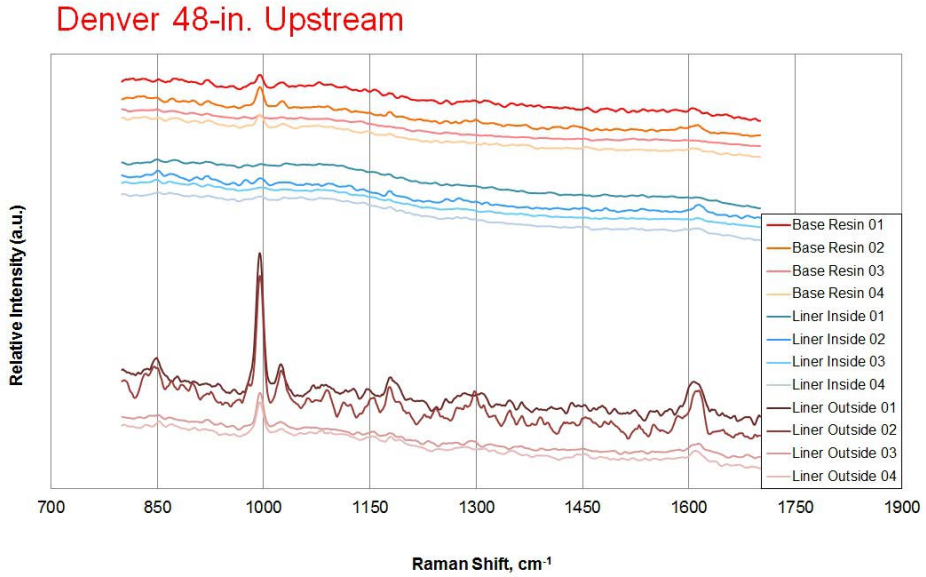
Figure 4-49. Raman Spectroscopy Plots (Denver 48-in. Upstream)

4.3.11.3 Upstream Sample. The Raman spectroscopy plots for the Denver 48-in. upstream sample are shown in Figure 4-49. Four plots are shown for each of the virgin resin, inside liner surface, and exterior liner surface. The location of peaks is generally the same for the plots for each location with the exterior surface exhibiting the most variability. A discussion of the possibilities for using Raman spectroscopy for liner evaluation is given in Section 6.

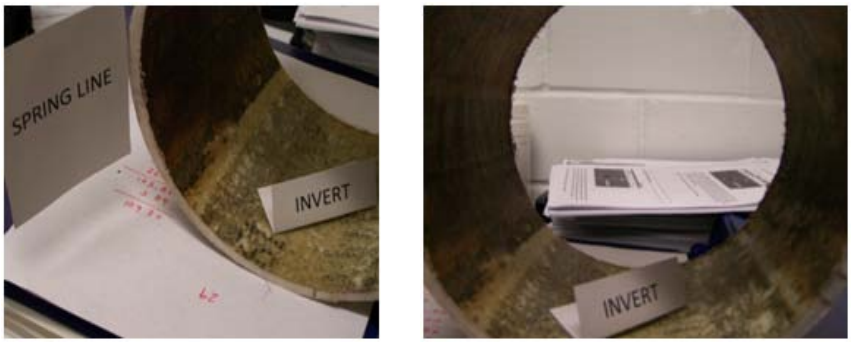
5.2.3 Visual Inspection of Liner. The visual inspection in the field was documented by Ed Kampbell of Jason Consultants. The liner appeared to be in good shape overall (see Figure 5-2). The polymeric film on the CIPP appeared to be intact with no evidence of hydrolysis. In-situ measurements indicated that the CIPP was at least 6.0 mm thick around the circumference, with the greatest thickness observed being approximately 6.5 mm. The annular space was very small, including that at the branch connection. A large amount of resin was formed around the circumference of the liner at each branch connection location. There was no evidence of external hydrostatic loading (no visible signs of a seasonal water table). The resin-impregnated felt was solid and intact. The stitch holding together the CIPP tube was found to be in good condition. Signs of wear were restricted to the bottom third of the tube. The liner varied significantly in external diameter as it accommodated the short pipe segments between the four branches.

Figure 5-2. Images of the Inner Surface of the 5-year Old Columbus 8-in. Liner

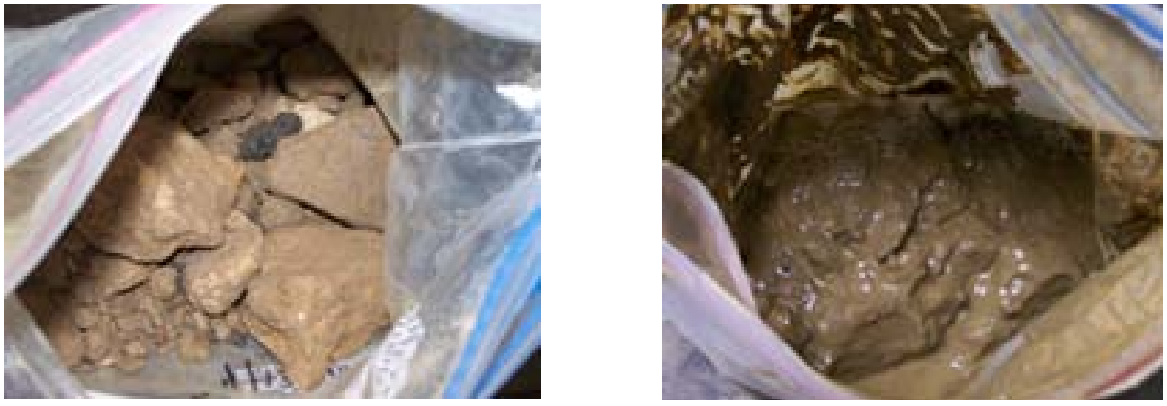
Figure 5-4. Collected In-Situ Soil Samples (Columbus 8-in. Site)

5.2.5.1 Particle Size Distribution. The soil gradation analysis followed ASTM C136. Based on visual inspection, the soil samples were categorized as fine aggregates. Some large particles (e.g., asphalt, rocks) (see Figure 5-4) were also present, but were considered a foreign material and were excluded from the sieve analysis. For the analysis, 500 g of soil material was taken from each of the six soil samples and placed on a No. 4 sieve (4.76 mm). For all samples (excluding the large foreign material), 85 to 95% of the particles passed through the No. 4 sieve.

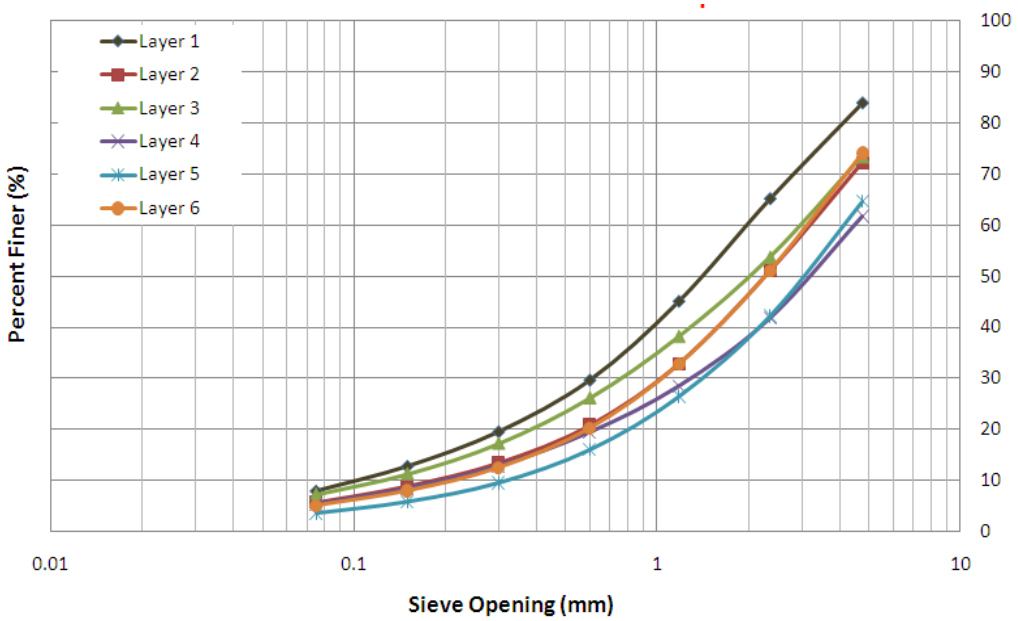
Figure 5-5. Grain Size Distribution of Soil Samples (Columbus 8-in. Liner Site)

Based on the grain size distribution, both the backfill and bedding soils can be considered to be sandy soils. The flatter slopes of the resulting gradation curves suggest that the bedding and surrounding soil are well-graded.

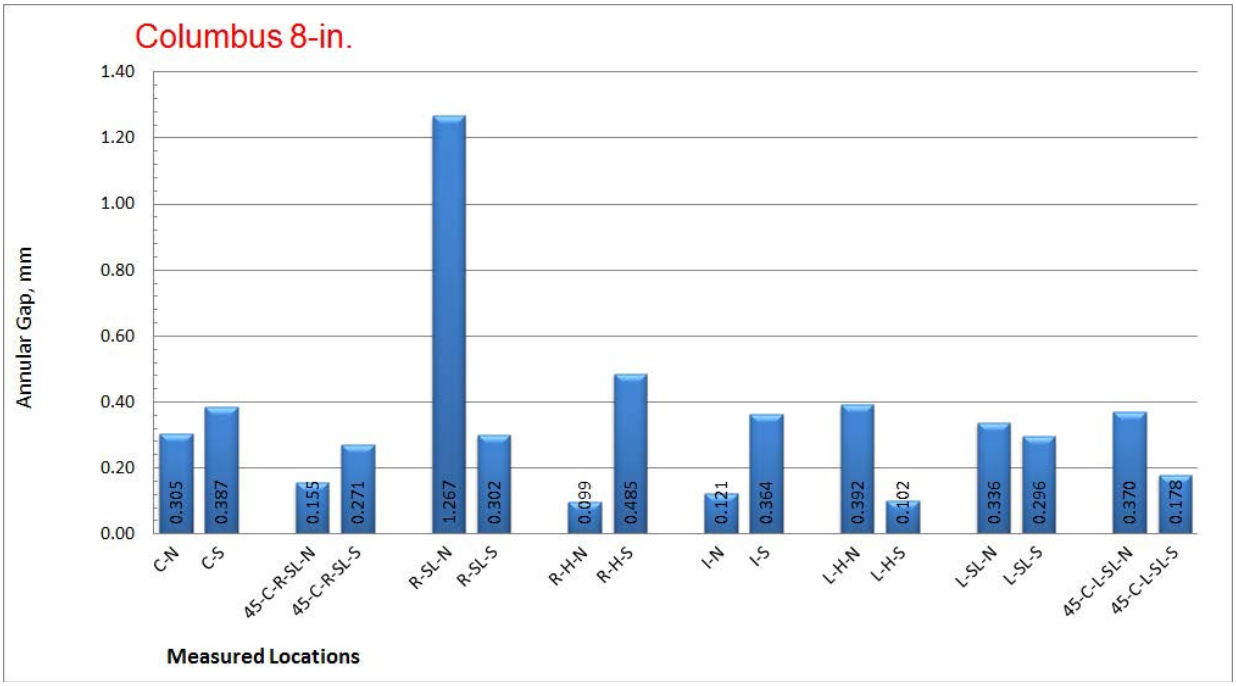
Figure 5-7. Histogram of Annular Gap Measurements (Columbus 8-in. Liner)

5.2.8 Annular Gap. The gap between the CIPP liner and the host pipe was measured at 45 degree increments around the circumference of the liner at both ends of the exhumed sample, as well as exposed ends of the remaining pipe sections. In the laboratory, nine separate measurements were made at each of the eight circumferential locations and averaged for the value at that location. The CIPP liner was found to tightly fit with the inner wall of the host pipe, with the average and standard deviation for the gap being 0.35±0.26 mm. The measurements are summarized in Table 5-6 and Figure 5-7.

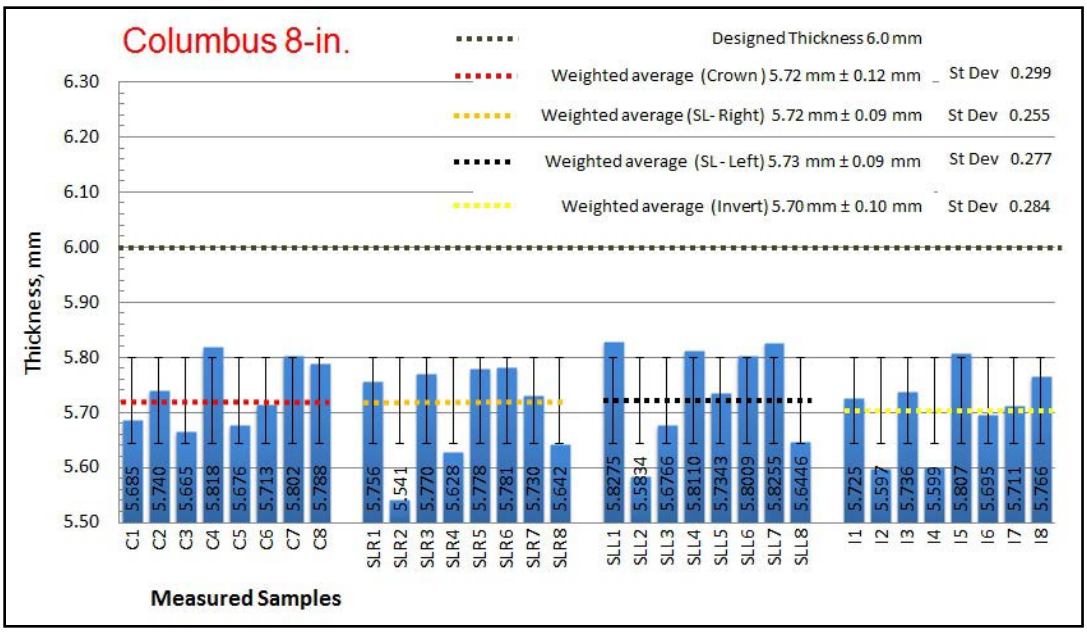
Figure 5-8. Average Thickness at Different Locations (Columbus 8-in. Liner)

The average thickness of the liner at different locations is shown in Figure 5-8. The thickness at the crown (5.7 mm) was found to be similar in thickness to the other locations (invert and spring line) around the circumference of the liner. The average liner thickness for each location is slightly less than the as-specified liner thickness of 6.0 mm. Additional discussion of the data measured at the time of installation with the current data is given in Section 5.2.14.

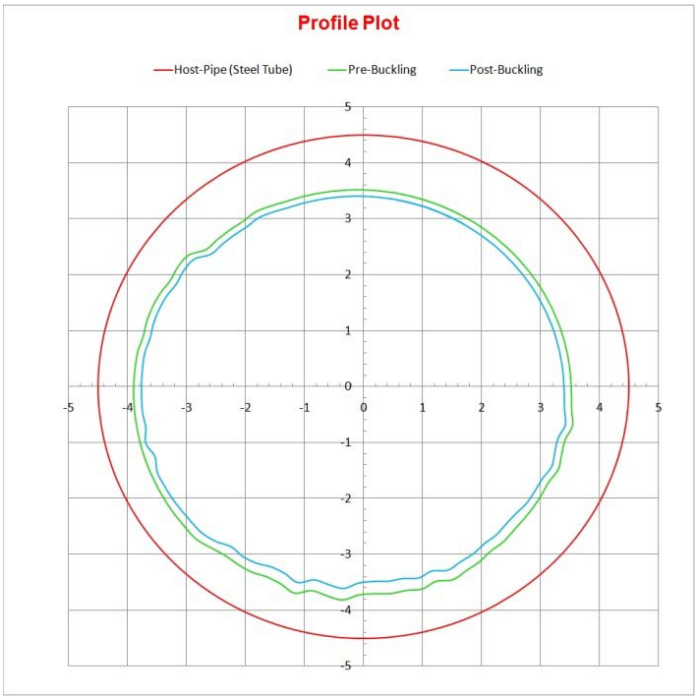
Figure 5-11. Profile Plot of Steel Host Pipe and Liner Before and After the Buckling Test (Columbus 8-in. Liner)

Figure 5-11 compares the pre-buckling and post-buckling profile plots. From the pre-buckling profile plot, it can be seen that the liner did not follow a perfect circular shape. The liner had several irregularities that probably matched irregularities in the original host pipe with the largest excursion (nearly a quarter inch outwards) from a circular shape occurring at the invert of the liner. The ovality of the liner calculated in accordance with ASTM F1216 was 7.4%. It should be noted that for the buckling test (described in Section 5.1.15), the liner was inserted and sealed within a circular steel pipe.

Once the setup was completed, the buckling test commenced (Figure 5-22). The liner held a pressure of over 50 psi (corresponding to around 115 ft depth of immersion in water) for nearly 15 minutes (Figure 5-23). Leakage of water was observed through the liner material on the inner wall of the CIPP liner. These leaks suggest the presence of some migration paths though the resin matrix (Figure 5-24) at this elevated pressure. The cross-sectional profile of the liner before and after buckling is shown in Figure 5-11.

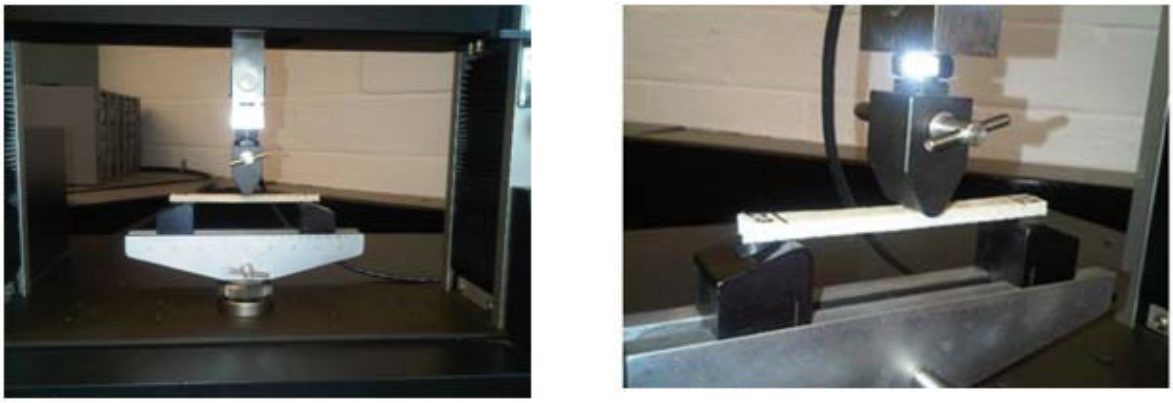
Figure 5-12. Flexural Test Specimens (ASTM D790): Before Test (Left) and After Test (Right)

5.2.12 Flexural Testing. Specimens with a geometry described in ASTM D790 were cut from the crown, spring line, and invert of the retrieved CIPP liner for measuring the liner's flexural strength and flexural modulus elasticity. A total of 15 specimens were prepared and tested (five from each location). The sides of specimens were smoothed using a grinder and a table router. The water jet cutter normally used for specimen preparation could not be used in this case as the dimensions of the liner cutouts were too small to hold inside the cutting board. The specimens were marked as shown in Figure 5-12. Testing was performed using an ADMET eXpart 2611 machine (Figure 5-13). Table 5-7 lists the dimensions and moment of inertia for each of the 15 specimens.

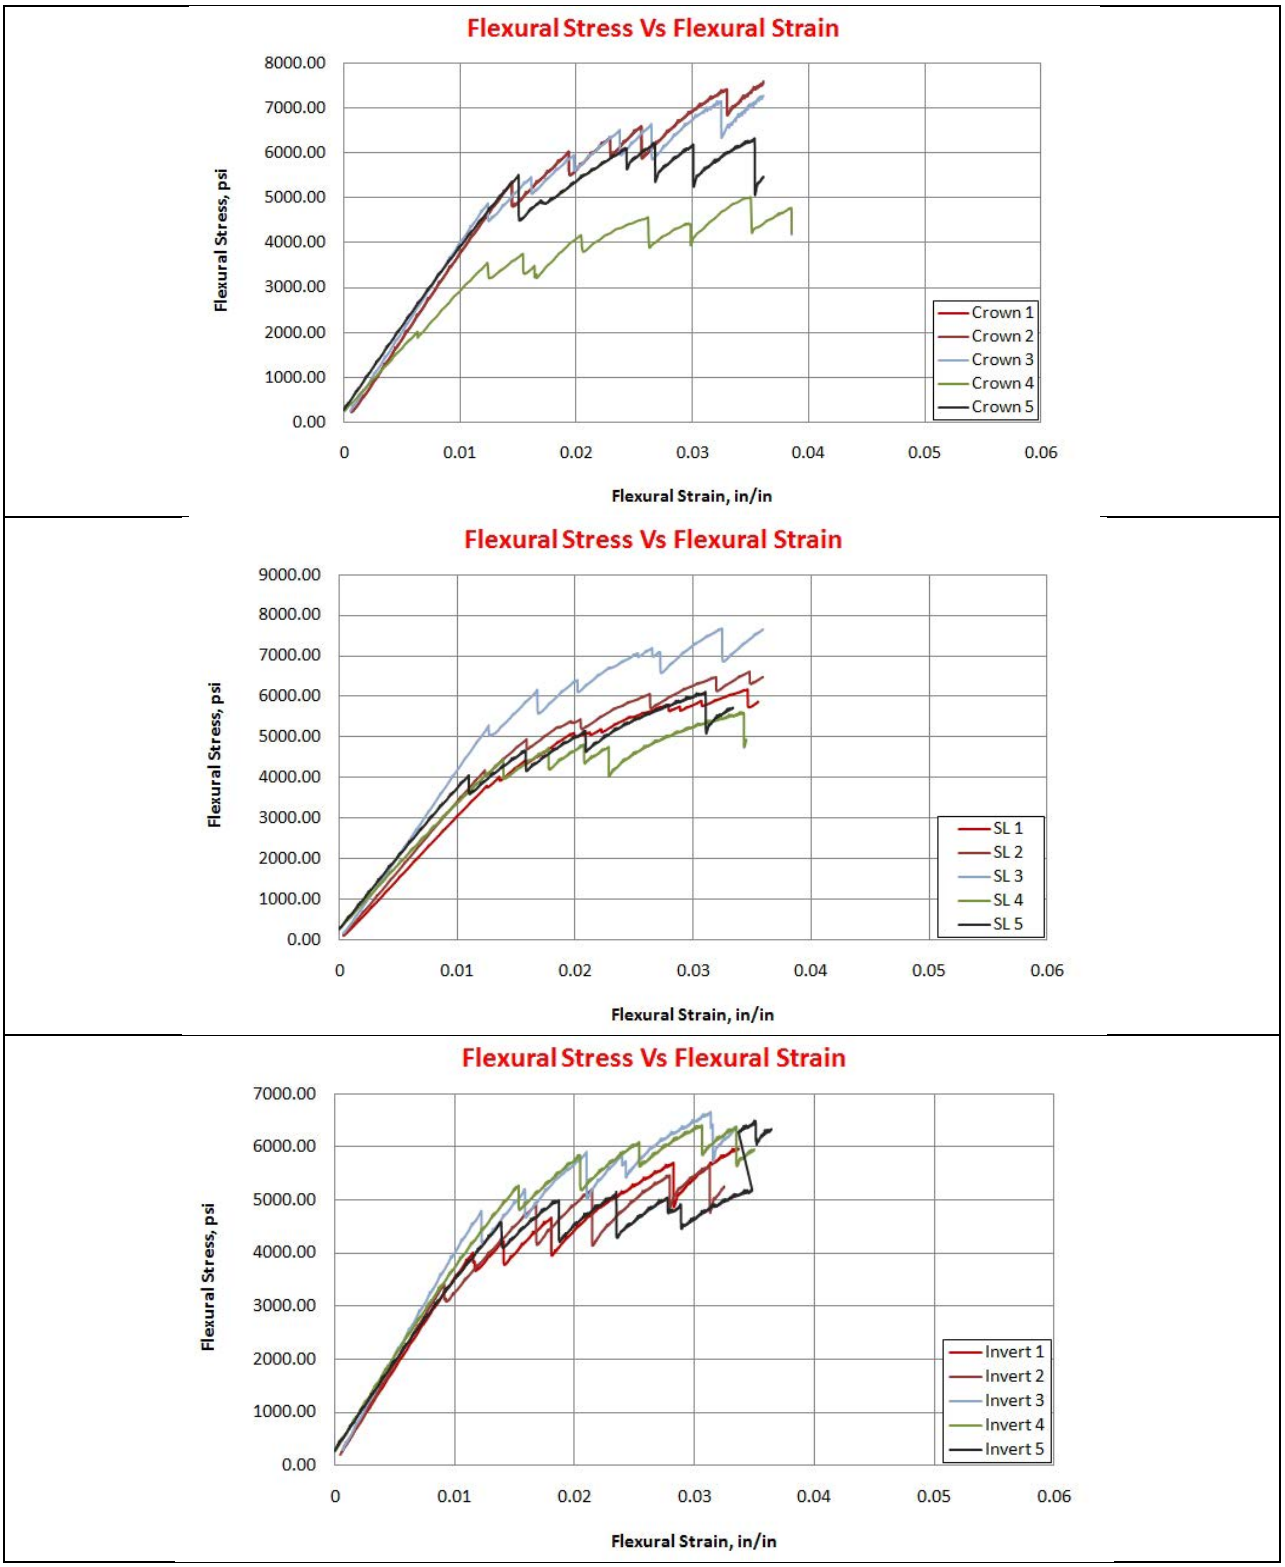
Figure 5-14. Flexural Stress-Strain Curves for Crown, Spring Line, and Invert Samples (Columbus 8-in. Liner)

Using the information in Table 5-7, the following flexural stress and strain graphs for crown samples, spring line samples, and invert samples were drawn and are shown in Figure 5-14.

Peak load, bending stresses, and deflections were obtained from the calculated data while the software 'MtestW' was used to calculate the peak shear stress and bending modulus of elasticity values for the different specimens. These values are given in Table 5-8.

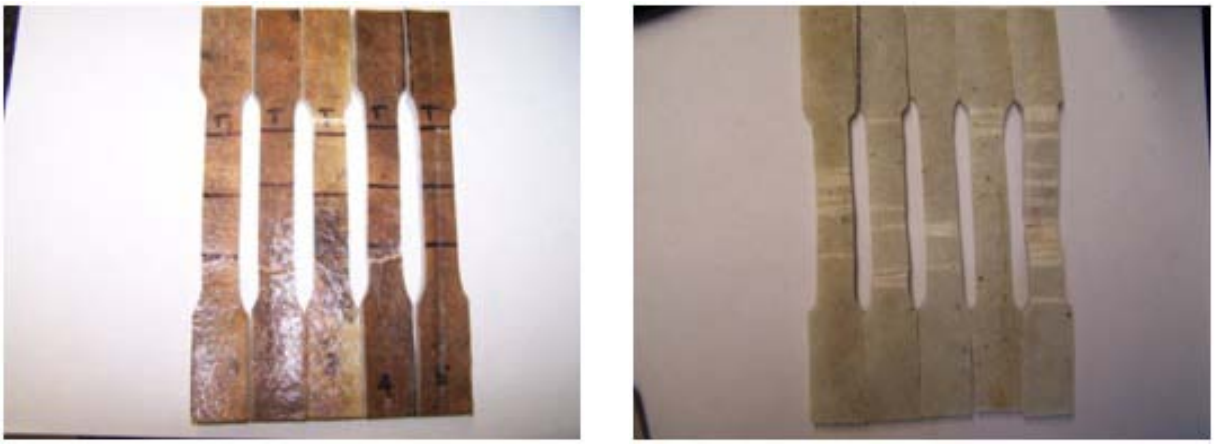
Figure 5-15. Tensile Specimens for Columbus 8-in. Liner: Before the Test (Left) and Following the Test (Right)

5.2.13 Tensile Testing. Specimens with dimensions consistent with the values provided by ASTM D638 were cut from the crown, spring line, and invert of the exhumed CIPP liner as shown in Figure 5-15. A total of 15 specimens were prepared and tested (five from each location).
