EPA/600/R-12/004 | January 2012 | www.epa.gov /nrmrl

A Retrospective Evaluation of Cured-in-Place Pipe (CIPP) Used in Municipal Gravity Sewers

Office of Research and Development
National Risk Management Research Laboratory - Water Supply and Water Resources Division

September 2011

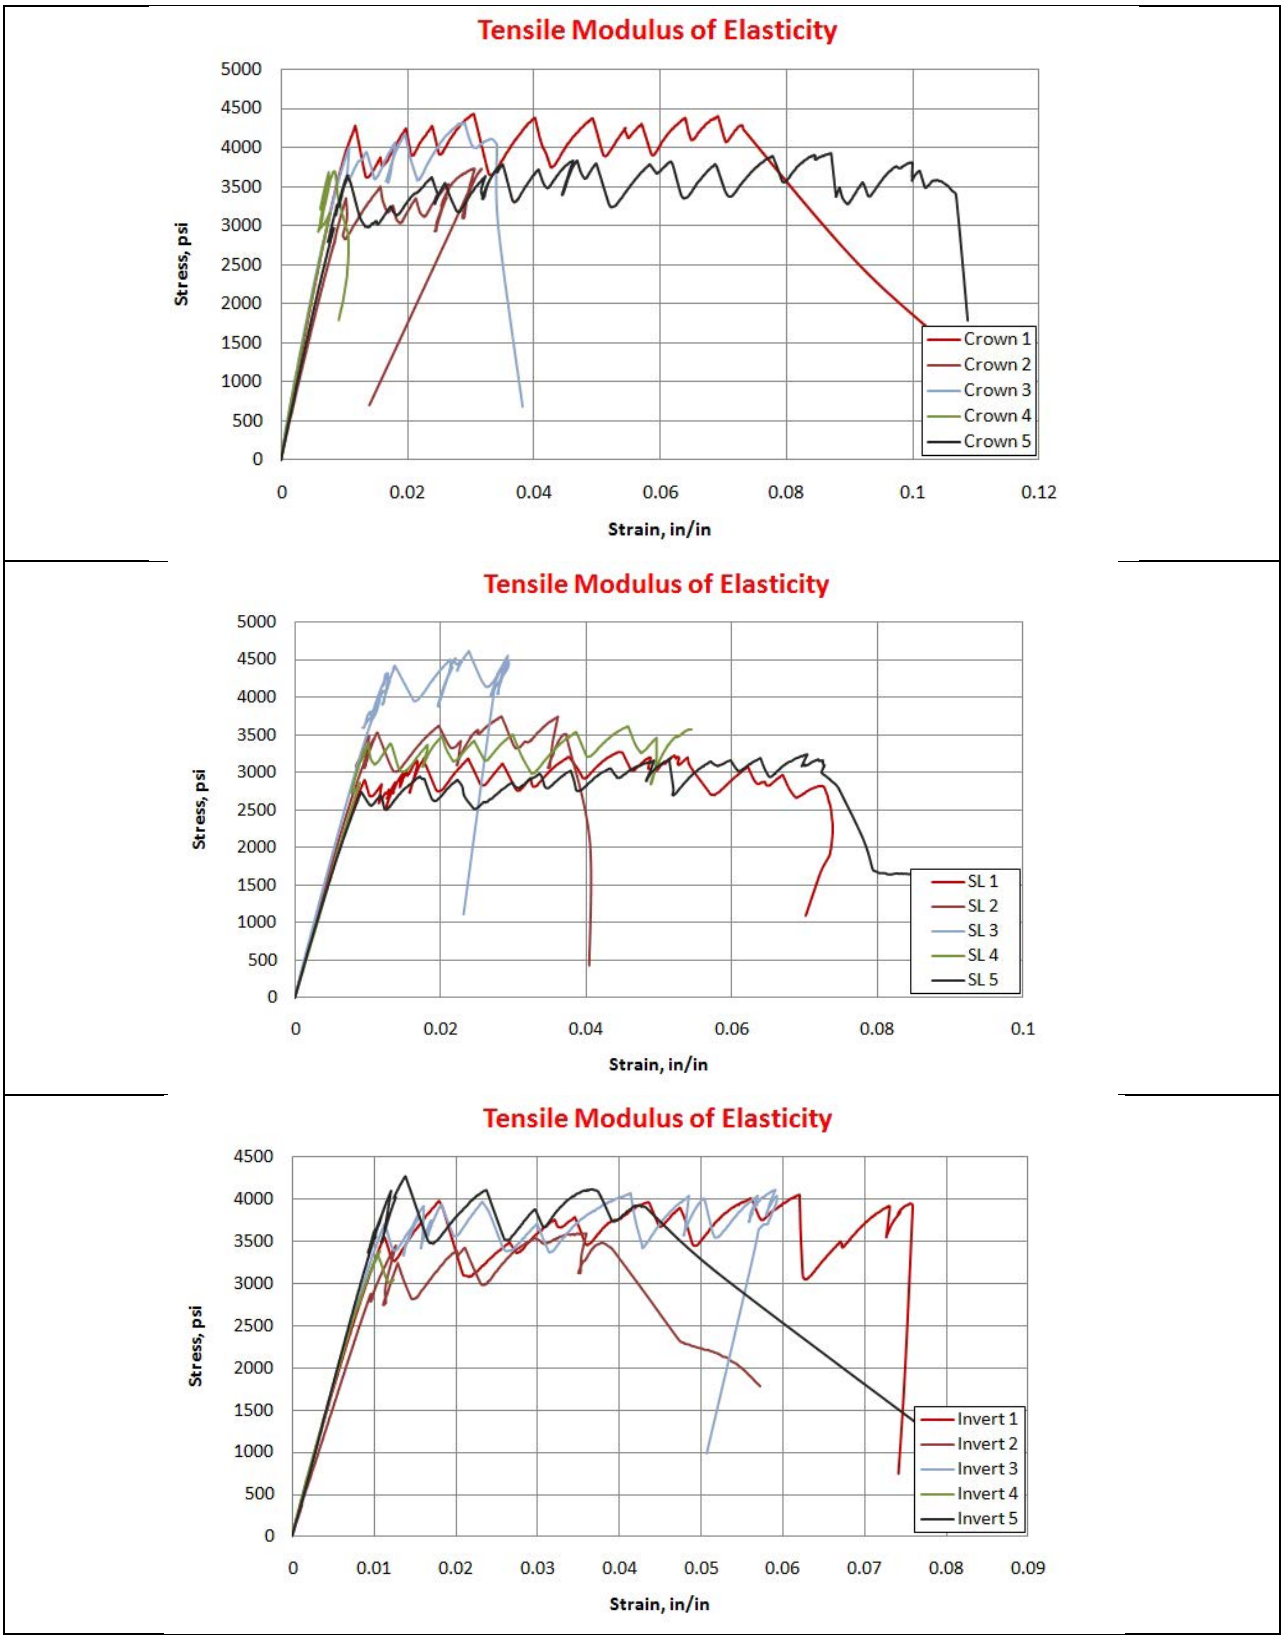
Figure 5-16. Tensile Stress-Strain Curves for Crown, Spring Line and Invert (Columbus 8-in.)

Using the information given in Table 5-9, the following figures were drawn: Stress-strain curves for crown samples, spring line samples, and invert samples (Figure 5-16).

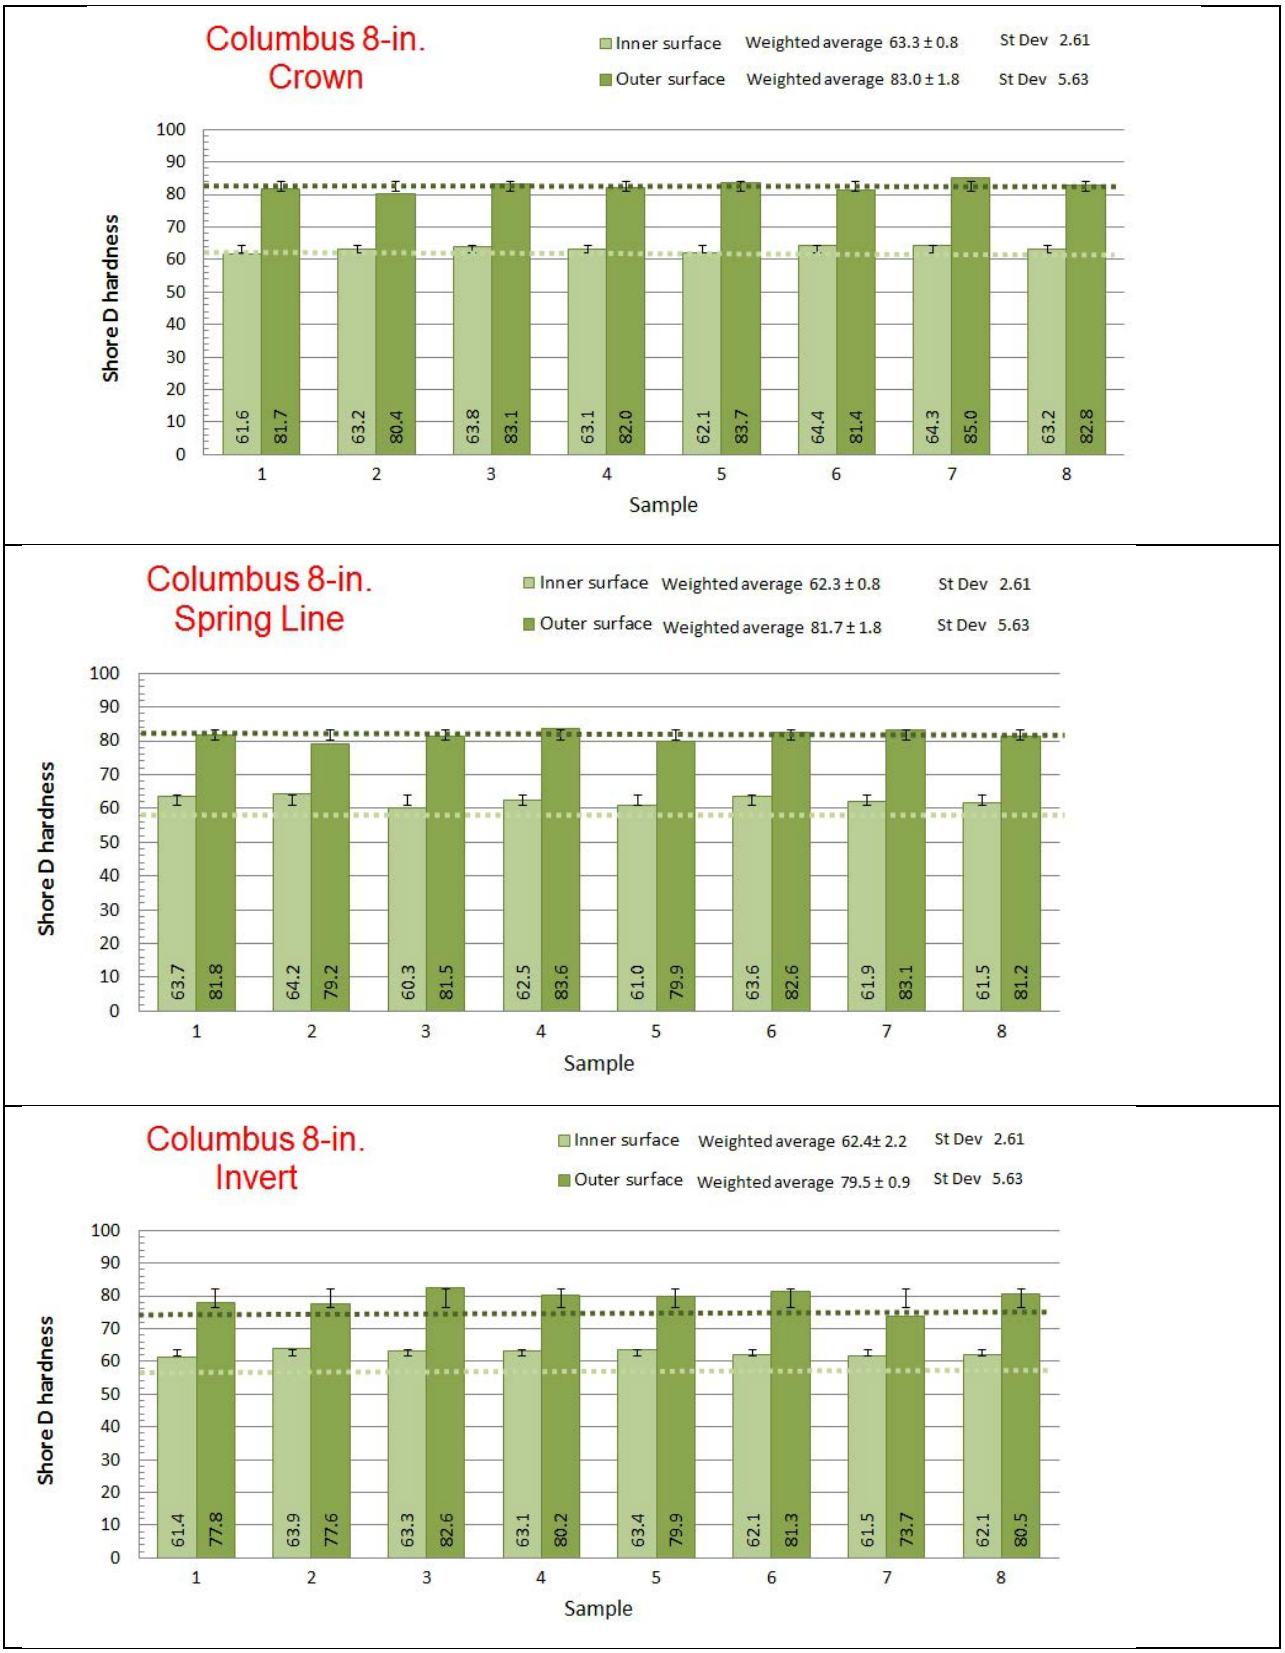
Figure 5-25. Shore D Hardness Readings on Inner and Outer Surfaces (Columbus 8-in. Liner)

All tests were performed using the Shore D hardness scale, which utilizes a weight of 10 lb (4,536 g) and a tip diameter of 0.1 mm. Tests were conducted on the inner and outer surfaces and a total of 1,440 readings were performed on samples taken from all of the locations. The recorded values are shown in Figure 5-25. As was noted in the Denver studies, it can be seen that the inner surface readings are approximately 23% softer (63.3, 62.3, and 62.4) compared with outer surfaces of the liner (79.5, 81.7, and 83.0). However, it is difficult to separate any effects of exposure to the waste stream from differences due to the presence of the interior surface coating.

5.2.17 Barcol Hardness. Specimens were also subjected to the Barcol hardness test (ASTM D2583) as described for the Denver samples in Section 4. The results of the Barcol hardness testing for this liner are shown in Figure 5-26. The values (average of 6.77 for the inner surface and 13.76 for the outer surface) are much lower than for the equivalent testing for the Denver samples. For the inner surface, this may be a result of the different coating material used in recent liners than was used in the earlier liners retrieved from the Denver sites. Differences of similar magnitude are not seen in the Shore D hardness values between the Columbus and Denver 8-in. liners. While there is no correlation between these two hardness measurements methods, Barcol hardness is the more commonly utilized method in the CIPP industry. The Barcol hardness values for the 5-year old Columbus 8-in. liner show little difference between the inner and outer surfaces or between the invert readings and the crown readings. This may be due to the relatively short exposure of the liner to service conditions.

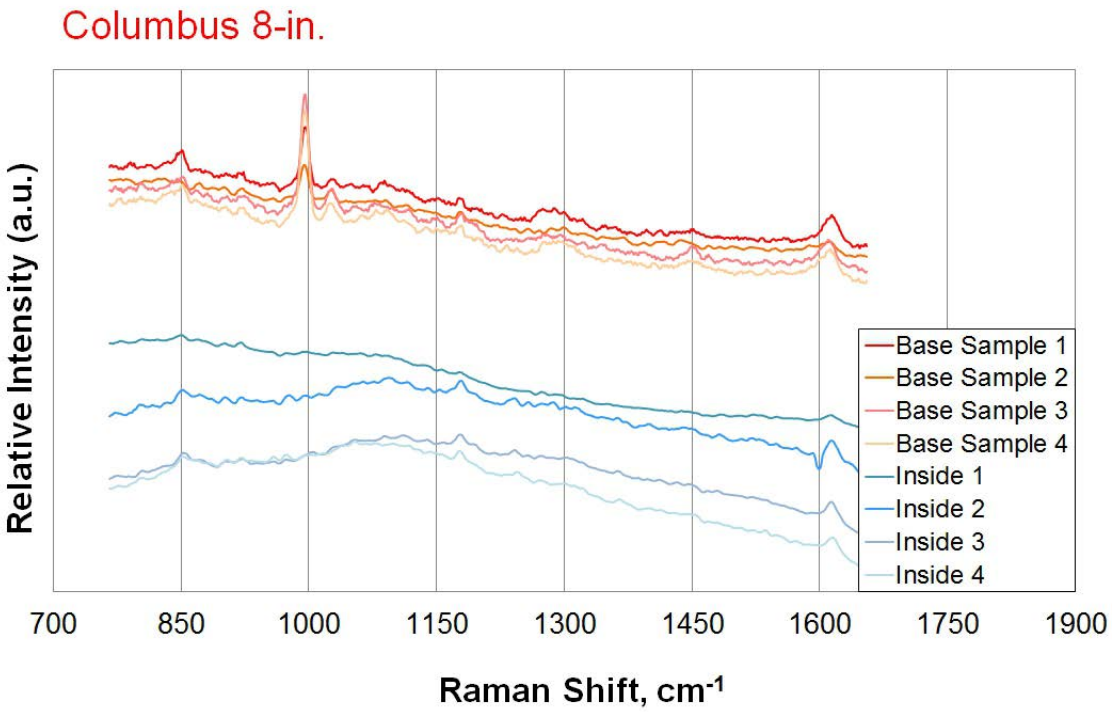
Figure 5-27. Raman Spectra for the Columbus 8-in. Liner

5.2.18 Raman Spectroscopy. The Raman spectroscopy plots for the Columbus 8-in. liner sample are shown in Figure 5-27. Plots are shown for the virgin resin, and several locations on the inside and outside liner surfaces. There is one clear difference in the presence of peaks between the base resin samples and the exhumed specimens, which was not seen in the Denver samples. A discussion of the possibilities for using Raman spectroscopy for liner evaluation is given in Section 6.

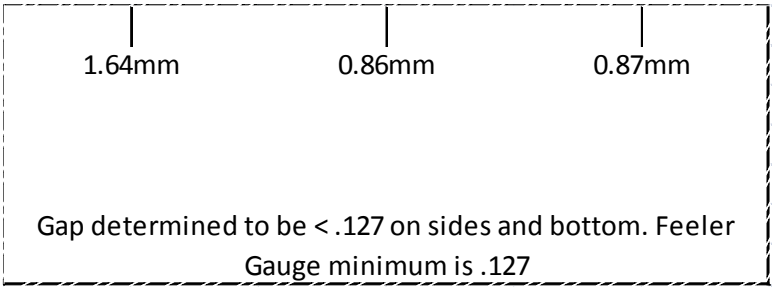
Figure 5-31. Annular Space Measurements Around the Sample Removal Area (Columbus 36-in. Liner)

5.3.5 Annular Gap. A feeler gauge was used to measure the annular space around the perimeter where the sample was removed. The liner appeared to be very tight along the sides and bottom of the sample and a spacing greater than 0.127 mm was measured at only three locations (see Figure 5-31) – all along the top side of the sample removal area (see note on crown annulus gap in Section 5.3.3). The end measurements shown in Figure 5-31 were taken at approximately 4 in. from each end of the cutout and the middle measurement was taken at its center. Since the liner sample was removed from the host pipe, no laboratory annular space measurements were possible.

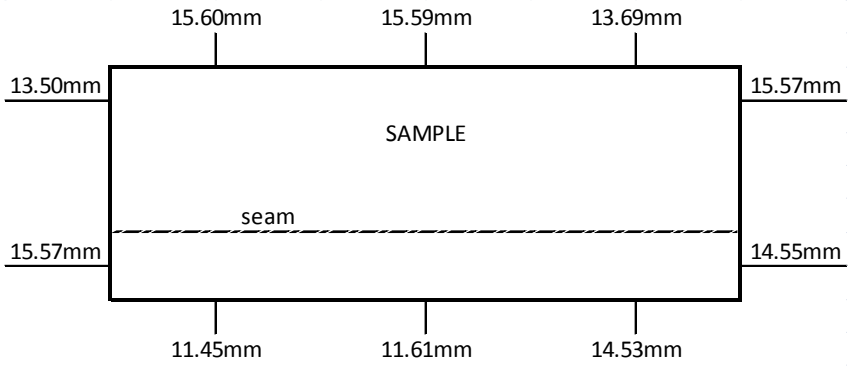
Figure 5-33. Caliper Measurements of Columbus 36-in. Sample

5.3.6.2 Field Measurements. Caliper measurements of the exhumed liner thickness were recorded around the edges of the extracted sample in the field as shown in Figure 5-33. The liner thickness measurements taken in the field are shown in Figure 5-34. The average thickness for the sample was calculated to be 14.2 mm and standard deviation was 1.5 mm. The original design thickness was not known, but it was assumed to be 15 mm (i.e., the same as the liner used for the adjacent line).

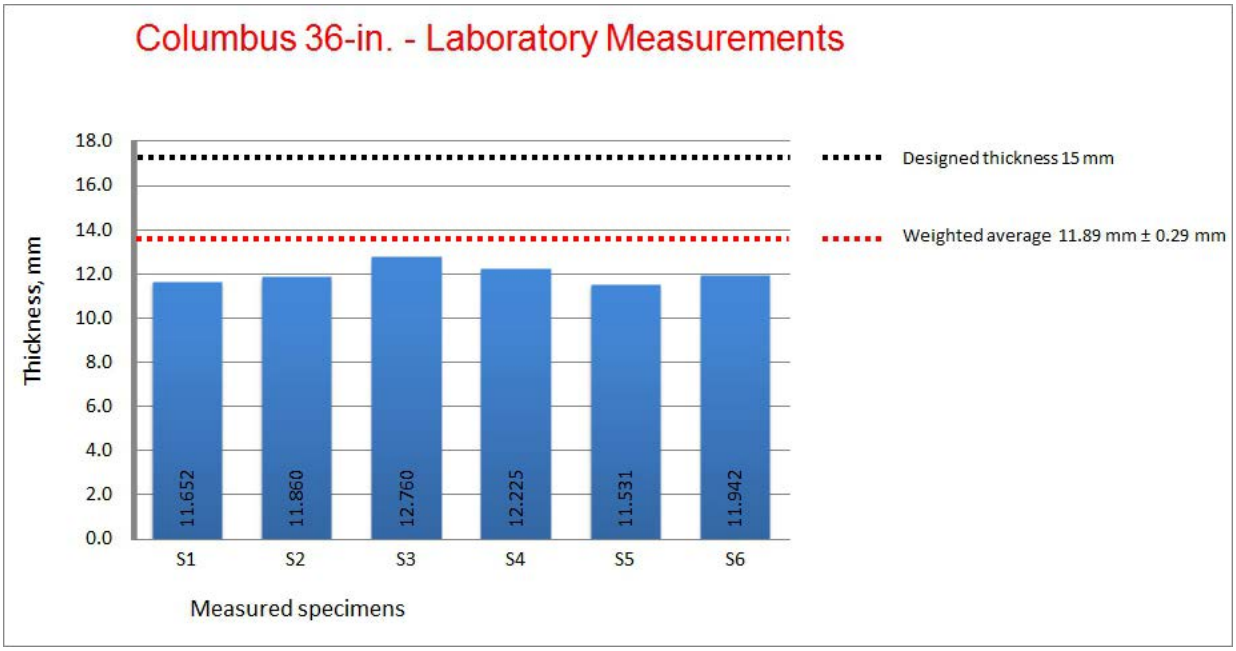
Figure 5-35. Laboratory Measurements of Thickness for the Columbus 36-in. Liner

5.3.6.3 Laboratory Measurements. For determining the liner thickness in the laboratory, specimens cut out from the liner sample for the ASTM tensile and flexural tests were used. Six specimens were used and five readings were taken for each of the specimens using a micrometer. The average calculated values and their standard deviations are shown in Figure 5-35. The original design thickness stated in the figure was not known, but it was assumed to be 15 mm based on the thickness used for the adjacent liner. The weighted average for the sample thickness measurements was calculated to be 11.9 mm and the weighted error ±0.3 mm. The laboratory measured values were 16% lower than the field measured values.

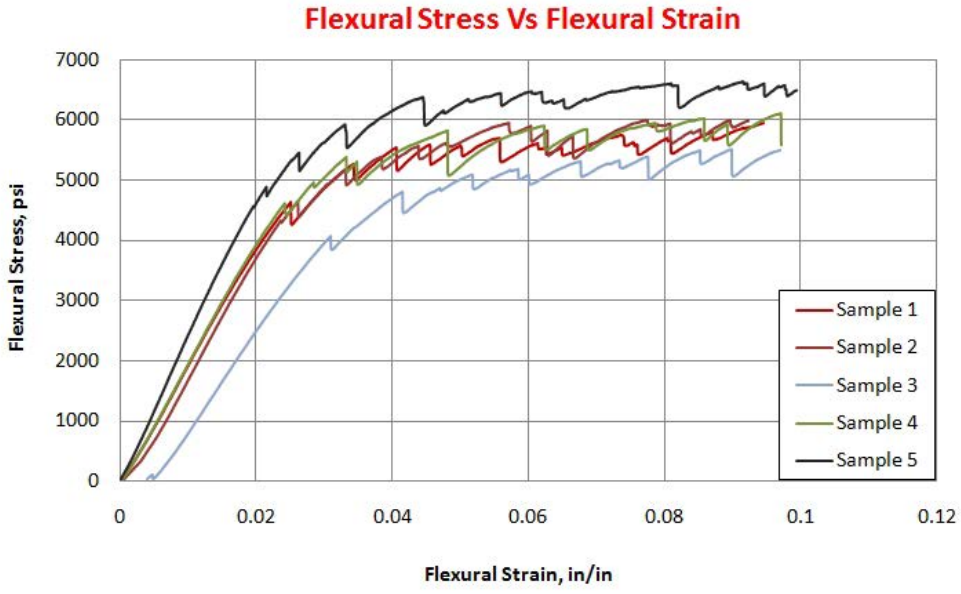
Figure 5-36. Flexural Stress-Strain Curves (Columbus 8-in. Liner)

Using the information in Table 5-13, the flexural stress and strain data for all samples was drawn (Figure 5-36). Peak load, peak shear stress, and flexural modulus values for each specimen, obtained using the software 'MtestW', are listed in Table 5-14.

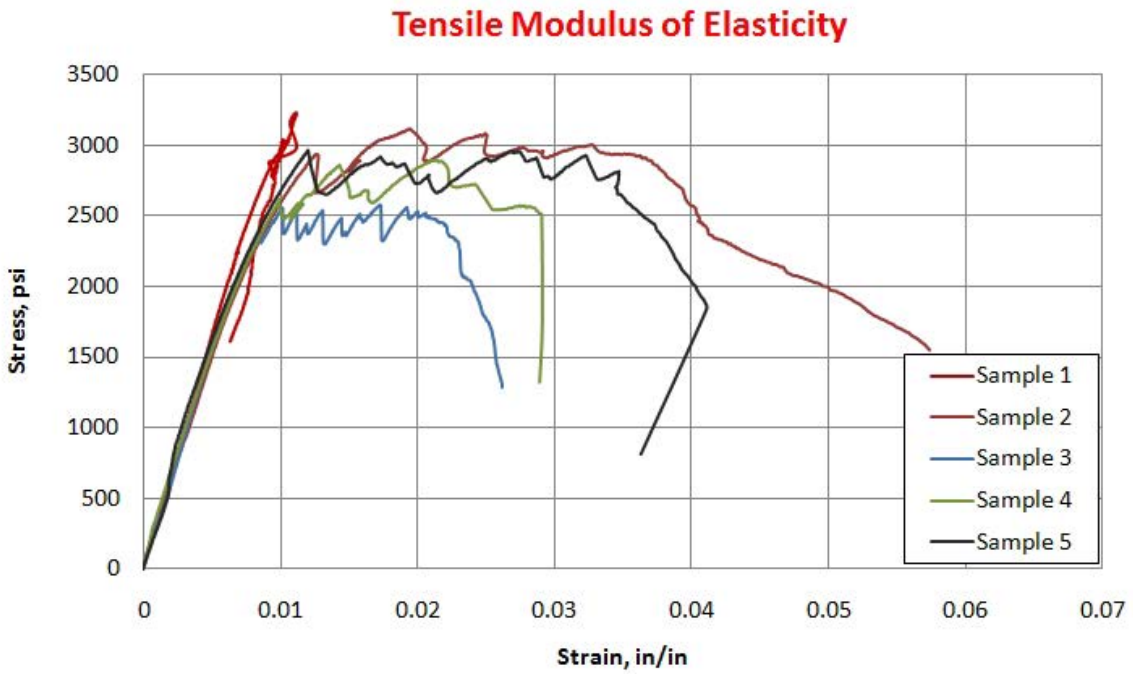
Figure 5-37. Tensile Stress-Strain Curves (Columbus 36-in. Liner)

5.3.9 Tensile Testing. Specimen cutting and preparation for testing in accordance with ASTM D638 followed the procedures described earlier for the other retrospective samples. Table 5-15 provides the results from tensile testing. Using the information given in Table 5-15, the tensile stress-strain curves for all samples were developed and are presented in Figure 5-37.

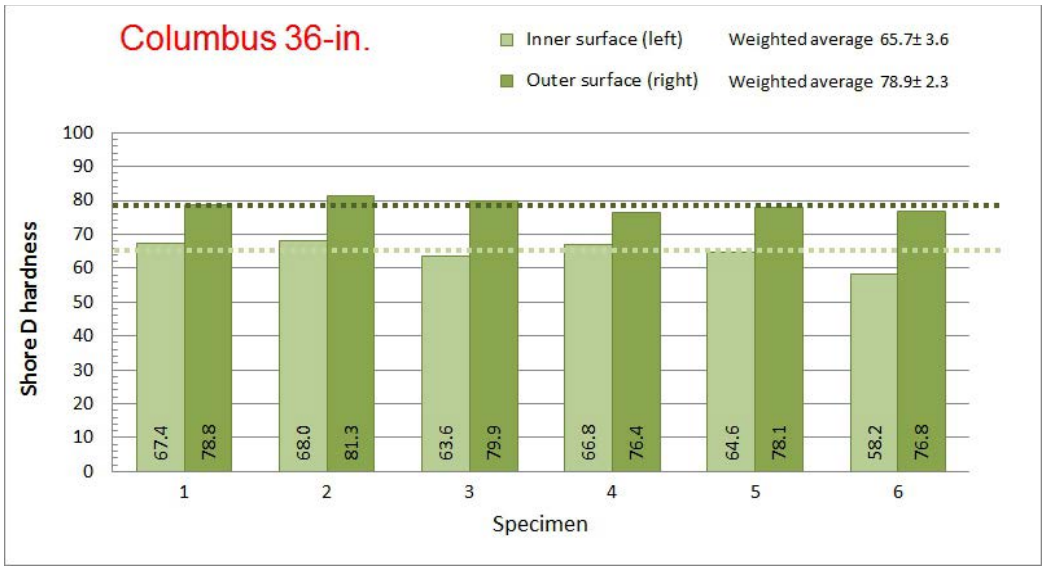
Figure 5-38. Shore D Hardness of Columbus 36-in. Liner Sample

5.3.10 Shore D Hardness. A total of six specimens measuring approximately 1 in. × 1 in. were prepared and tested using the Shore D hardness test. A total of 36 tests were conducted on each sample: 18 tests on the inner surfaces and 18 tests on the outer surfaces. The average calculated values and their standard deviations are shown in Figure 5-38. The weighted average of Shore D hardness for the sample inner surface was calculated to be 66±4, and for the outer surface 79±2.

The liner hardness was found to be medium to high on the Shore D hardness scale. For the Shore D test on this sample, the inner surface has an average hardness approximately 17% less than the outer liner surface.

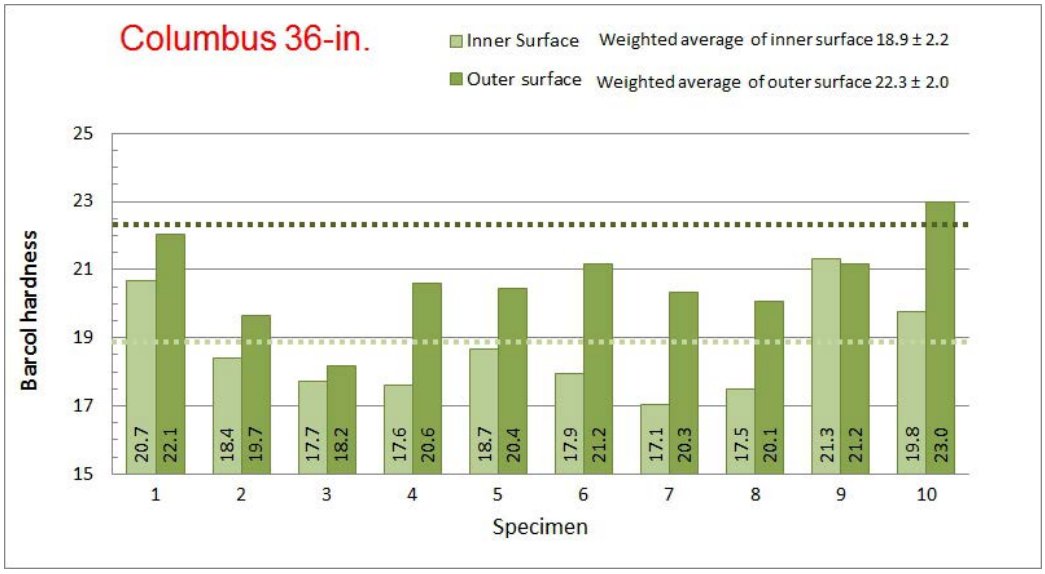
Figure 5-39. Barcol Hardness Readings on Inner and Outer Surfaces (Columbus 36-in. Liner)

5.3.11 Barcol Hardness. For each of 10 specimens, a total of 36 readings of Barcol hardness were taken: 18 on the outer surface and 18 on the inner surface. The average calculated values and their standard deviations are shown in Figure 5-39. The weighted average of Barcol hardness for the sample inner surface was calculated to be 18.9±2.2 and for the outer surface 22.3 ±2.0. As for most of the liners tested, the outer surface hardness is higher than for the inner surface. For the Barcol test on this sample, the inner surface has an average harness approximately 15% less than the outer surface.

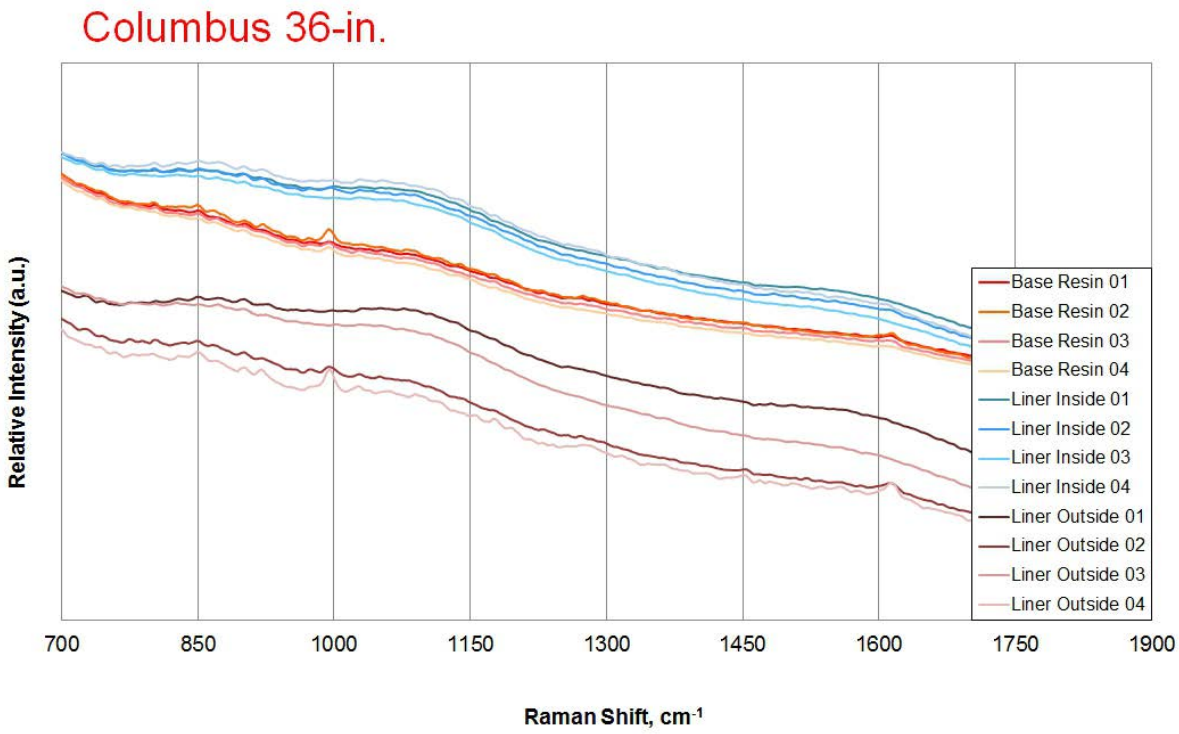
Figure 5-40. Raman Spectroscopy Plots (Columbus 36-in. Liner)

5.3.12 Raman Spectroscopy. The Raman spectroscopy plots for the Columbus 36-in. liner sample are shown in Figure 5-40. Plots are shown for the virgin resin, and several locations on the inside and outside liner surfaces. There are no clear differences in the shapes of the curves or the presence of peaks between the base resin samples and the exhumed specimens. This is similar to the results from most of the retrospective liner samples. A discussion of the possibilities for using Raman spectroscopy for liner evaluation is given in Section 6.

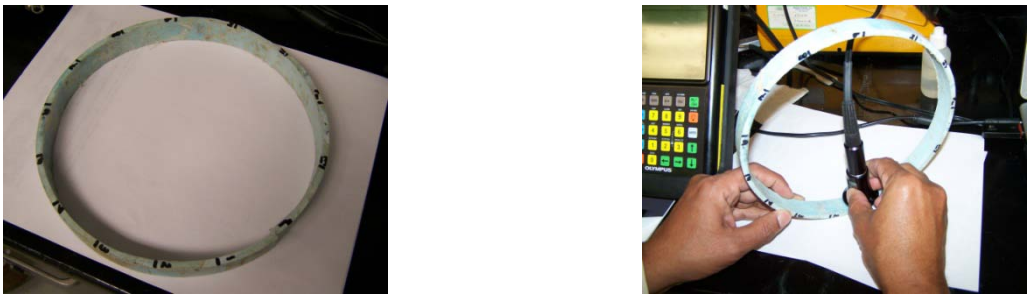
Figure B-4. Ultrasonic Thickness Measurements on Improperly Cured Liner
