Sydney Water's Trial Project of New Technology to Assess Water Tightness of Cured-In-Place Pipe (CIPP)

Chuck Hansen[1], Michael Condran, PE[2], Toby Bourke[3]

EXECUTIVE SUMMARY

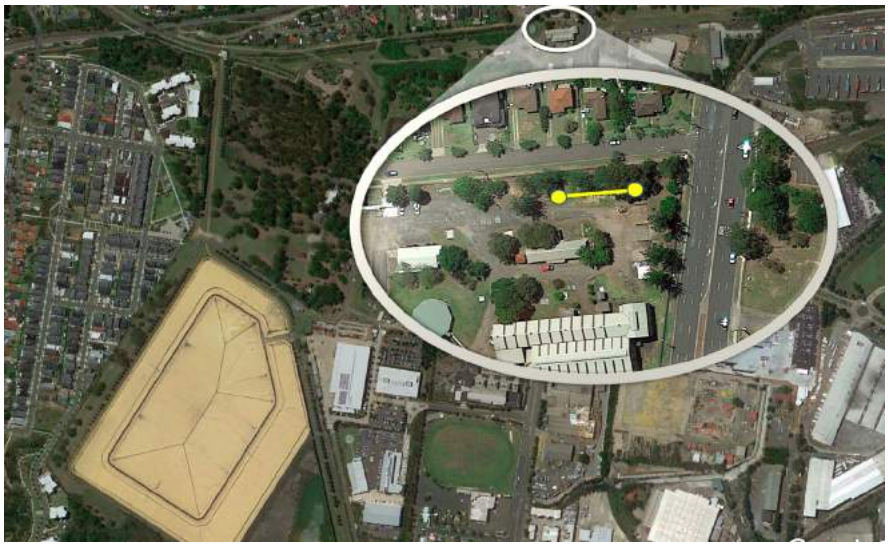
Sydney Water's test bed represented a 10m Vitrified Clay Pipe (VCP) segment, followed by a 2m Polyvinyl Chloride (PVC) section, followed by a 4m VCP sectional.

Potts Hill, Lewis Street training facility.

Sydney Water trial test bed for pipe evaluations.

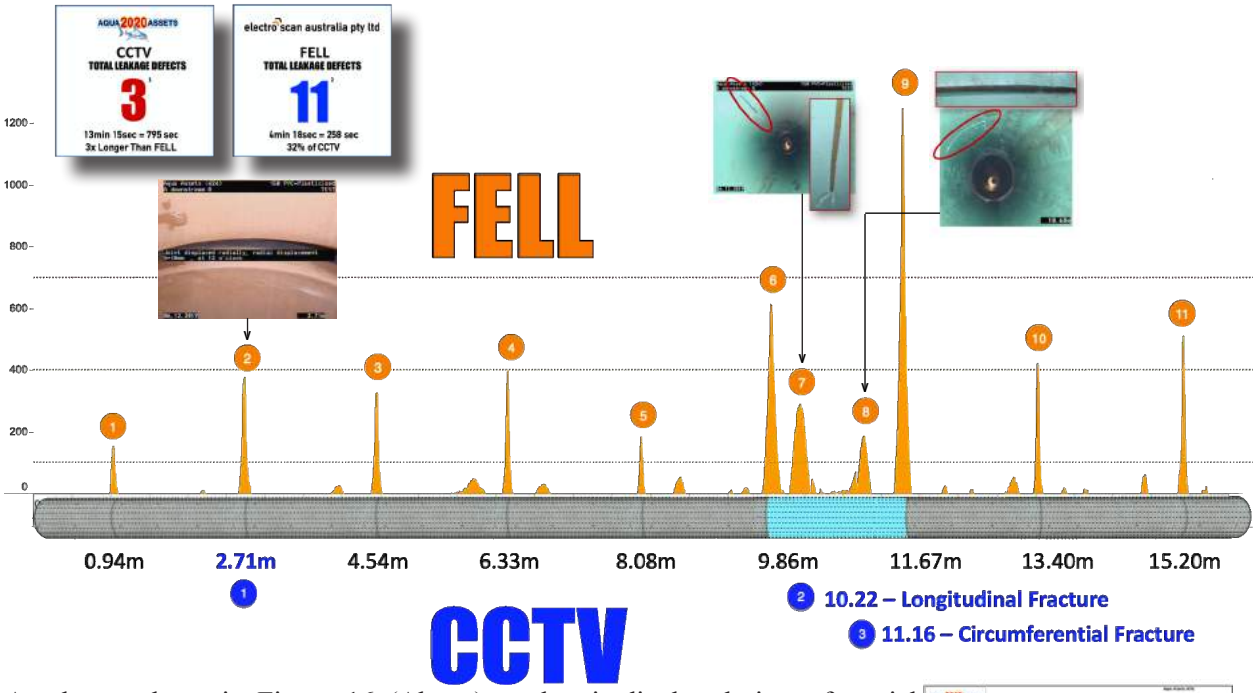
As shown above in Figure 16 (Above), CCTV recorded three (3) defect locations, including (a) displaced joint at 2,71m, (b) longitudinal fracture @10.22m, and (c) circumferential fracture @ 11.16m, with both defects at (b) and (c) placed by Sydney Water staff. Once fully set-up with the camera positioned in the pipe CCTV inspection took 13 minutes, 15 seconds to complete its inspection.

In contrast, FELL recorded eleven (11) defect locations, including leak locations at joints, defects at both changes in material, and both previously installed defects at longitudinal and circumferential locations.

Two (2) of the 11 defects may have been influenced by a metallic flange in each of the ferno fittings, but separation of FELL results, indicates that 'no impact' was made on any other defects identified.

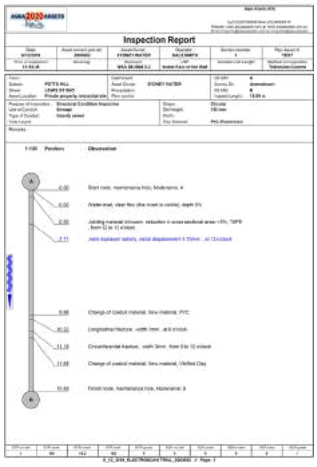
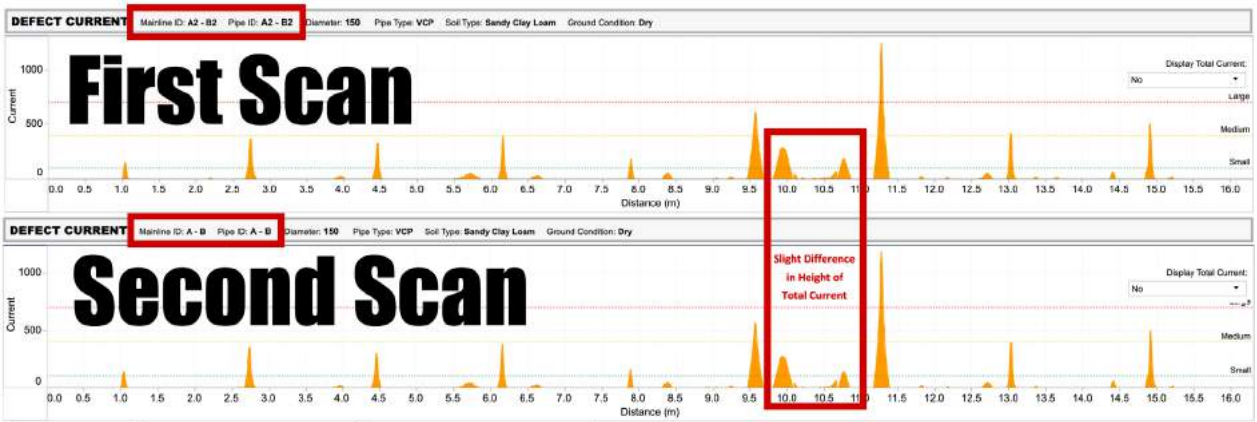
DEFECTS		LENGTHS	LPS SUMMARY	
Large	1	1.08%	Severe	0.288
Medium	3	1.67%	Moderate	0.298
Small	7	3.08%	Minor	0.329
Pinhole	0	0.00%	Total LPS	0.915
All Defects	11	5.84%	LPD	79,094
			Severe %	31.400%
			Moderate %	32.600%
			Minor %	35.980%

79,094 LPD

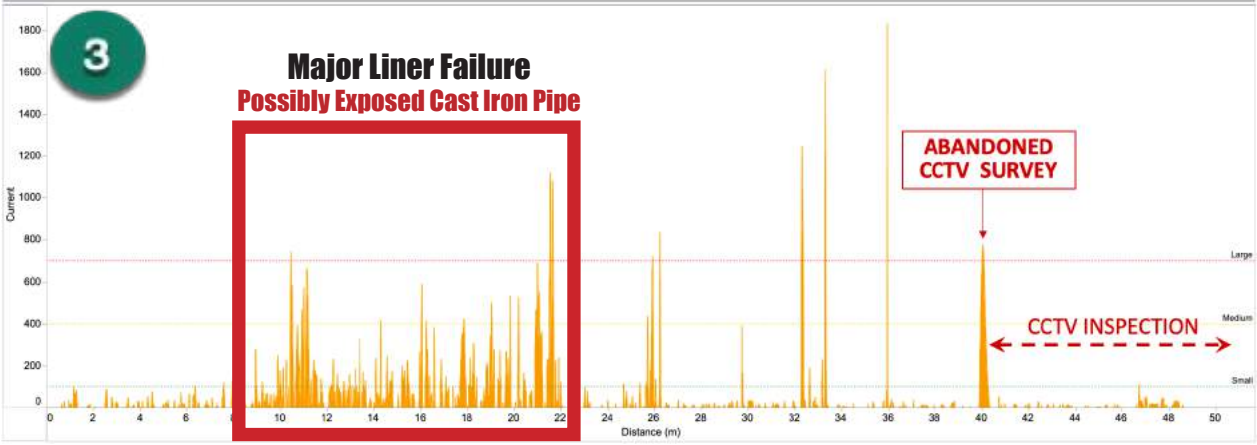
Date	Mainline ID	Pipe ID	Pipe Type	Diameter							
13/12/2019	1285623 - 1285939	3575745	VCP	225	30	0	36	12	3	2.937	253,744
	1283207 - 1285939	3822108	VCP	225	68	0	80	23	6	6.088	526,021
	1285947 - 1283215	3576181	CIPP	225	49	114	55	11	9	5.790	500,237
	1283211 - 1283215	3576177	VCP	225	38	0	21	4	6	2.189	189,095
	1285939 - 1283211	3578905	VCP	225	15	0	13	9	7	2.593	223,981

DEFECT CURRENT Mainline ID: **1285947 - 1283215** Pipe ID: **3576181** Diameter: **225** Pipe Type: **CIPP** Soil Type: **Sandy Clay Loam** Ground Condition: **Dry**

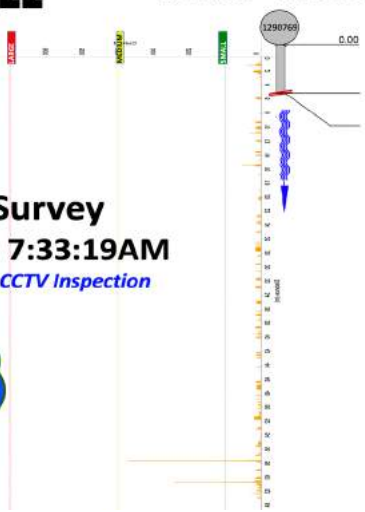
FELL Survey
8/12/2019 7:33:19AM
2 Days Before CCTV Inspection

NO CCTV OBSERVATIONS - BULGES

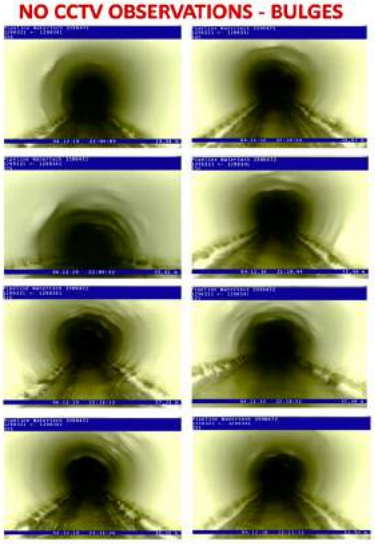
0.00	Start node, maintenance hole, Nodename: 1290321
0.00	Water level, turbid or discoloured flow, depth 15%
6.13	Water level, turbid or discoloured flow, depth 10%
16.51	The lining is bulged , reduction in cross sectional area: 5-20% , from 10 to 3 o'clock
20.29	The lining is bulged , reduction in cross sectional area: <5% , from 11 to 4 o'clock
21.87	The lining is bulged , reduction in cross sectional area: <5% , from 9 to 1 o'clock
27.62	The lining is bulged , reduction in cross sectional area: <5% , from 8 to 3 o'clock
35.02	The lining is bulged , reduction in cross sectional area: <5% , from 8 to 3 o'clock
59.45	Finish node, maintenance hole, Nodename: 1290341

NO CIPP LEAKS VISUALLY NOTED BY CCTV

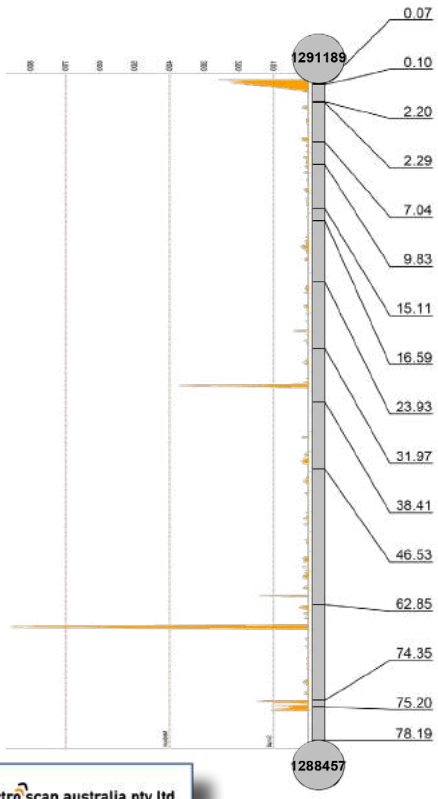
0.07	Start node, maintenance hole, Nodename: 1291189
0.10	Water level, turbid or discoloured flow, depth 5%
2.20	Water level, turbid or discoloured flow, depth 15%, RAGS

15.11	Defective junction, roots are growing into and/or down the connec conduit, magnitude of obstruction <5% , at 12 o'clock
16.59	Deposit is fine sediments- Sand or Silt in the invert Obstruction: at 6 o'clock

38.41	Deposit is fine sediments- Sand or Silt in the invert Obstruction: at 6 o'clock
46.53	Defective junction, roots are growing into and/or down the connect conduit, magnitude of obstruction <5% , at 1 o'clock

62.85	Deposit is fine sediments- Sand or Silt in the invert Obstruction: at 6 o'clock
74.35	Defective junction, roots are growing into and/or down the connect conduit, magnitude of obstruction 5-20% , at 12 o'clock

FELL
TOTAL LEAKAGE DEFECTS
19

CCTV
TOTAL LEAKAGE DEFECTS
2

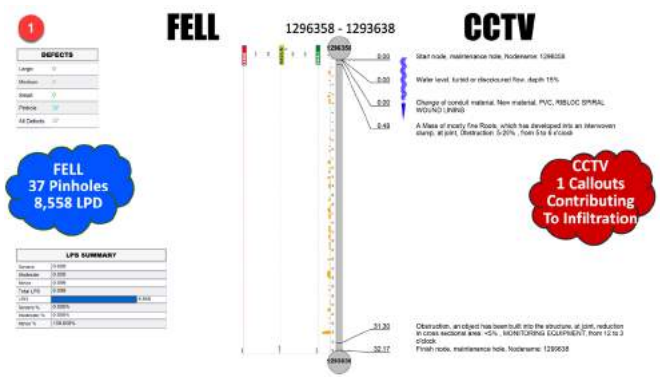
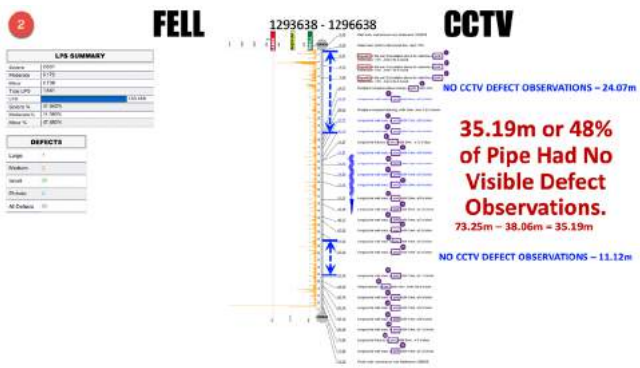
2
FELL
1293638 - 1296638
CCTV
NO CCTV DEFECT OBSERVATIONS – 24.07m
35.19m or 48% of Pipe Had No Visible Defect Observations.
73.25m – 38.06m = 35.19m
NO CCTV DEFECT OBSERVATIONS – 11.12m

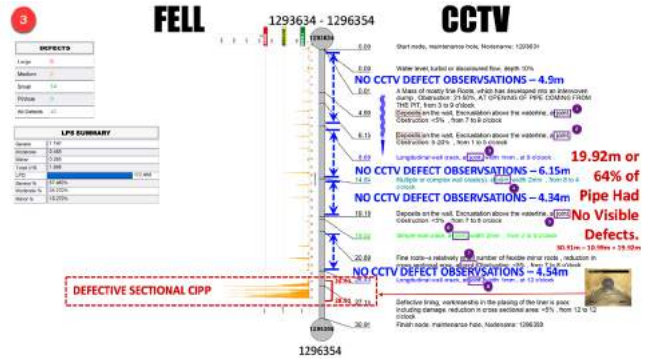
3
FELL
1293634 - 1296354
CCTV
NO CCTV DEFECT OBSERVSATIONS – 4.9m
NO CCTV DEFECT OBSERVSATIONS – 6.15m
NO CCTV DEFECT OBSERVSATIONS – 4.34m
NO CCTV DEFECT OBSERVSATIONS – 4.54m
19.92m or 64% of Pipe Had No Visible Defects.
DEFECTIVE SECTIONAL CIPP
1296354

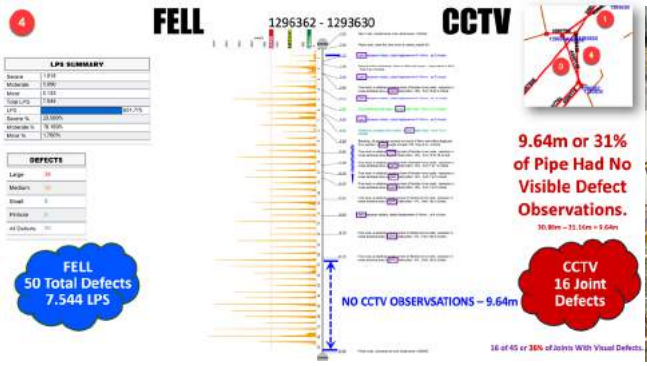
4
FELL
1296362 - 1293630
CCTV
9.64m or 31% of Pipe Had No Visible Defect Observations.
FELL
50 Total Defects
7.544 LPS
CCTV
16 Joint Defects
NO CCTV OBSERVSATIONS – 9.64m
16 of 45 or 36% of Joints With Visual Defects

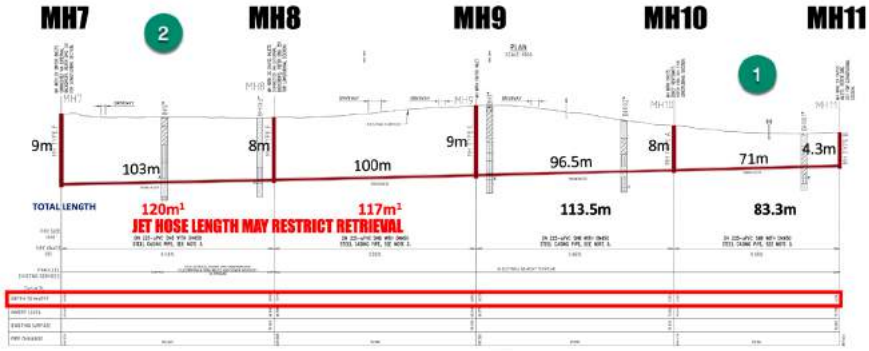
Corkscrew device to retrieve jet hose without person entry.
