# **Field Demonstration of Condition Assessment Technologies for Wastewater Collection Systems**

**Kathy Martel, P.E.  
The Cadmus Group, Inc.**

**Contract No. EP-C-05-058  
Task Order No. 59**

**National Risk Management Research Laboratory  
Office of Research and Development  
U.S. Environmental Protection Agency  
Cincinnati, Ohio 45268**

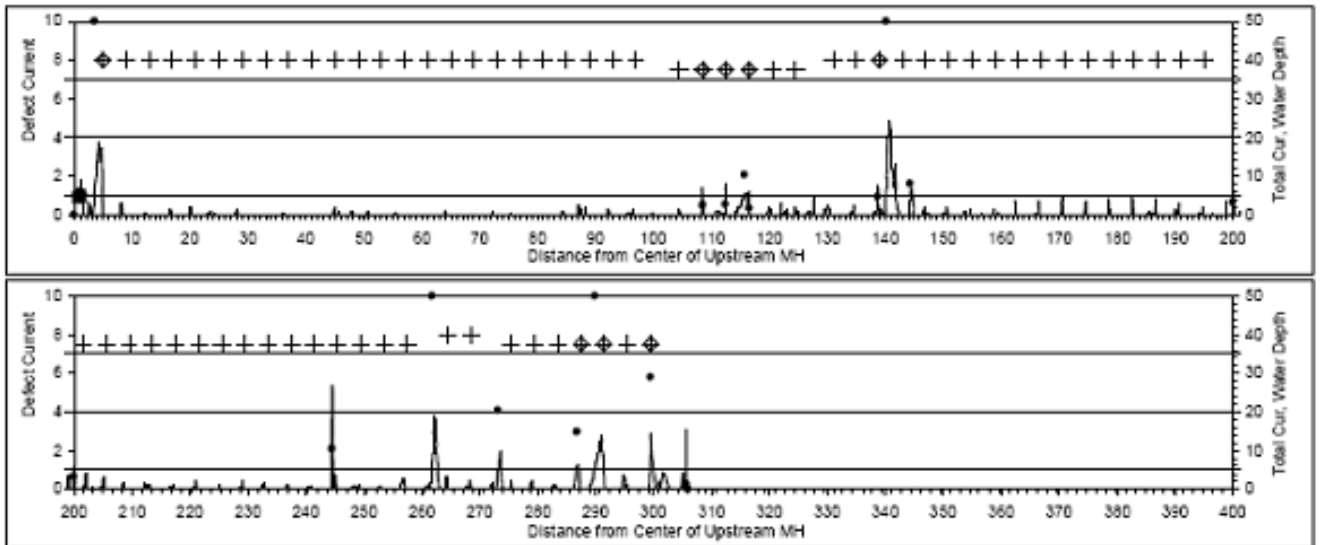
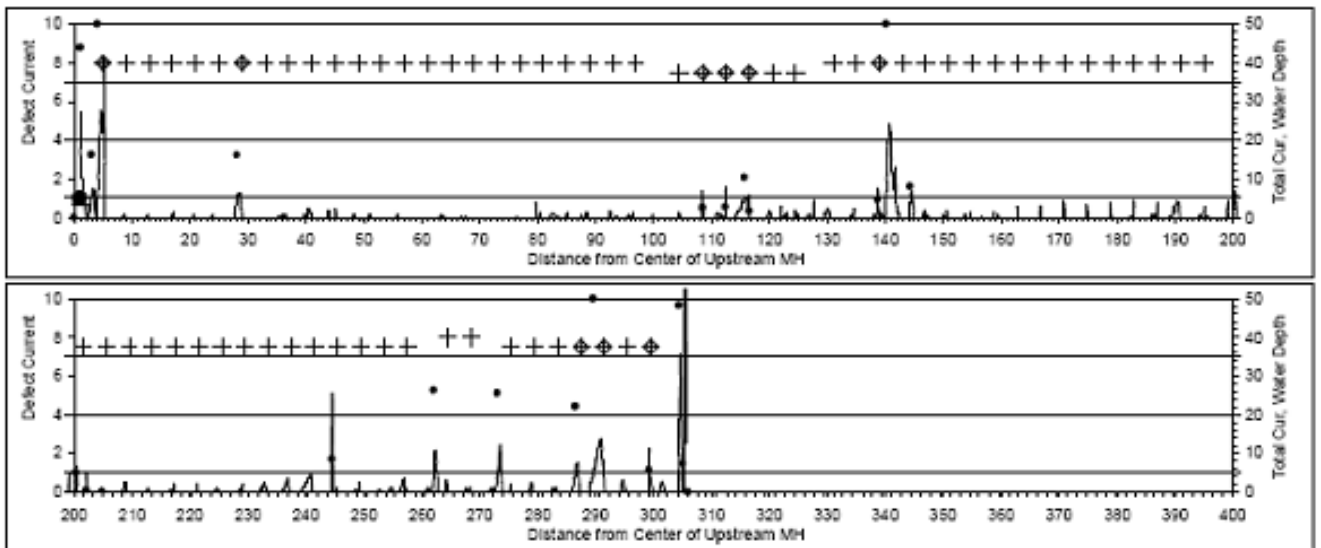
**Figure 5-7. Duplicate Electro-Scans for Pipe Segment 101 to 100.**

The precision of the electro-scanning results was evaluated by duplicate inspections of the pipe segment from SMH 101 to SMH 100 which was 306-ft long (See comparisons in Table 5-14 and Figure 5-7). The two scans were very similar; scan B revealed only three more defects than scan A. The two scans had several differences including a small defect at 29-ft, which is only seen in the second scan, and a defect at 6-ft, which had a higher electrode current in the second scan (i.e., a higher severity). The observed differences in results may be attributed to changes in the sonde's travel rate which occurred at the start and end of the scan. The high current at the end of the second scan may have been caused by a steel pole used to move the probe into the middle of the downstream manhole. Although the ground stake placement varied between the two scans, it was not expected to affect the results.

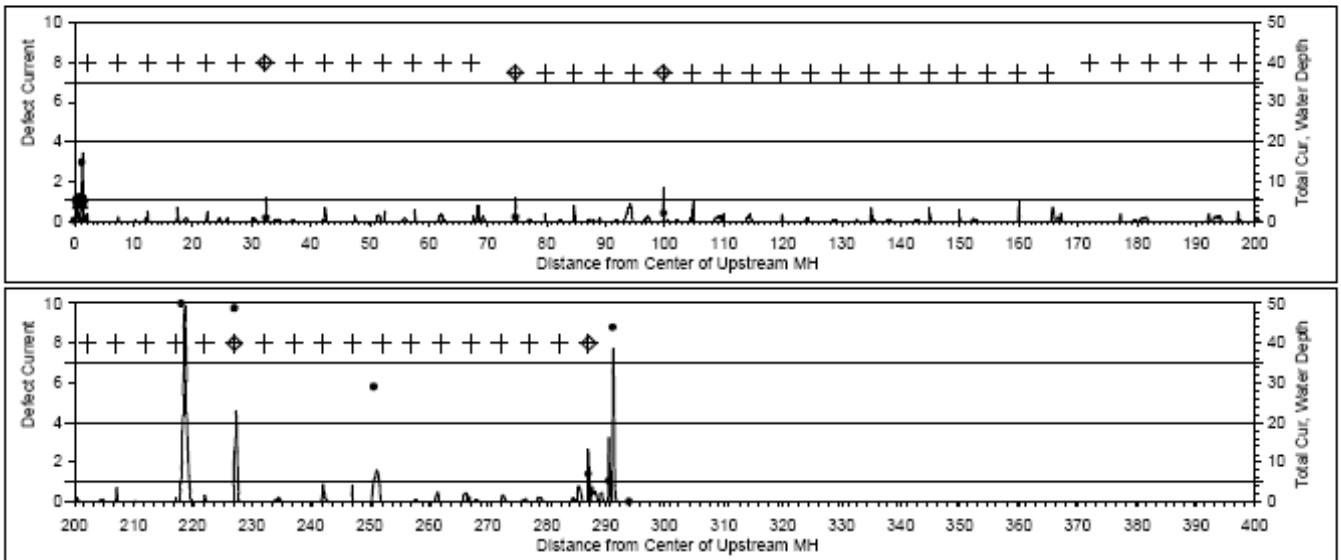
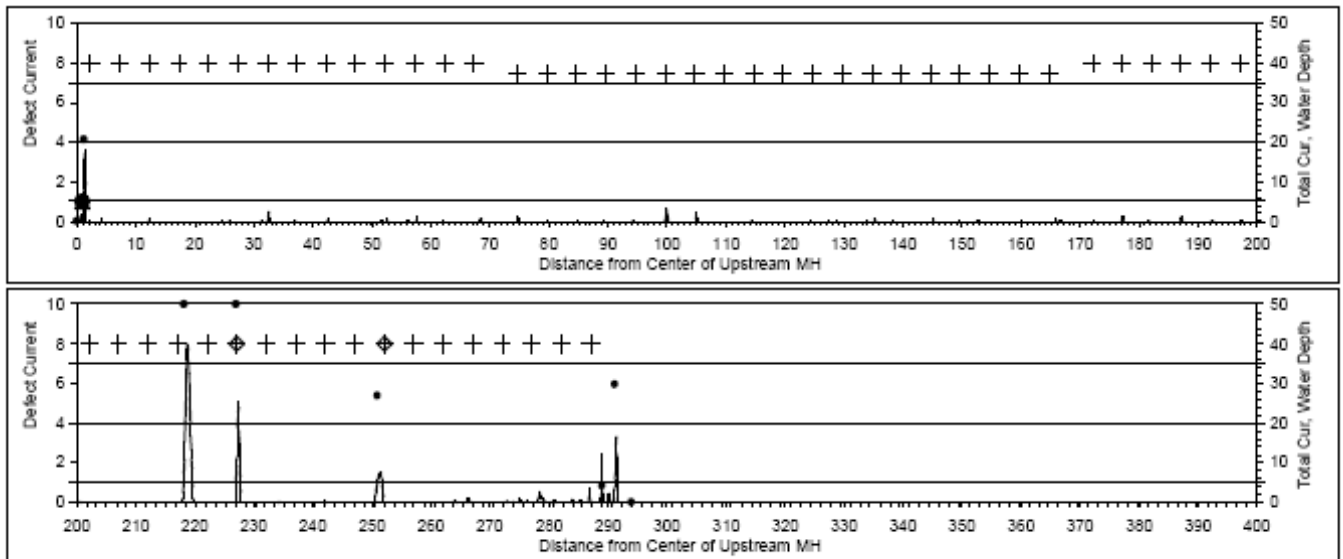
**Figure 5-8. Comparison of FELL-41 (upper) and MSI-1620 (lower) for Pipe Segment 102-101.**

Comparison of results for the FELL-41 and MSI-1620 electro-scanning systems obtained for three pipe segments (SMH 102 to SMH 101; SMH 127 to SMH 125; and SMH 174 to SMH 173) shows that the FELL-41 generally registered more increases in electrode current than the MSI-1620 (Tables 5-15, 5-16, and 5-17; Figures 5-8, 5-9 and 5-10). Figures 5-8, 5-9, and 5-10 show more small current spikes, some of which exceeded the threshold and are listed as small defects. Anomalies that are seen on the traces for both instruments tend to be greater on the FELL-41 results. For example, in pipe segment 102-101, small joint defects at 74-ft, 100-ft, and 287-ft detected by the FELL-41 system were not detected above the threshold by the MSI-1620. However, current spikes at the pipe entry for SMH 101 were significantly greater for the FELL-41. For the segment from SMH 127 to SMH 125, FELL-41 detected small joint defects at 6-ft, 175-ft, and 185-ft. These were not detected above the threshold by the MSI-1620. These results suggest that the FELL-41 unit may be more sensitive than the MSI-1620.

Scan	Anomaly Summary (Number of Defects)						Anomaly Length of Pipe Length Tested (%)						Joints (Number)	
	Large	Med.	Small	Joint	Other	Total	Large	Med.	Small	Joint	Other	Total	Total	Defects
FELL	0	4	14	8	10	<b>18</b>	0	0.9	3.3	1.8	2.4	<b>4.2</b>	<b>52</b>	8
MSI	1	2	13	6	10	<b>16</b>	0.9	0.5	2.0	2.0	1.4	<b>3.4</b>	<b>52</b>	6

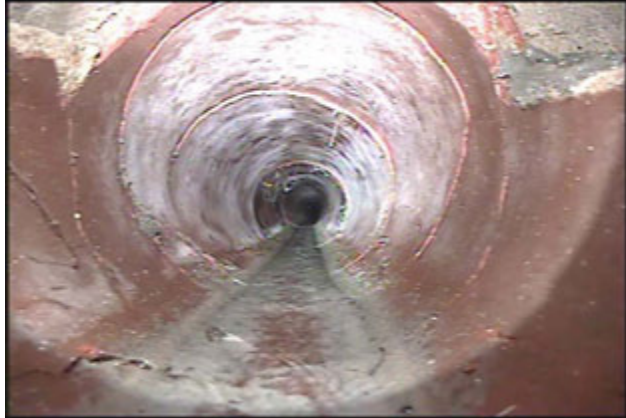
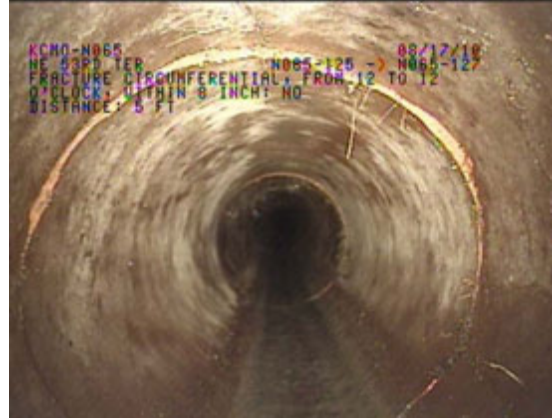
In pipe segment 125-127, nine defects were identified by CCTV and five were identified by zoom camera including three from MH 125 and two from MH 127 (Table 6-3). The Grade 2 circumferential fracture identified by the zoom camera inspection from manhole 125 (located at 2 ft from manhole 125) appeared to be the same defect as the one identified by CCTV (Figure 6-1); although the defect location appeared to be offset by 3-ft between zoom camera and CCTV, it is noted that distance was difficult to estimate with zoom camera and was often provided as a range. The four other defects identified by zoom camera (at 55, 117 and 219 ft from manhole 125) appeared to be different defects than those identified by CCTV.

**Figure 6-1. Comparison of Zoom Camera and CCTV Images of Grade 2 Circumferential Fracture in Gracemor Pipe Segment 125-127.**

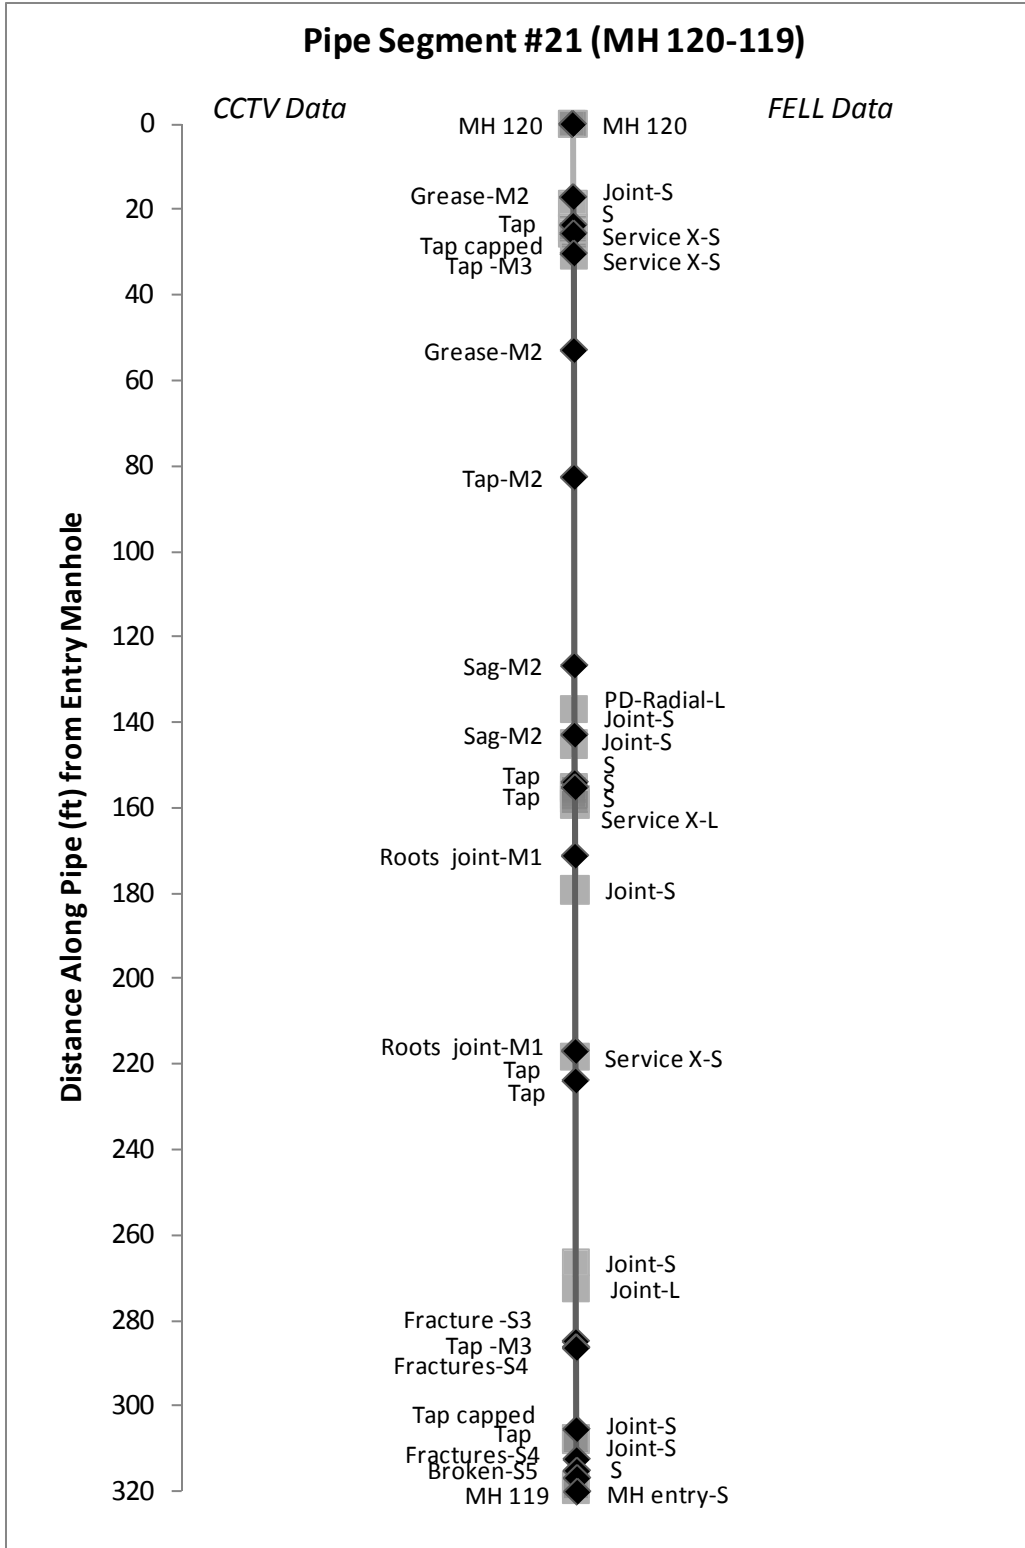
**Figure 6-3. Comparison of Electro-scanning and CCTV for Pipe Segment 120-119.**

A visual review of Figures 6-3 through 6-8 shows that pipe segments with a larger number of CCTV defects, especially defects associated with leakage (e.g., cracks, fractures, defective joints, faulty taps and root intrusion), generally have a larger number of electro-scanning anomalies (e.g., pipe segment #21 in Figure 6-3). Clusters of CCTV defects also often coincide with clusters of electro-scanning anomalies.

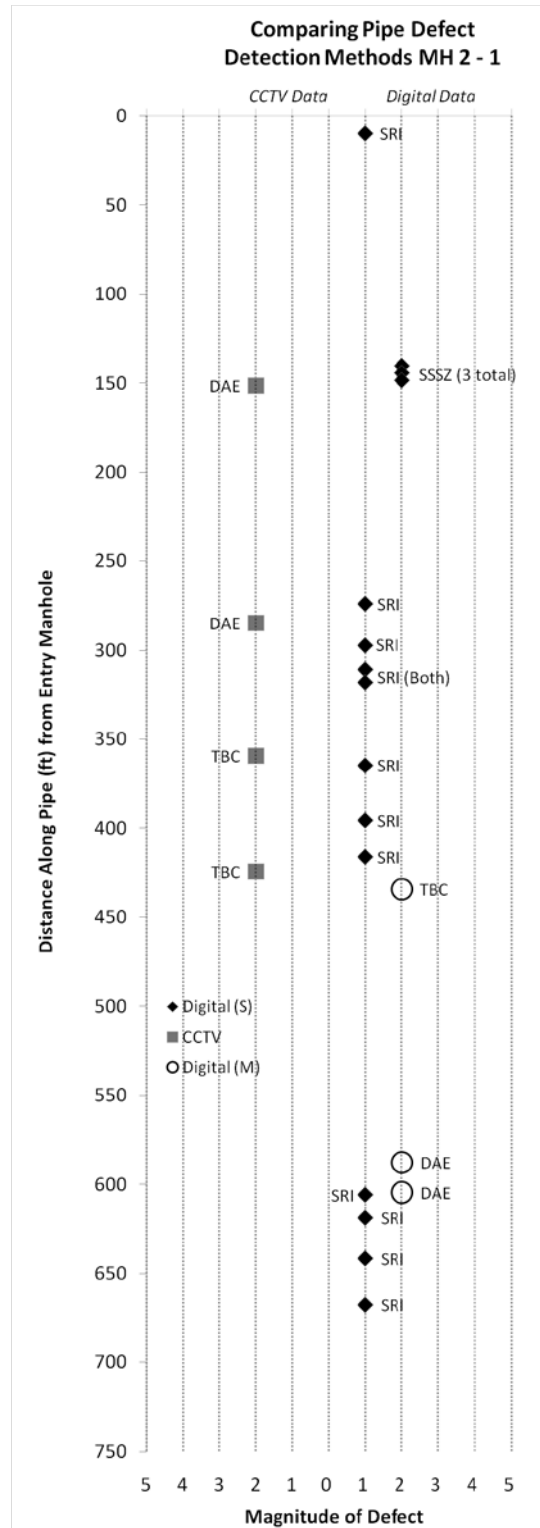
**Figure 6-9. Comparison of Digital and CCTV Defect Observations for Pipe Segment MH 2-1.**

The grading of defects identified by the digital scan was compared to CCTV. As shown in Figure 6-9 between SMH 2 and SMH 1, the results of the CCTV inspection appeared to differ from the digital scan. In this pipe segment, both the CCTV and digital scan data indicated a similar number of encrustation deposits (coded as DAE) of the same rating at “2”. However, the two deposits noted in the CCTV inspection were located in the first 300-ft of sewer, while the three deposits noted in the digital scan were located in the last portion of the pipe between 450-ft and 600-ft.

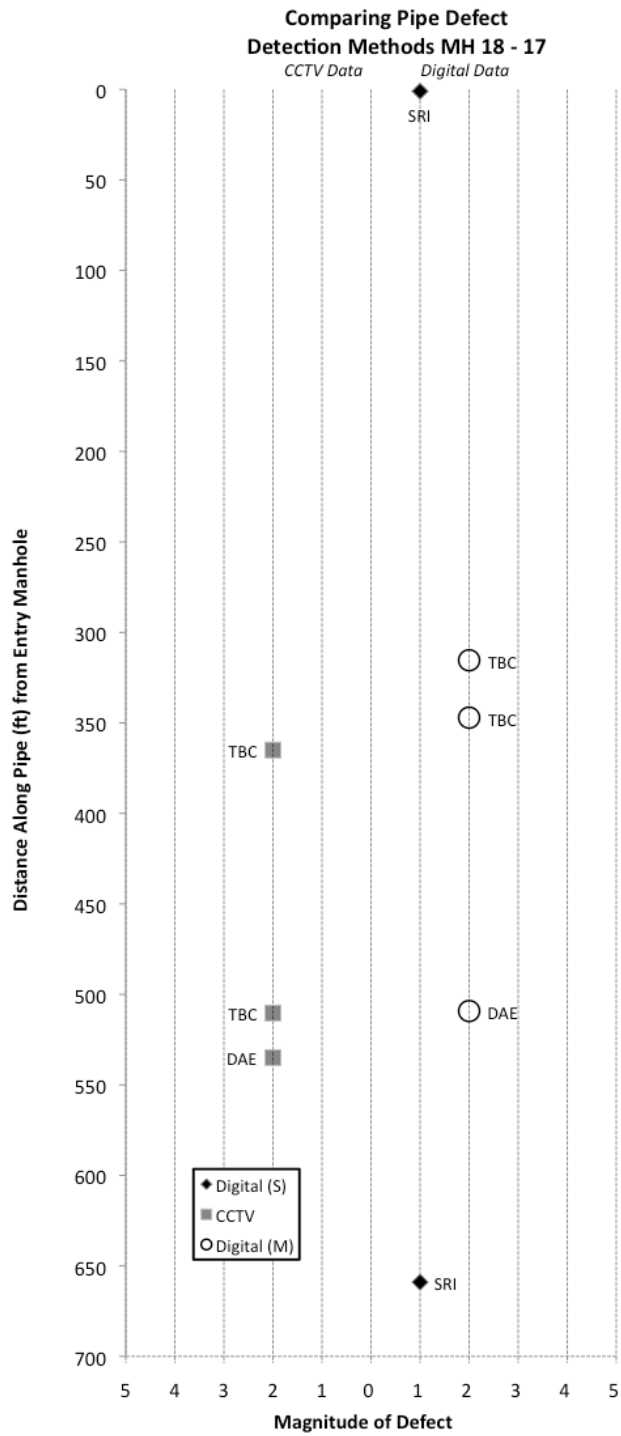
**Figure 6-10. Comparison of Digital and CCTV Defect Observations for Pipe Segment SMH 18-17.**

In contrast, as shown in Figure 6-10 for the sewer between MH 18 and 17, the encrustation deposits (coded as DAE) and the capped sewer connection defects (coded as TBC) of the same grade were located in similar locations. For example, a single encrustation deposit was noted in the CCTV data at 535-ft and the deposit noted in the digital scan was located at 509-ft. In addition, a capped sewer connection defect was identified by the CCTV at 365 ft while the digital scan noted capped sewer connection defects at 315-ft and 347-ft.

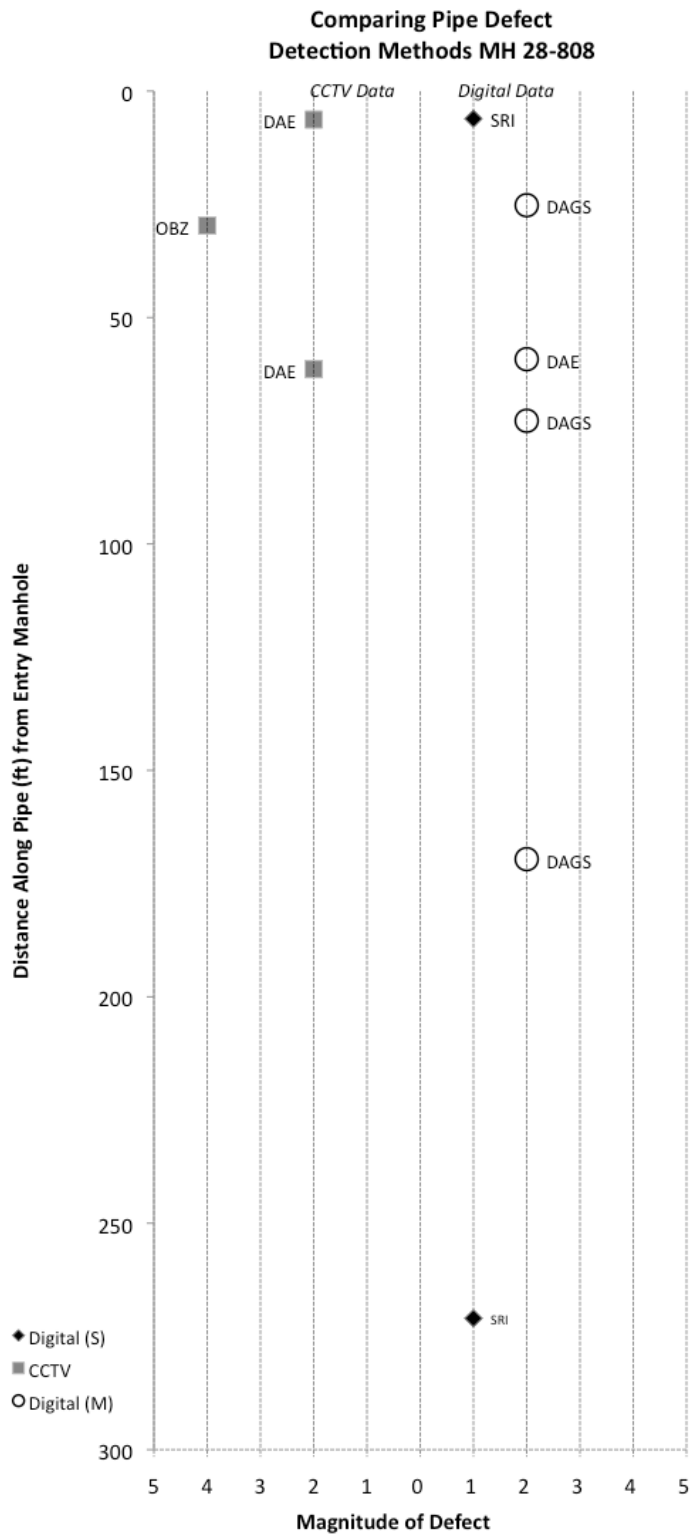
**Figure 6-11. Comparison of Digital and CCTV Defect Observations for Pipe Segment SMH 28-808.**

As shown in Figure 6-11, the operational defects identified by CCTV and the digital scan were similar in location and grade in the first 100-ft of the sewer between MH 28 and 808. For example, the location of the obstacle identified in the CCTV inspection, coded as OBZ, appeared to coincide with the grease deposit, coded as DAGS, noted in the digital scan. Similarly, the encrustation deposit, coded as DAE, noted during the CCTV inspection at 61-ft appeared to coincide with the encrustation deposit, coded as DAE, identified by the digital scan at 59-ft. However, deposits were identified in the CCTV inspection that were not noted in the digital scan (e.g., DAE at 5-ft) and deposits noted in the digital scan that were not identified in the CCTV inspection (e.g., DAGS at 75-ft and at 175-ft).

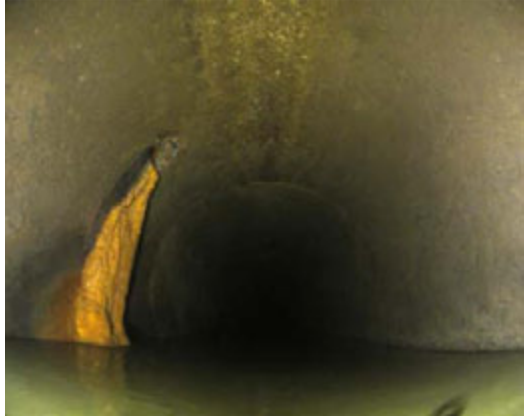
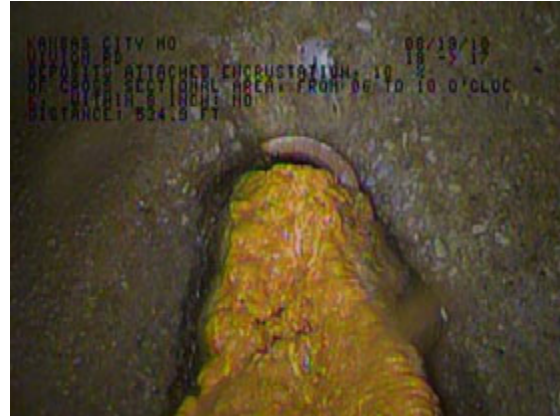
**Figure 6-12. Encrustation Deposit Between SMH 18 and 17  
Digital Scan (Multi-sensor) (left), CCTV(right).**

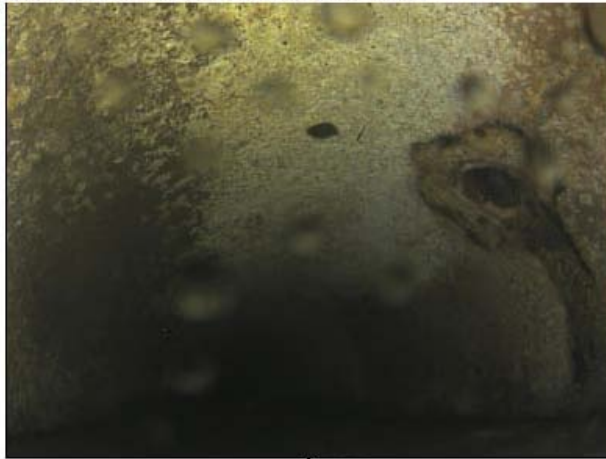
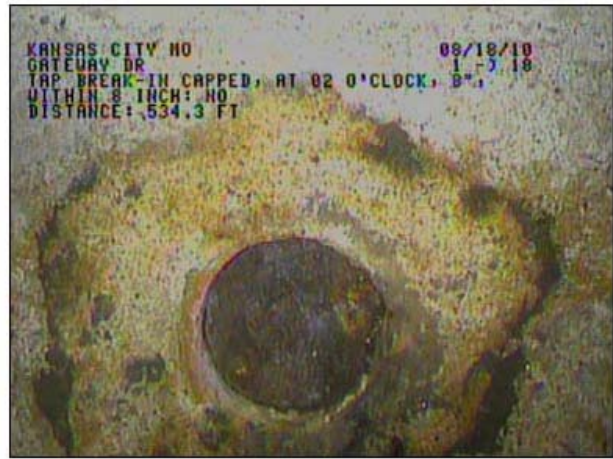
Photo: 19, Tape/Media No.: 081810DJ, 00:12:24  
534.3FT, Tap Break-In Capped, at 02 o'clock, 8", within 8 inch:  
NO

**Figure 6-13. MH 1-18, Multi-sensor Data (left) and CCTV Data (right) of Capped Lateral.**
