SEWER ELECTRO-SCAN  
CEDAR CREEK STREAM CROSSINGS  
CITY OF OLATHE  
KANSAS  
JULY 2011

CH2M HILL INC  
PO Box 241329  
Denver, CO 80224

LEAK BUSTERS, INC  
3157 Bentley Drive  
Rescue  
California, 95672  
Phone 530 558 5241

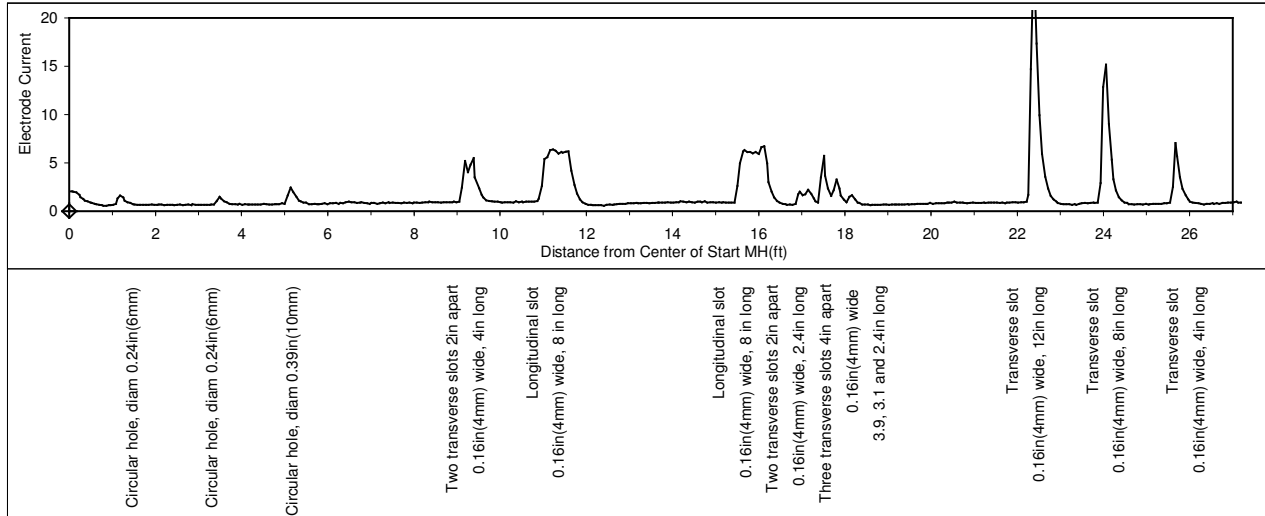
**Figure 2 Electro-scan – Pipe Material: PVC, Diameter 8 inch**

The electro-scan of a pipe that was buried after holes were cut in the pipe is shown in Figure 2.

Note that the greater the defect size the greater the s-e current. The defect size is one of the factors that will control the amount of water that will leak through the defect. Other factors that affect the leakage volume include the differential water pressure between the inside and outside of the pipe and the permeability of the soil surrounding the pipe. If these factors are the same for two pipe sections then the pipe with more or larger defects will have a higher leakage rate.
