Sewer Leak Detection – Electro-Scan Adds a New Dimension

Abstract

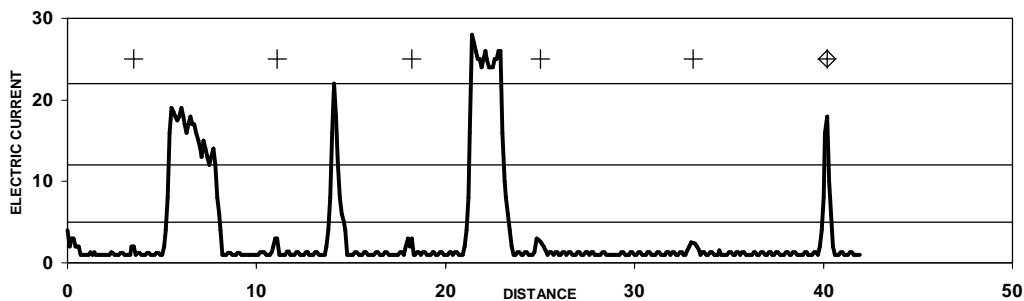
Figure 2. Electro-Scan Testing and Current Trace

As the sonde is pulled through the pipe the electric current flow and the position of the sonde in the pipe are recorded and displayed in real time as a “current trace” on a notebook computer (See Figure 2). When the middle of the sonde comes within 20 to 30

Regions on the current trace where the sonde electrode current levels are above the threshold level are called “anomalies”. The threshold level is shown as the lowest horizontal line on the current trace (See Figure 2).

Anomalies that occur at regular intervals are usually due to joint defects. To assist with the identification of these anomalies points shown as “+” on the current trace are marked at the joint interval. Anomalies that occur at these intervals are considered to be associated with a joint defect and are marked with a “◇” plotted over the “+” (See Figure 2). Other anomalies are usually due to faulty service connections and structural defects.
