## Benchmark Demonstration: Comparison of WRc-based CCTV Inspections v. Electro Scanning

Topsham, England  
8 November 2012

Presented in Cooperation with  
South West Water  
Pell Frischmann, and  
Electro Scan Inc.

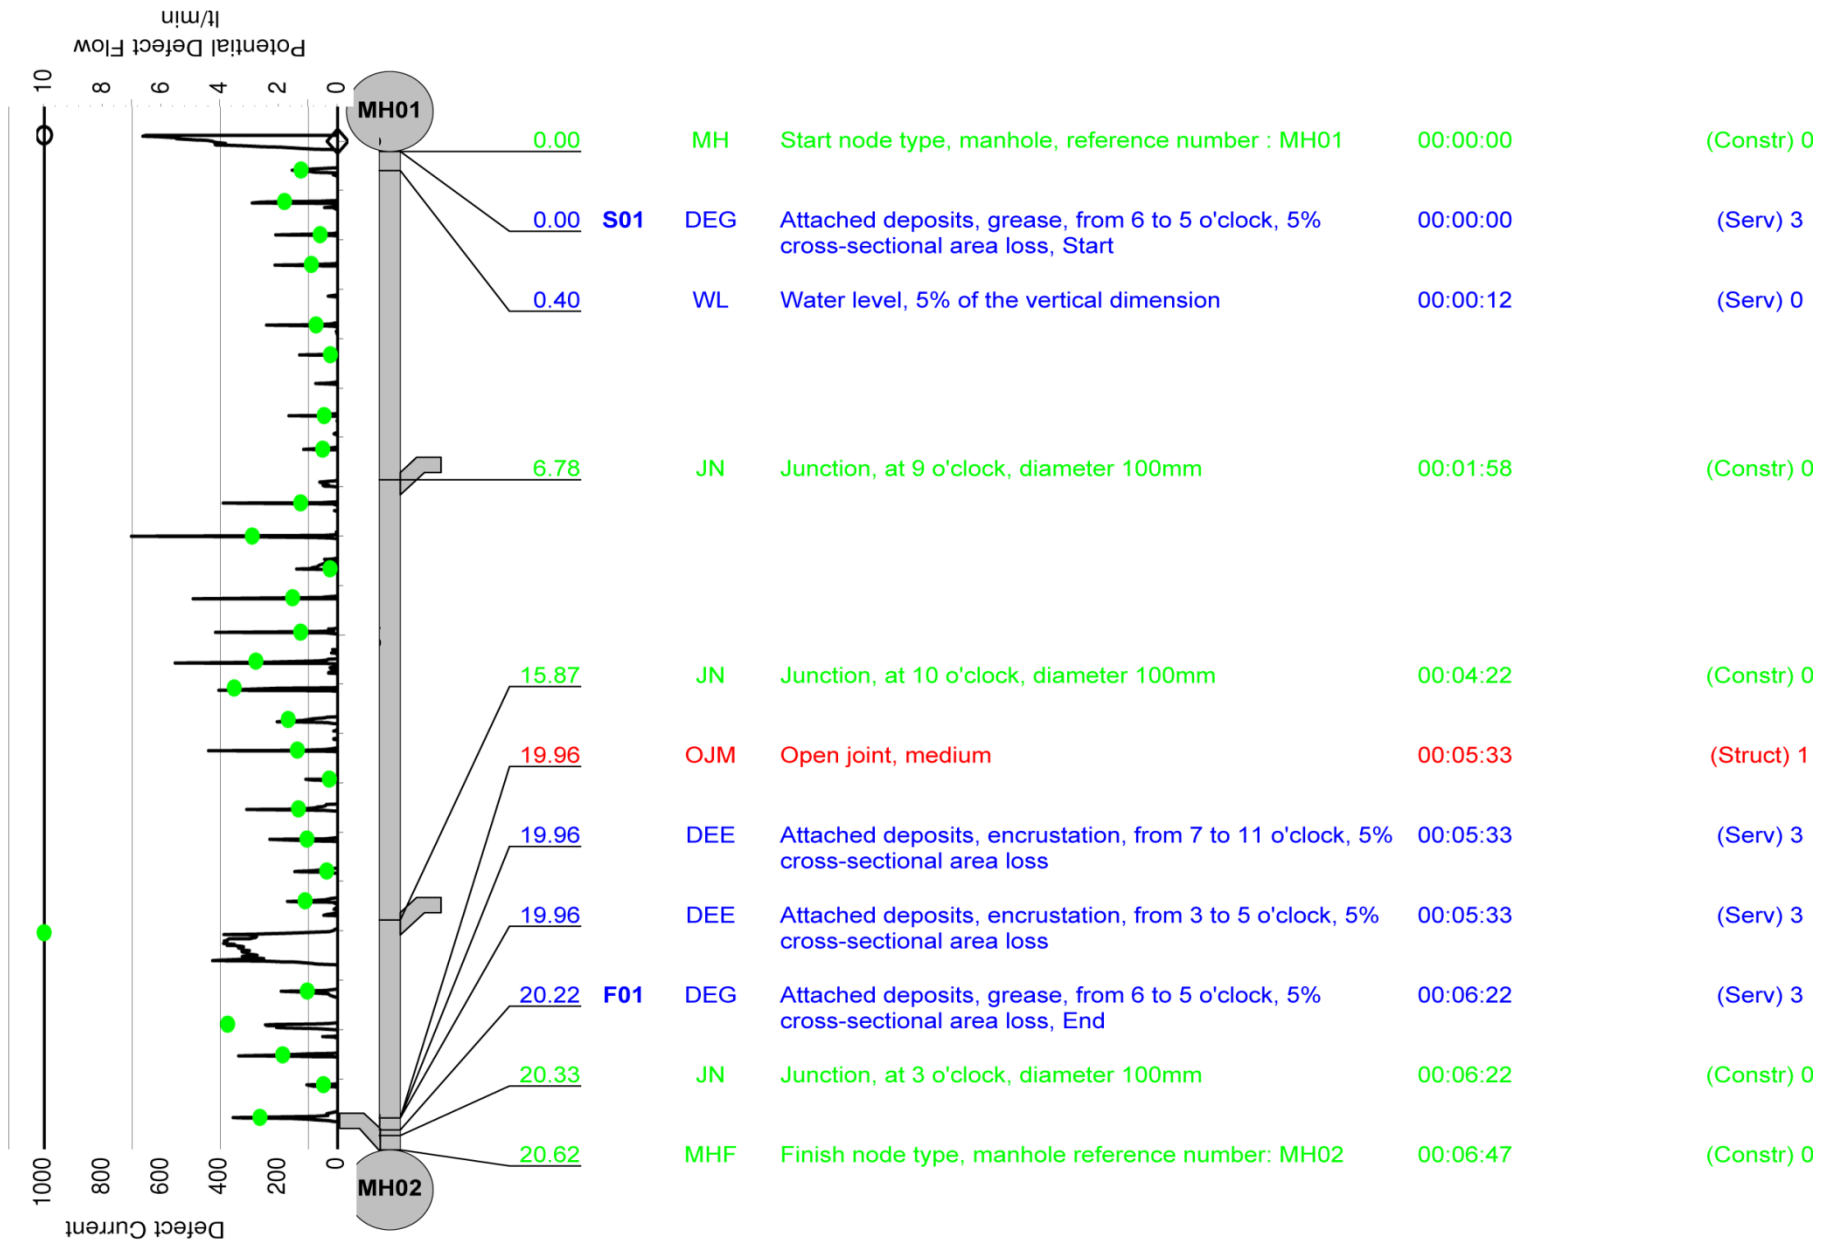
# Electro Scan and CCTV Comparison

- Defect location appears to be offset from CCTV measurements by as much as 0.13 m (towards end of pipe) due to differences in zeroing of data cable, and potential slack in CCTV data cable.
- Defects with length reading of '0' are considered radial pipe defects of < 10mm in size.
- Regular interval of defects indicated many leaking joints.

Electro Scan	
Size Grading of Defect	Number of Defects Identified
Small	24
Medium	4
Large	0
Total	28

CCTV		
Nature of Defect	Number of Defects Identified	Grade
Structural	1	1
Service	3	4
