SW 199th Terrace and SW 81st Court
Cutler Bay, FL

Thursday, February 21, 2013

Miami-Dade Water and Sewer
3071 SW 38th Avenue
Miami, Florida 33146
www.miamidade.gov/water

SW 199th Terrace Electro Scan Demo – Scan 1

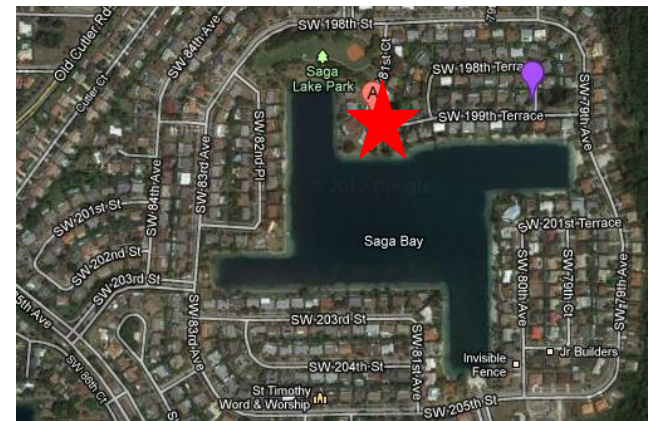
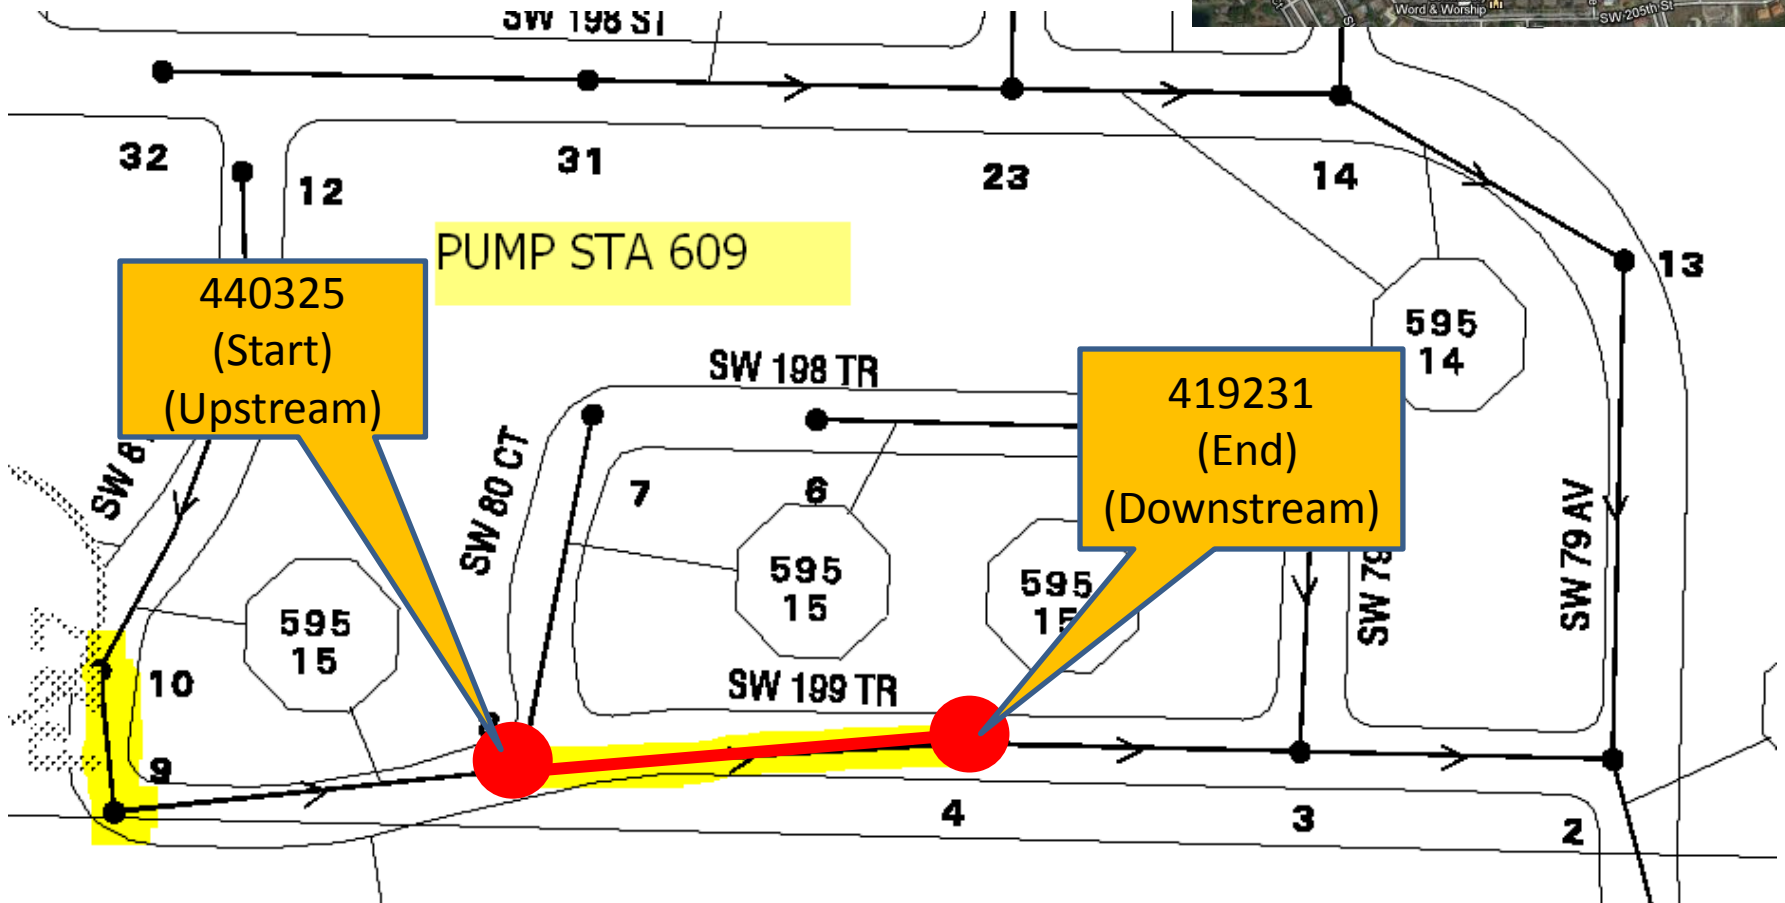
SW 199th Terrace Scan 1

Electro Scan located **3** total defects – all of them large. Based on the size and quantity of those defects, it is estimated that this pipe length could infiltrate **15.6 gallons per minute**.

The defects appear to correspond to lateral connections. In reviewing the CCTV video, no lateral or connection lining or sealing method had been used. The Electro Scan results reveal that all three service connections are faulty and are a source for infiltration into the newly lined pipe. Because of these unaddressed connections, this pipe has the possibility of infiltrating about 22,464 gallons per day.

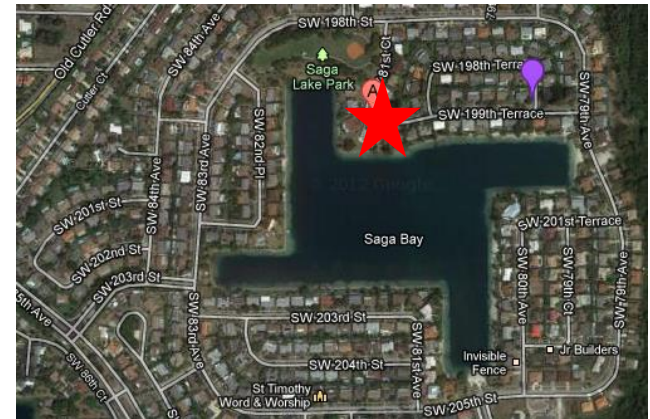
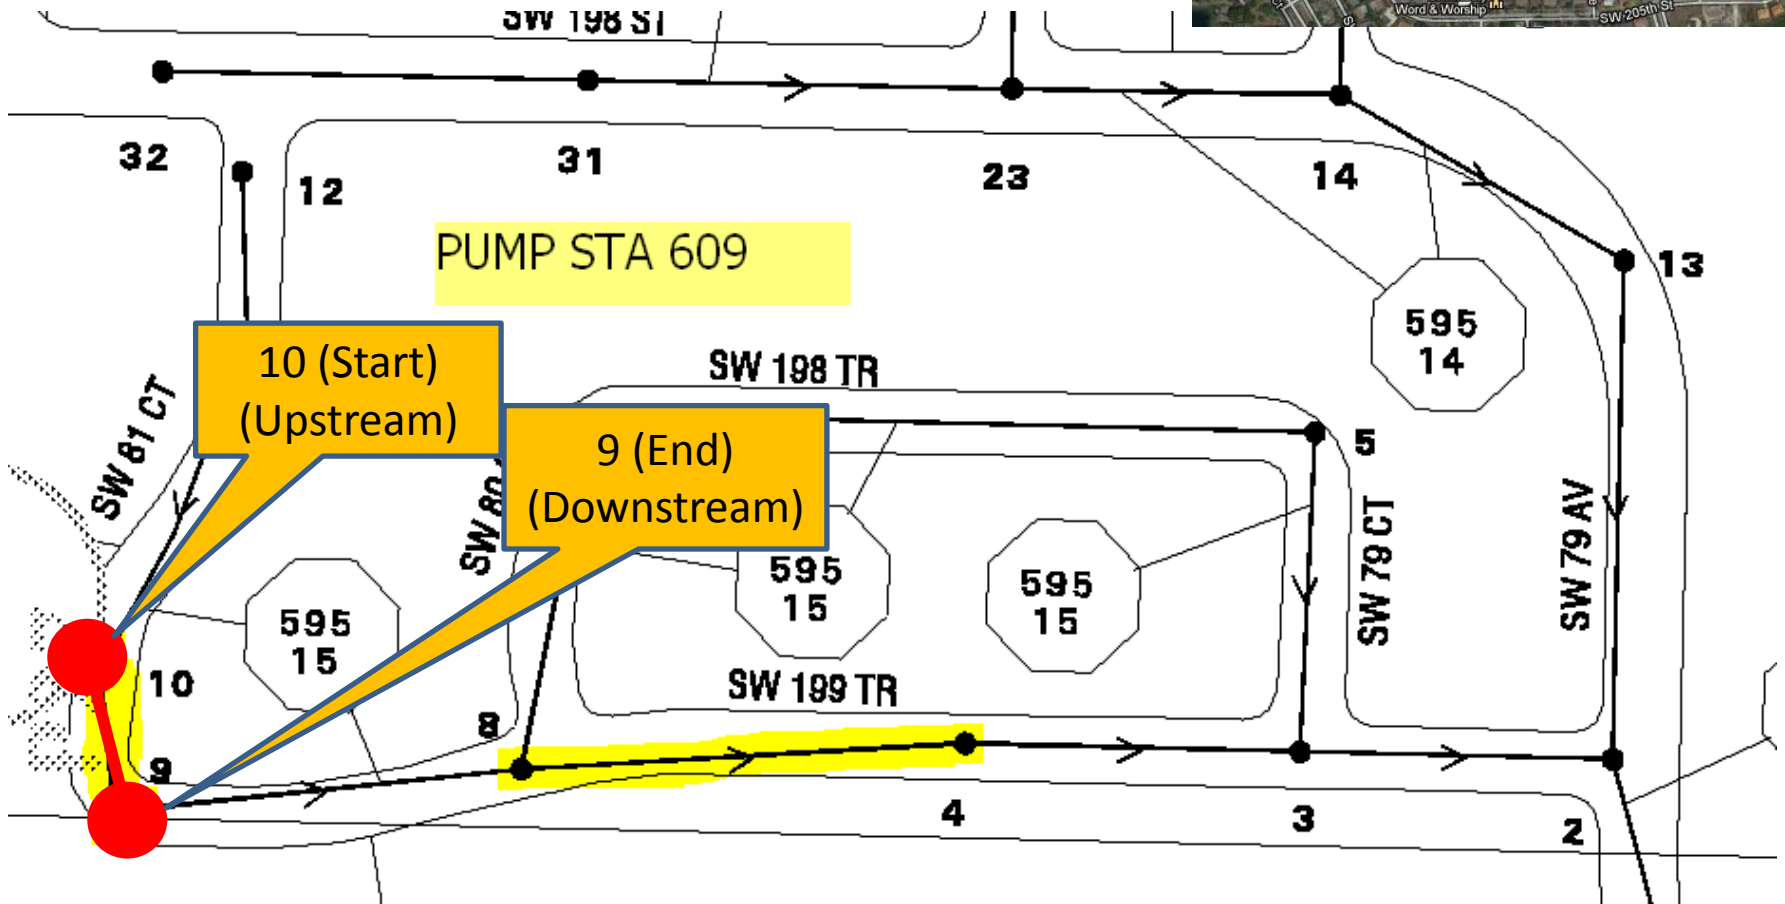
SW 81th Ct. Scan 2

Electro Scan located **6** total defects – 4 small and 2 medium. Based on the size and quantity of those defects, it is estimated that this pipe length could infiltrate **2.9 gallons per minute**.

The majority of this pipe (including most joints) are in good shape. From the graph and chart, almost all the infiltration is occurring in a 15' section between the 51 foot and 66 foot marks – where the spot repair and new lateral tie-in occurred. Correcting that area could prevent almost 4200 extra gallons per day.
