**North American Society for Trenchless Technology (NASTT)
NASTT's 2015 No-Dig Show**

MA-T1-01

**Small Agency, Big Ambition - How a Pennsylvania Township
Authority Chose New Technology to Begin Addressing Their
Infiltration Issues**

Mark Grabowski, Electro Scan, Inc., Sacramento, CA
Sharon Purnell, Hamilton Township Municipal Authority, Chambersburg, PA

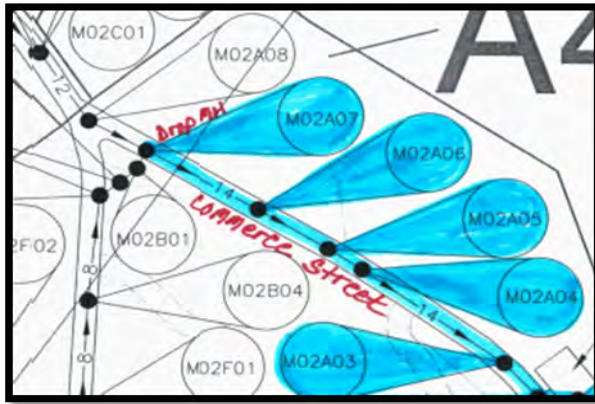
The large majority of the pipe in HTMA’s system is PVC (~70%) and Asbestos Cement (~30%), and between 30 and 40 years old. The first section of pipe that was examined as part of this mini-project was a 14” asbestos cement (AC) interceptor on Commerce Street. (Figure 1)

Figure 1. Map showing the pipe segments inspected on Commerce Street

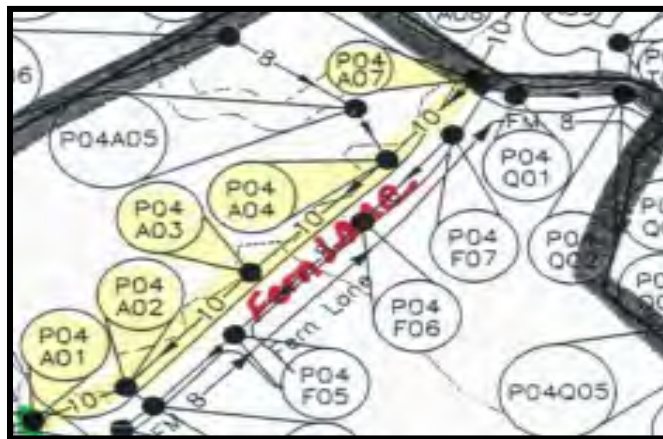
The second section of pipe that was to be examined as part of the mini-project is also an interceptor that runs to a pump station, except this line is 10" PVC. These four (4) sections of pipe run adjacent to a small creek, and are located within the flood plain of the creek. Data from the pump station and creek level observations indicate that flow rates and pump run times increase in tandem with adjacent creek levels. During extreme wet weather conditions the pump station cannot keep up with the incoming flow and is pumping more than 60,000 gallons per hour with metering data recording flows of nearly 1.1 mgd. Again, due to constant flows, the Authority has been unable to assess this section of pipe via CCTV. Historically, there have not been any repairs made to this section of pipe.

Figure 2. Map showing the pipe segments inspected on Fern Lane
