Tri-Cities North Regional Wastewater Authority

Electro Scan Field Demonstration

Friday, March 22, 2013

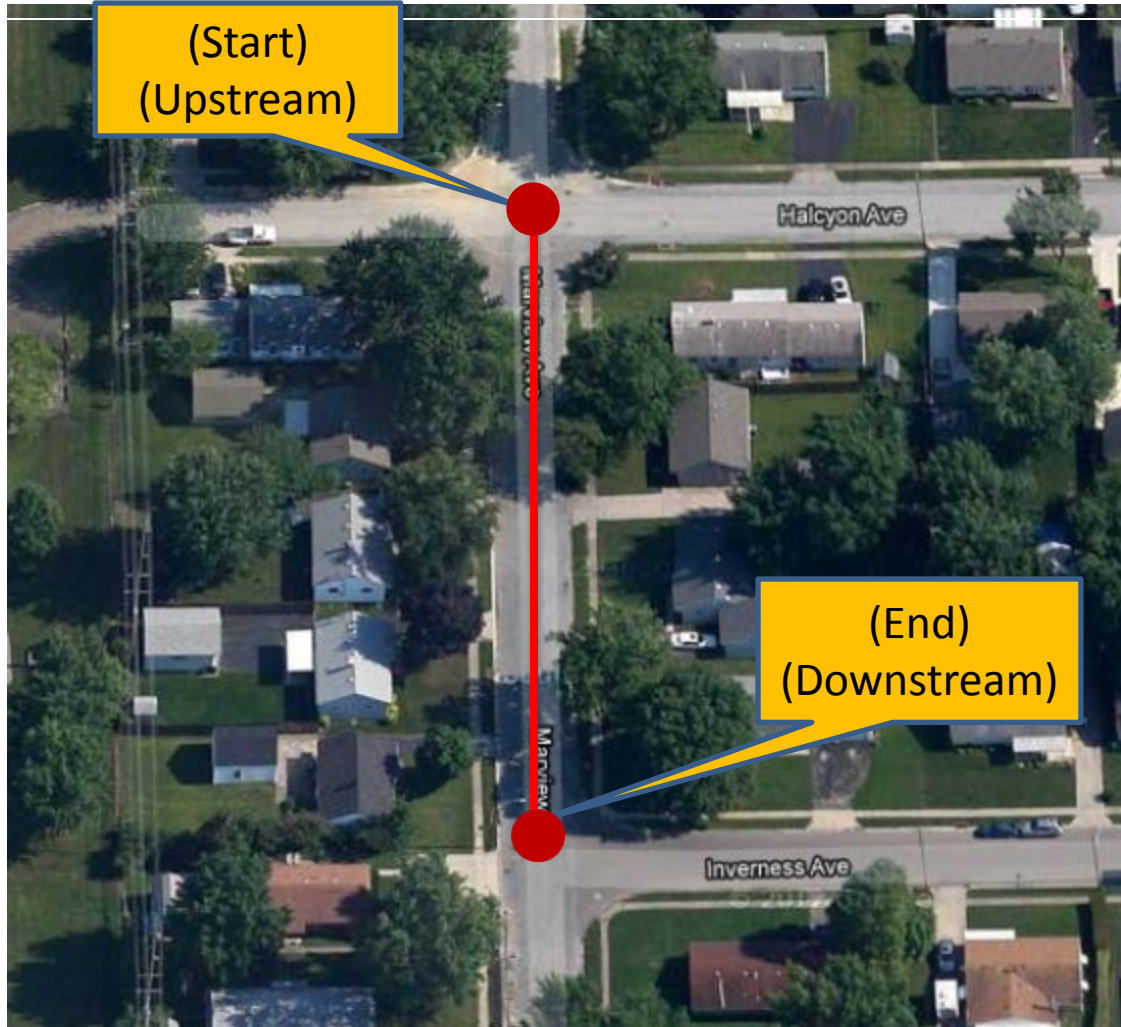
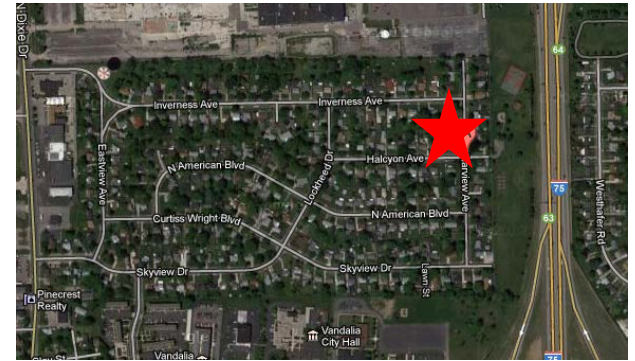
Scan #1 Marview Avenue

- 8" VCP sanitary sewer line, laid at minor grade, with a minimal flow and 8 lateral connections. Pipe segment had been lined within last few years using a CIP lining process. MH to MH distance is about 300 feet. Electro Scan was stopped short at about 295 feet
- Objective: Determine if Electro Scan can identify any defects within the lining.

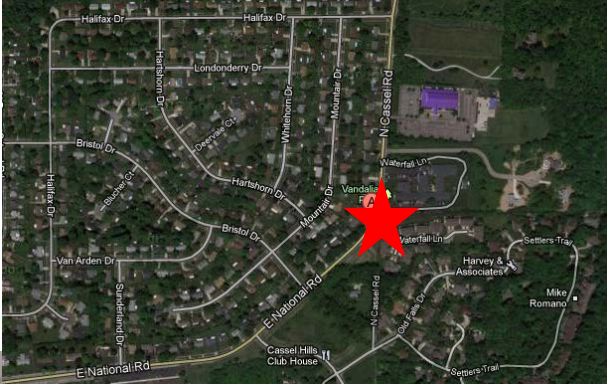
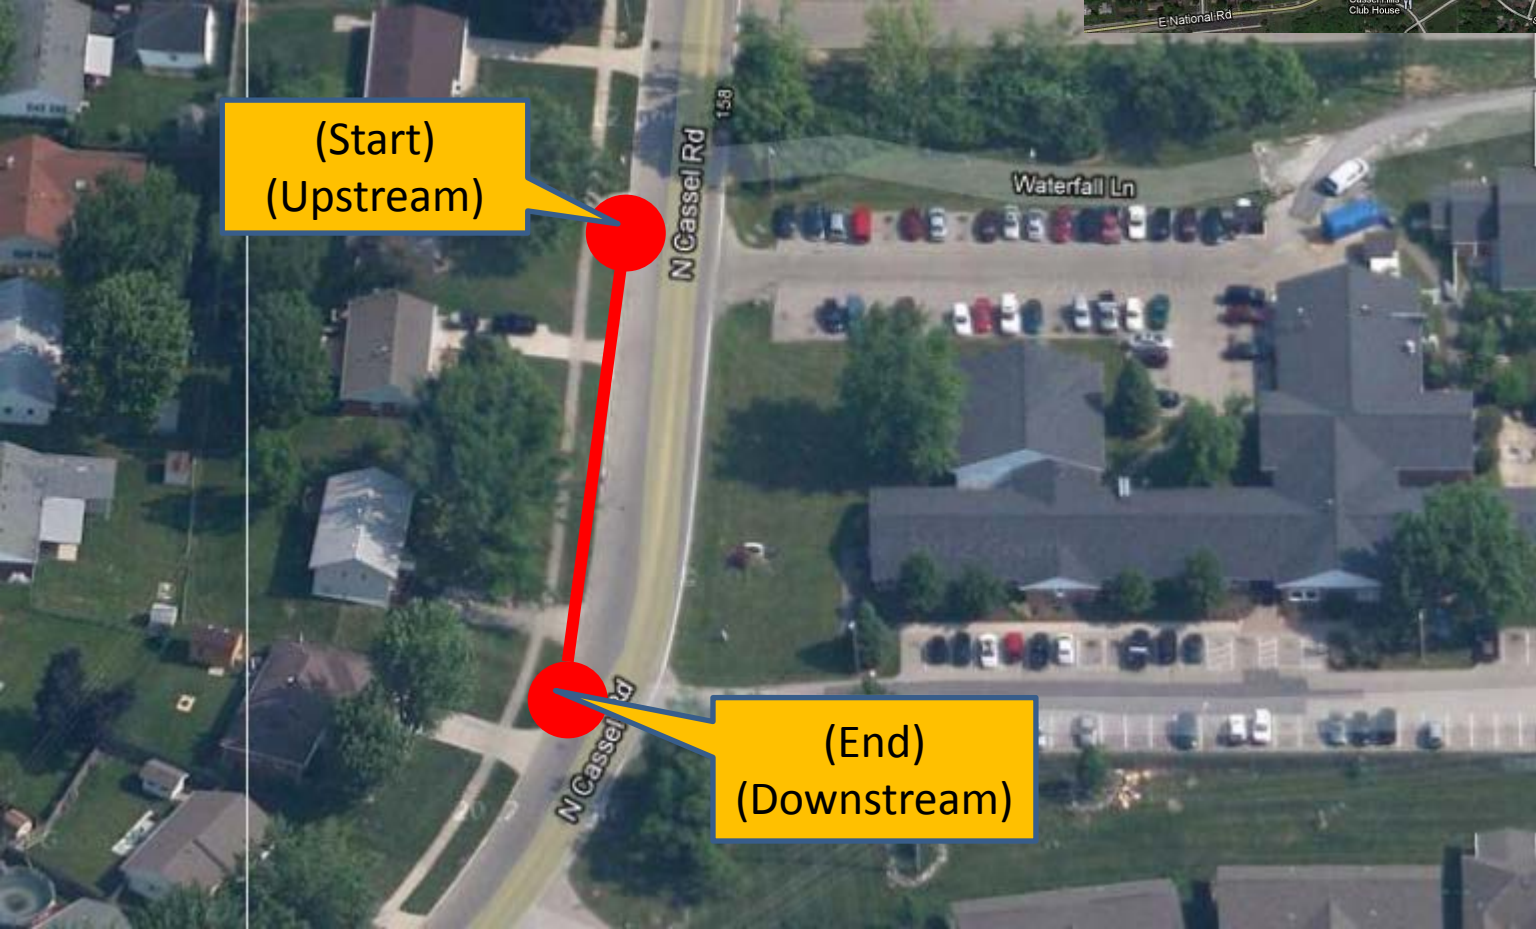
Scan #2 - Cassel Road

- 8" VCP sanitary sewer line, laid at minor grade, with medium flow with a few lateral connections. MH to MH distance is about **170** feet.
- Objective: Determine if Electro Scan can identify any defects.
