## Using Electro Scan to certify Post-CIPP Lining Projects.

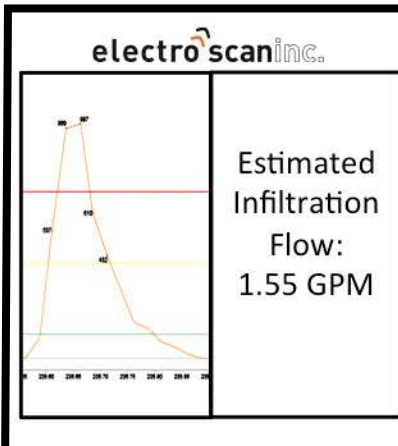
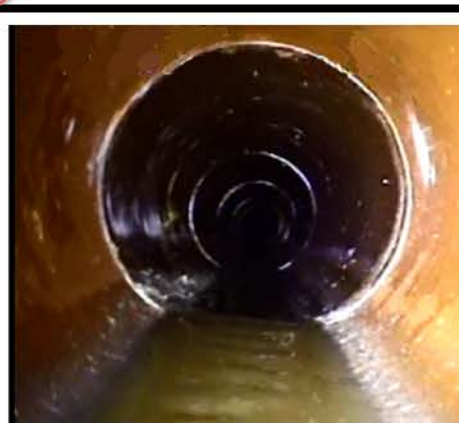
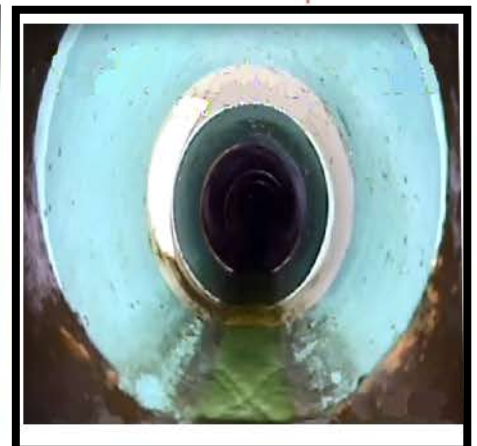
### 2 Vitrified Clay Pipe with CIPP Repair

Defect Count		Defects % of Scan Length		GPM Summary	
S	70	Small Defects	2.530%	Minor GPM Flow	29.91
M	12	Medium Defects	0.710%	Moderate GPM Flow	24.63
L	8	Large Defects	0.900%	Severe GPM Flow	9.76
		All Defects	4.140%	Total Gpm Flow	64.30
				Approx Flow All Defects Per Day	92,592
				Minor % of Total Flow	46.52%
				Moderate % of Total Flow	38.30%
				Severe % of Total Flow	15.18%

**NOTE:**  
While initial CCTV indicated only a portion of this main needed repair, which appears water tight, the remaining portion of the pipe has substantial potential for infiltration.
