Use of Low Voltage Conductivity to Conduct a 10km (30,461 LF) Inspection of Legacy Cured-In-Place Pipe (CIPP) for a Leak Assessment Project

Chuck Hansen¹

¹ Chairman, Electro Scan Inc., United States

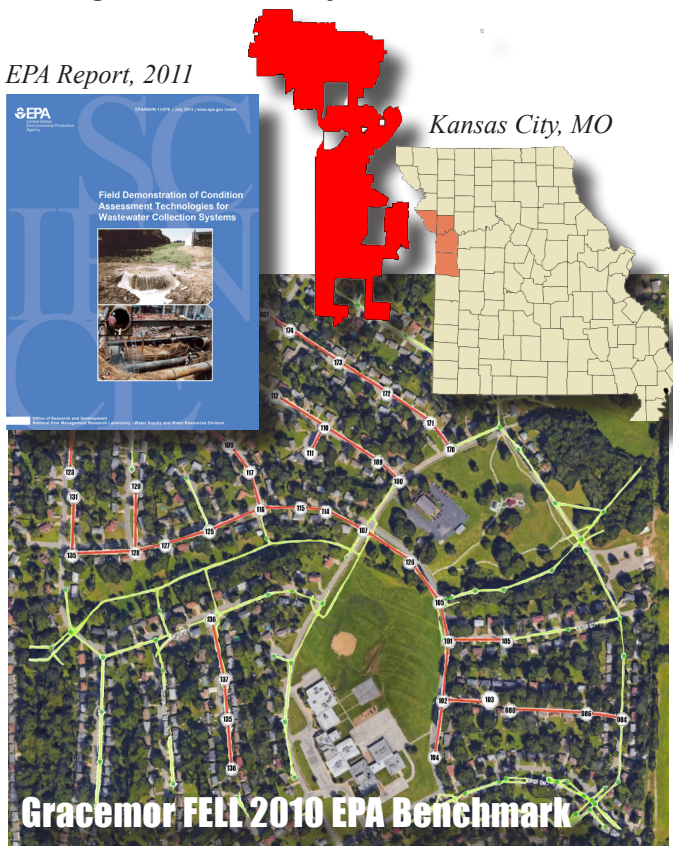
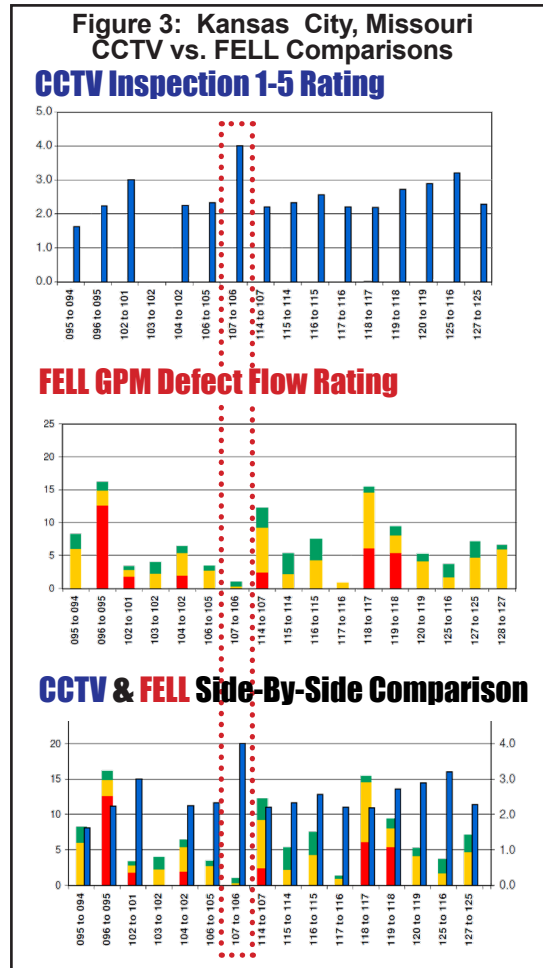
Figure 2: Kansas City EPA Benchmark Area

Field demonstrations were conducted in August 2010, hosted by the Kansas City, MO (KCMO) Water Services Department. Electro Scan was tested in Gracemor, a residential area with predominantly 8-in. vitrified clay pipe (VCP), with traditional CCTV inspection performed to compare findings, Figure 2 (Below).

1. CCTV 1-5 Ratings do not provide a reliable indication of infiltration or leakages, Figure 2.
2. The Worst CCTV Rating was due to a Maintenance related observation, not Structural Defects, which compared to one of the smallest leakages found by FELL.
3. Pipes that were cleaned prior to CCTV Inspection resulted in more missed visual defects.
4. FELL demonstrated repeatability of results and usefulness on multiple pipe materials.

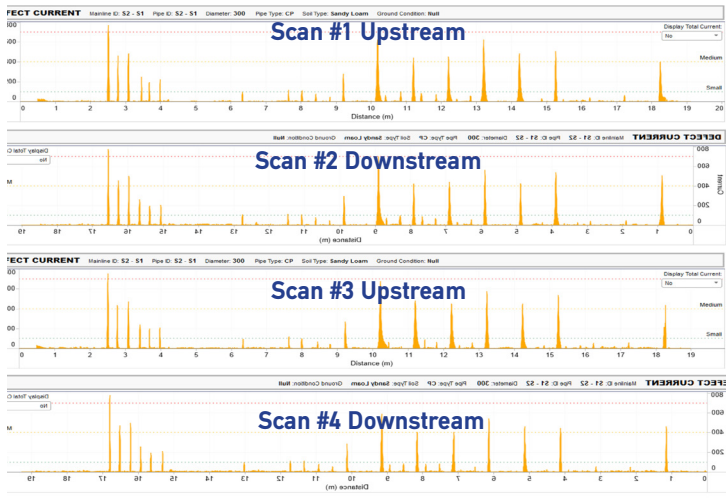
Figure 39. IKT Repeatability Testing in Germany

Published in 2018, Electro Scan Inc. and WRc under contract with IKT provided confidential survey services as part of IKT's Short-Liner CIPP research project. While detailed results by CIPP supplier remain confidential, IKT conducted rigorous evaluation of the top performing suppliers also using Electro Scan's FELL technology to test for permeability. As shown in Figure 39, repeatability tests were also conducted for each liner.
