## **The Use of New Condition Assessment Technologies for Selecting Trenchless Rehabilitation of Wastewater Networks in Ras Al Khaimah, UAE**

Abdul Qadir Malik<sup>1</sup>

<sup>1</sup> Head of Capital Projects, Ras Al Khaimah Wastewater Agency, UAE

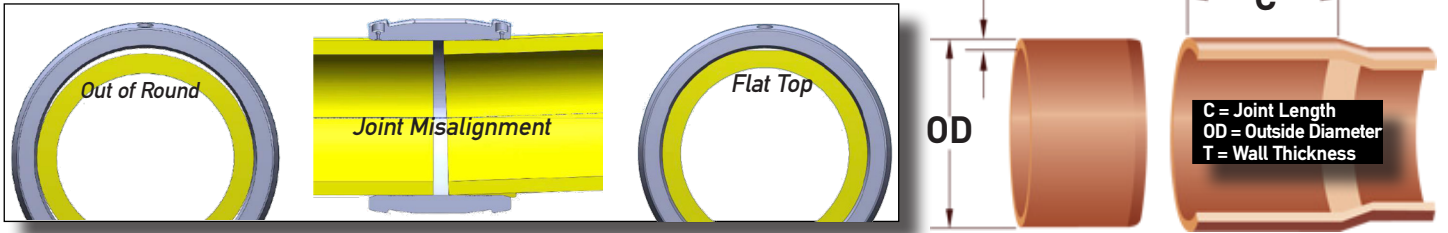
**Figure 7. Examples of Easy to Detect and Catalog Pipe Defects**

**Easy to Detect 'Visual' Problems.** A detailed review of Post-Installation / Pre-Commission of PVC sewer pipes can show obvious problems that should not be identified months or years after installation. Improperly sealed joints, poorly placed gaskets, and collapsed pipes should never be accepted if properly evaluated prior to acceptance, as shown in Figure 7 (Below).
