The Need to Quantify Pre- and Post-Rehabilitation Effectiveness

By Chuck Hansen¹

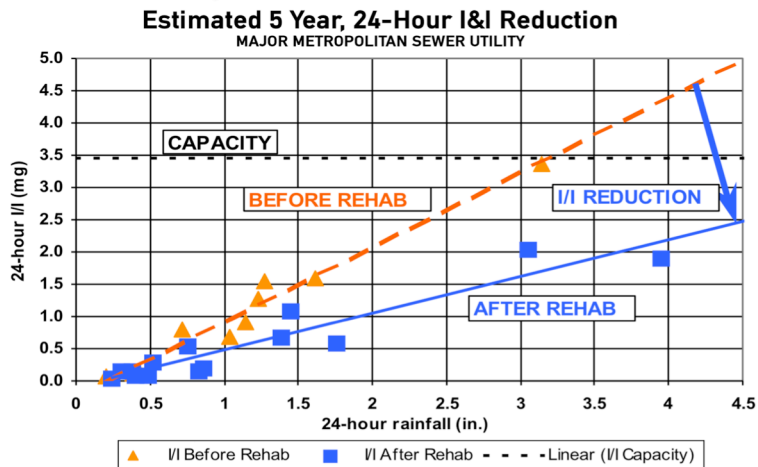
Figure 1. Sample analysis from a large metropolitan sewer utility on expectations in I/I reductions from rehabilitation.

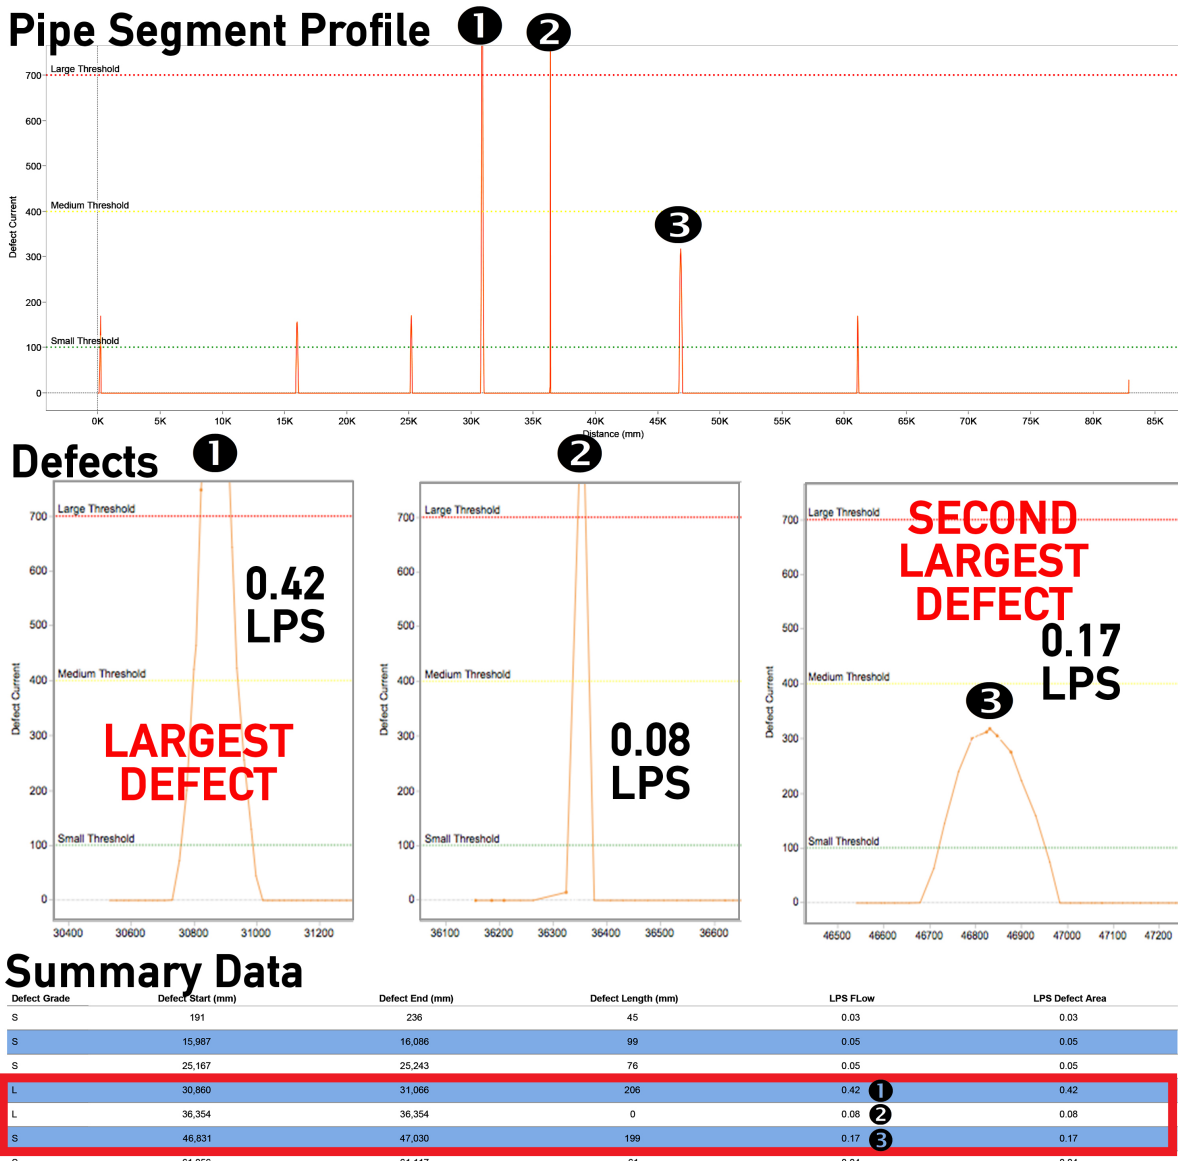
Figure 4. Individual scanned pipes, ranked sixth (6th) out of a total of 49 pipe segments. Total pipe segment defect flow of 19,066 GPD, .084 LPS, or 72,190 LPD), including two (2) Large Defects and five (5) Small Defects. 00000180_apr012014_145714PM

A selected analysis of one (1) of the forty-nine (49) post-CIPP sewer mains electro scanned, showed several defects, as shown in Figure 4, representing a combined estimated defect flow of 19,066 GPD (0.84 LPS). As Electro Scan measures the area of each defect (i.e. height and width or start & end), it should be noted that while the highest *defect currents* are noted in Defect ① and ②, Defect ③ actually contributes the second highest defect flow rate as shown by its larger calculated area.

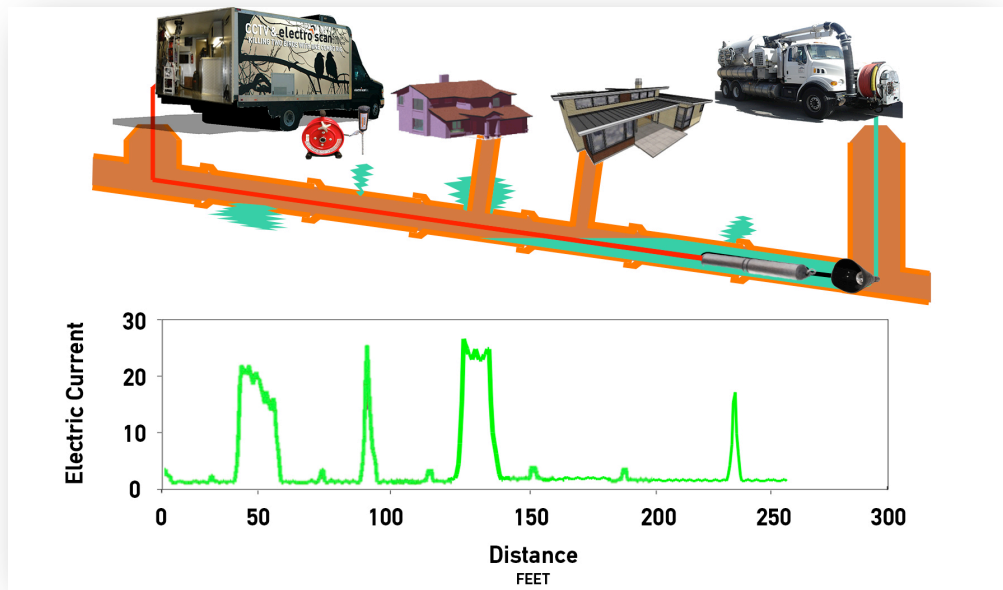
Figure 14. Example electric current traces, by defect.

As shown in Figure 14, regions on the current trace (i.e. where the current levels are above a threshold level), show specific defect areas in the wall of the pipe, with Electro Scan's patent-pending technology able to measure the amount of current flow through the defect, including its start and end position, to determine the total size of the defect.

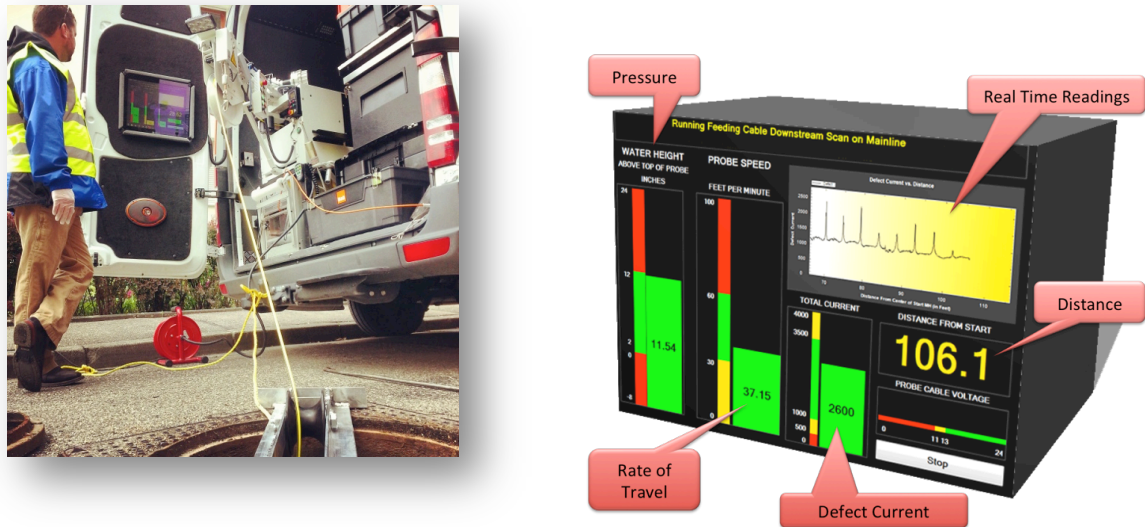
Figure 16. Data automatically displayed on Operator's Real Time Console, requiring no data entry or interpretation during scanning process.

Without reliance on subjective or qualitative identification of defect locations or sizes, operators manage the rate of speed and ensure that defect current levels perform within manufacturer's parameters, as shown in Figure 16.

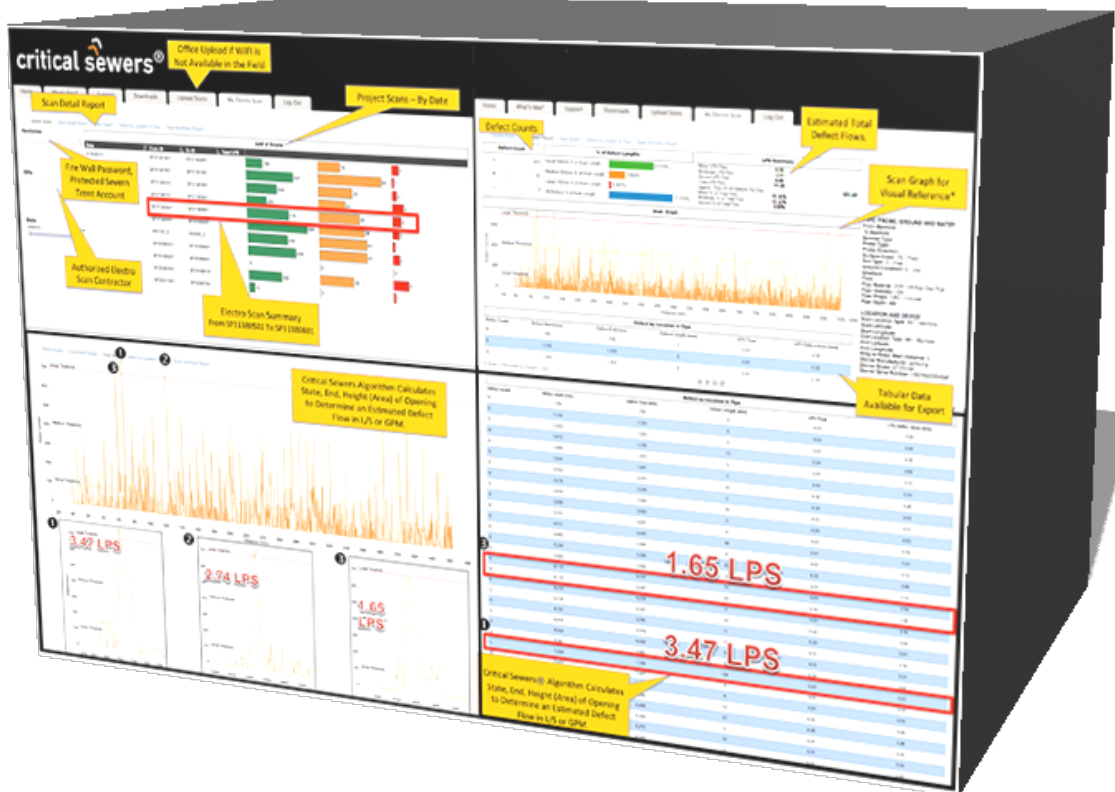
Figure 17. Sample reports automatically available from a cloud application, without operator interpretation.

Once a scan is complete, crews benefiting from a Wifi connection in the field may have results immediately uploaded to a cloud-based application where raw data is processed, filtered, and transmitted to a customer portal, as shown in Figure 17.
