The Need to Quantify Pre- and Post-Rehabilitation Effectiveness

By Chuck Hansen¹

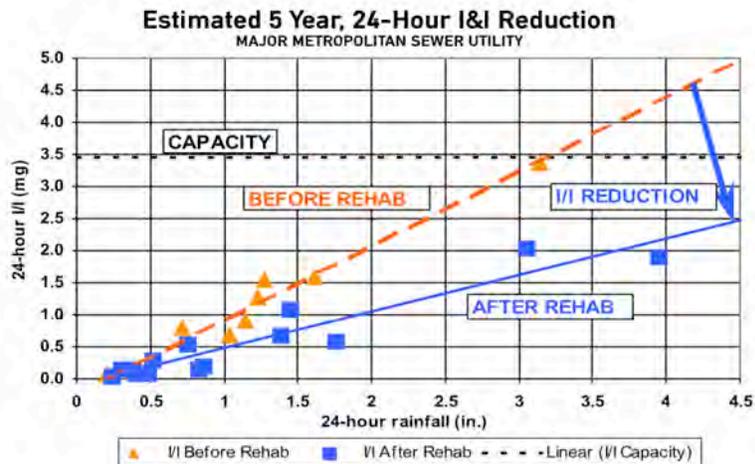
Figure 1. Sample analysis from a large metropolitan sewer utility on expectations in I/I reductions from rehabilitation.

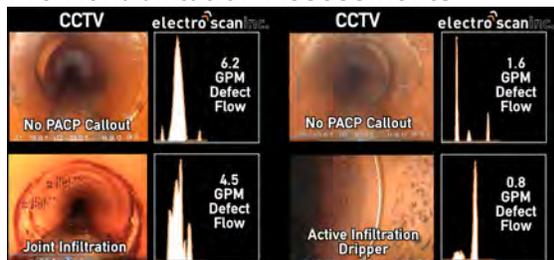
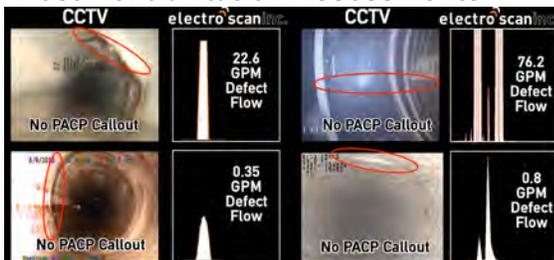
Figures 2. Sample side-by-side CCTV and Electro Scan comparisons for pre- and post-rehabilitated pipes.

In 2011 the USEPA benchmarked several emerging technologies in comparison to CCTV inspections.² CCTV defects that were categorized as potential leaks were closely examined to determine if any other technology showed defects at the same internal pipe location. As illustrated in Figure 2, this defect-by-defect comparison was able to show that Electro Scan technology identified pipe defects for 82% of the pipe defects shown by CCTV; however, the Electro Scan technology identified 2.1 times more defects than CCTV, including 4.8 times more defects at joints and 30 times more defective manhole-to-pipe joint locations.³ In fact, CCTV missed many defects, including the largest defect flows identified by Electro Scan.

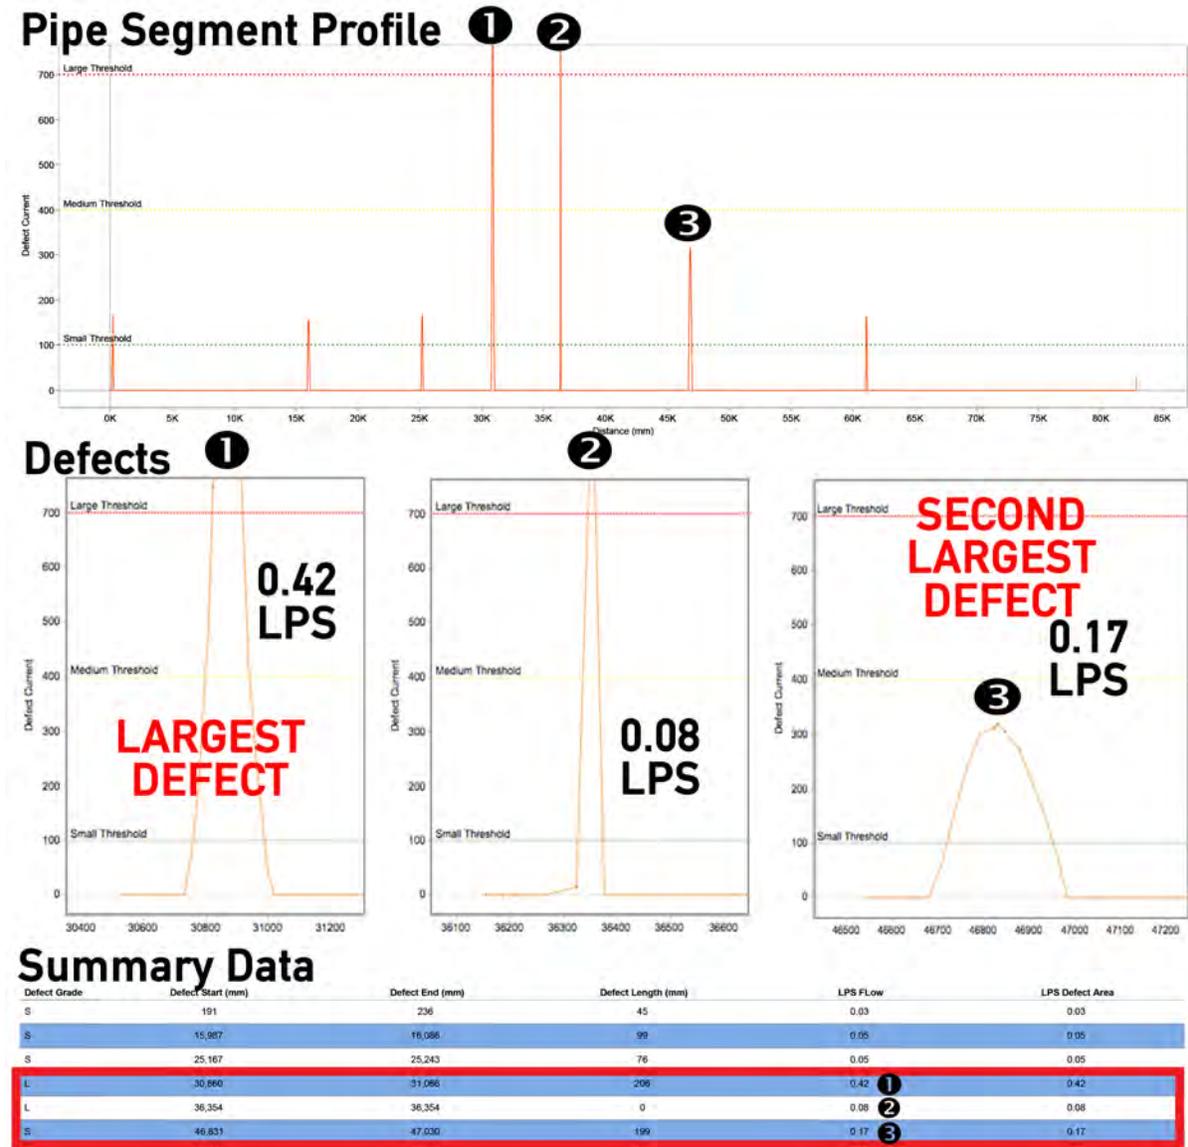
Figure 4. Individual scanned pipes, ranked sixth (6th) out of a total of 49 pipe segments. Total pipe segment defect flow of 19,066 GPD, .084 LPS, or 72,190 LPD), including two (2) Large Defects and five (5) Small Defects. 00000180_apr012014_145714PM

An analysis of one of the forty-nine (49) post-CIPP sewer mains that was electro scanned, showed several defects, as shown in Figure 4, representing a combined estimated defect flow of 19,066 GPD (0.84 LPS). As Electro Scan measures the area of each defect (i.e. height and width or start & end), it should be noted that while the highest *defect currents* are noted in Defect ① and ②, Defect ③ actually contributes the second highest defect flow rate as shown by its larger calculated area.

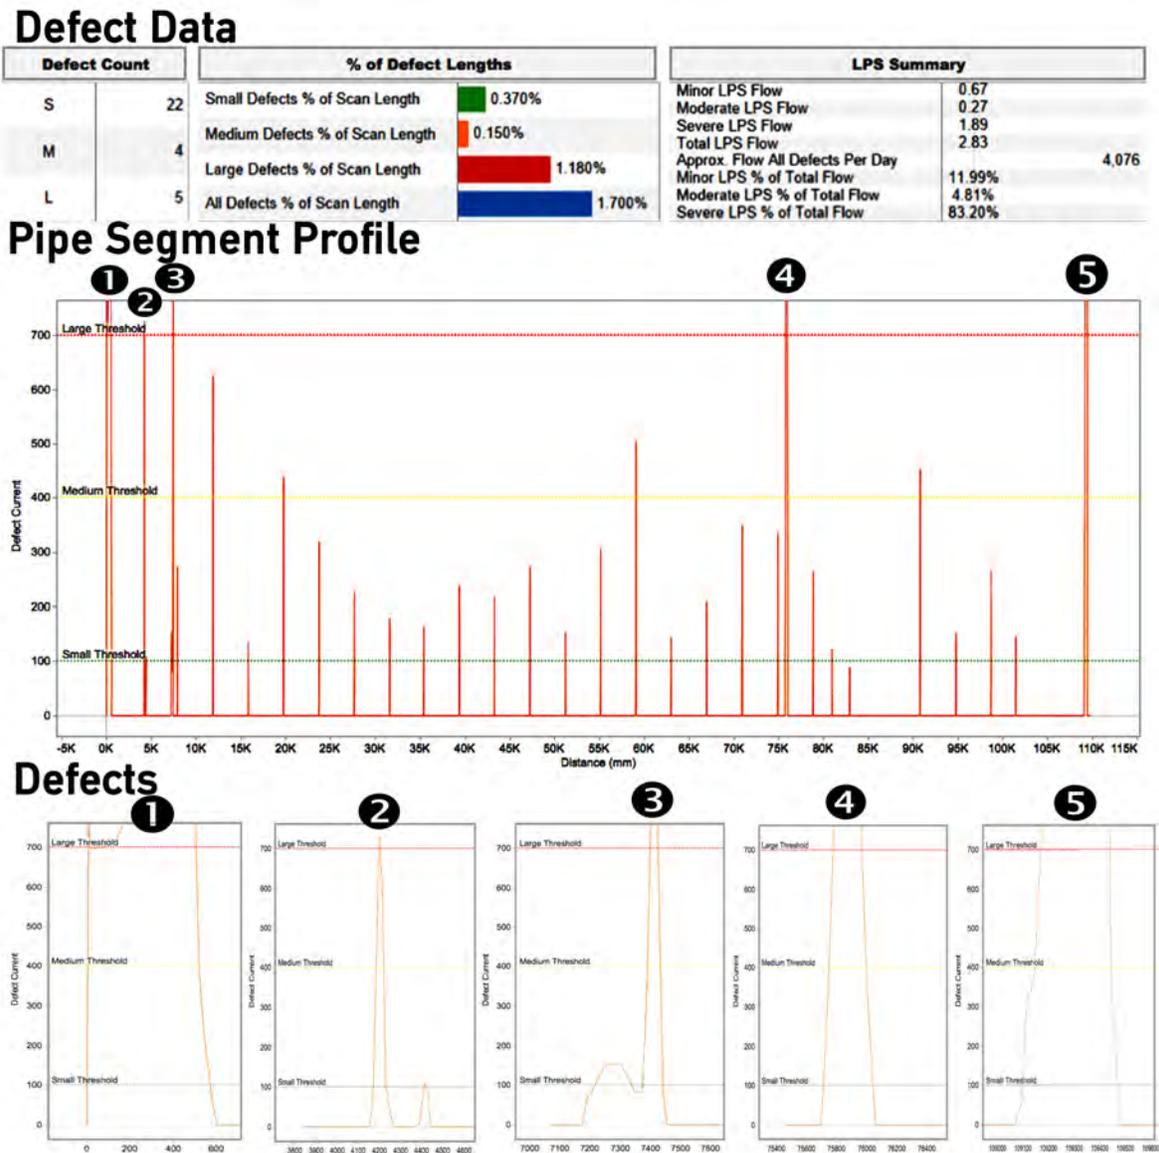
Figure 5. Electro Scan results from an 8" PVC pipe 0000145_mar302014_103257AM.

So, how did Electro Scan evaluate a typical 8" PVC pipe, without CCTV showing measurable defects? While the majority of PVC pipes had no recorded defects from CCTV, a single 8" PVC pipe, scanned in March 2014 showed 1,077 GPM (4,076 LPD).

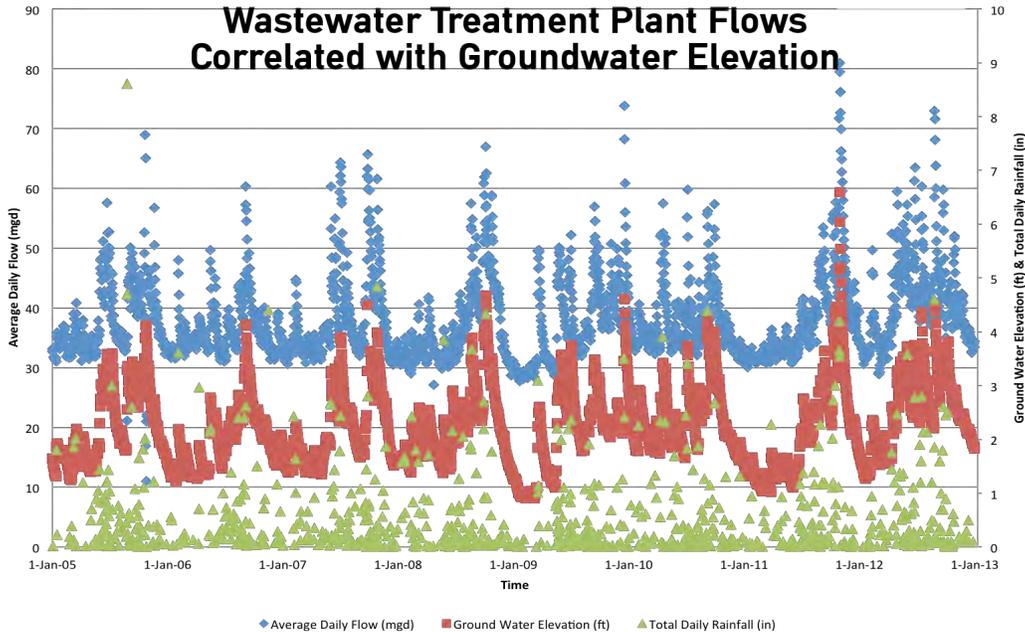
Figure 6. Inflow & Infiltration Analysis at WWTP, 2005-2012.

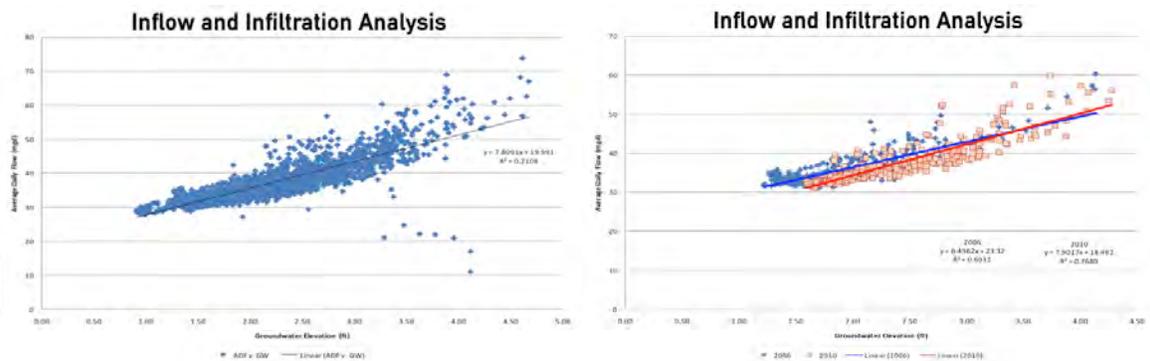
Figure 7. (Left) WWTP flows correlate strongly with groundwater elevation, while (Right) correlation has not changed over time.

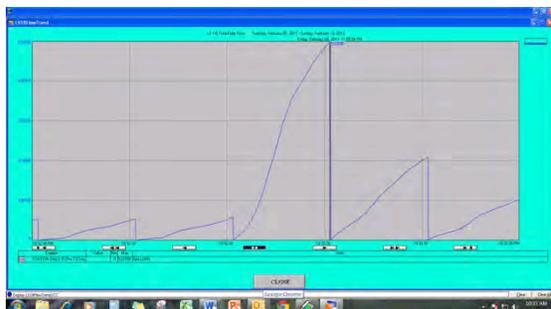
Figure 8. LS 1-8 Flow Monitoring Trend, post-rehab effort

As shown in Figures 8 & 9, 2013 flow monitoring captured trends for a rain event occurring February 8, 2013 totalling 1.75-inches of rainfall. The rain began at 9:00PM on 7 February 2103 and ended at 10:00AM on 8 February 2013, indicating that flows began to spike upward around 12:30AM on 8 February 2013, and continued at an elevated rate of flow throughout the day [Note: Flow monitoring trends reset to zero at approximately midnight, indicating both systems were susceptible to I/I since flows responded fairly early to wet weather and remained elevated following cessation of the precipitation].

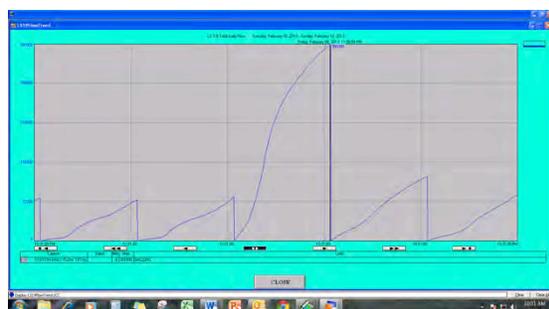
Figure 9. LS 1-9 Flow Monitoring Trend, post-rehab effort.

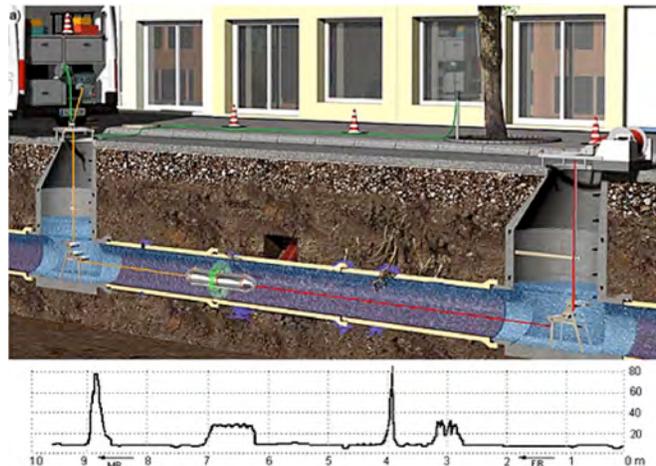
Figure 10 – Early electro scan single electrode prototype set-up.

As illustrated in Figure 10, early prototypes of the innovation required a sewer or stormwater channel to be closed off and flooded with water, with a reference electrode inside the pipe and grounding electrode positioned on the surface to attempt a closed circuit to identify cracks, defects, or fissures.

While earlier prototypes utilized a single electrical contour emitted from its probe, resulting in a wide distribution of electric current, later prototypes implemented a tri-electrode array, creating a focused current to increase its locational and accuracy.

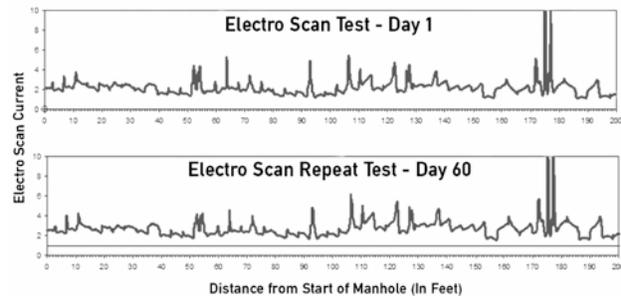
Figure 11. EPA Electro Scan consistency test traces, Day 1 and Day 60

Other improvements included more consistent data resolution (i.e. accuracy) and data fidelity (i.e. point-to-point difference matching) as demonstrated in independent testing.⁶ As part of the EPA's 2011 *Field Demonstration of Condition Assessment Technologies for Wastewater Collection Systems*, shown in Figure 11, Electro Scan readings were taken on the same pipe, 60-days apart, with near exact readings, with similar test results later found in sewer lateral benchmarks.

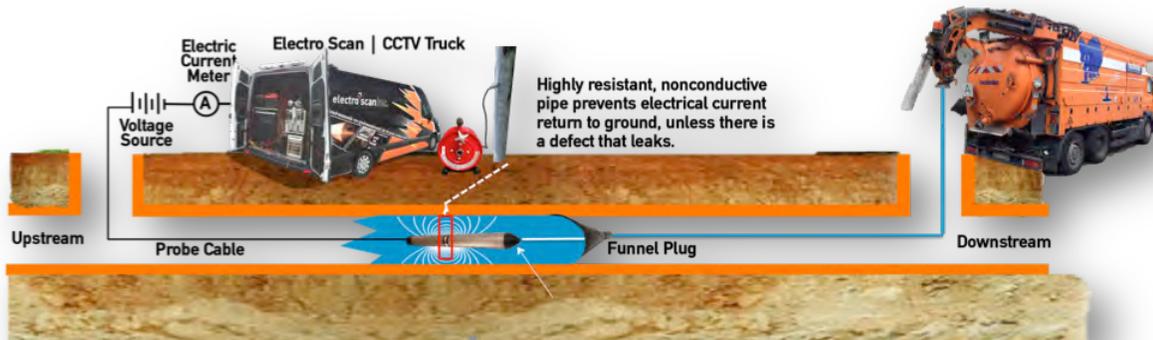
Figure 12 - Electric Circuitry of a Sewer System,

The water in the pipe is at a level that ensures that the pipe is full at the probe location (i.e. not requiring the entire pipe to be filled with water). Provided electrical current is prevented from flowing along the inside or out of the pipe, the electrical resistance of the current path between the probe in the pipe and the ground stake, will be very low -- unless a defect exists that provides a pathway through the non-conductive pipe wall to ground (e.g. at a crack, defective joint, faulty service connection, over-cooked or defective liner), as shown in Figure 12.

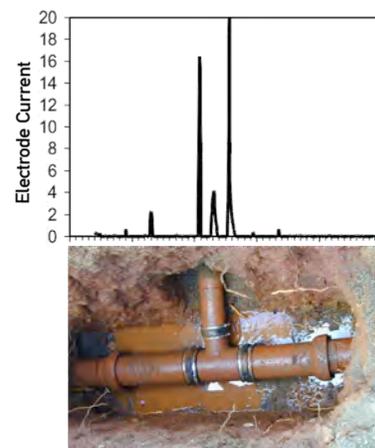
Figure 13. Electro Scan Current Trace Verification With Excavation and Testing

As shown in Figure 13, Electro Scan readings can be precisely aligned with defects confirmed by excavating the pipe, followed by either pressure testing or open-trench smoke testing. In this case, Fernco fittings had not been tightened, and missed by CCTV surveys.

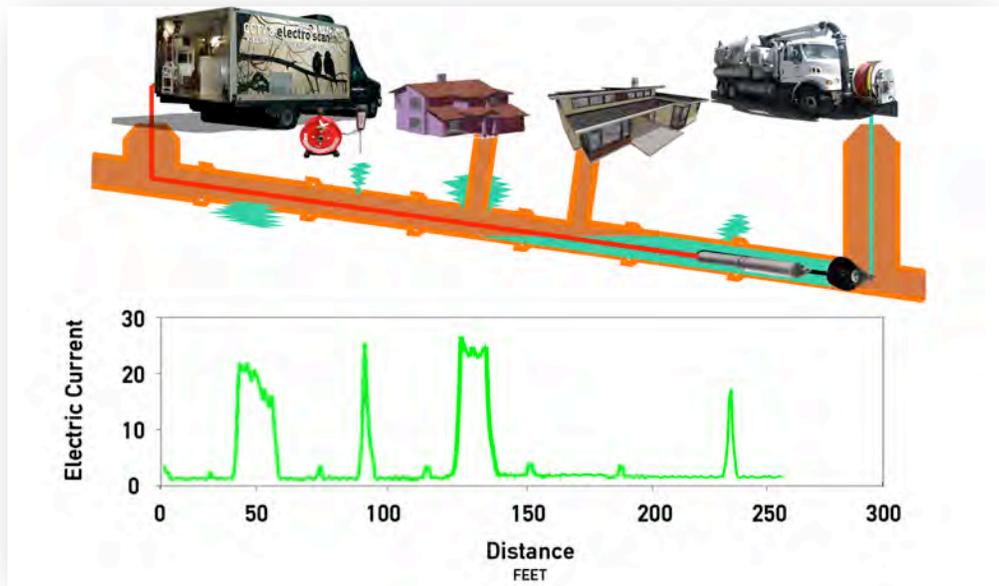
Figure 14. Example electric current traces, by defect.

As shown in Figure 14, regions on the current trace (i.e. where the current levels are above a threshold level), show specific defect areas in the wall of the pipe, with Electro Scan's patent-pending technology able to measure the amount of current flow through the defect, including its start and end position, to determine the total size of the defect.

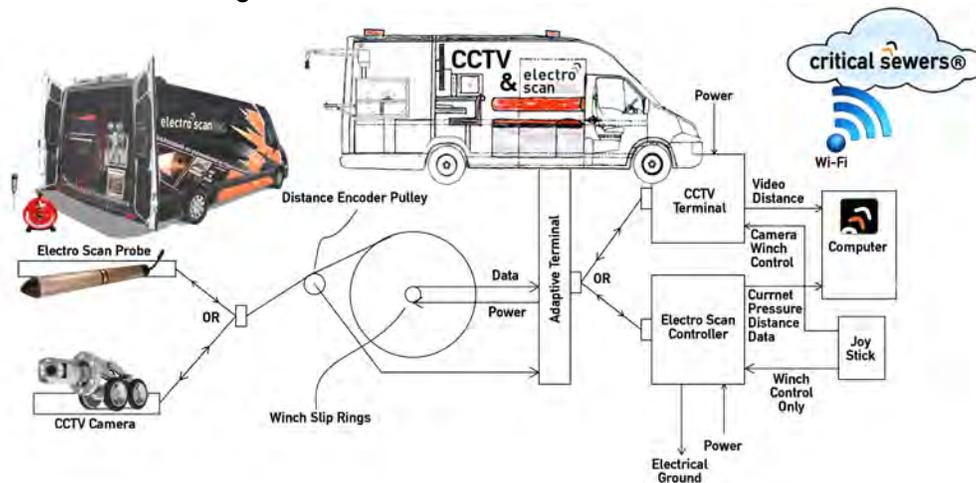
Figure 15. Electro Scan's adaptive design with traditional CCTV trucks or vans.

Utilizing an adaptive design with existing CCTV vehicle-related cable and reels (Figure 15), field crews can change from CCTV to Electro Scan, and back, in 10 minute or less.⁸

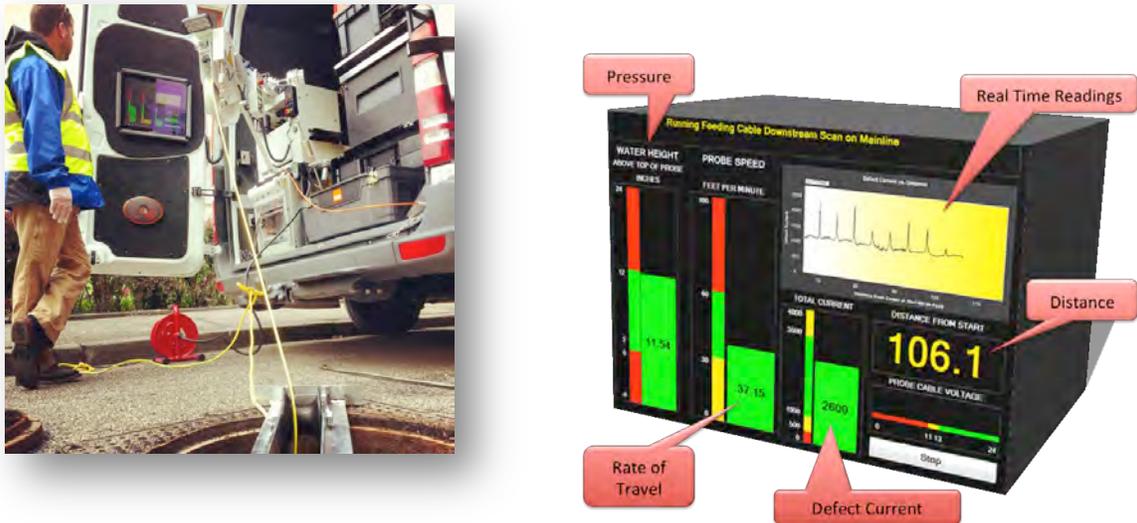
Figure 16. Data automatically displayed on Operator's Real Time Console, requiring no data entry or interpretation during scanning process.

Without reliance on subjective or qualitative identification of defect locations or sizes, operators manage the rate of speed and ensure that defect current levels perform within manufacturer's parameters, as shown in Figure 16.

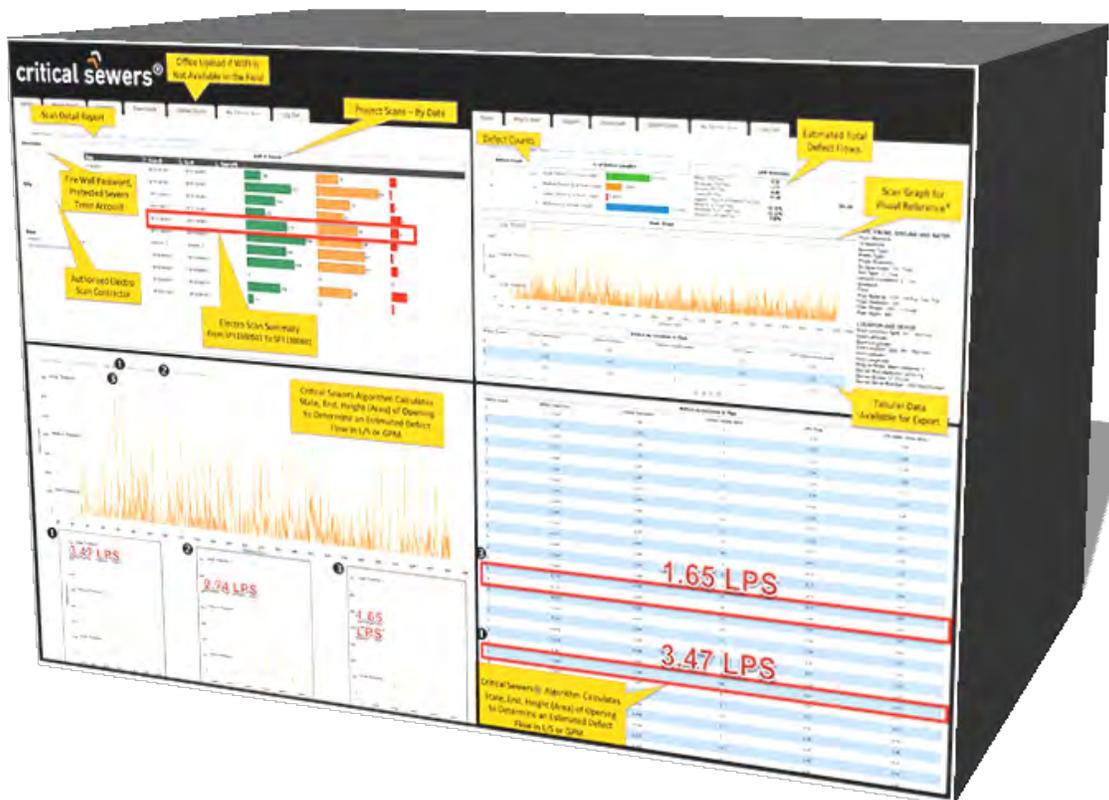
Figure 17. Sample reports automatically available from a cloud application, without operator interpretation.

Once a scan is complete, crews benefiting from a Wifi connection in the field may have results immediately uploaded to a cloud-based application where raw data is processed, filtered, and transmitted to a customer portal, as shown in Figure 17.

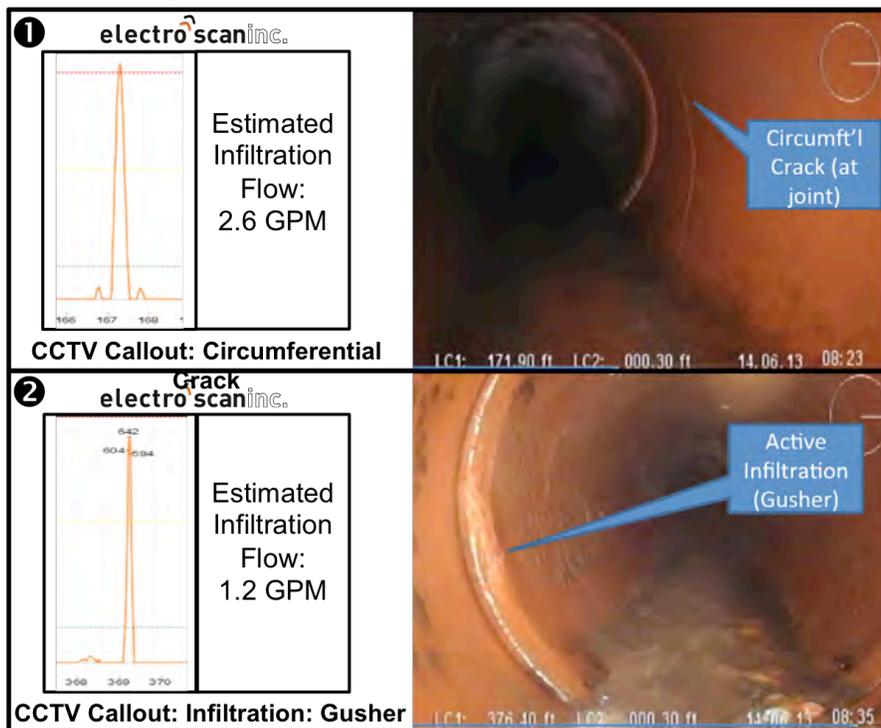
Figure 18. Calibration of previously identified defects using PACP coding standards with Electro Scan.

Key objectives for the benchmark were (1) to test Electro Scan's ability to automatically locate existing visually detected defects (Figure 18), (2) determine if Electro Scan could locate defects, not previously identified by CCTV (Figure 19), and (3) compare Electro Scan results from surveying a post-CIPP liner (i.e. pipe-within-a-pipe) with CCTV inspection of pre-CIPP conditions (Figure 20).

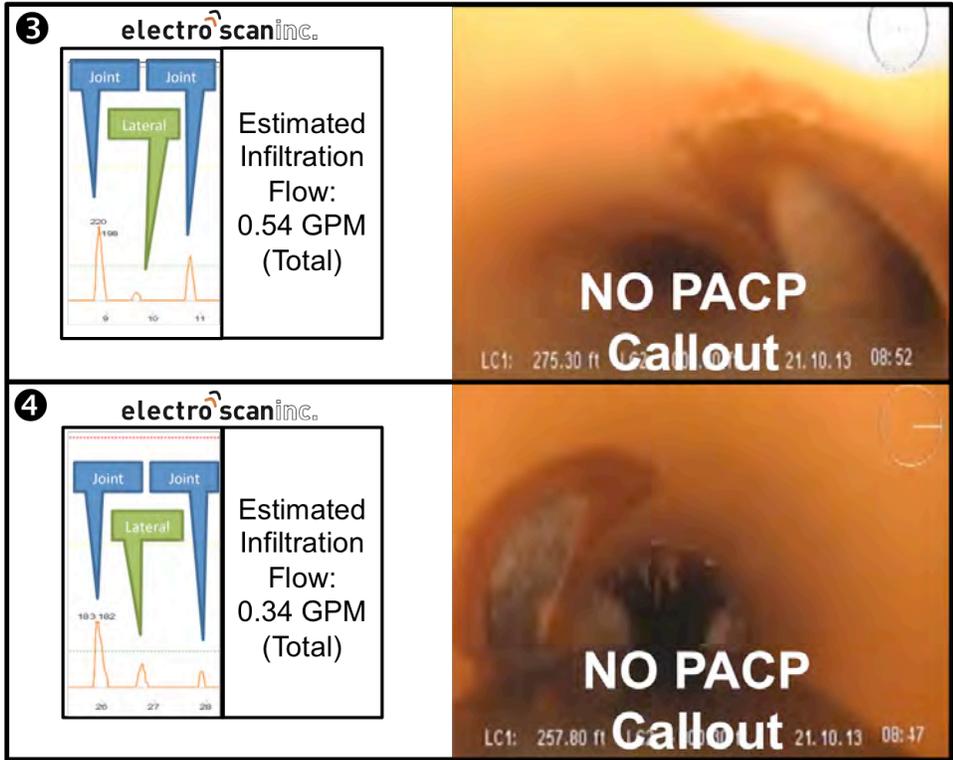
Figure 19. Electro Scan defects found, compared to No PACP defects found by CCTV.

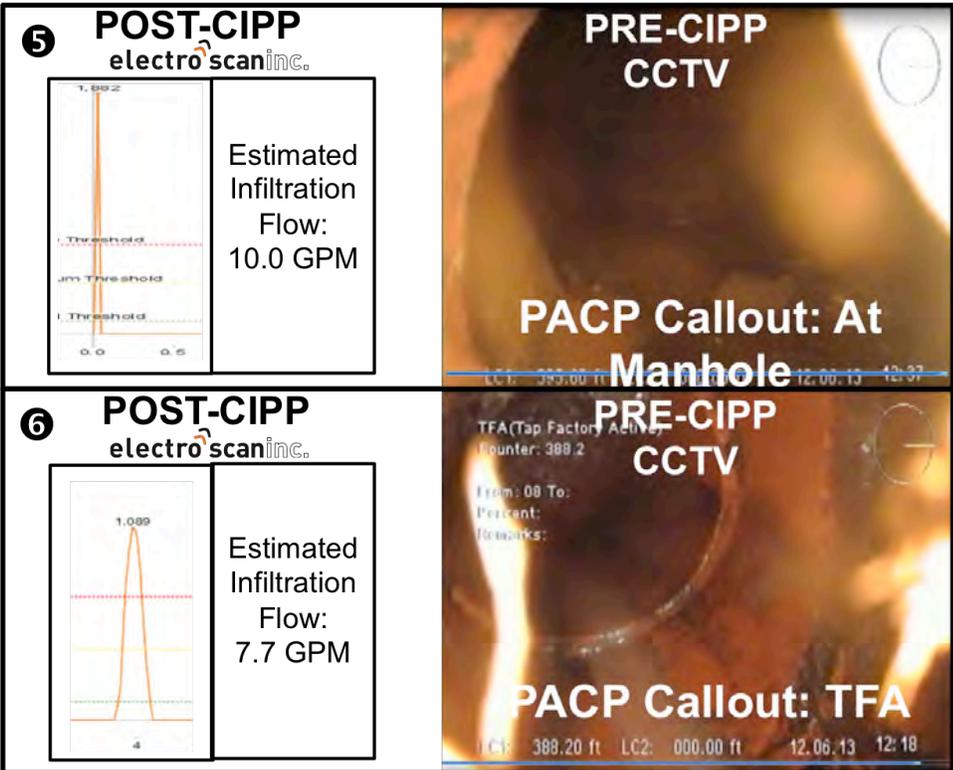
Figure 20. Post-CIPP Electro Scan results compared to pre-CIPP CCTV results, useful in diagnosing pipe-within-a-pipe problems were cracks were not grouted prior to CIPP.

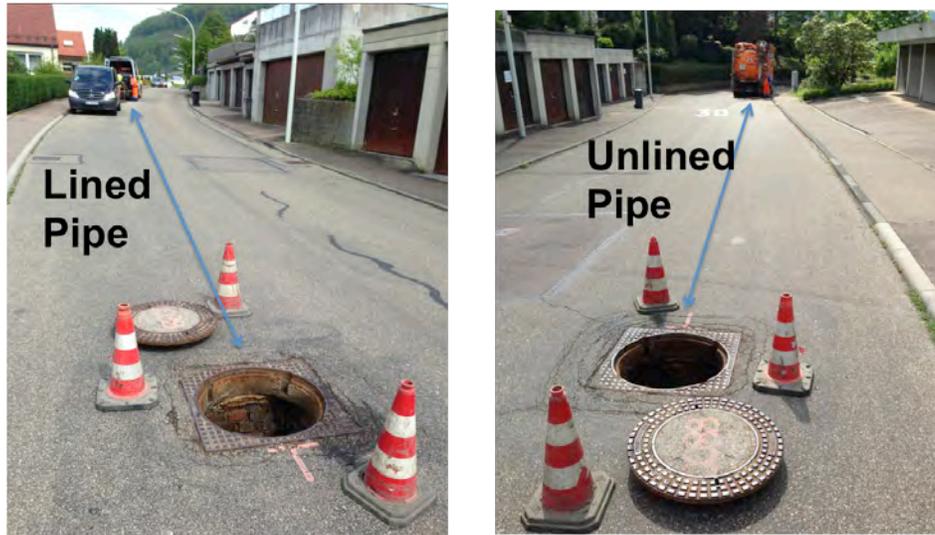
Figure 21. Field photographs of upstream and downstream segments having lined and unlined pipe, respectively.

In 2014 a leading European manufacturer of CIPP, liners, and coating products made available two (2) contiguous sewer mains (Figure 21); one segment (upstream) that had been recently relined (Figure 22) and another segment (downstream) that had not been relined (Figure 23). Only one of the pipe segments was CIPP lined, as CCTV inspection did not indicate sufficient defects to warrant lining, with the manufacturer wishing to evaluate whether to undertake pre-CIPP testing to ensure all lines that should be lined, are lined.

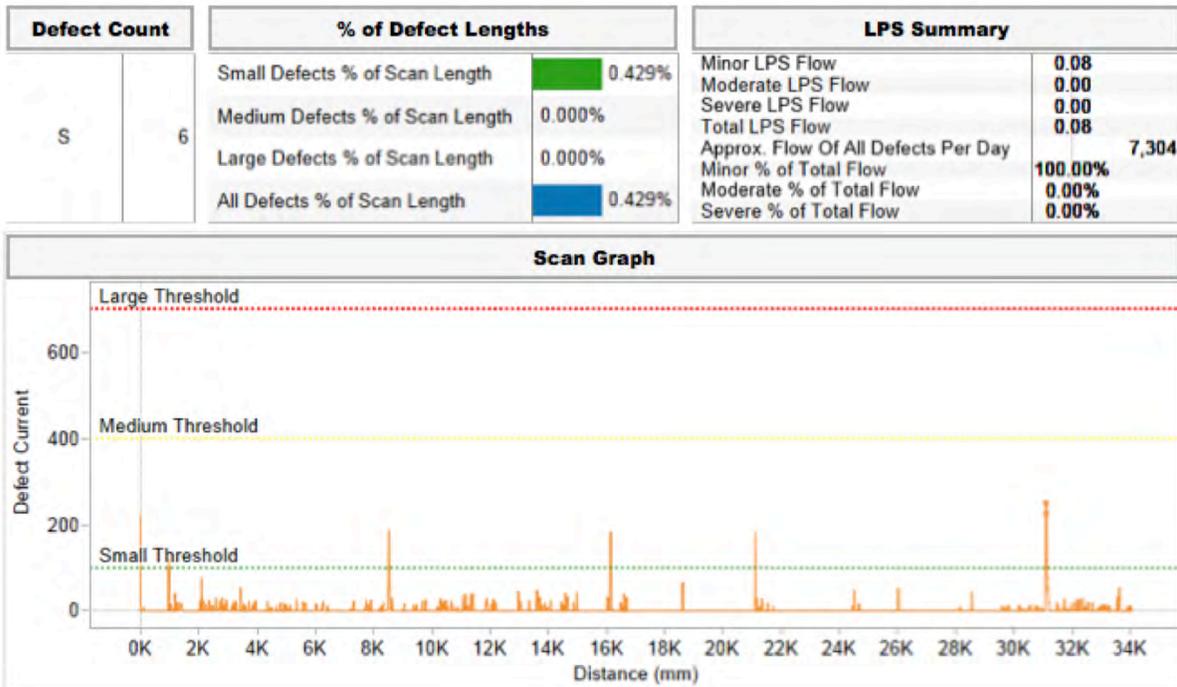
PRE-CIPP ASSESSMENT

Figure 22. Electro Scan report for non-CIPP sewer main segment, with six (6) small defects representing 7,305 litres per day of defect flow.

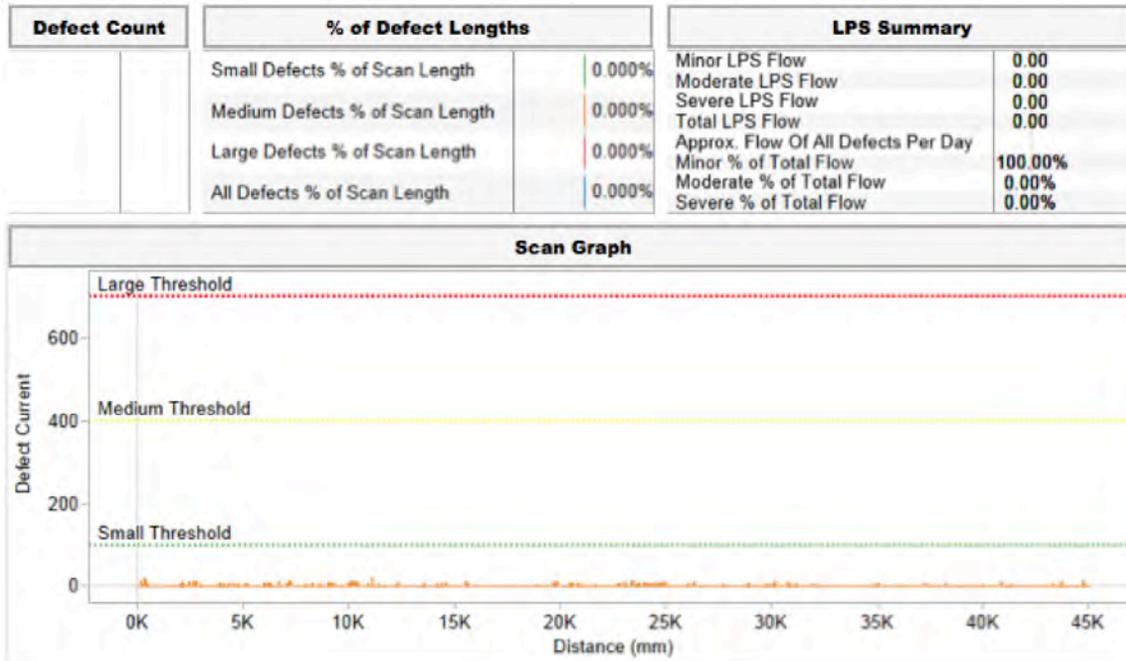
POST-CIPP ASSESSMENT

Figure 23. Electro Scan report for CIPP pipe having no defect flows.

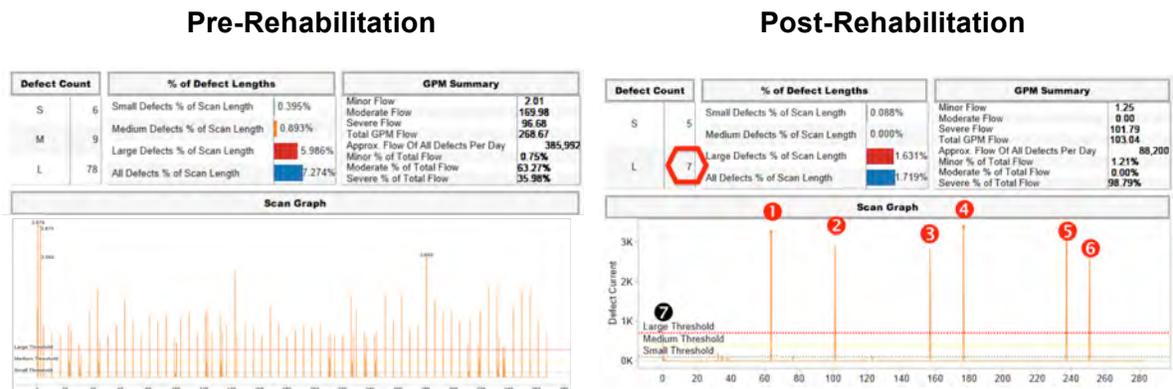
Figure 24. Sample Pre-Rehabilitation and Post-Rehabilitation, i.e. before and after, condition assessment reporting.

Once rehabilitation has been completed, scanning may be done whenever legacy CCTV inspections occurs, providing a pre and post-rehabilitation defect flow as illustrated in Figure 24 and summarized in Table 7.
