# If You Are Using CCTV to Find Defects in Sewers, You Might Be Fixing the Wrong Pipe

**Abstract.** Sewer authorities are coming under increasing pressure to correctly assess, rank, and prioritize sewer rehabilitation projects. While many agencies are moving towards the ‘smarter use of utility survey data,’ leading authorities are embracing a ‘smarter use of utility data gathering’ to prioritize needed upgrades and improvements. While recent studies have documented a number of shortcomings in the use of legacy Closed Circuit Television (CCTV) surveying, a new technology, known as Electro Scan, has emerged as a new standard to rapidly quantify sewer defects.

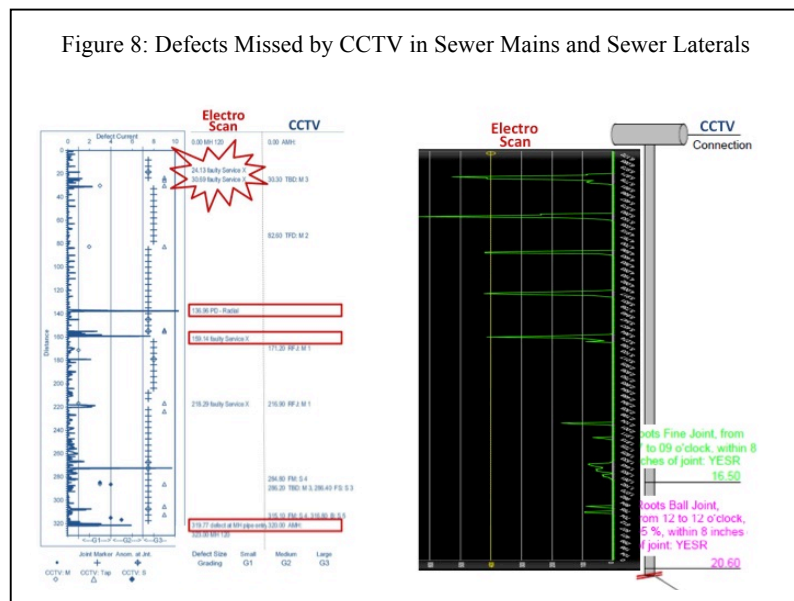
Figure 8: Defects Missed by CCTV in Sewer Mains and Sewer Laterals

As shown in Figure 8, several significant defects found by Electro Scan, were not identified by CCTV. In fact, so many significant defects were not identified by CCTV, that CCTV reports were further reviewed to ensure that the CCTV reports matched the related video captured during the original investigation.

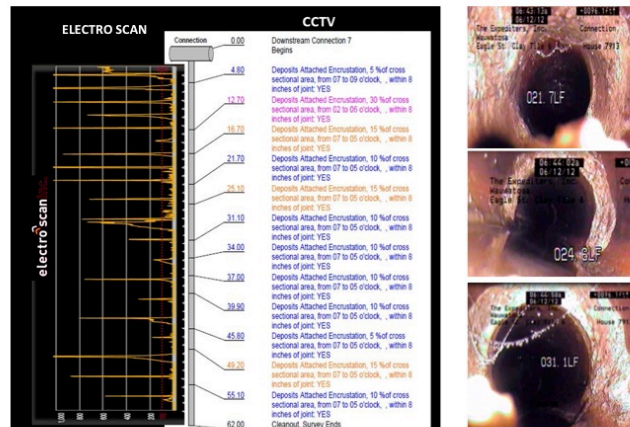
Figure 11: CCTV v. Electro Scan in Indicating Needed Repair

Visual inspection using CCTV can lead to false interpretations, as shown in Figure 11. As indicated, the pipe segment had visible 'encrustations' throughout the pipe, and even successfully passed a water pressure test, which many industry observers might refer to as a self-healing occurrence; however, as build-up in a pipe is non-conductive, i.e. allowing electrical current to pass through to assess potential flow patterns, Electro Scan is able to diagram the location and peak potential for leaks. As encrustation is not an approved method of pipe rehabilitation, Electro Scan correctly recommends repair.

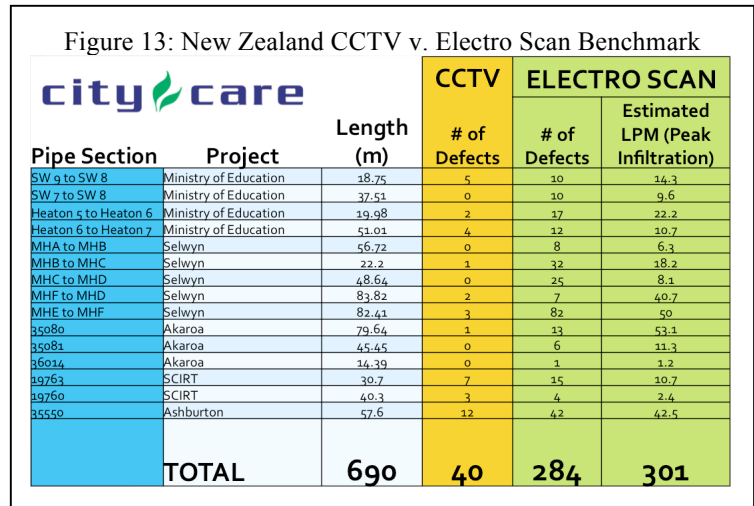
As shown in Figures 12 and 13, individual comparisons of CCTV and Electro Scan defects in New Zealand, routinely showed ‘No Defect’ for CCTV, with a measured estimated litre per minute of leak infiltration. In association with City Care (Christchurch, NZ), CCTV identified a total number of 40 defects, compared to 284 identified by Electro Scan.

Similar competitive survey results from Christchurch, New Zealand also confirms the consistent inability of CCTV cameras to identify, locate, and measure defects, particularly in accurately certifying relined, repaired, and newly installed projects as “leak-free.”
