THE CITY OF RACINE ORDERS AN “MRI” FOR CIPP TESTING & ACCEPTANCE

By Carissa Boudwin

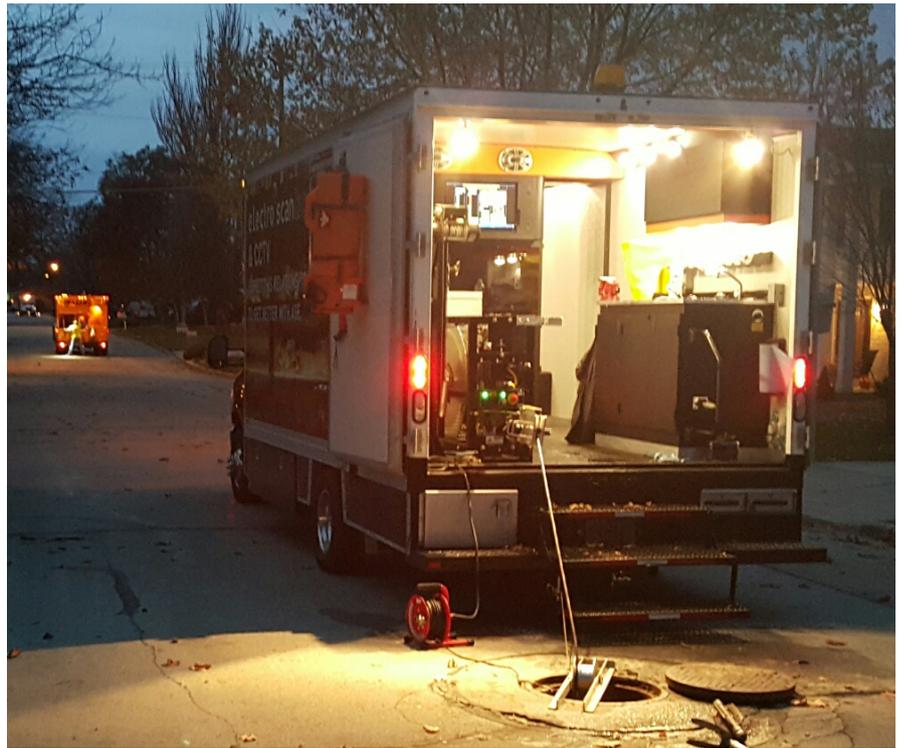
Electro Scanning equipment easily modified to be added to standard CCTV Trucks.

Sacramento-based Electro Scan Inc. was contracted to locate and measure all of the potential leak sources, before and after CIPP. Using the same coax cable and reel typically used for a high-resolution CCTV camera, a focused array of low voltage electric current (i.e. 40 milli-amps or 5AA batteries) measured the variation of electricity that escaped through openings (i.e. defects) in a pipe’s wall.
