Raising the grade

An innovative solution to certifying wastewater infrastructure rehabilitation

A California sewer agency demonstrates the effectiveness of Focused Electrode Leak Location (FELL) to find and measure leaks in cured-in-place pipe liners. Jamie Johnson of Electro Scan Inc. reports.

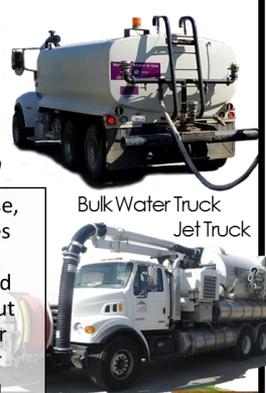
Electro Scanning Inspection

“If a Pipe Leaks Electricity, It Will Leak Water, too.”

Bulk Water Truck
Jet Truck

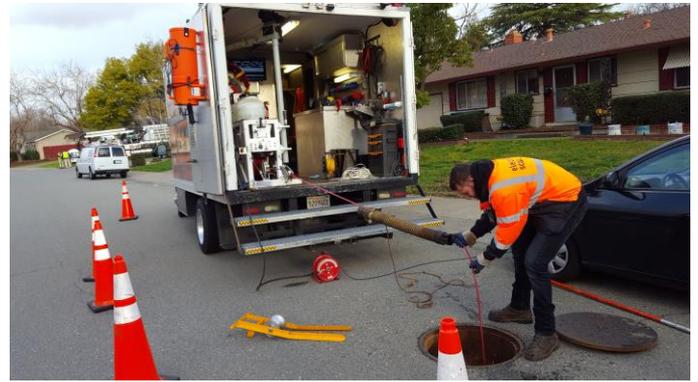
Electro Scanning Inspection locates within 1 cm and measures in water volume per second each crack, fracture, bad joint, hole, defective service connection, or any other opening. Photo by Electro Scan Inc.
