# The Need to Quantify Pre- and Post-Rehabilitation Effectiveness

By Chuck Hansen<sup>1</sup>

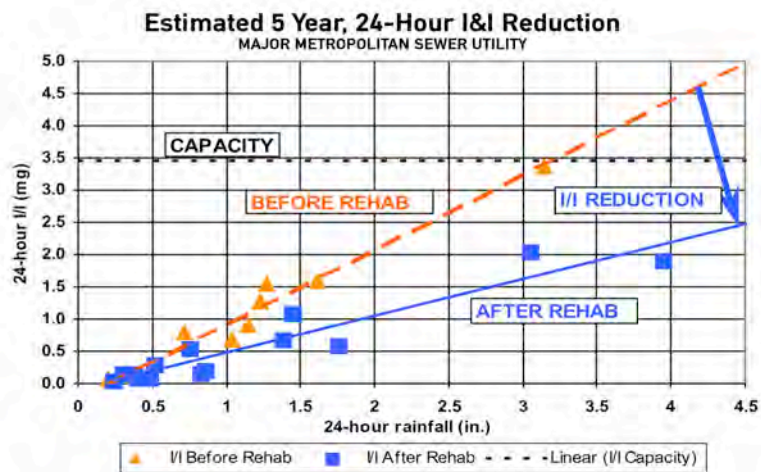
Figure 1. Sample analysis from a large metropolitan sewer utility on expectations in I/I reductions from rehabilitation.

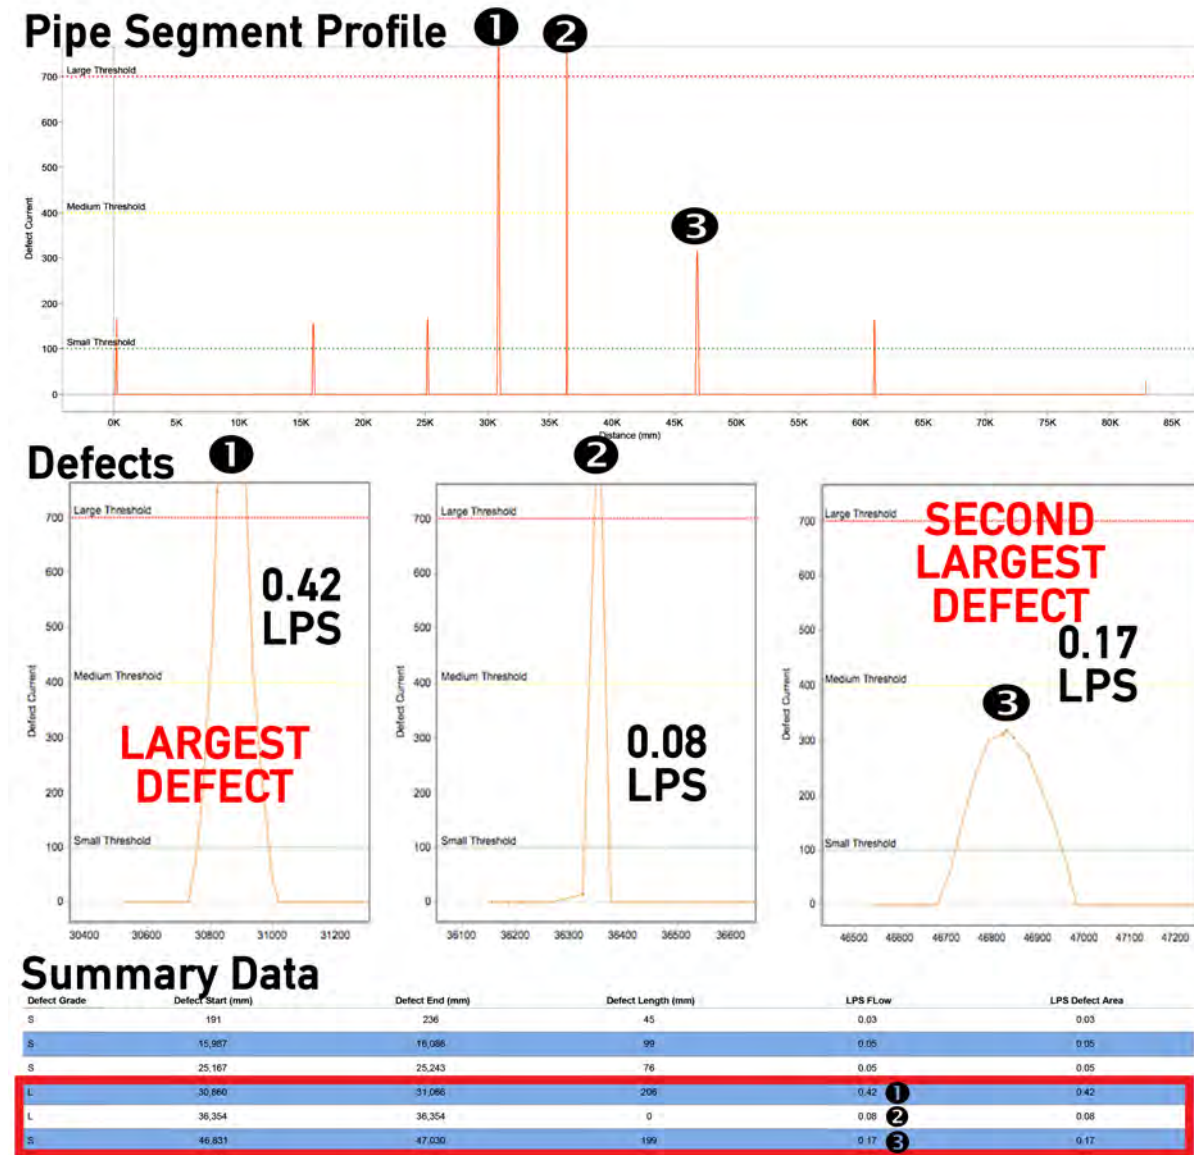
**Figure 4. Individual scanned pipes, ranked sixth (6<sup>th</sup>) out of a total of 49 pipe segments. Total pipe segment defect flow of 19,066 GPD, .084 LPS, or 72,190 LPD), including two (2) Large Defects and five (5) Small Defects. 00000180\_apr012014\_145714PM**

A selected analysis of one (1) of the forty-nine (49) post-CIPP sewer mains electro scanned, showed several defects, as shown in Figure 4, representing a combined estimated defect flow of 19,066 GPD (0.84 LPS). As Electro Scan measures the area of each defect (i.e. height and width or start & end), it should be noted that while the highest *defect currents* are noted in Defect ① and ②, Defect ③ actually contributes the second highest defect flow rate as shown by its larger calculated area.

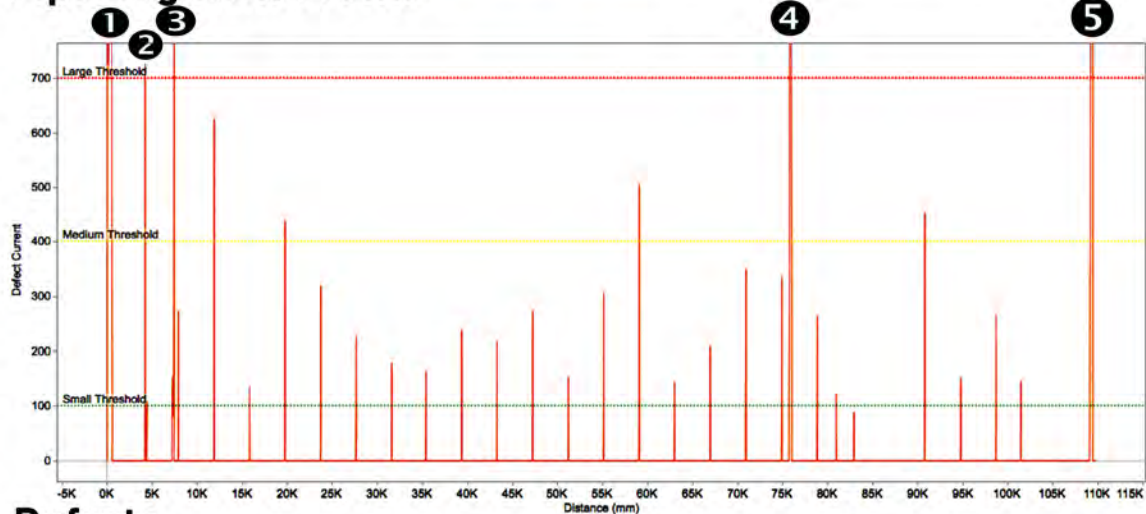
Figure 5. Electro Scan results from an 8" PVC pipe 00000145\_mar302014\_103257AM.

So, how did Electro Scan evaluate a typical 8" PVC pipe, without CCTV showing measurable defects? While the majority of PVC pipes had no recorded defects from CCTV, a single 8" PVC pipe, scanned in March 2014 showed 1,077 GPM (4,076 LPD).

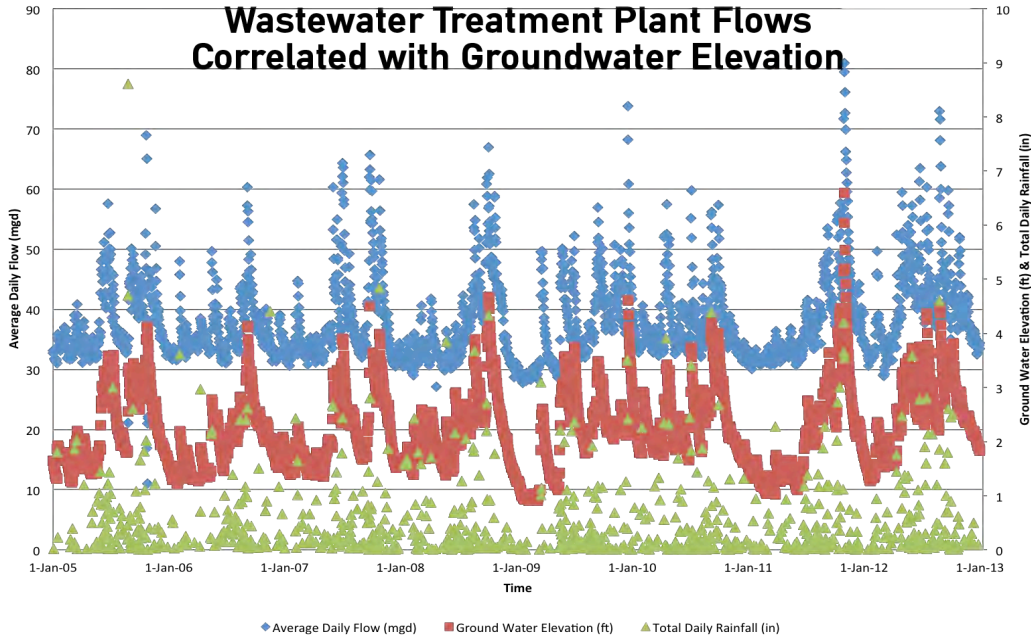
Figure 6. Inflow & Infiltration Analysis at WWTP, 2005-2012.

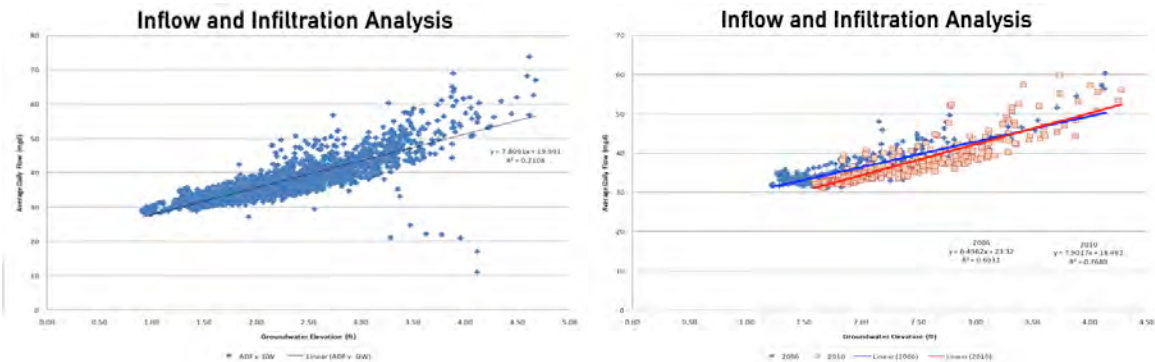
Figure 7. (Left) WWTP flows correlate strongly with groundwater elevation, while (Right) correlation has not changed over time.

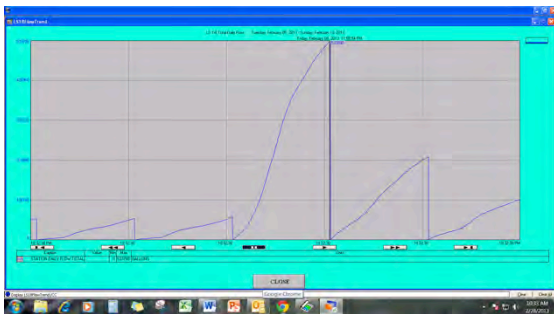
Figure 8. LS 1-8 Flow Monitoring Trend, post-rehab effort

As shown in Figures 8 & 9, 2013 flow monitoring captured trends for a rain event occurring February 8, 2013 totalling 1.75-inches of rainfall. The rain began at 9:00PM on 7 February 2103 and ended at 10:00AM on 8 February 2013, indicating that flows began to spike upward around 12:30AM on 8 February 2013, and continued at an elevated rate of flow throughout the day [Note: Flow monitoring trends reset to zero at approximately midnight, indicating both systems were susceptible to I/I since flows responded fairly early to wet weather and remained elevated following cessation of the precipitation].

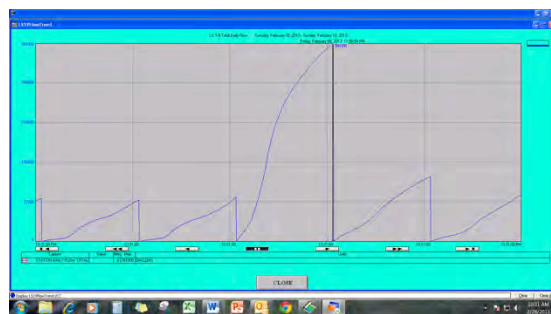
Figure 9. LS 1-9 Flow Monitoring Trend, post-rehab effort.

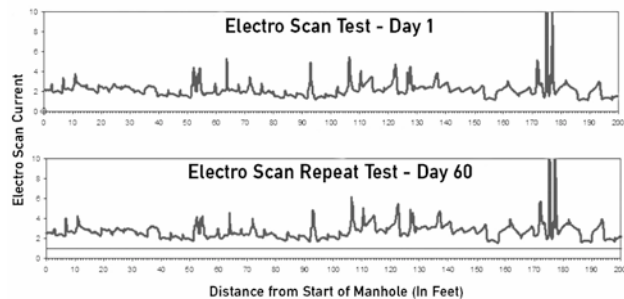
Figure 11. EPA Electro Scan consistency test traces, Day 1 and Day 60

Other improvements included more consistent data resolution (i.e. accuracy) and data fidelity (i.e. point-to-point difference matching) as demonstrated in independent testing.<sup>6</sup> As part of the EPA's 2011 *Field Demonstration of Condition Assessment Technologies for Wastewater Collection Systems*, shown in Figure 11, Electro Scan readings were taken on the same pipe, 60-days apart, with near exact readings, with similar test results later found in sewer lateral benchmarks.

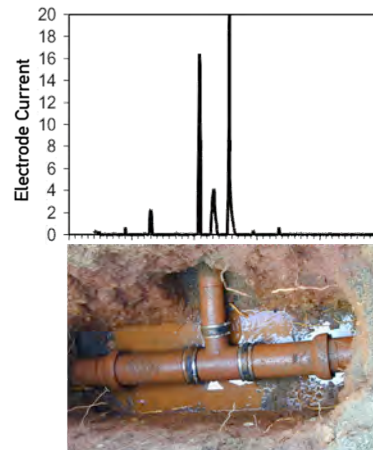
Figure 13. Electro Scan Current Trace Verification With Excavation and Testing

As shown in Figure 13, Electro Scan readings can be precisely aligned with defects confirmed by excavating the pipe, followed by either pressure testing or open-trench smoke testing. In this case, Fernco fittings had not been tightened, and missed by CCTV surveys.

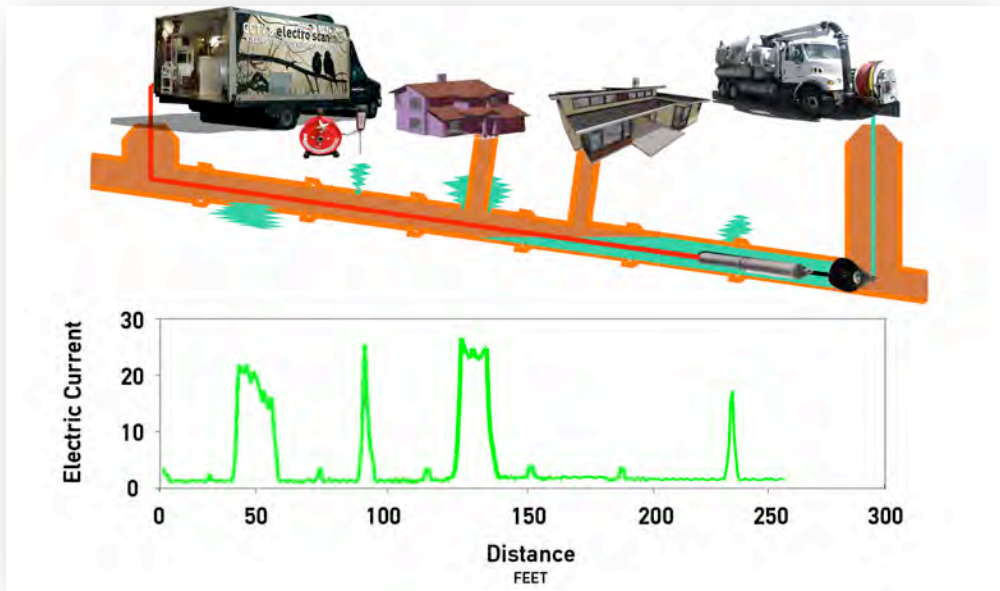
Figure 14. Example electric current traces, by defect.

As shown in Figure 14, regions on the current trace (i.e. where the current levels are above a threshold level), show specific defect areas in the wall of the pipe, with Electro Scan’s patent-pending technology able to measure the amount of current flow through the defect, including its start and end position, to determine the total size of the defect.

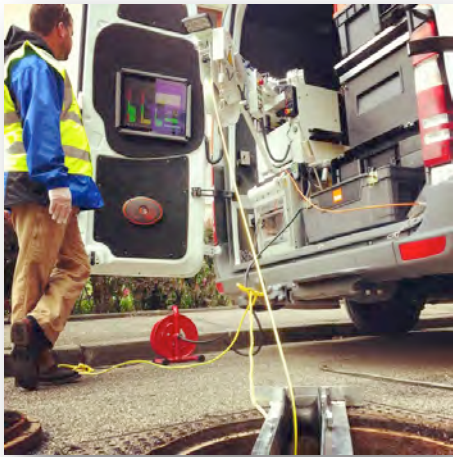
Figure 16. Data automatically displayed on Operator's Real Time Console, requiring no data entry or interpretation during scanning process.

Without reliance on subjective or qualitative identification of defect locations or sizes, operators manage the rate of speed and ensure that defect current levels perform within manufacturer’s parameters, as shown in Figure 16.

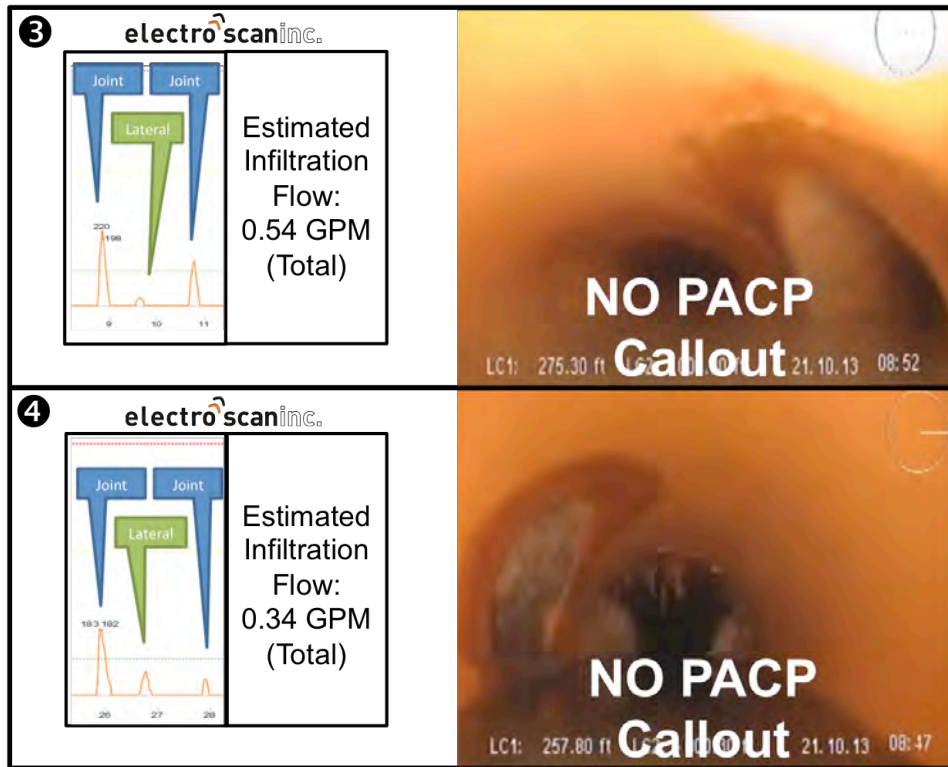
Figure 19. Electro Scan defects found, compared to No PACP defects found by CCTV.

Key objectives for the benchmark were (1) to test Electro Scan’s ability to automatically locate existing visually detected defects (Figure 18), (2) determine if Electro Scan could locate defects, not previously identified by CCTV (Figure 19), and (3) compare Electro Scan results from surveying a post-CIPP liner (i.e. pipe-within-a-pipe), with CCTV inspection of pre-CIPP conditions (Figure 20).

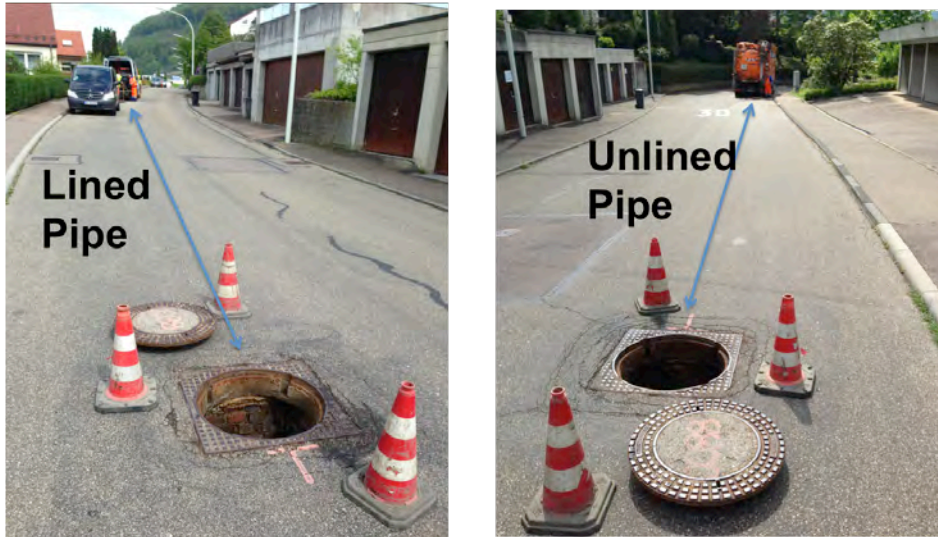
Figure 21. Field photographs of upstream and downstream segments having lined and unlined pipe, respectively.

In 2014, a leading European manufacturer of CIPP, liners, and coating products made available two (2) contiguous sewer mains (Figure 21); one segment (upstream) that had been recently relined (Figure 22) and another segment (downstream) that had not been relined (Figure 23). Only

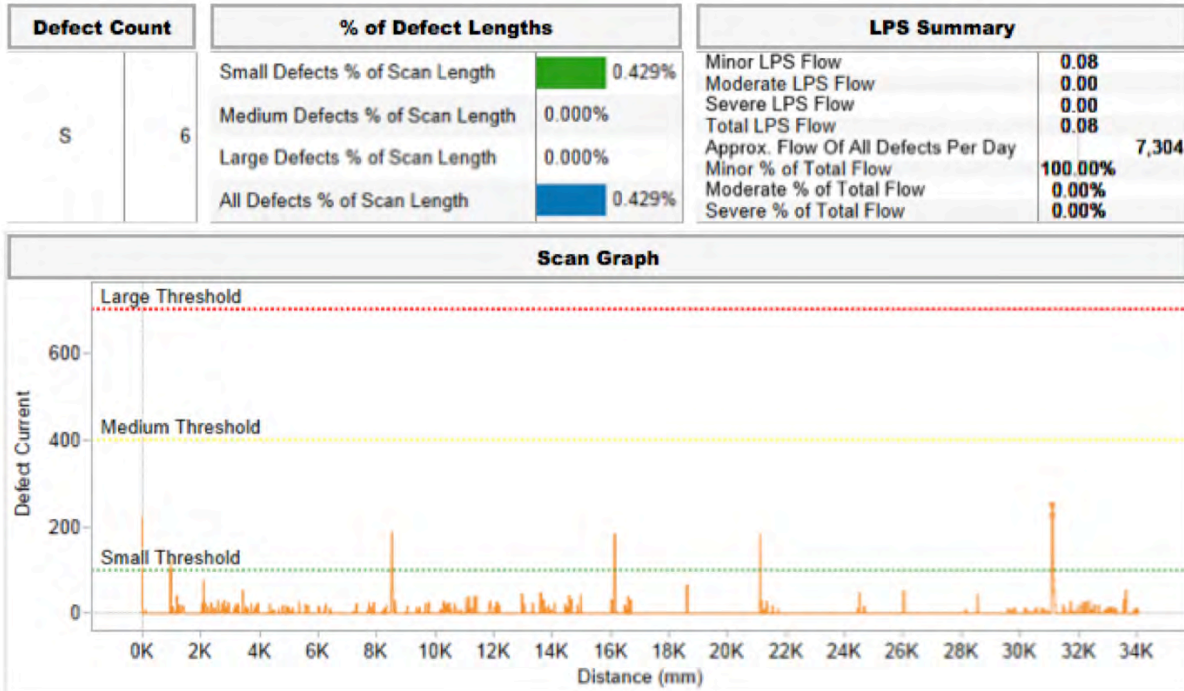
Figure 22. Electro Scan report for non-CIPP sewer main segment, with six (6) small defects representing 7,305 litres per day of defect flow.

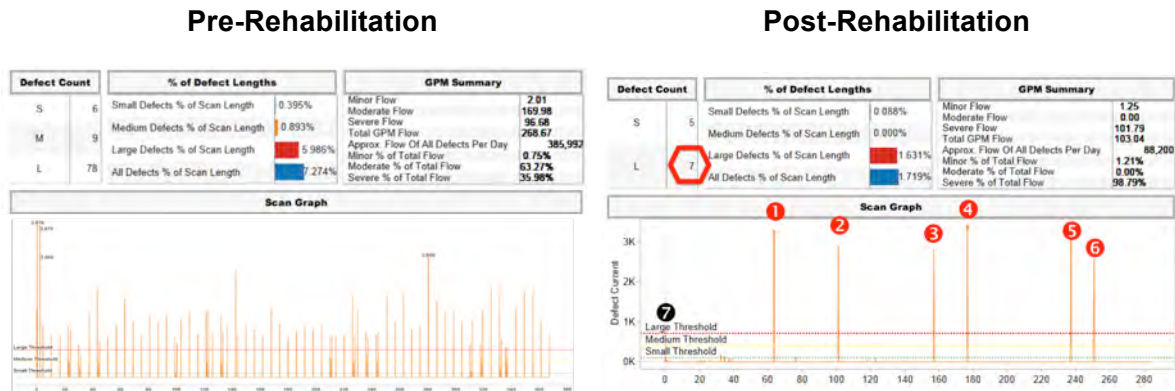
Figure 24. Sample Pre-Rehabilitation and Post-Rehabilitation, i.e. before and after, condition assessment reporting.

Once rehabilitation has been completed, scanning may be done whenever legacy CCTV inspections occurs, providing a pre and post-rehabilitation defect flow as illustrated in Figure 24 and summarized in Table 7.
