Focused Electrode Leak Location (FELL) Pipeline Assessment By Major Pipe Materials

FELL PIPE ASSESSMENT BY PIPE MATERIAL

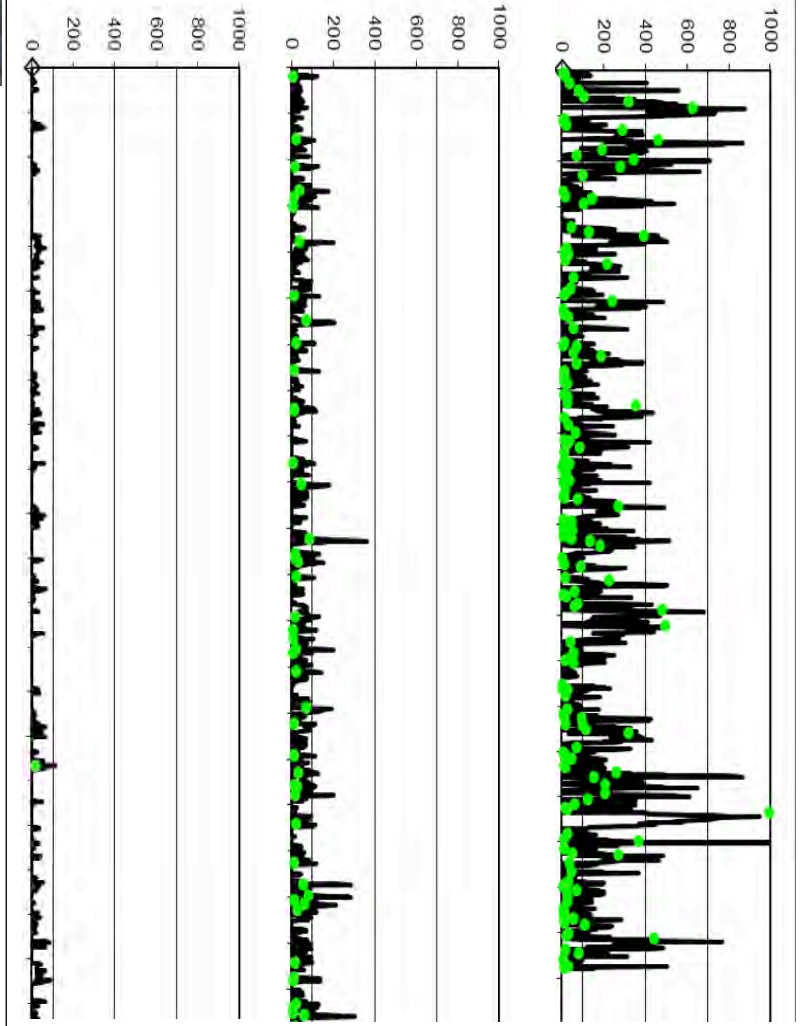
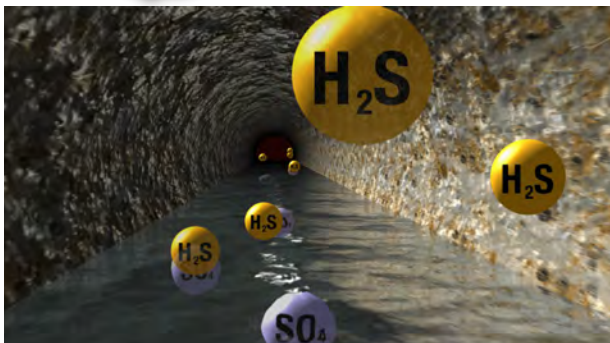
Rating Levels of Corrosion in ACP

LOW **MEDIUM** **HEAVY**

AC pipe has been installed in water systems in North America starting in the 1930s and up until the early 1980s, mainly as an affordable, non-corroding alternative to metallic pipes in areas prone to corrosion. But, AC pipes can deteriorate as a result of a variety of factors, including working environment and operational conditions, and eventually, when stresses exceed their strength, they fail.

Due to the substantial variability in the deterioration rate of AC pipes, and therefore also in their condition, FELL has become a new way to assess remaining pipe walls and corrosion.

Electro Scan FELL is unique in its ability to geometrically map the remaining wall, i.e. corrosion of ACP.

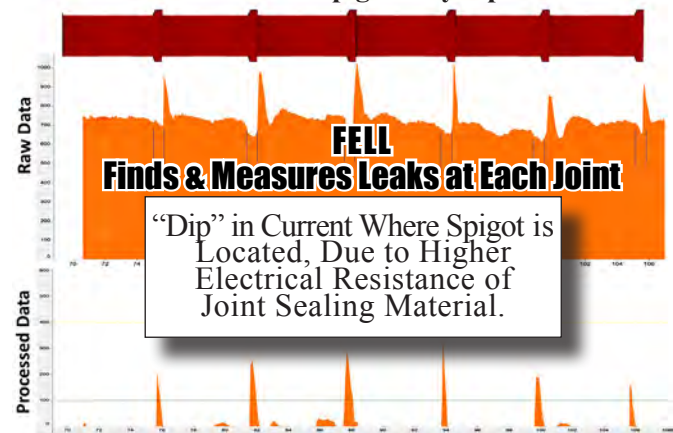
15" Bell & Spigot Clay Pipe

FELL Finds & Measures Leaks at Each Joint

"Dip" in Current Where Spigot is Located, Due to Higher Electrical Resistance of Joint Sealing Material.

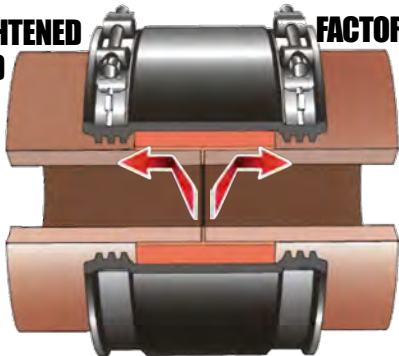
Plain End Clay Pipe with Rubber Couplings

FIELD TIGHTENED END **FACTORY TIGHTENED END**

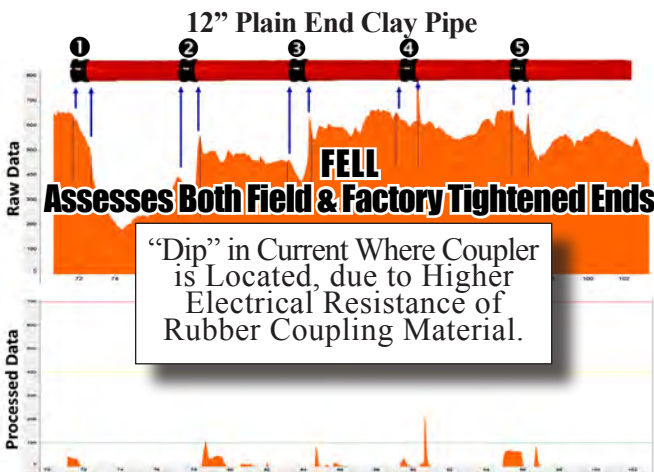
12" Plain End Clay Pipe

FELL Assesses Both Field & Factory Tightened Ends

"Dip" in Current Where Coupler is Located, due to Higher Electrical Resistance of Rubber Coupling Material.

FELL Identified Defects, By Coupling

- ① Watertight connection. No potential leakage.
- ② Leak from Field-Side (downstream) tightened side of coupler.
- ③ Minor leakage from Field-Side tightened coupler. Does not cross FELL Defect Threshold.
- ④ Leak from Field-Side tightened coupler.
- ⑤ Minor leakage from Field-Side tightened coupler. Does not cross FELL Defect Threshold.

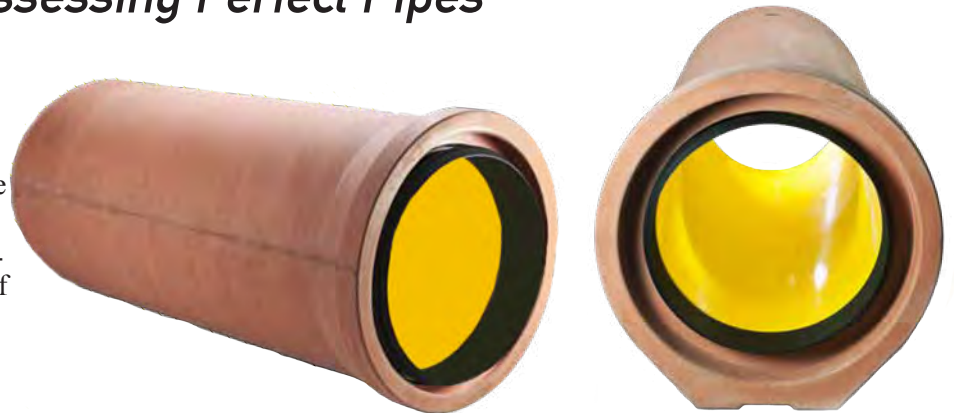
Specialty Gaskets – Assessing Perfect Pipes

Even gaskets with overwhelming design qualities may experience defects. As shown below, the average distance between these double FELL spikes is approximately 8 inches, i.e. measured width of the pipe connector, meaning that openings or leakage was detected on both sides of the connector.

Given that some joints are in perfect condition while others show varying amounts of leakage, Electro Scan does not believe that these defects are false positives. Typically when there is a material that may cause a false positive, Electro Scan's readings will show higher signs of consistency.

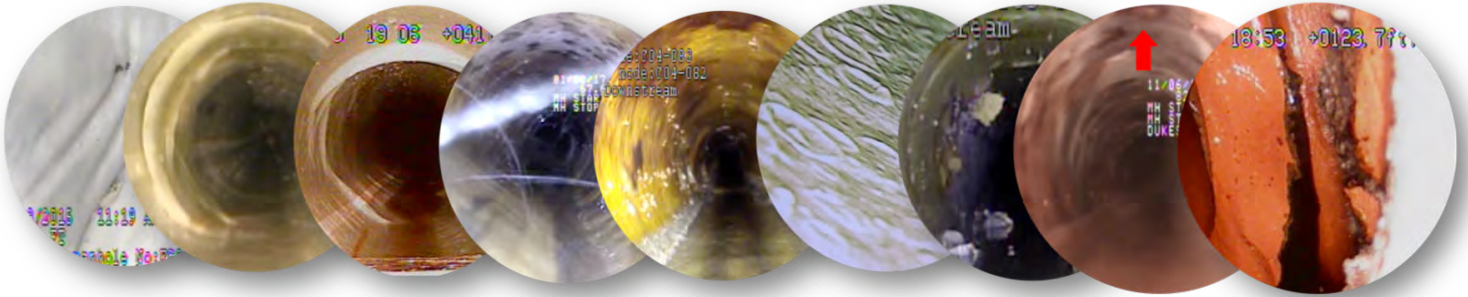
Finding & Measuring Defects Missed By CCTV

CIPP May Not Reduce Infiltration If Not Properly Installed or Tested

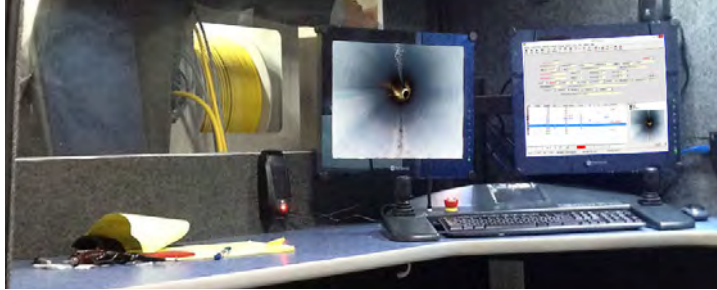
CCTV or Visual Inspection NOT ABLE To Test CIPP Liners.

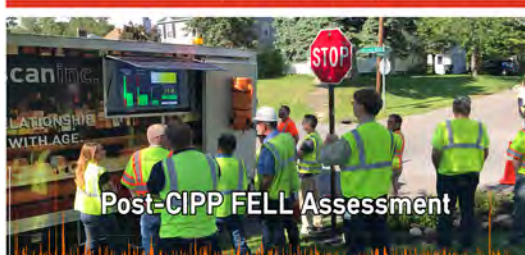
Post-CIPP CCTV ZERO PACP DEFECTS

Structural		O & M		Overall	
Grade 1	Index	Grade 1	Index	Grade 1	Index
Grade 2		Grade 2		Grade 2	
Grade 3		Grade 3		Grade 3	
Grade 4		Grade 4		Grade 4	
Grade 5		Grade 5		Grade 5	
Rating	Quick	Rating	Quick	Rating	Quick
	0000		0000		0000

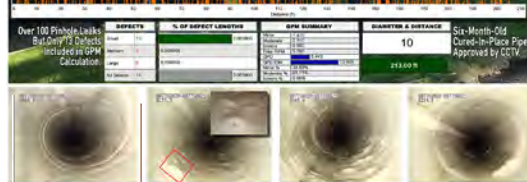
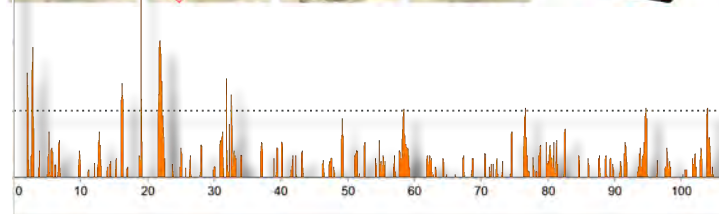
Post-CIPP FELL Assessment

BUT, CURED-IN-PLACE PIPE (CIPP) FAILED 6 MONTHS AFTER CURING.

**NOT SEEN BY
CCTV**

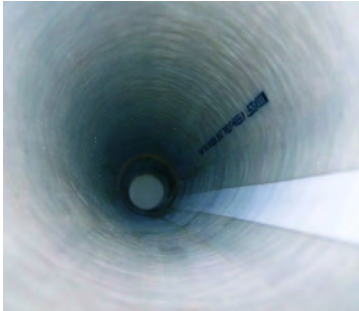
Post-CIPP, Pre-Lateral Reinstatement

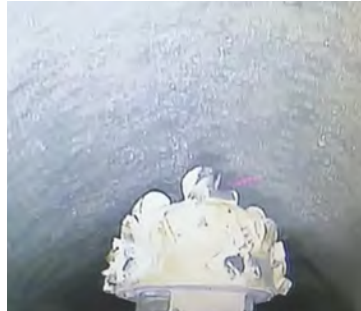
Poor Lateral Cutting Positioning

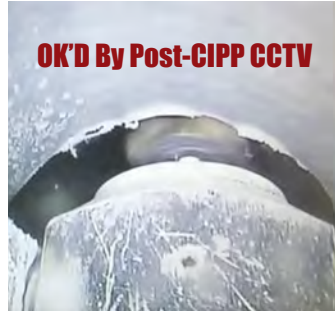
Damage to Lateral Not Present Pre-CIPP

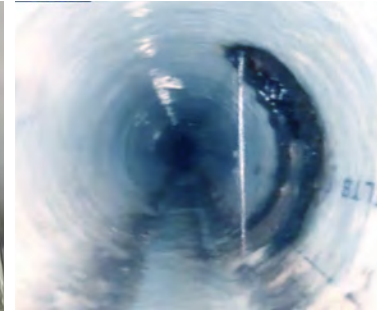
Active Infiltration Where None Occurred

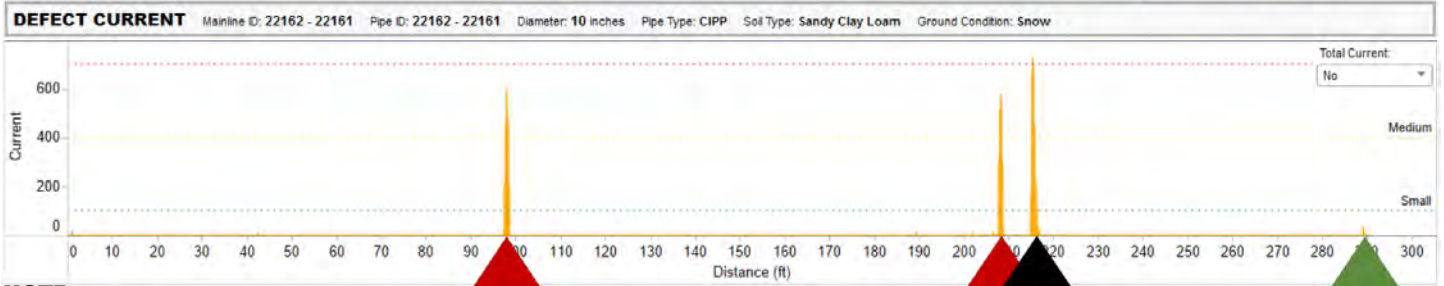
Leaking Laterals & Liner Defects Immediately Detected By FELL After CIPP Curing

DEFECTS		% OF DEFECT LENGTHS	GPM SUMMARY		DIAMETER & DISTANCE		OPERATOR INFO	
Small	1	0.00080	Minor	0.600	10	291.00 ft	Tech Electroscan	
Medium	2	0.00740	Moderate	0.000			Project	
Large	1	0.00310	Severe	20.570	Demo		Job	
All Defects	4	0.01130	Total GPM	21.170	Demo		Demo	
			GPD	30.485			Atmospheric Test	
			GPD IDM	55.322			Scan Start	
			Minor %	2.83%			1/19/2018 6:13:51 AM	
			Moderate %	0.00%			1/19/2018 7:08:36 AM	
			Severe %	97.17%

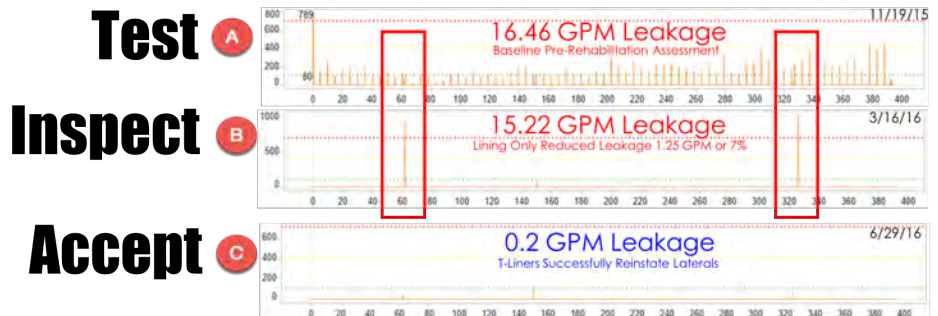
Minimal Reductions in Infiltration Tied to Poor Quality Assurance Testing of Rehabilitation

Date	Pipe ID	Diameter	Pipe Type	Small Defects	Medium Defects	Large Defects	GPM	GPD	GPD/IDM
11/19/2015	A 1-35-1-34	8	VCP	54	2	1	16.46	23,702	30,592
3/16/2016	B 1-35-1-34	8	CIPP	0	0	2	15.22	21,917	36,908
6/29/2016	C 1-35-1-34	8	CIPP	1	0	0	0.20	288	481

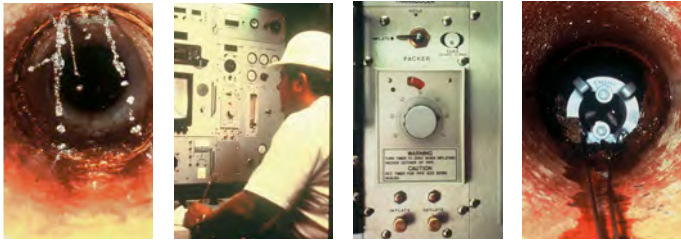
Chemical Grout for Pipe Joints & Laterals

JOINTS

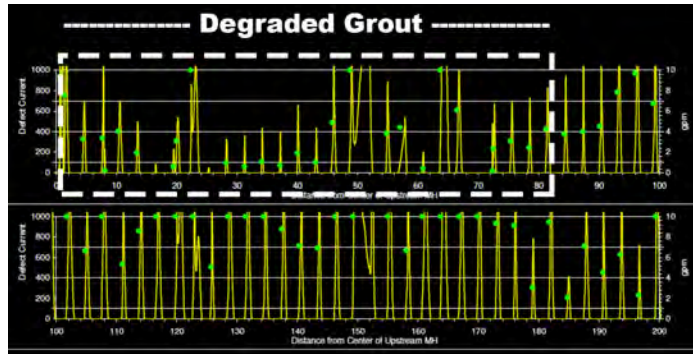
FELL Testing Calibrated to Pre- Post- and Legacy Grout By a National Grout Supplier & Contractor

Diameter for Water Height Label:	18
Mainline ID:	MH1 - MH2
Ground Condition:	Dry
Pipe ID:	MH1 - MH2
Pipe Type:	VCP
Scan Detail Id:	361479778
Soil Type:	Clay
Small:	100.0
Medium:	400.0
Large:	700.0
Min. Select Current:	20.4
Min. Detail Distance (ft):	20.4
Min. final corrected defect current:	3,495

When FELL readings are 1,000 amps or below, calibration tests of 15-year old grouted joints confirms that visible infiltration was evident where lines were previously grouted.

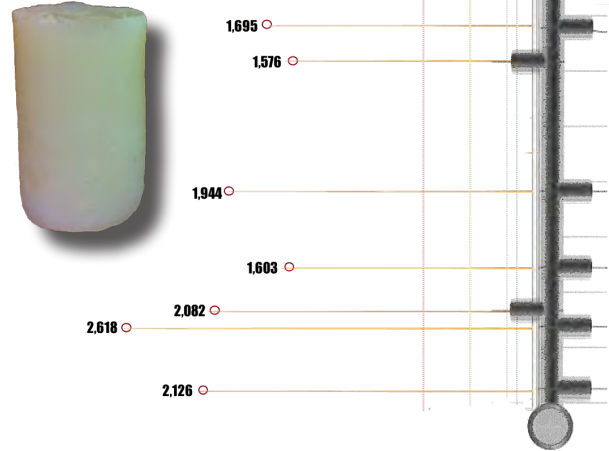
GOOD LATERAL

All Readings Above 1,000 amps

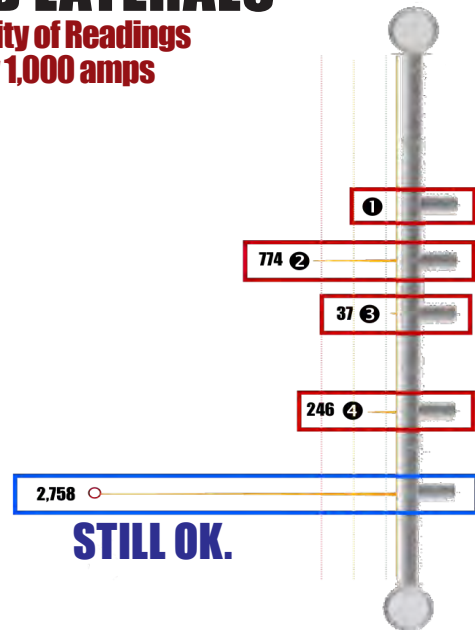
BAD LATERALS

Majority of Readings Below 1,000 amps

- Grout has decayed and is now termed defective.
- Grout was not applied in enough quantities to fully correct a prior leak, or
- Suspected 'leak' was not sufficient to warrant grout, therefore resulting in a lower FELL reading.

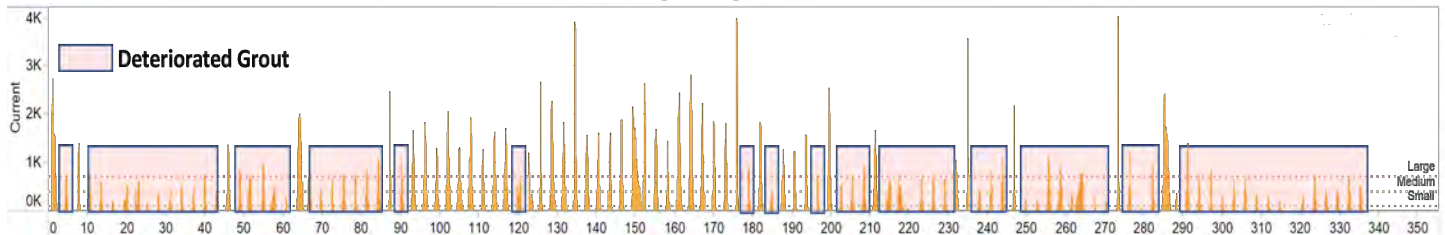
SAMPLE 15-Year Old Grout Showing Signs of Active Infiltration By CCTV

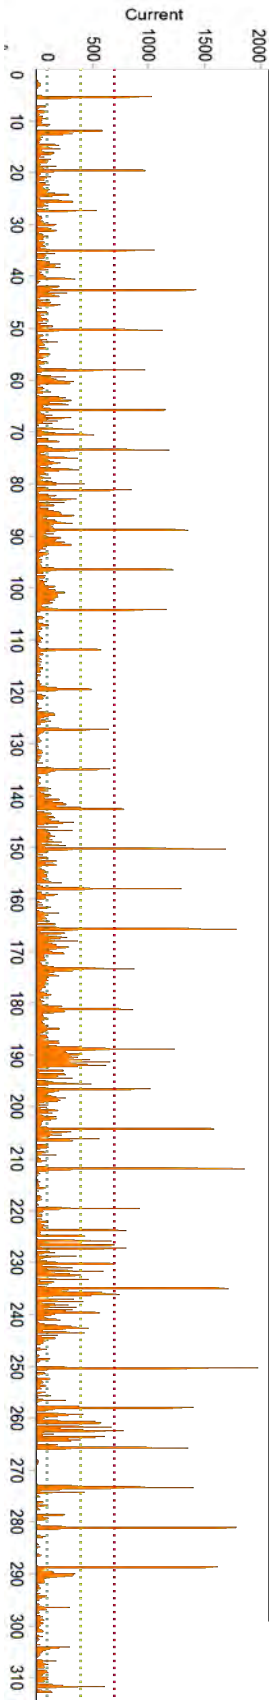
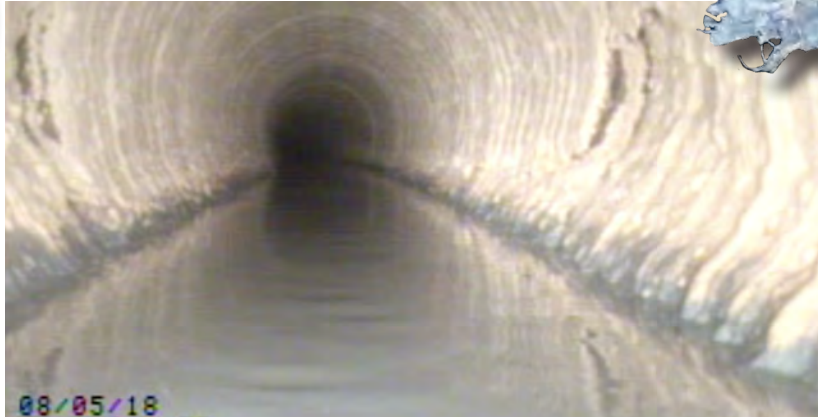
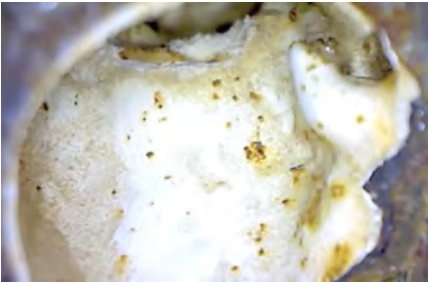
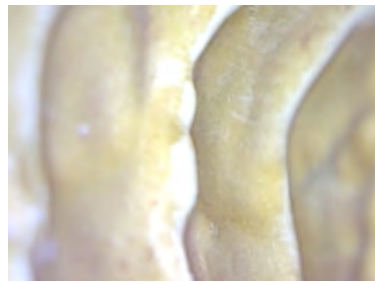
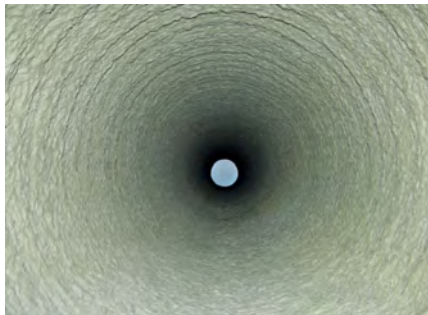
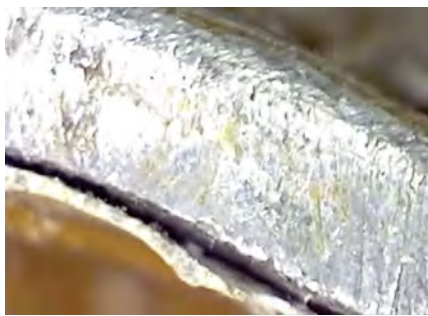
Sewer Main SIPP Assessment

FELL and ASTM F2550 is the new recommended standard to assess Spray-In-Place Pipe (SIPP) for watertightness.

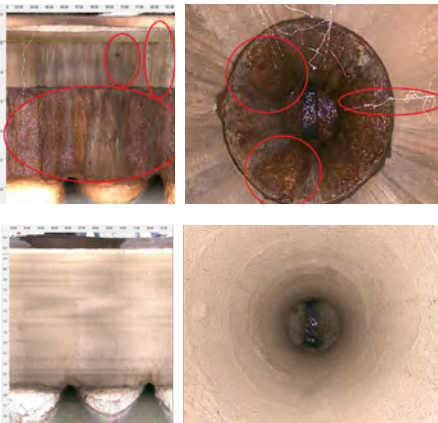
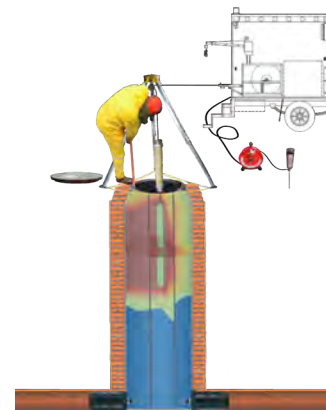
Manhole SIPP Assessment
