## Machine-Intelligent Non-Acoustic Leak Detection

1745 Markston Road  
Sacramento, California 95825  
Tel: +1 916 779 0660  
<https://www.electroscan.com> | Email: [info@electroscan.com](mailto:info@electroscan.com)

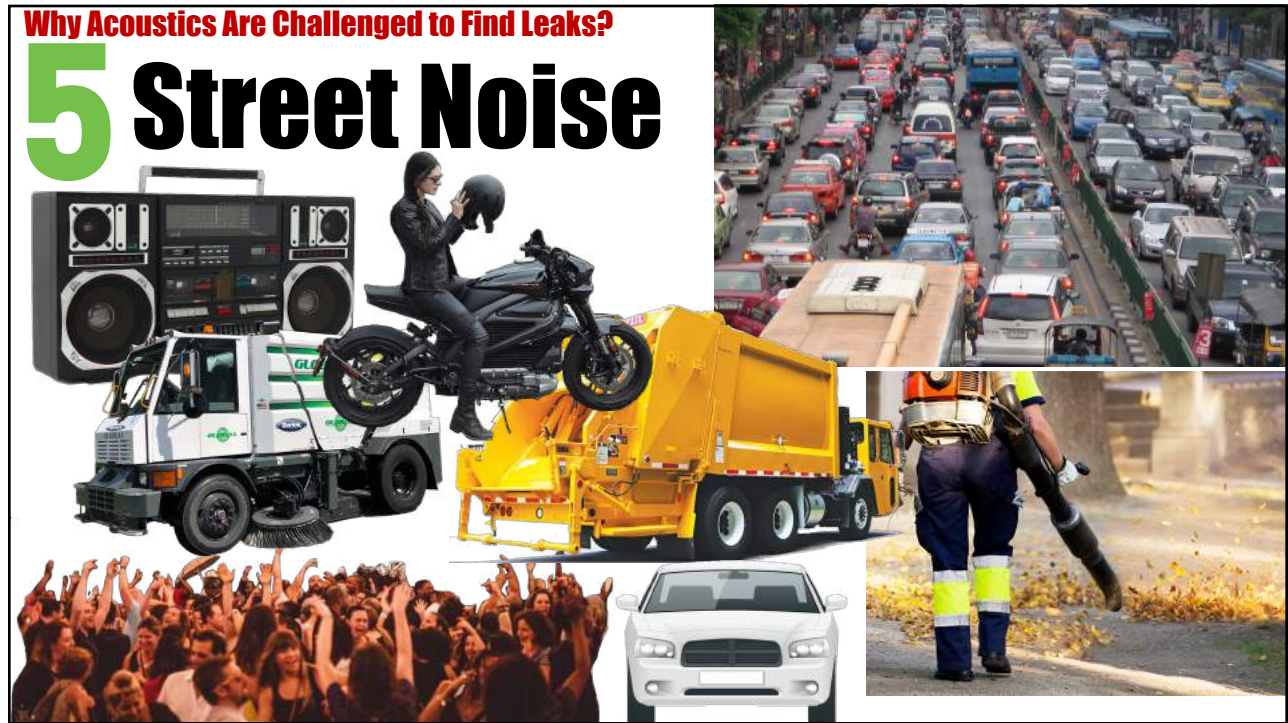
# 5 Street Noise

This collage illustrates various sources of street noise. It includes a large boombox, a person on a motorcycle, a white street sweeper truck, a yellow garbage truck, a white car, a crowd of people at a concert, a traffic jam on a highway, and a worker in safety gear using a tool on a road.

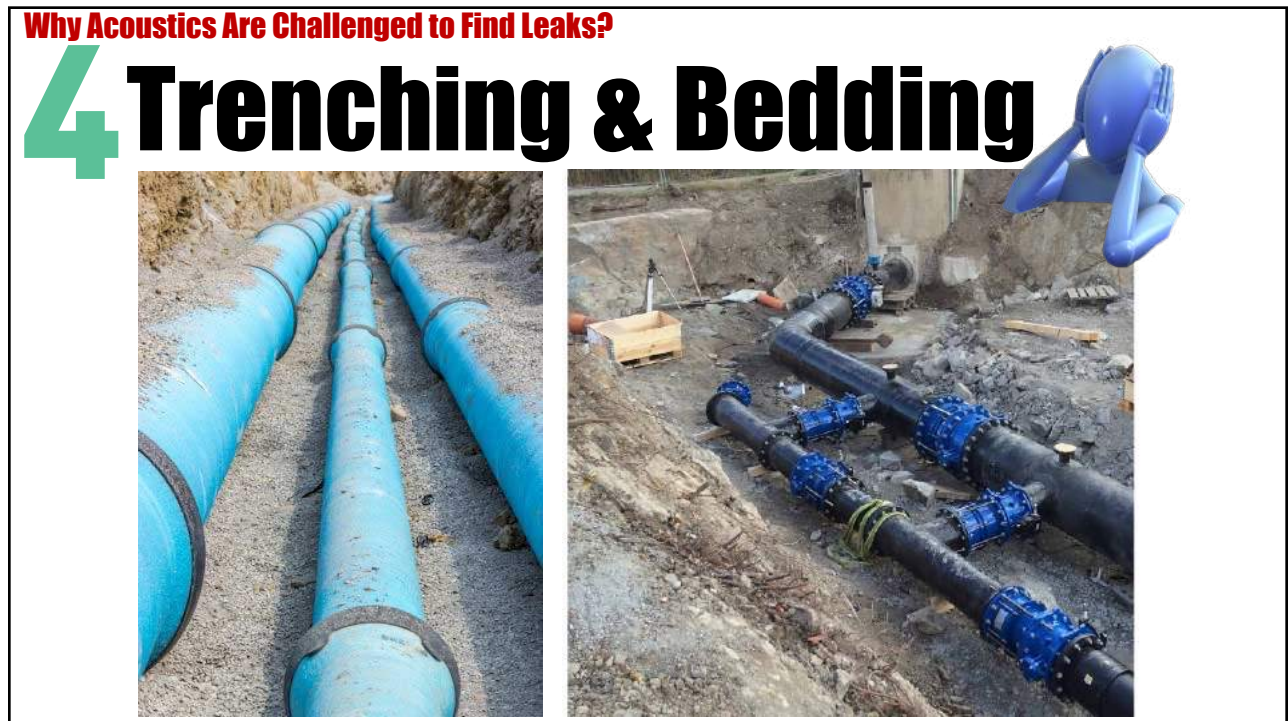
# 4 Trenching & Bedding

This section shows two photographs of trenching and bedding work. The left photo shows blue pipes laid out in a trench. The right photo shows black pipes with blue valves being installed in a trench. A blue cartoon character is visible in the top right corner.

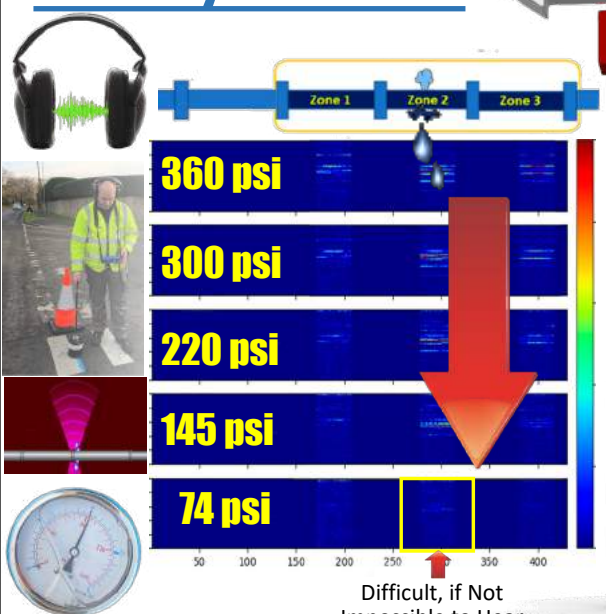
# 1 Acoustics Can't Hear Leaks at Low Pressures

**'Ability to Hear'** **OLD WAY**

**NEW WAY** **electroscaninc. 'Size of Hole'**

360 psi  
 300 psi  
 220 psi  
 145 psi  
 74 psi

Difficult, if Not Impossible to Hear

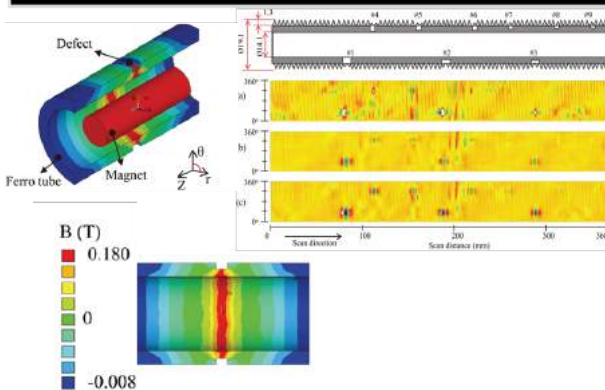
## ELECTRO-MAGNETIC

**No Precise Leak Location.**

**Unable to Estimate Leak Quantity.**

**Prone to Stray Interference.**

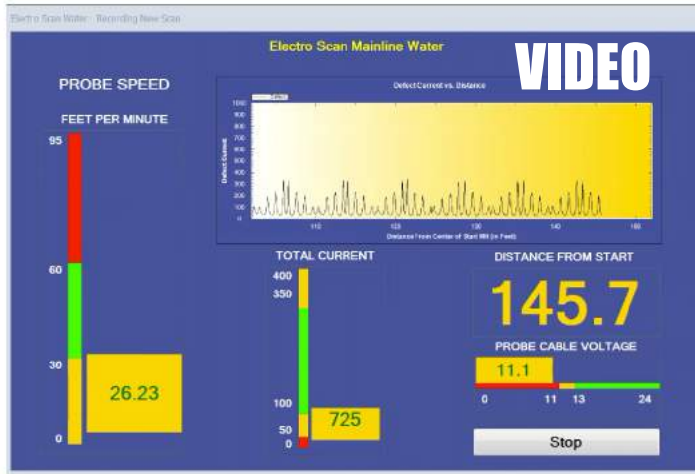
### Scientific Principle

**Bernoulli Equation, Plus Ohms' Law,  
 Plus Torricelli's Law.**

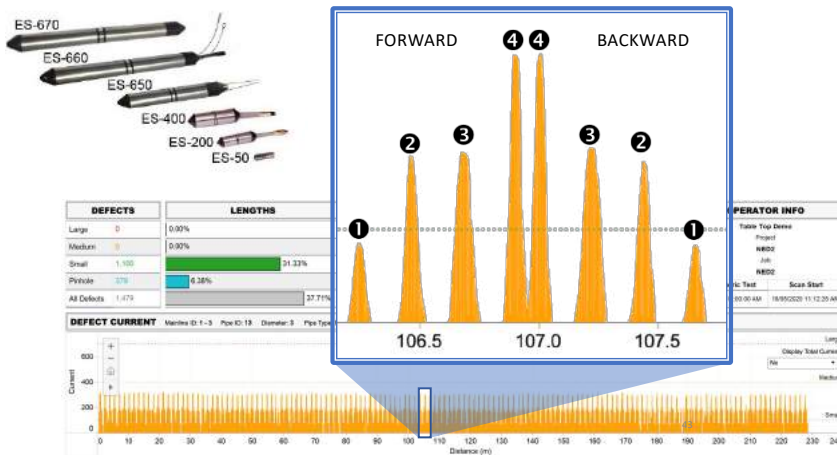
### Scientific Principle

**Electro Scan's Use of Ohms Law  
 Provides Unmatched Data Repeatability.**

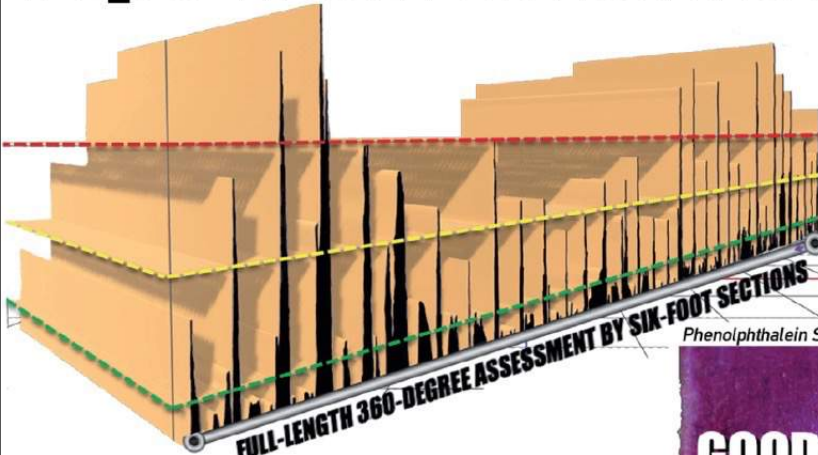
# Pipe Wall Thickness

**FULL-LENGTH 360-DEGREE ASSESSMENT BY SIX-FOOT SECTIONS**

Wall Thickness Measured By Electro Scan.  
Missed By Acoustic Sensors & CCTV Cameras.

Asbestos Cement Pipe  
Pipe Wall Thickness Measurement

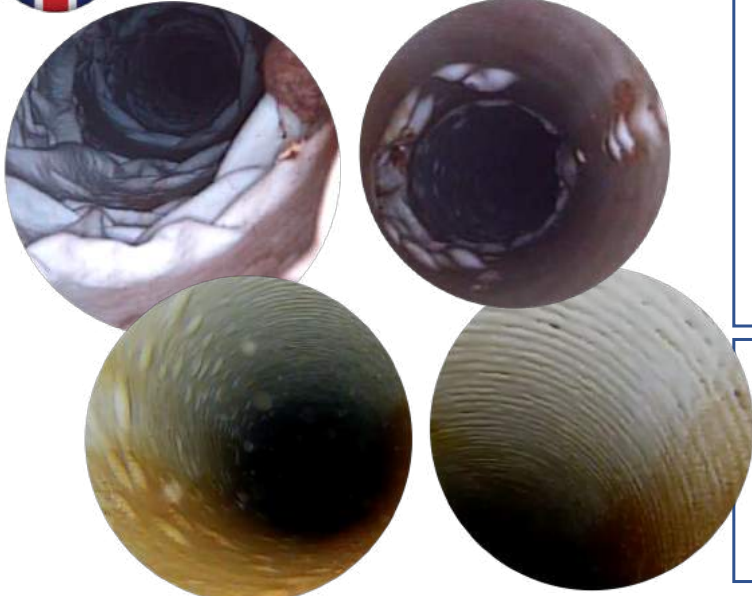
Trenchless Pressurized Water Main Rehabilitation

**CIPP By Curing Method**

- 1. THERMAL-CURED CIPP Boiling Water
- 2. STEAM-CURED CIPP
- 3. UV-CURED CIPP
- 4. LED-CURED CIPP

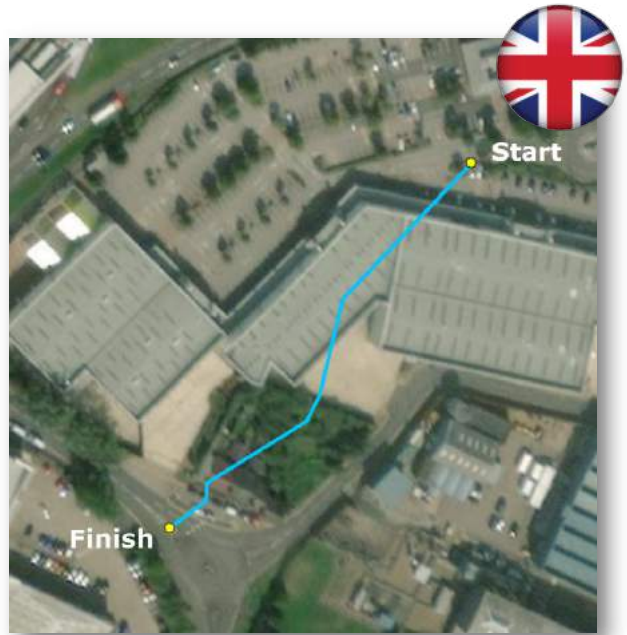
# DELTA Case Study #1

**561ft (171m) Pipe Length**  
**24in (800mm) Diameter**  
**Cement Mortar Lined Ductile Iron**

1. **FAILED** Multiple Hydrostatic Test
2. **NO LEAKS RECORDED** by Previous Tests
  - a. Acoustic Hydrophone
  - b. Data Loggers & Helium Tracer
  - c. In-Pipe Tethered Acoustic Sensors
3. **PRESSURES** are Erratic
4. **FLOW** is Turbulent
5. **NOISEY** Street Traffic

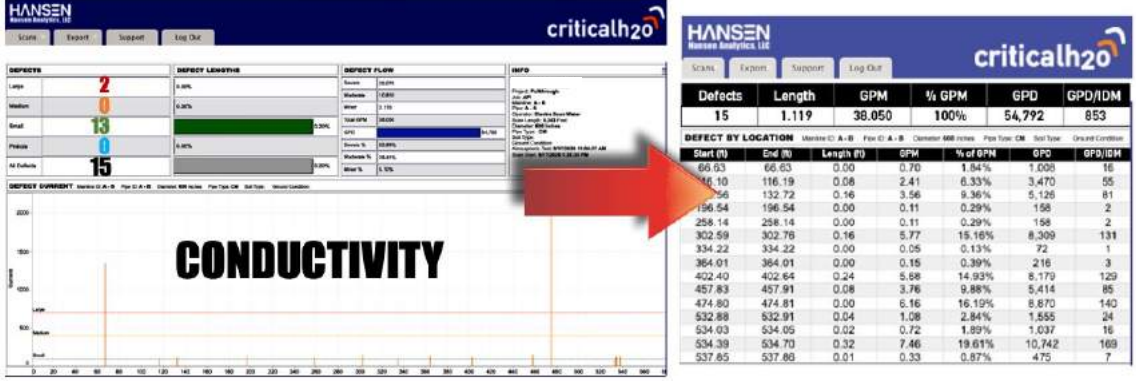
DEFECTS	
Large	2
Medium	0
Small	13
Pinhole	0
All Defects	15

DEFECT FLOW	
Severe	25.070
Moderate	10.810
Minor	2.170
<b>Total GPM</b>	<b>38.050</b>
GPD	54,792
Severe %	65.89%
Moderate %	28.41%
Minor %	5.70%

GPM = 38.050

Defects	Length	GPM	% GPM	GPD	GPD/IDM
15	1.119	38.050	100%	54,792	853

Defect (ft)	End (ft)	Length (ft)	GPM	% of GPM	GPD	GPD/IDM
66.63	66.63	0.00	0.70	1.84%	1,005	16
66.10	116.19	0.08	2.41	6.33%	3,470	55
56	132.72	0.16	3.56	9.36%	5,128	81
196.54	196.54	0.00	0.11	0.29%	158	2
258.14	258.14	0.00	0.11	0.29%	158	2
302.59	302.76	0.16	5.77	15.16%	8,309	131
334.22	334.22	0.00	0.06	0.13%	72	1
364.01	364.01	0.00	0.15	0.39%	216	3
402.40	402.64	0.24	5.68	14.93%	8,179	129
457.83	457.91	0.08	3.76	9.88%	5,414	85
474.80	474.81	0.00	6.16	16.19%	8,670	140
532.88	532.91	0.04	1.08	2.84%	1,555	24
534.03	534.05	0.02	0.72	1.89%	1,037	16
534.39	534.70	0.32	7.46	19.61%	10,742	169
537.85	537.86	0.01	0.33	0.87%	475	7

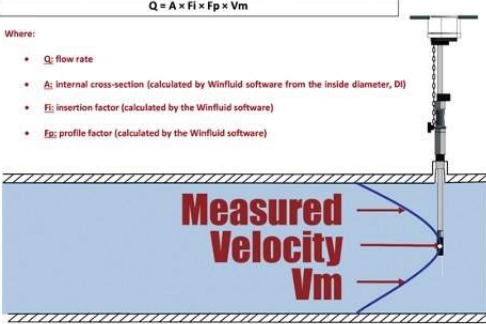
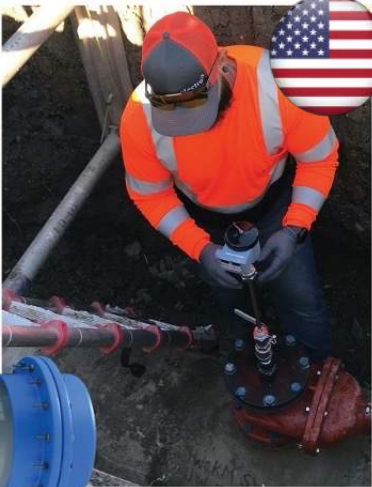
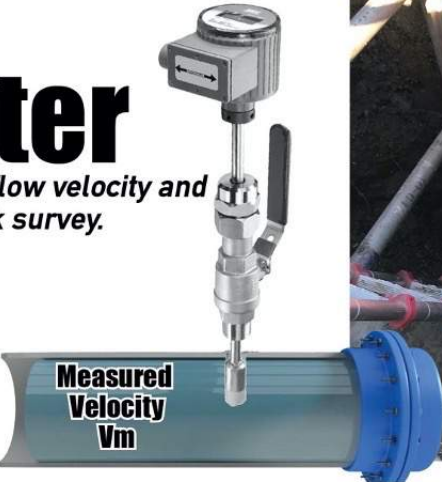
# 2 Flow Meter

*Electro Scan first measures flow velocity and flow direction before any leak survey.*

$Q = A \times F_i \times F_p \times V_m$

Where:

- $Q$ : flow rate
- $A$ : internal cross-section (calculated by Winfluid software from the inside diameter, DI)
- $F_i$ : insertion factor (calculated by the Winfluid software)
- $F_p$ : profile factor (calculated by the Winfluid software)

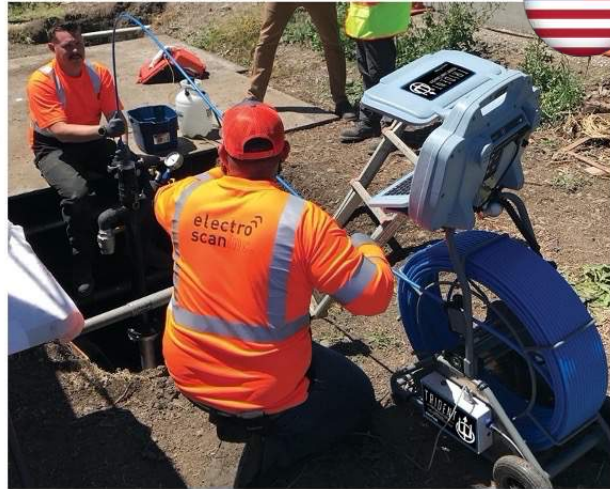
# 6 Push Reel

Utilizing a two-person team, Electro Scan's Trident is spooled off the reel and then pushed through the insertion tube for initial deployment.

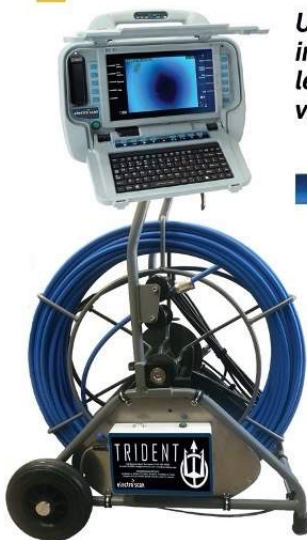
# 7 Data & Video Capture

Utilizing a two-person team, Electro Scan's TRIDENT is carefully 'spooled' into its insertion tube, then 'pushed' through the insertion tube for full pipe length deployment. Representing a breakthrough, data acquisition and video do not require operator interpretation.

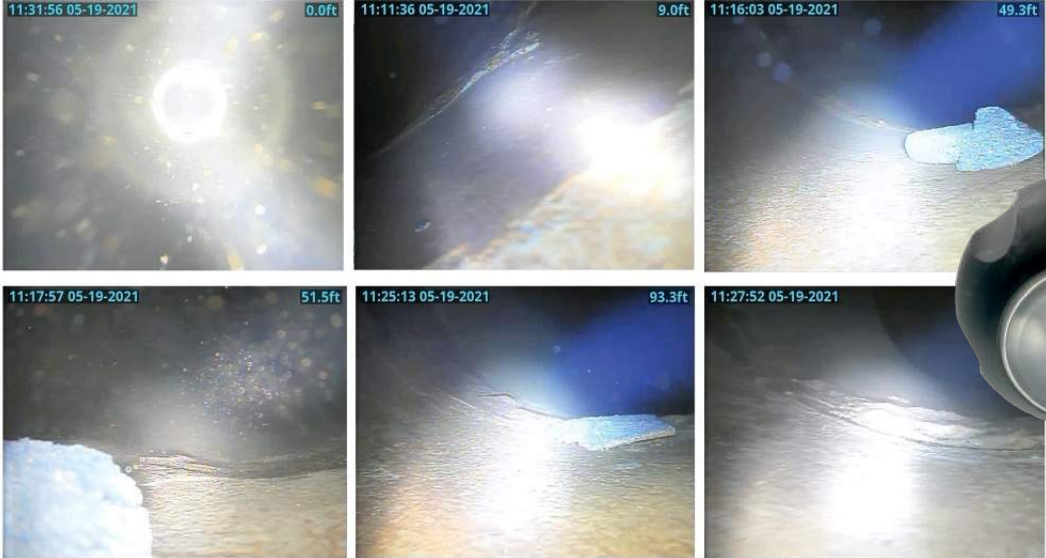
# 8 CCTV *Push Forward Direction*

11:31:56 05-19-2021 0.0ft

11:11:36 05-19-2021 9.0ft

11:16:03 05-19-2021 49.3ft

11:17:57 05-19-2021 51.5ft

11:25:13 05-19-2021 93.3ft

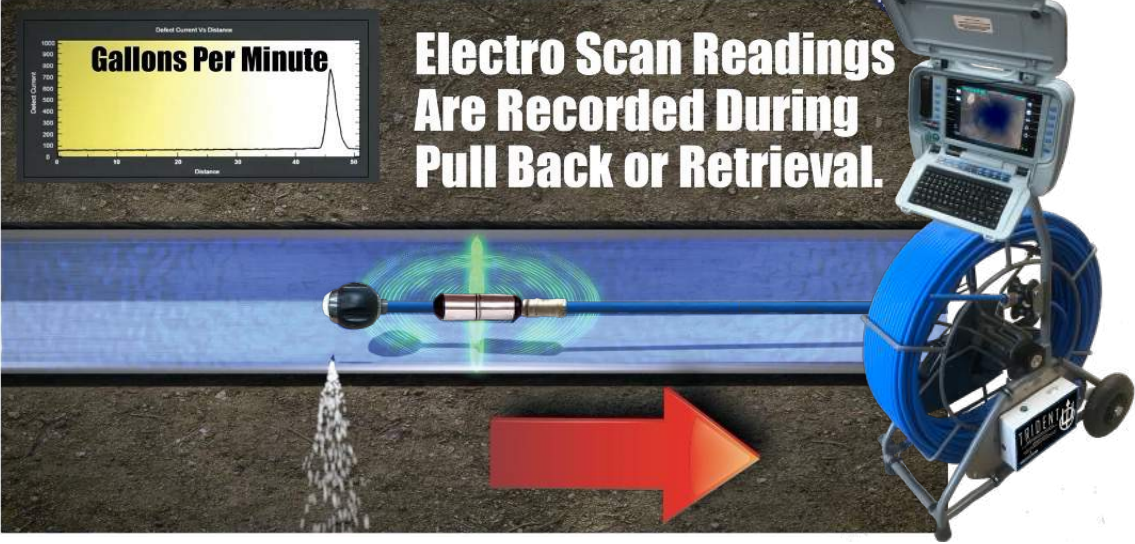
## Electro Scan Readings Are Recorded During Pull Back or Retrieval.

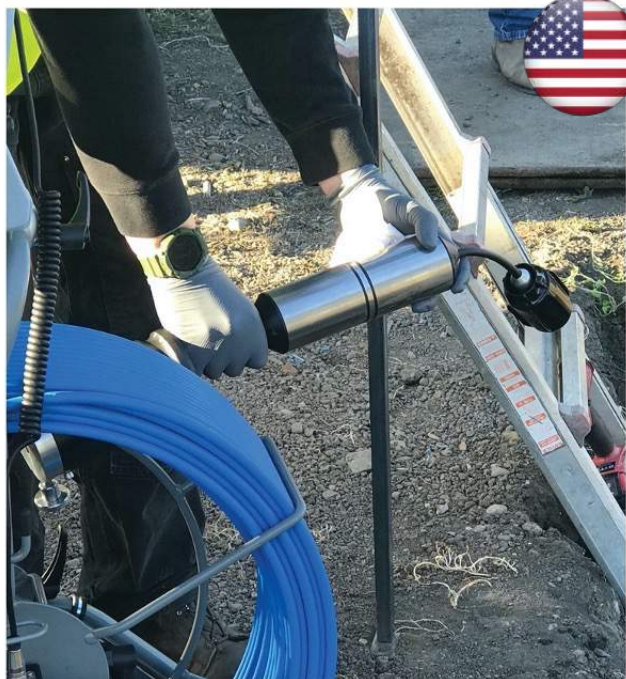
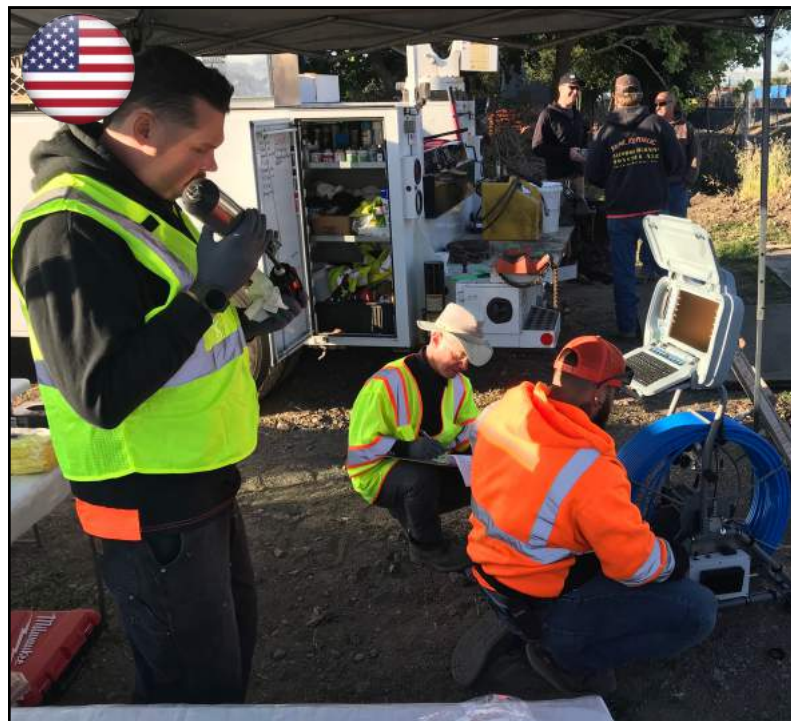
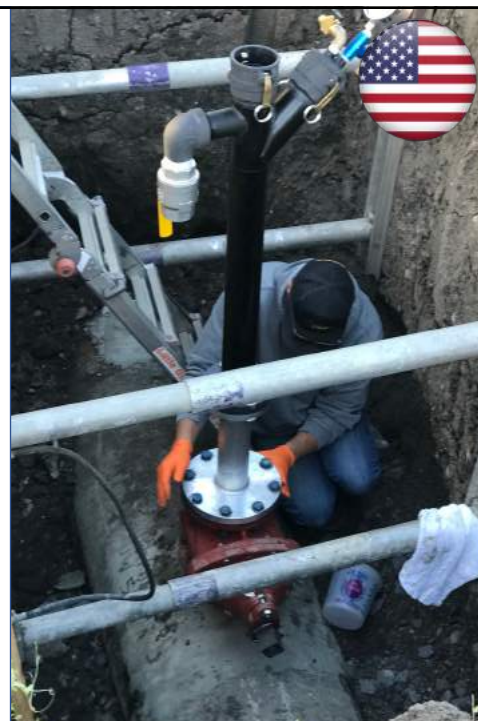
# 10 Probe Retrieval

*After the probe has exited the water main, while still in the insertion tube, the gate valve may be closed to allow for the probe to be fully retrieved from the pipe.*

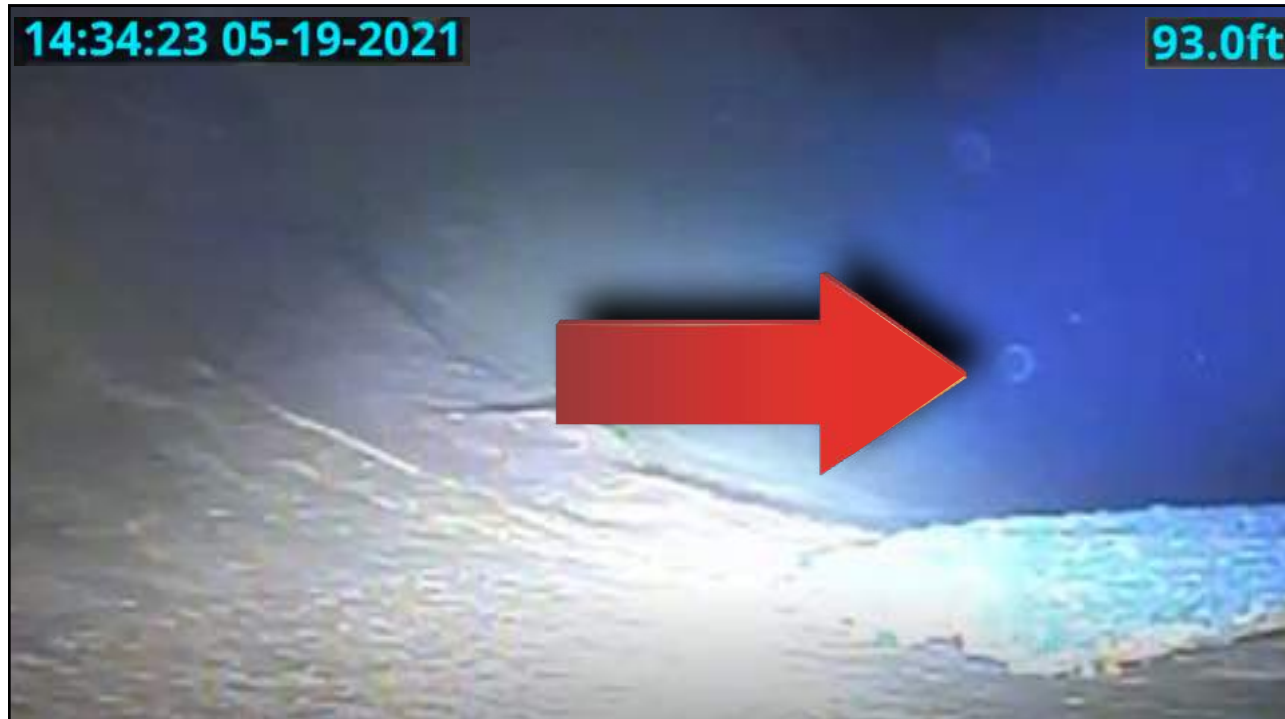
# 24" Lined Steel Pipe

4-Year Old  
Life-to-Date Leak  
20 Million Gallons
