USEPA Sewer Electro Scan Field Demonstration Revisited

Terry Moy¹, Charles G. Wilmut² and Robert J. Harris^{3*}

ABSTRACT

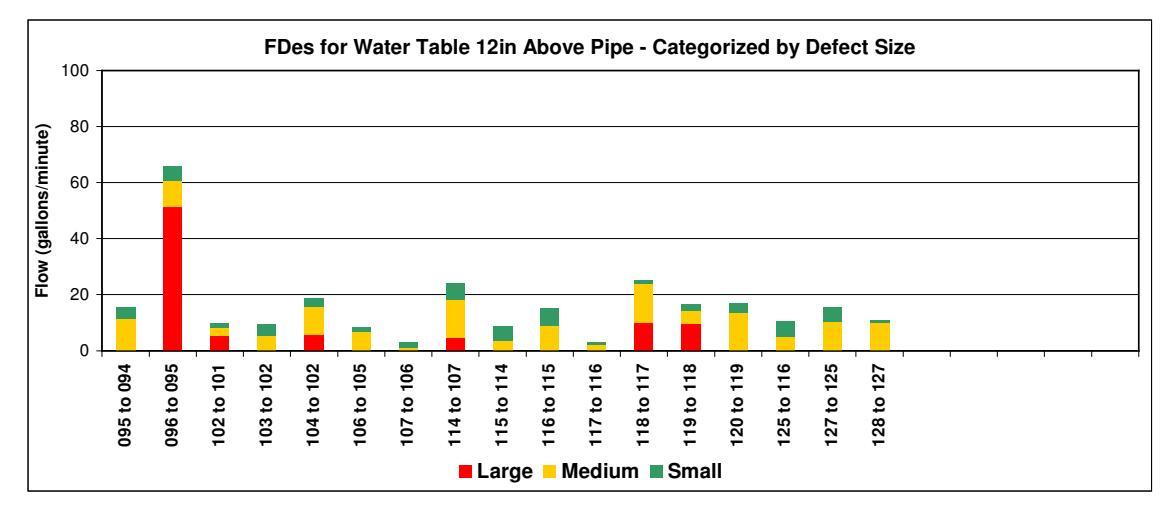
Figure 1.1 Total Defect Flow for Water Table 12in Above the Pipe – by Defect Size

The results of the electro scan processing are shown in Table 3 and graphically in Figures 1 and 2. In Table 3 the type of defect has been categorized as joint or other since at this time the processing software can only identify joint defects with an acceptable degree of certainty. The data in Table 3 shows that the source of about 80% of the potential RDI flow is from defects that are not joints. These sources are most likely due to faulty taps and faulty manhole to pipe connections. It can also be shown from the Table 3 data that repairing the "Other" defects in the worst pipe segments (096 to 095, 104 to 102, 114 to 107, 118 to 117) that is 26% of the total pipe length, has the potential to reduce RDI flow by 40%. Figure 1.2 makes readily apparent the effect of repairing all of the "Other" defects (mainly defective manhole connections and defective taps). Only the blue bars representing the joint defects would remain in Figure 1.2. That is 80% of the potential RDI would be removed.

There is a significant difference in the appearance of Figure 1 and Figure 2. It will depend on the objectives of the pipe condition assessment project whether DFes per Pipe Segment or DFes per 100ft is used. It is consider that the DFes per 100 ft of Pipe shown in Figure 2 is the most appropriate parameter to prioritize pipe segments for rehabilitation. Figure 2 shows that there is considerable variation of potential RDI flow between the pipe segments.

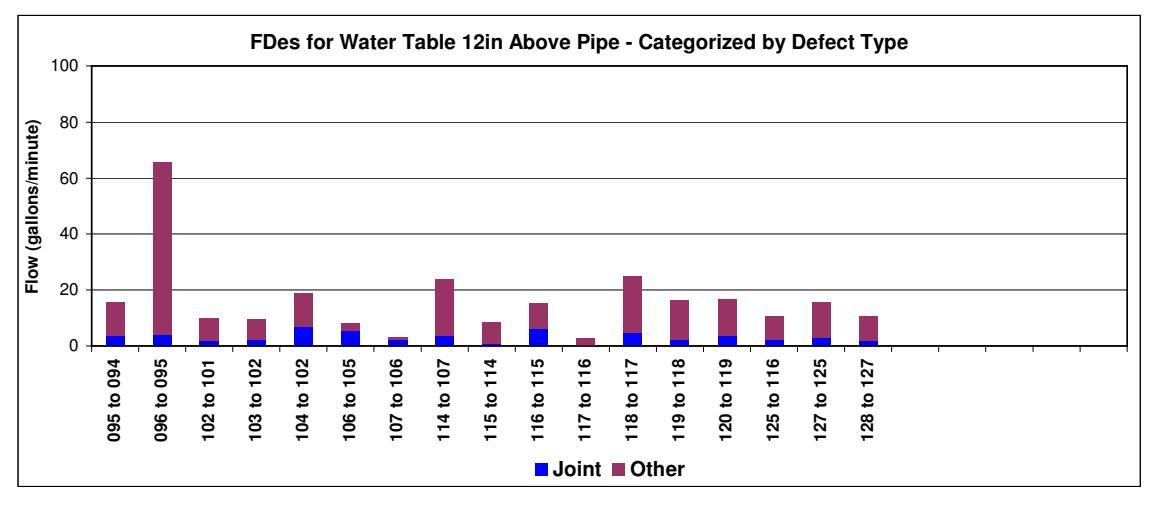
Figure 1.2 Total Defect Flow for Water Table 12 in Above the Pipe – by Defect Type

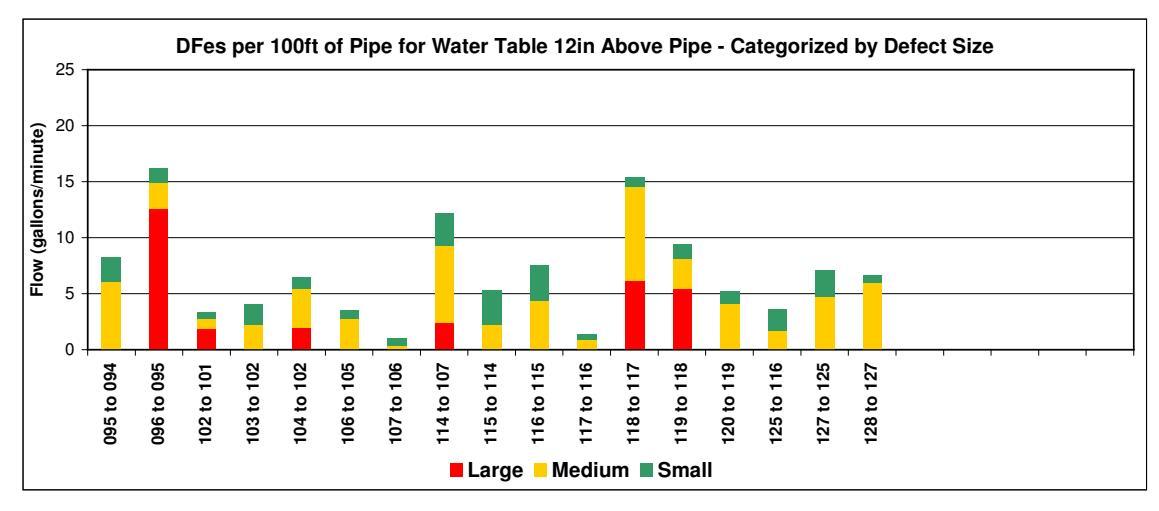
Figure 2.1 Defect Flow per 100 ft of Pipe for Water Table 12 in Above the Pipe – by Defect Size

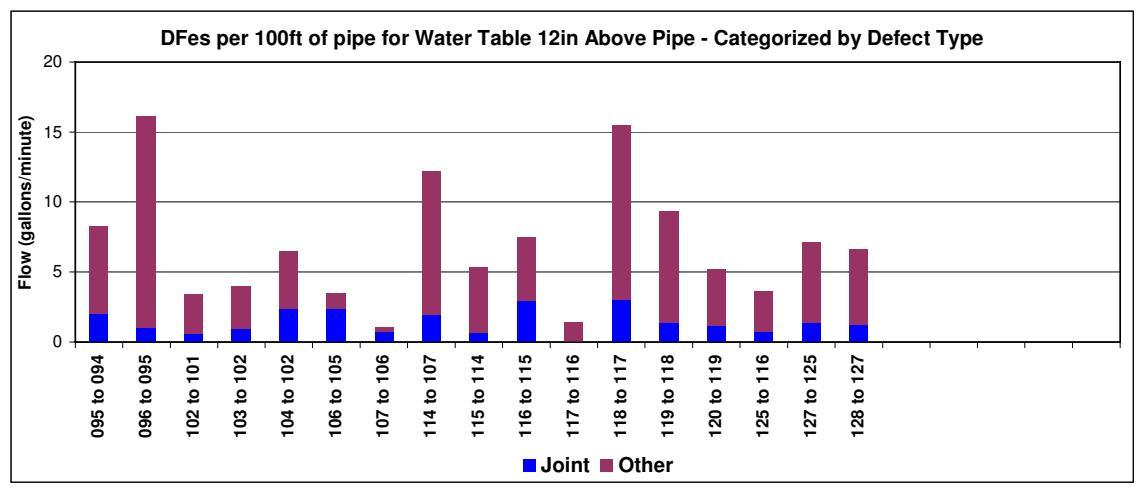
Figure 2.2 Defect Flow per 100 ft of Pipe for Water Table 12 in Above the Pipe – by Defect Type

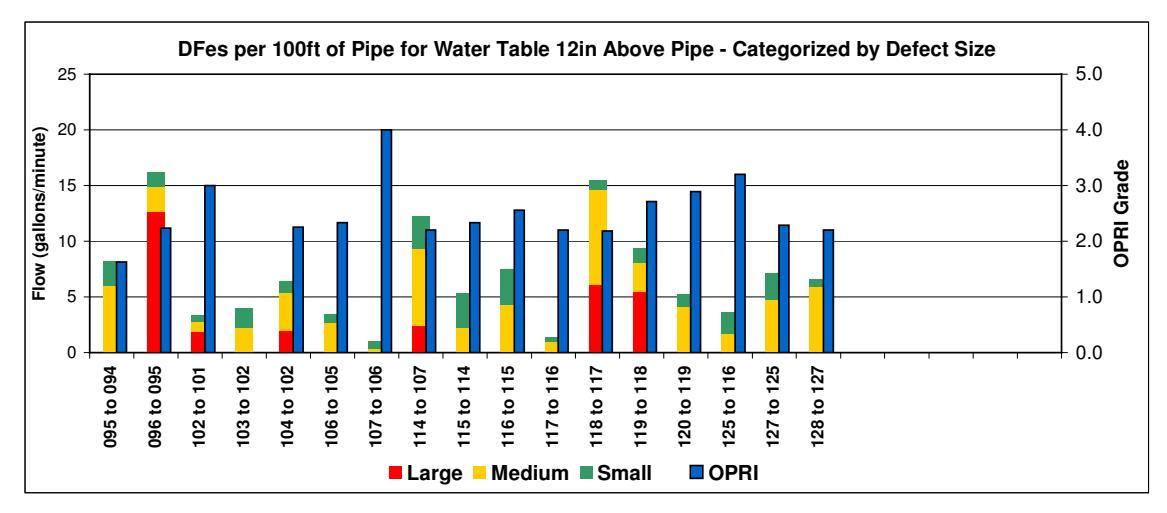
Figure 3. Comparison of the Defect Flow per 100 ft of Pipe with the Overall Pipe Index for Defects that are Potential Leaks

As a means of comparing the severity of the pipe defects observed by CCTV and those measured by electro scan the OPRI compiled according to the PACP method (NASSCO 2001) and the DFes per 100 ft of pipe for water table 12 in above the pipe are shown in Figure 3. The comparison shows that different pipe segments as the major contributors to potential leakage. The OPRI shows that pipe segments 107 to 106 and 125 to116 have the highest value and pipe segments 103 to 102 and 095 to 094 have the lowest value. The electro scan DFes per 100 ft shows that pipe segments 096 to 095 and 118 to 117 have the highest value and pipe segments 107 to 106 and 117 to 116 have the lowest value. The pipe segment 107 to 106 has the highest OPRI and the lowest DFes per 100 ft. Examination of the PACP codes for this pipe segment shows that it has one Grade 5 defect.

Since the DFes per 100 ft takes into account many more defects that can leak, if not all of them, than CCTV, it can be reasonably assumed that electro scan provides a much more reliable diagnostic for potential RDI than CCTV.

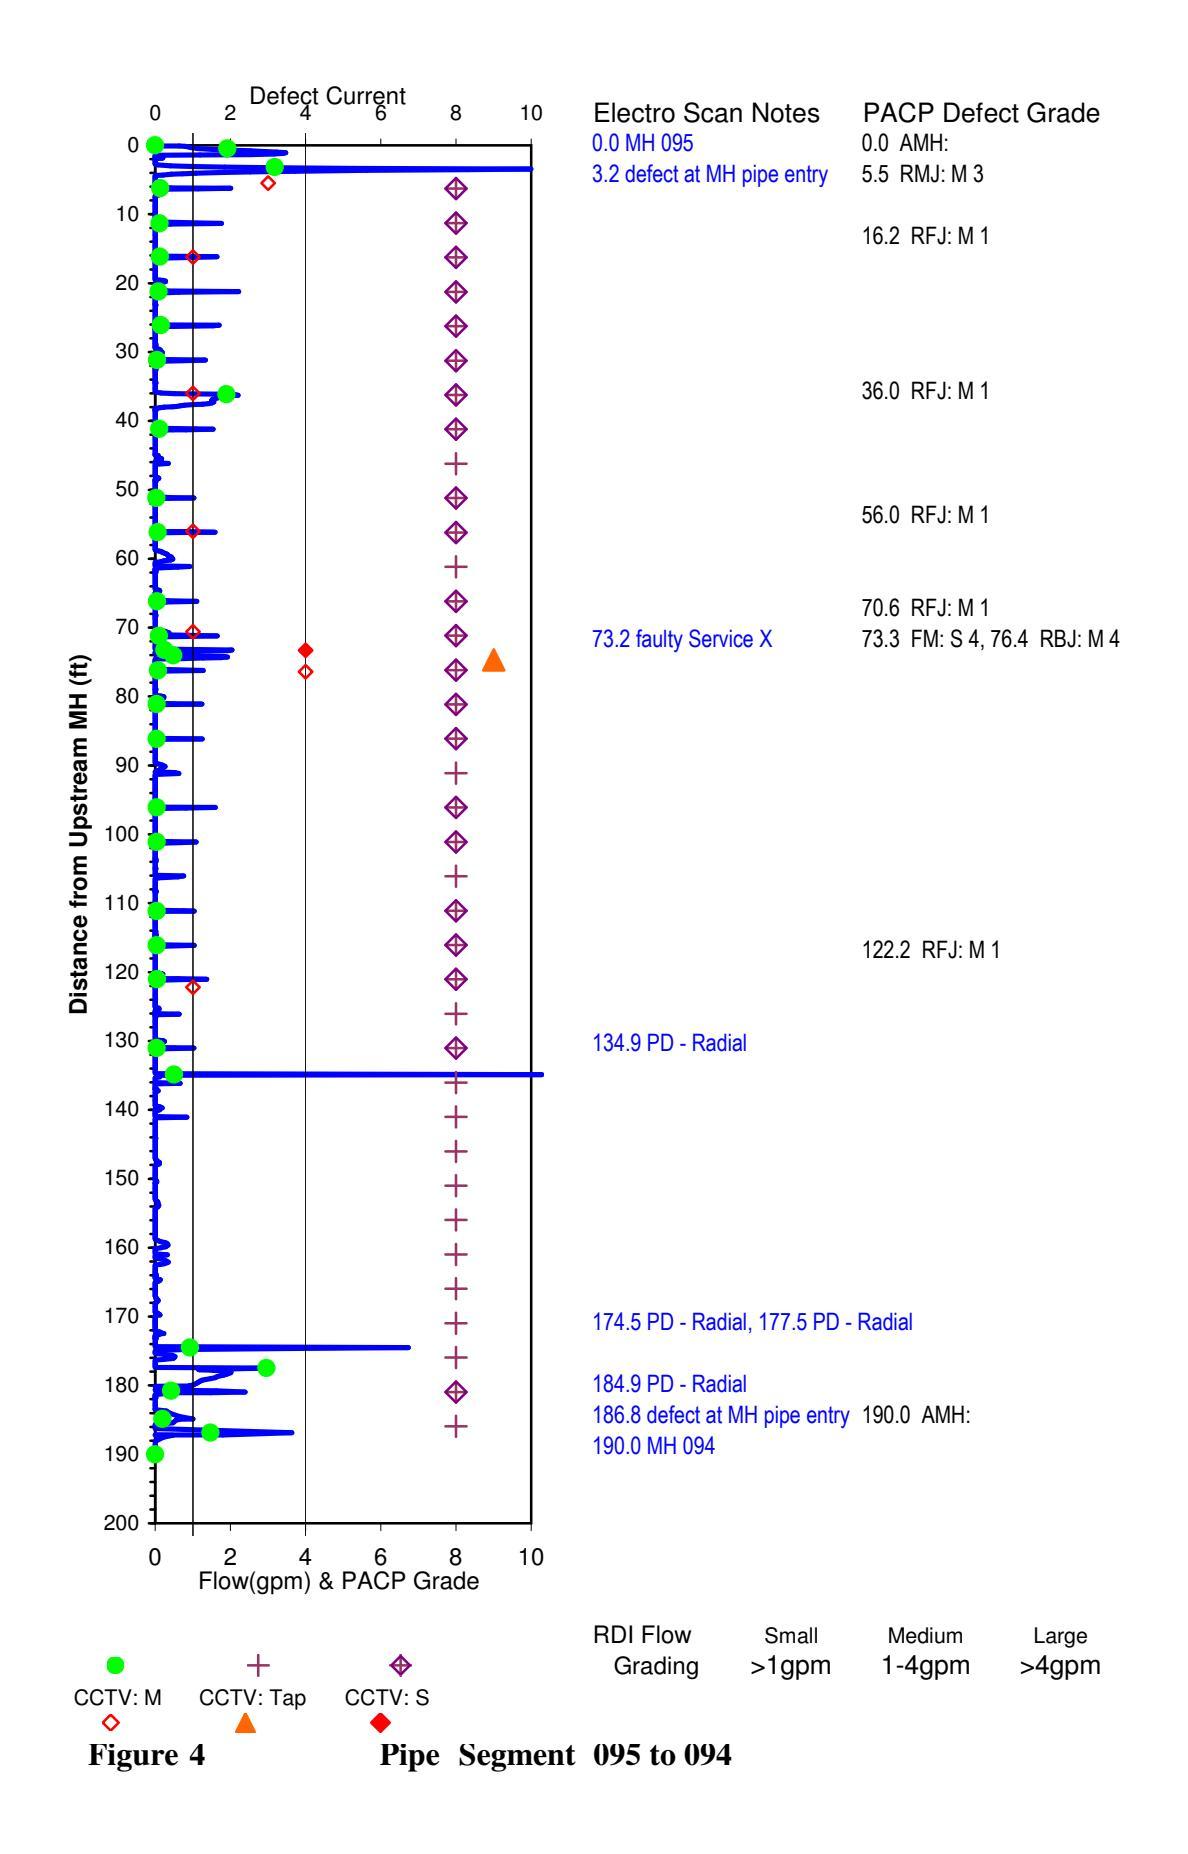
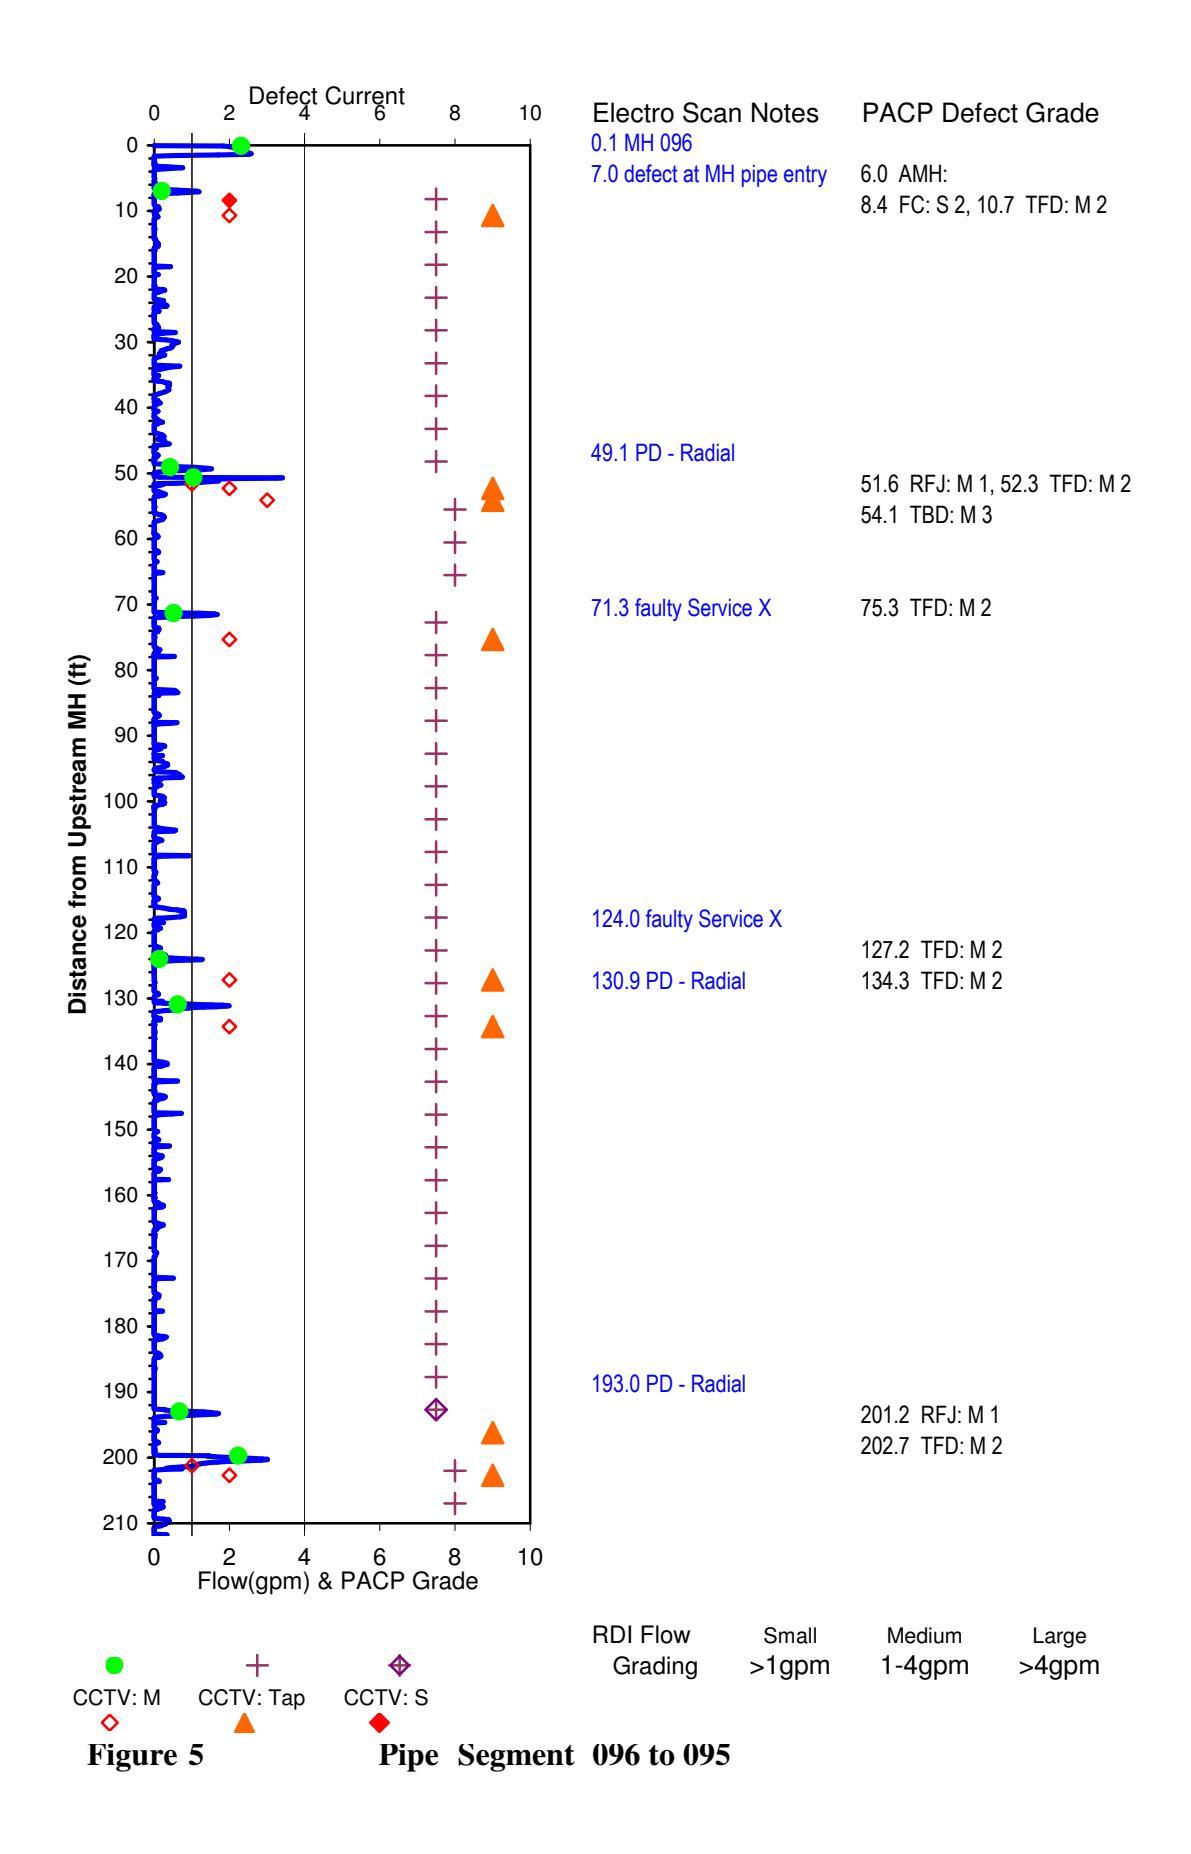
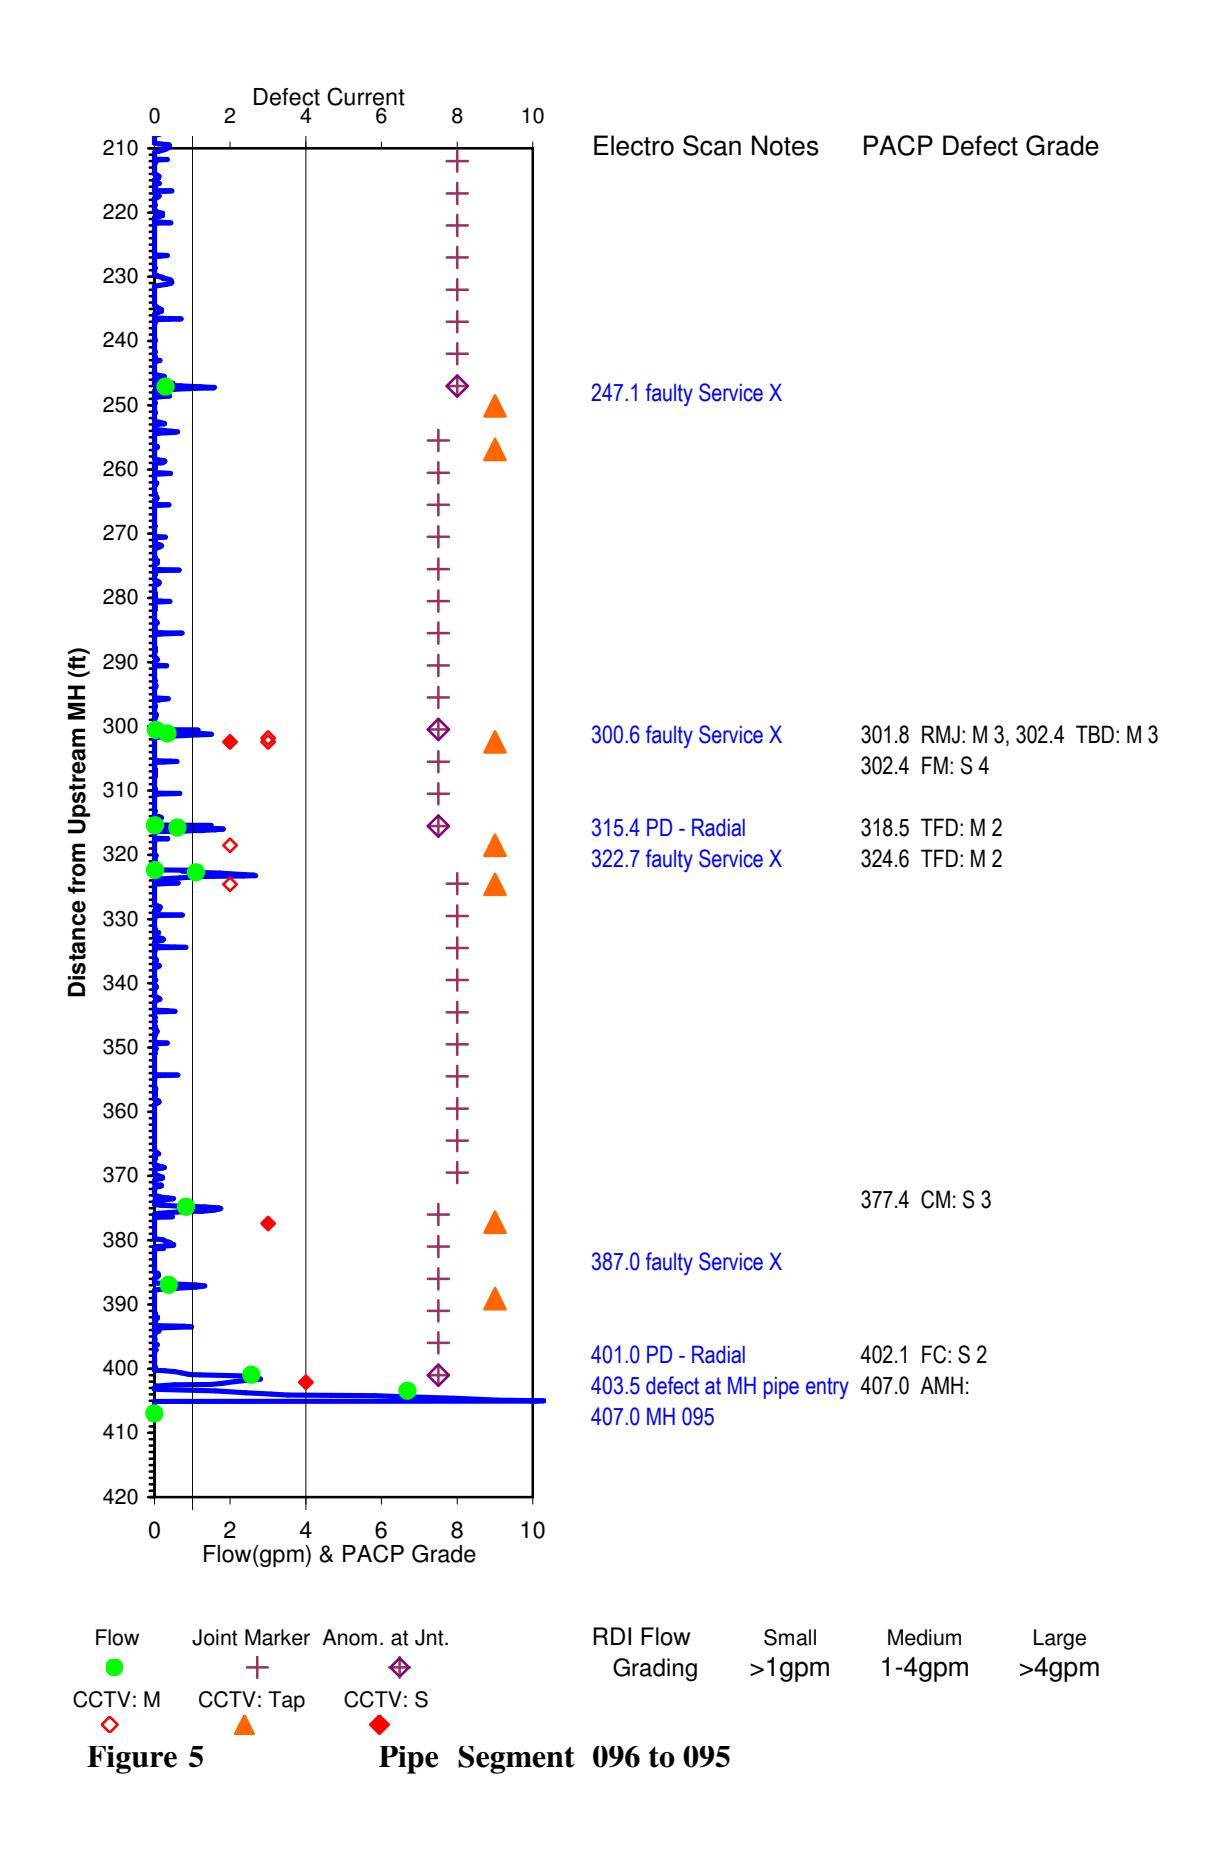
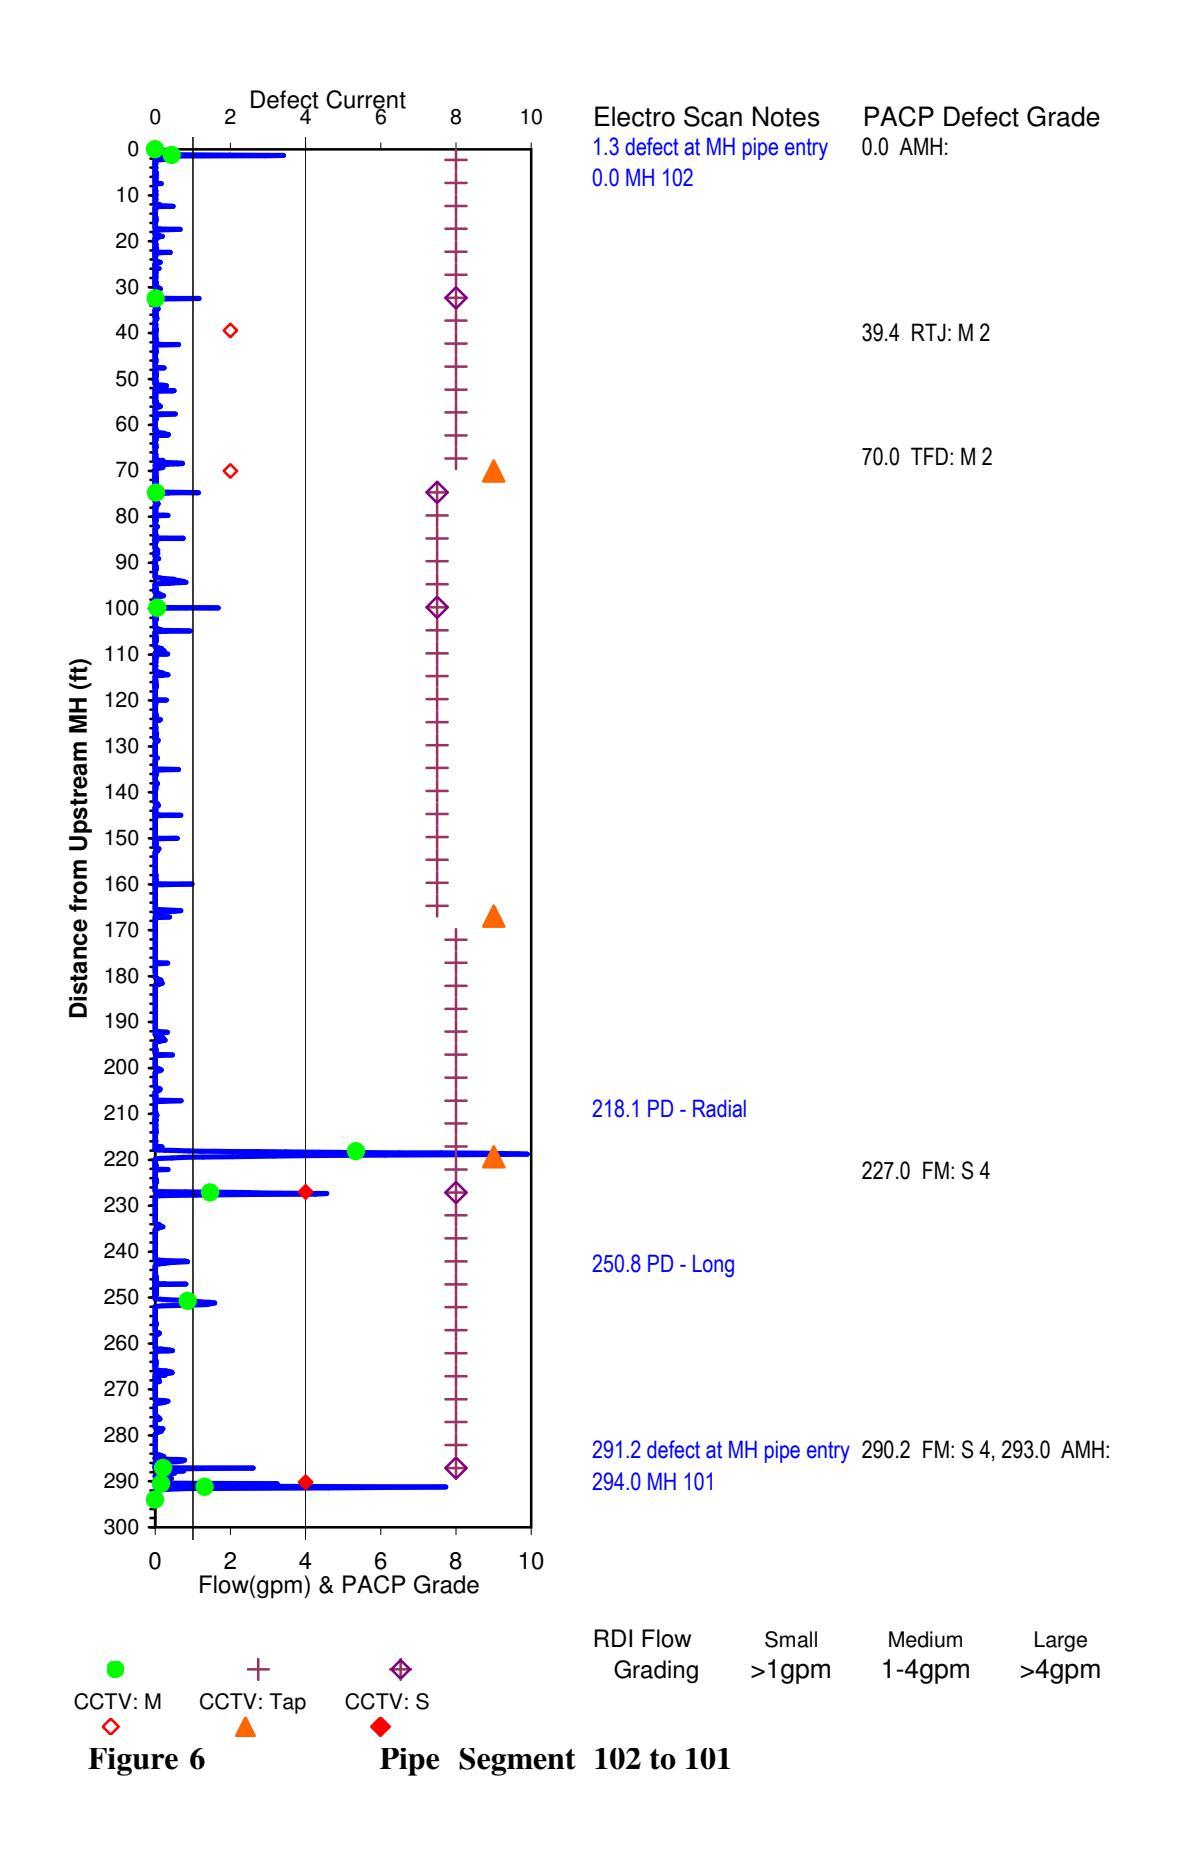
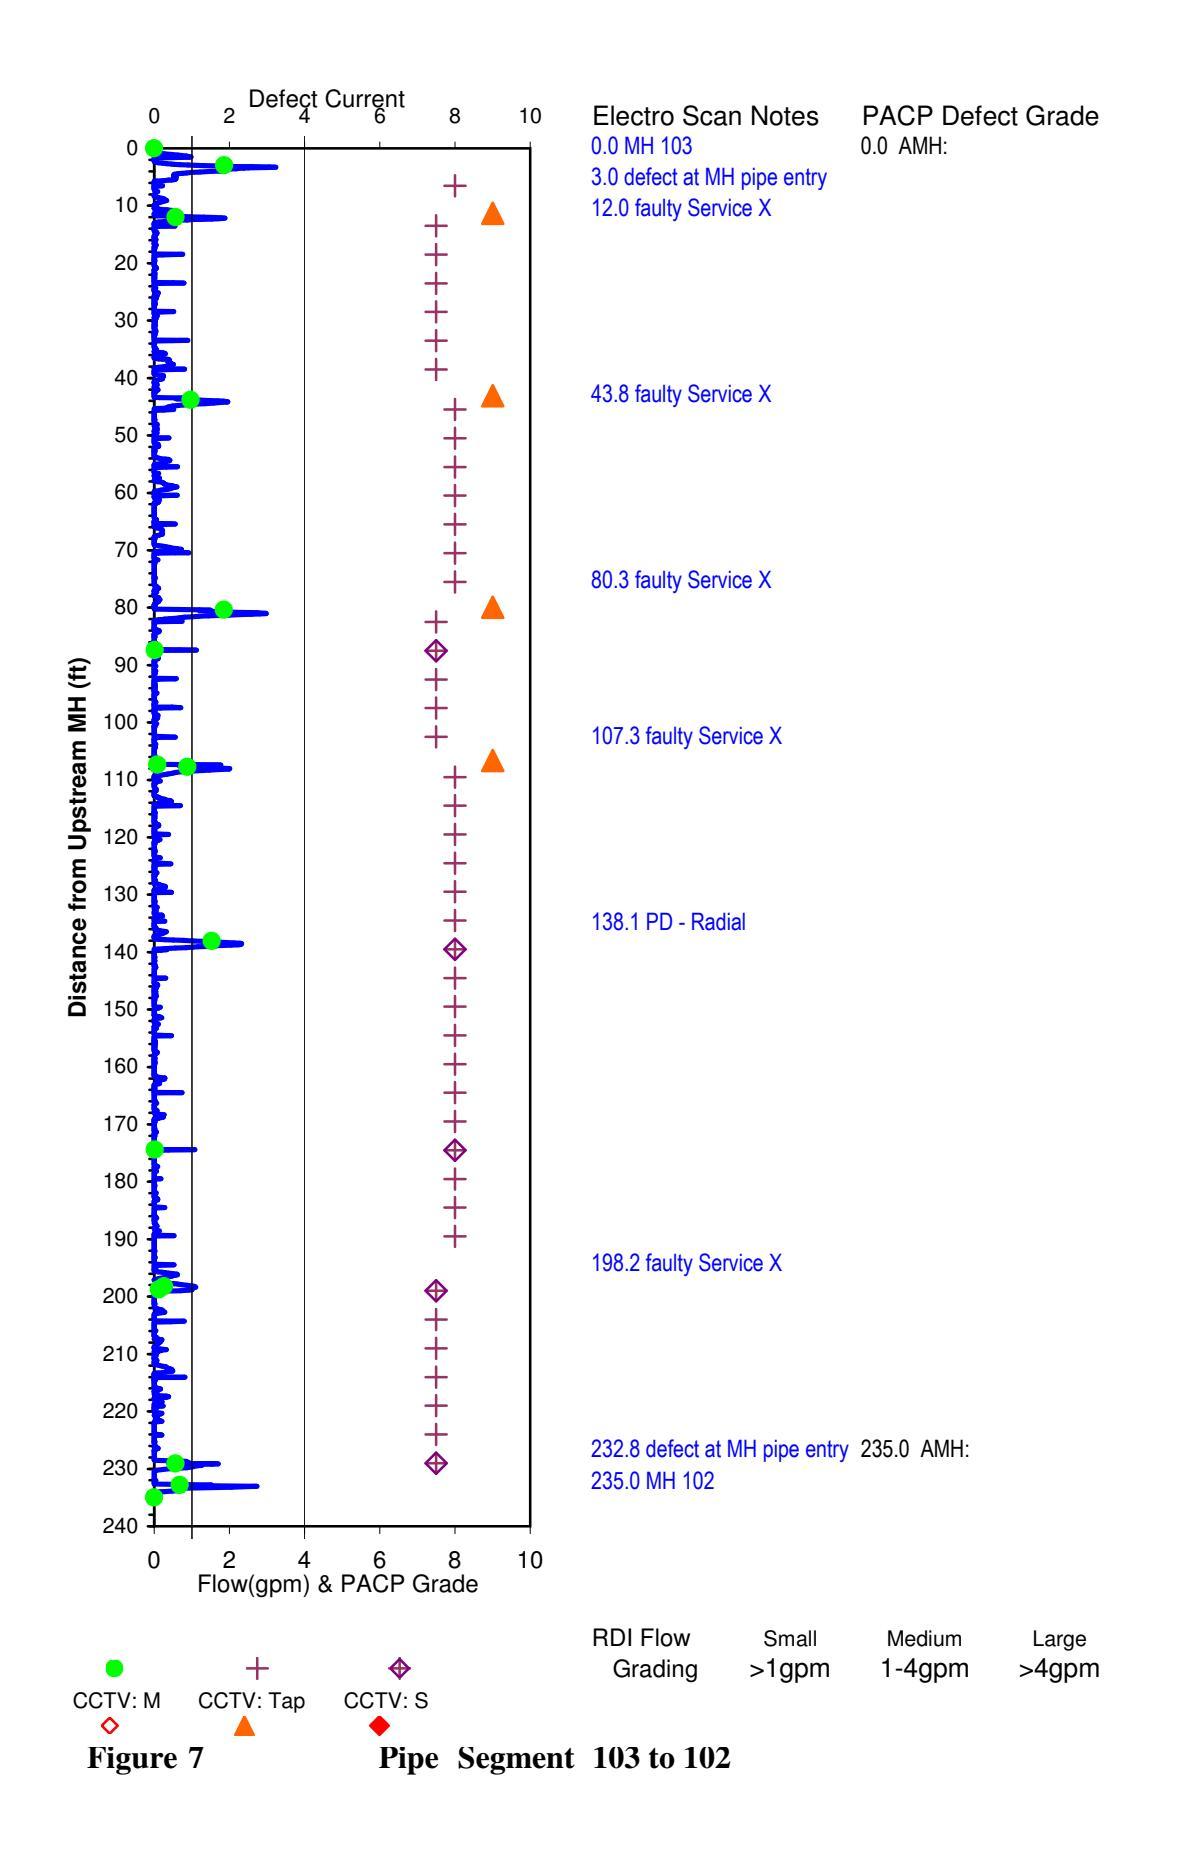
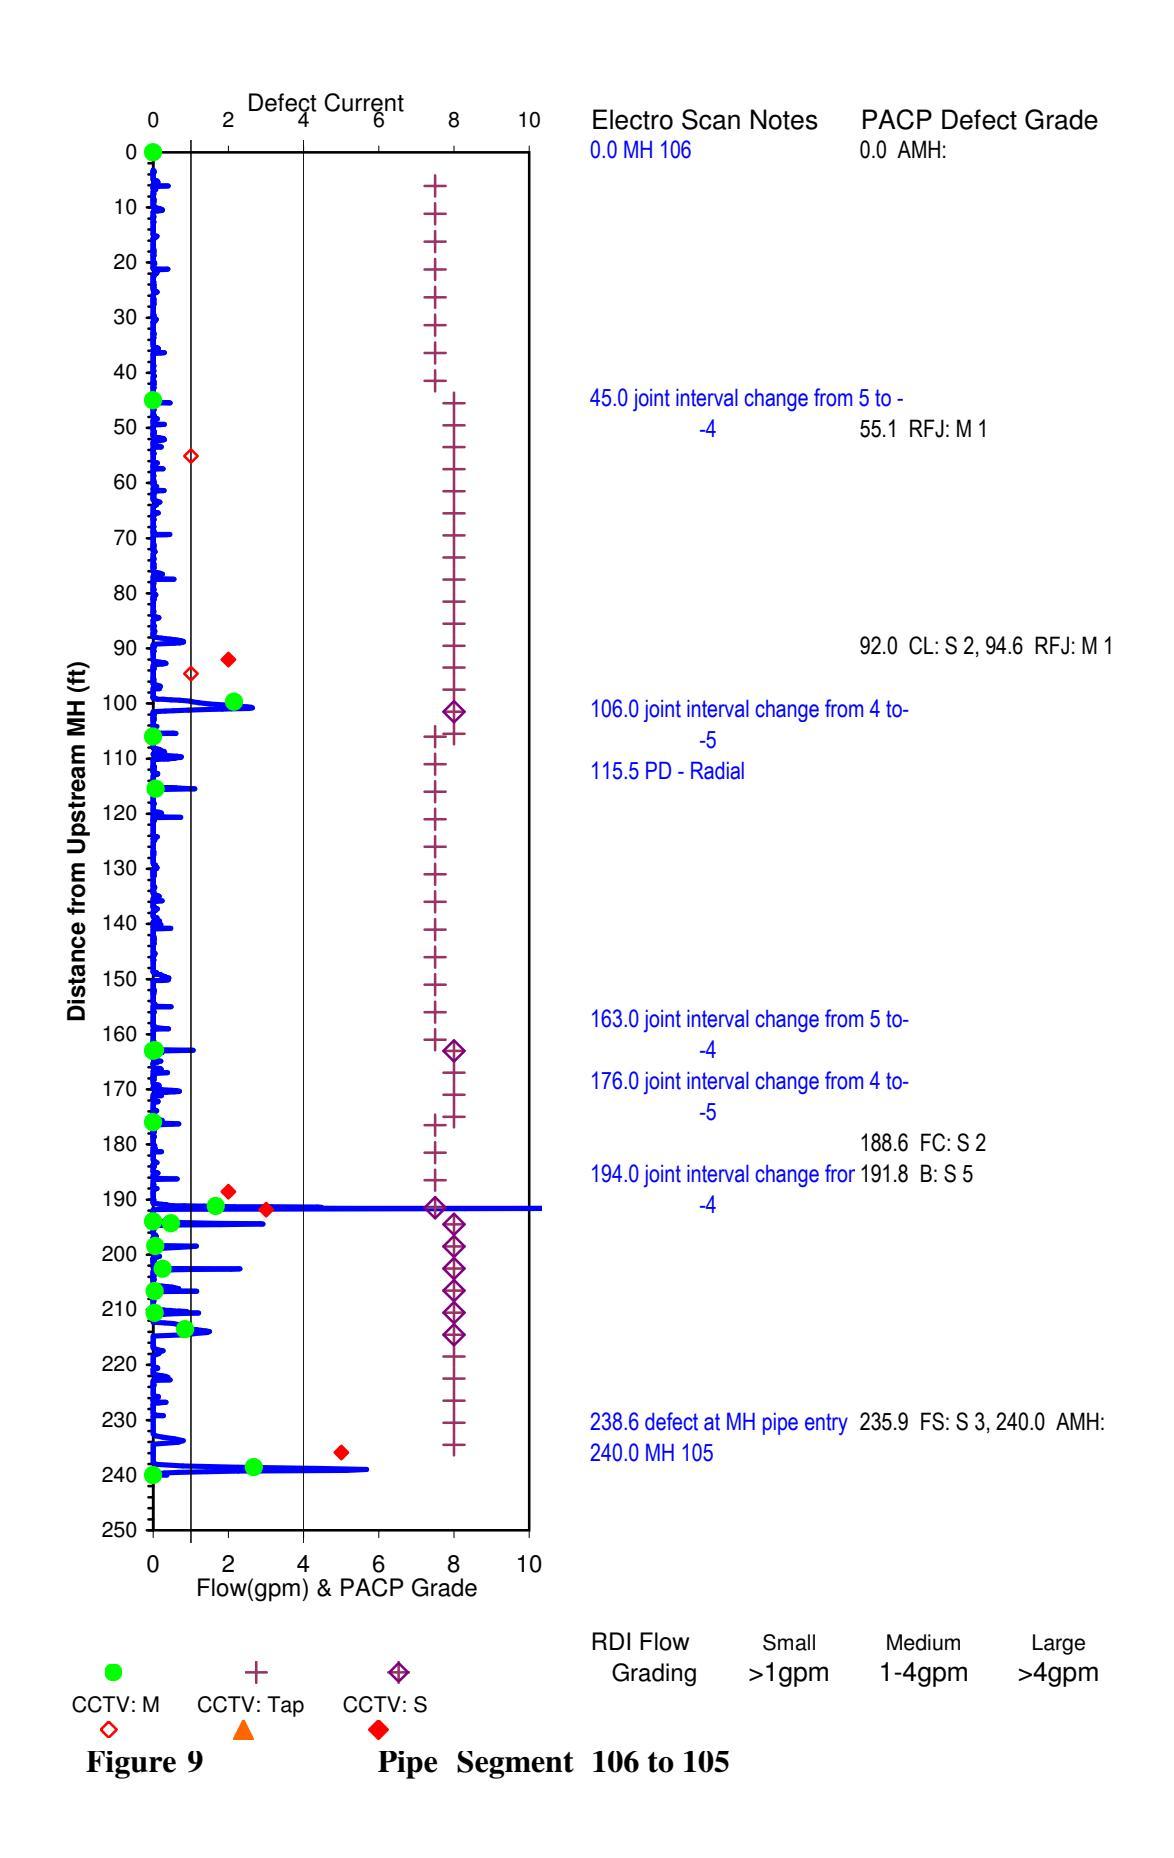
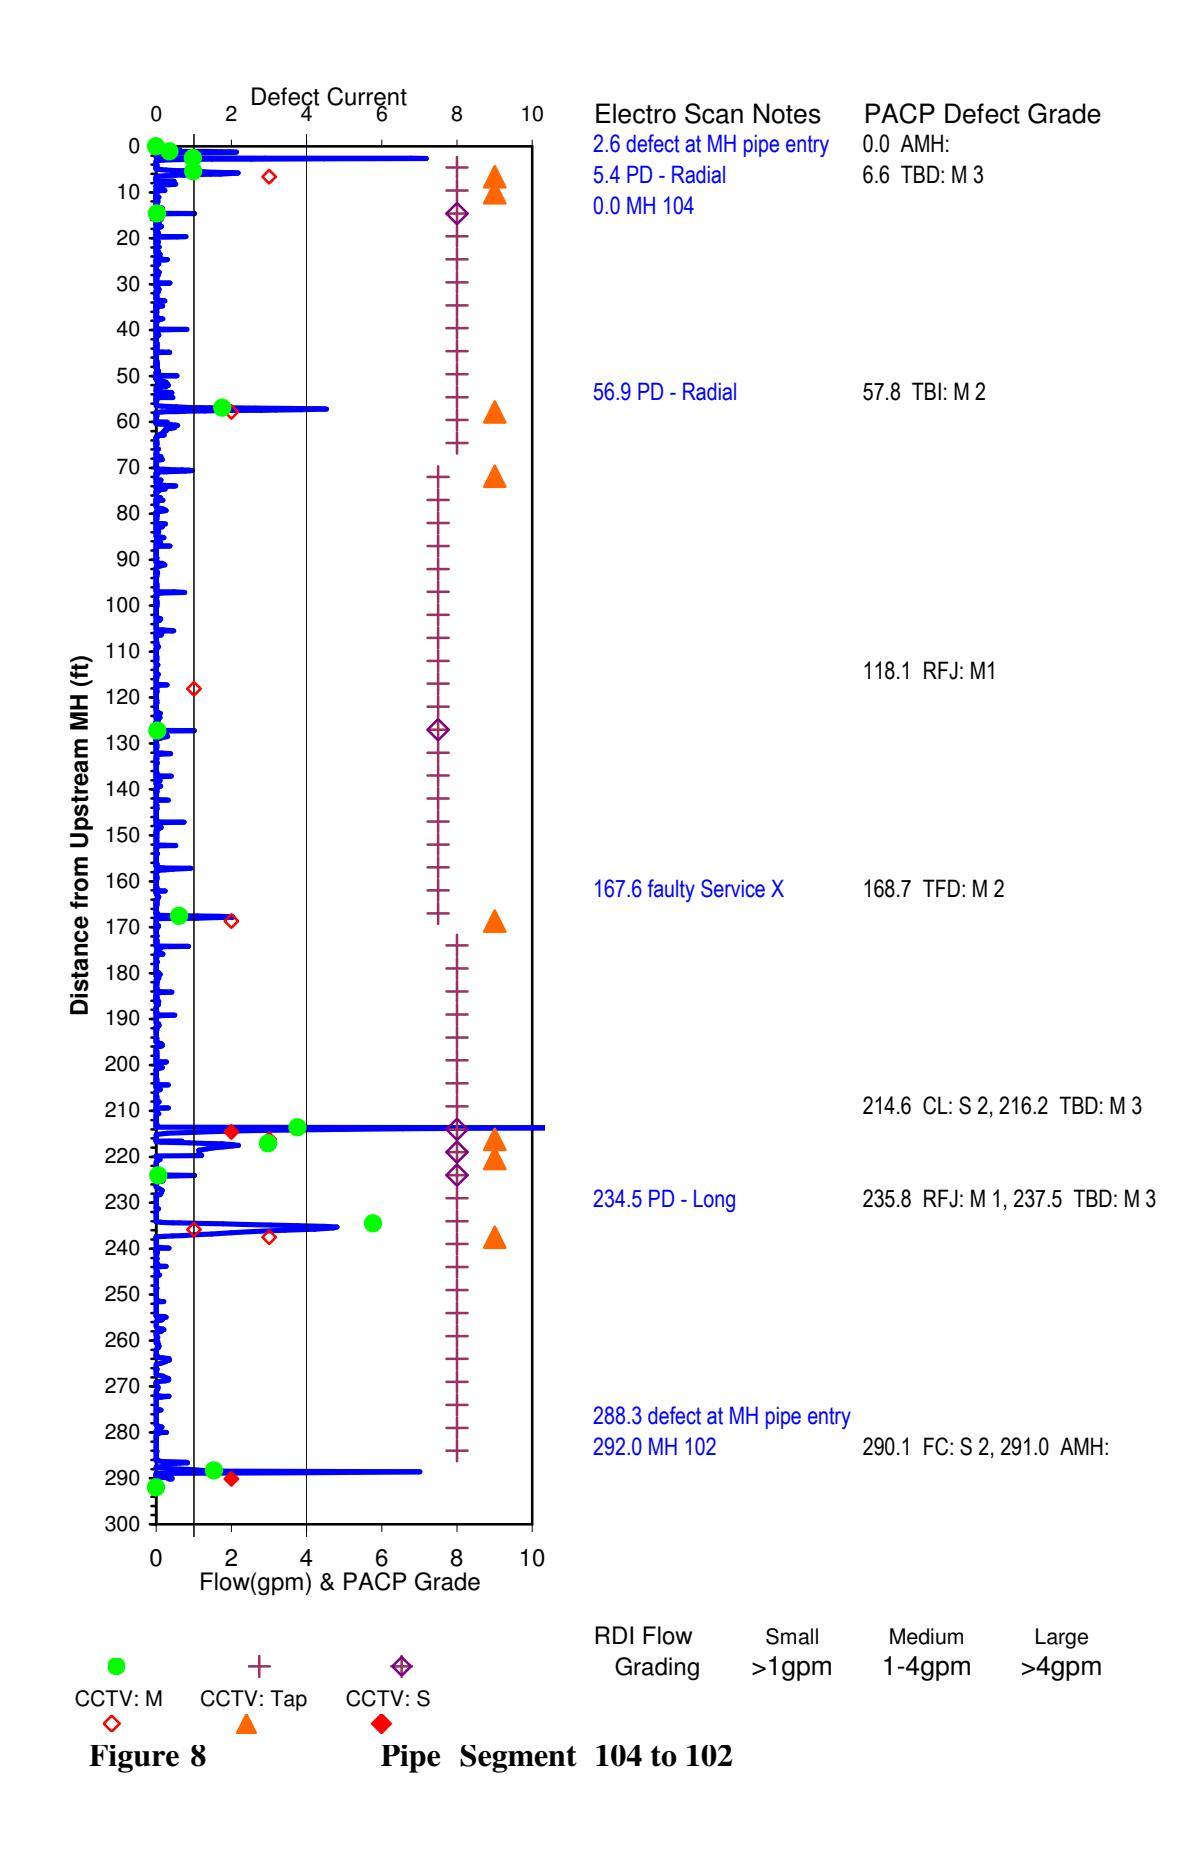
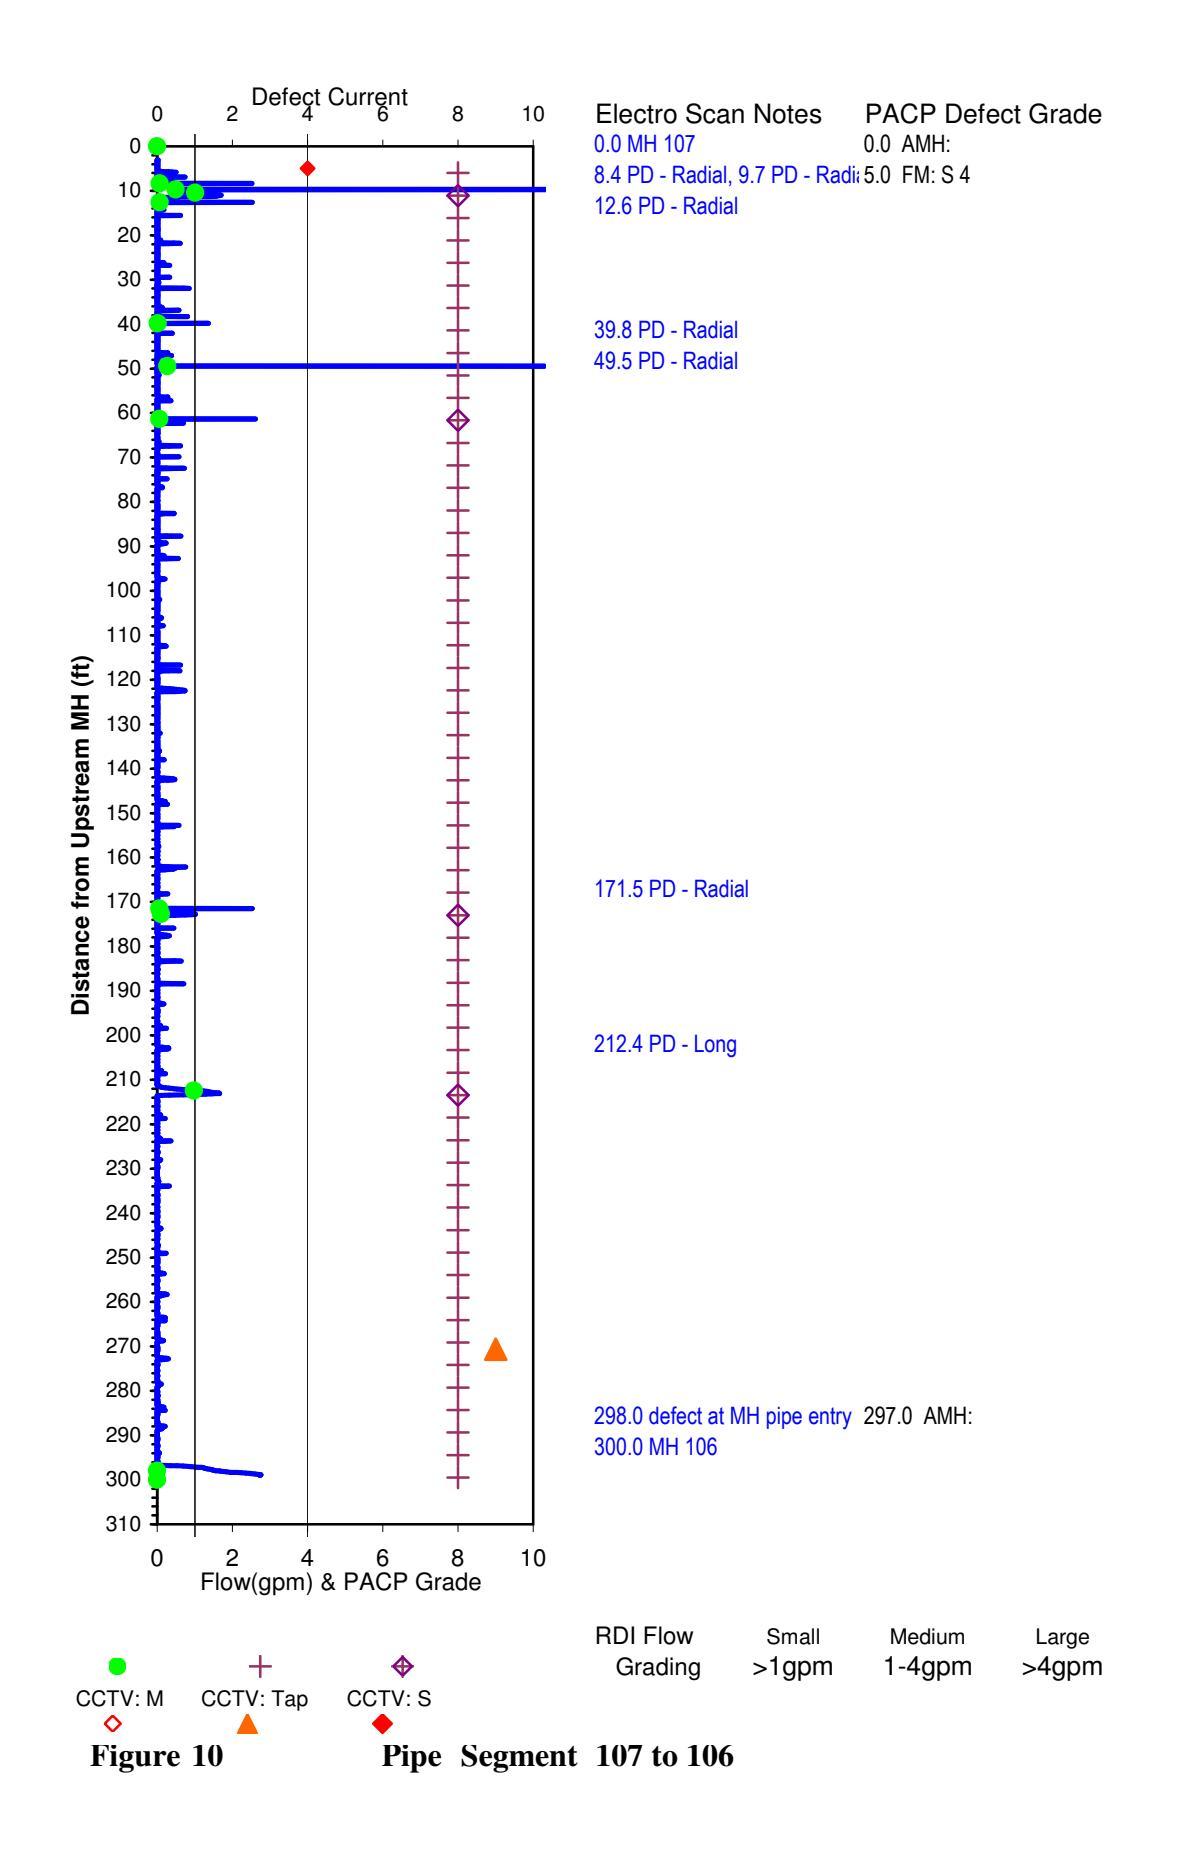
The electro scan for each pipe segment is shown as a graph of the defect electrode current (in units of 0.0001 Amp) vs. distance along the pipe from the center of upstream manhole (in units of ft). The DFes for each electro scan anomaly is also plotted. Symbols and comments are appended to the electro scan describing the type of defect such as defective joint, faulty tap (faulty service X) or manhole connection and pipe defect. The electro scans of the pipe segments are shown in Figures 4 to 20.

To enable a direct comparison of the electro scans with CCTV the PACP codes have been plotted on the electro scans shown in Figures 4 to 20. When making these comparisons it should be understood that the distances along the pipe segment shown by CCTV and electro scan may not exactly correspond. The distance between manholes of the pipe segments was measured with a distance wheel at the time the electro scan was recorded in the field and were within 1 ft of the distance recorded by the electro scan. The manhole to manhole distances shown on the CCTV reports showed the same distance within one foot for 9 of the 17 pipe segments. The others varied by 2 to 4 ft.

- Removal of the defect current offset above zero. This process enables a computer program to automatically pick and grade the electro scan "anomalies" as described below.
- Setting an electro scan "threshold" level. Electro scan values above the threshold level are called "anomalies". For this study the threshold level selected was 1.0 and is shown as the lowest unbroken horizontal line on the electro scans.(See Figure 4)

- Grading the potential infiltration flow rate for each defect as Large, Medium or Small. For this study the Large-Medium boundary and Medium-Small boundary flow levels were set at 4 gpm and 1 gpm respectively and are shown as unbroken horizontal lines on the electro scan.(See Figure 4)

Defects that were identified on the CCTV images were coded using the PACP method (NASSCO 2001) and are shown in Figures 4 to 20. The tap locations observed by the CCTV inspection are shown as triangle symbols (\triangle). CCTV PACP defect codes are listed and are shown on the graph plotted to the right according to the severity grade as diamonds (\blacklozenge) Only the CCTV PACP codes that are potential sources of leakage (e.g., joints, taps, manholes, pipe
