Surrey solves I&I mysteries with electrical pipe scanning system

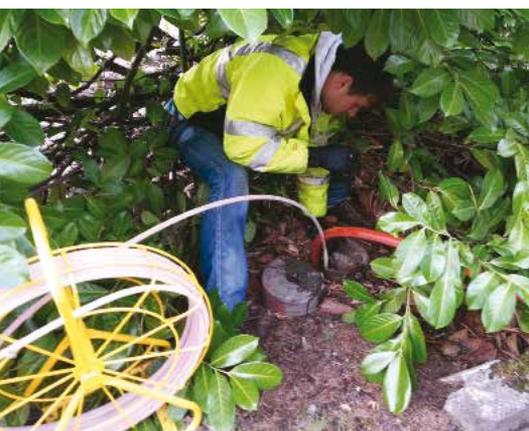
An Electro Scan technician with the ES-38 for sewer laterals and plug, scanning private laterals in Surrey, BC.

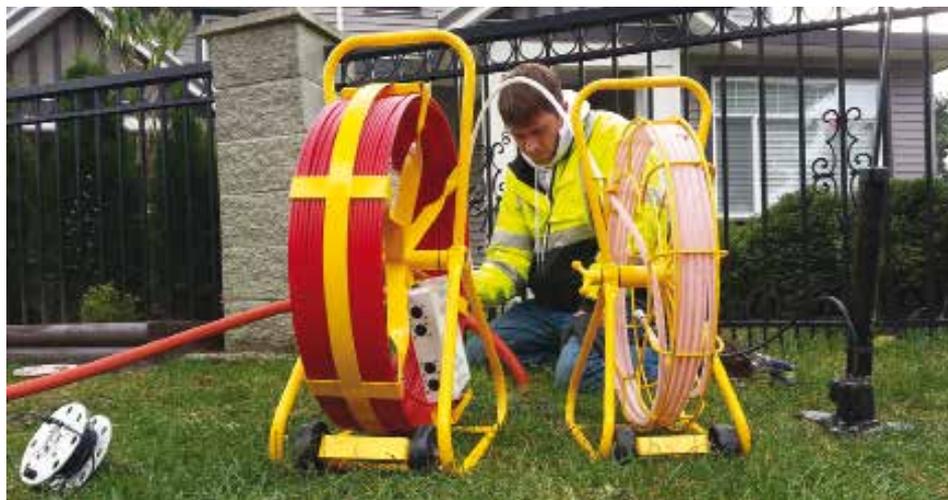
The ES-620 probe for sewer mains and grounding reel, ready to start scanning.

The Electro Scan probe releases a focused array of low-voltage high-frequency electrical current, of only 10 volts and 40 milliamps, which automatically locates and quantifies all defects in non-conductive sewer mains and laterals.

As the Electro Scan probe passes through the pipe, it measures the variation of electric current flow through the pipe wall, then through the ground to an electrode on the surface – a metal stake driven into the ground.

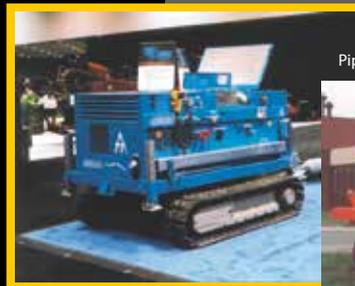
Pipe Renewal and Cable Pulling Winch RKW 5Crawler
