MACHINE-INTELLIGENT NON-ACOUSTIC LEAK DETECTION SOLUTION.

ELECTRO SCAN DELTA

MULTI-SENSOR TRIDENT PROBE

Multi-Sensor Leak Detection for Pressurized Pipes

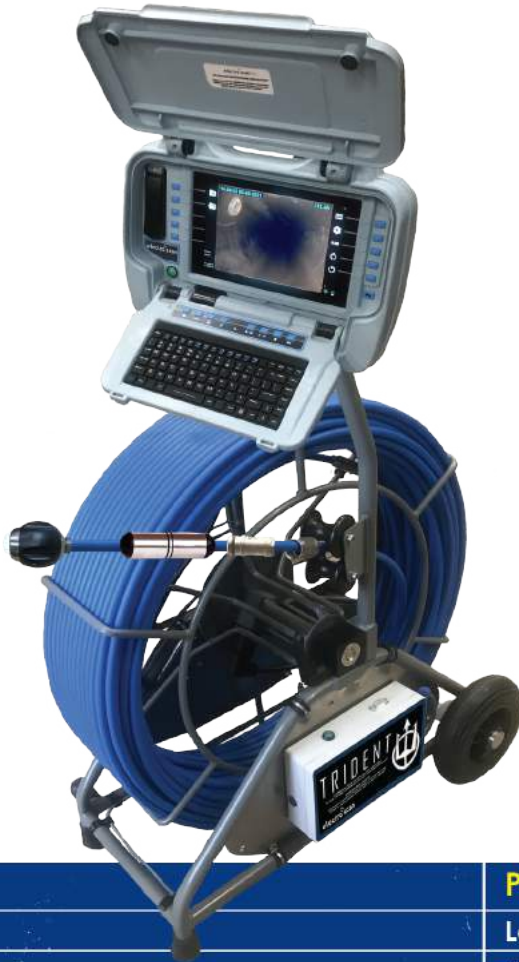
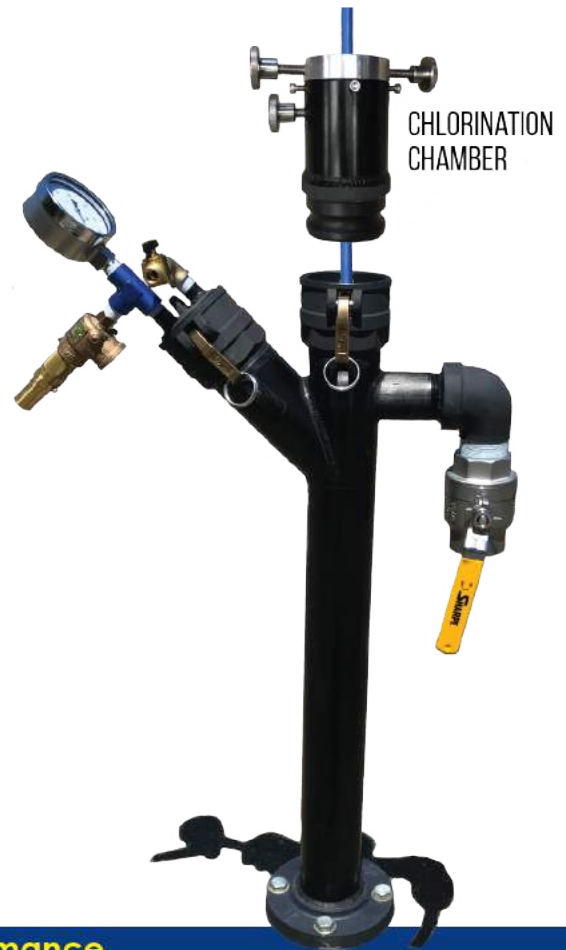
Pressurized Water Main Leak Detection.
Finding & Measuring Leaks in GPM or LPS.

Condition	Performance
Probe Sensors	Low Voltage Conductivity FELL and CCTV
Pipe Diameters	4-10 inches (100-255mm)
Pressure	0 to 160 psi (11 bar)
Temperatures	5-30°C, 41-86°F
Flow Rate	Push Cable able to handle flow or no-flow conditions
Pricing	Per Day or Per Meter Based on Total Project Size
Launch Points	Hydrants, Air Release Valves, Blow Off Valves, Gate Valves, Hot Taps, Meters
Pipe Length Per Survey	Up to 400ft (120m) in either direction from access
Construction	High impact ABS & powder-coated, zinc-plated mild steel
Dimensions (Length x Width)	5 inches x 1.6 inches
Camera Features	Display: 10.1", 1280 x 800 HD color TFT Storage: Internal 128Gb, USB flash storage supported Power Options: Mains Input (100-240 VAC), DC Output (16 VDC) or Built-In Battery (4S2P) Focal Range: 10mm to ∞ Active Pixels: 768 x 492 (NTSC) / 765 x 582 (PAL) LED Luminance: ≥ 208 Lumens Resolution: ≥ 460 TVL

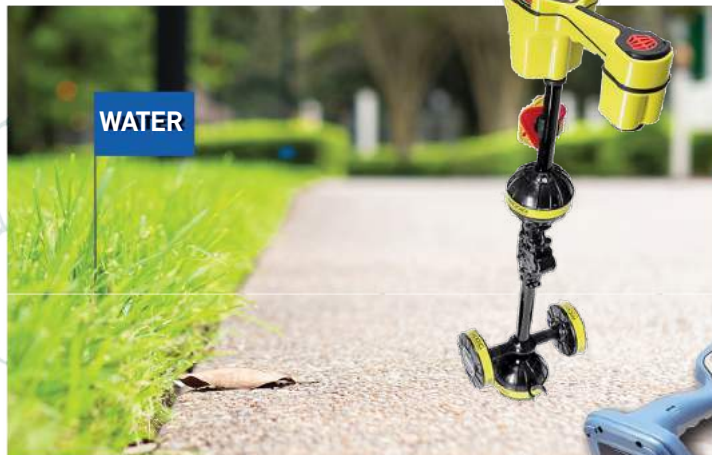
DRAWBACK OF GROUND PENETRATING RADAR:
DIFFICULTY LOCATING WATER MAINS

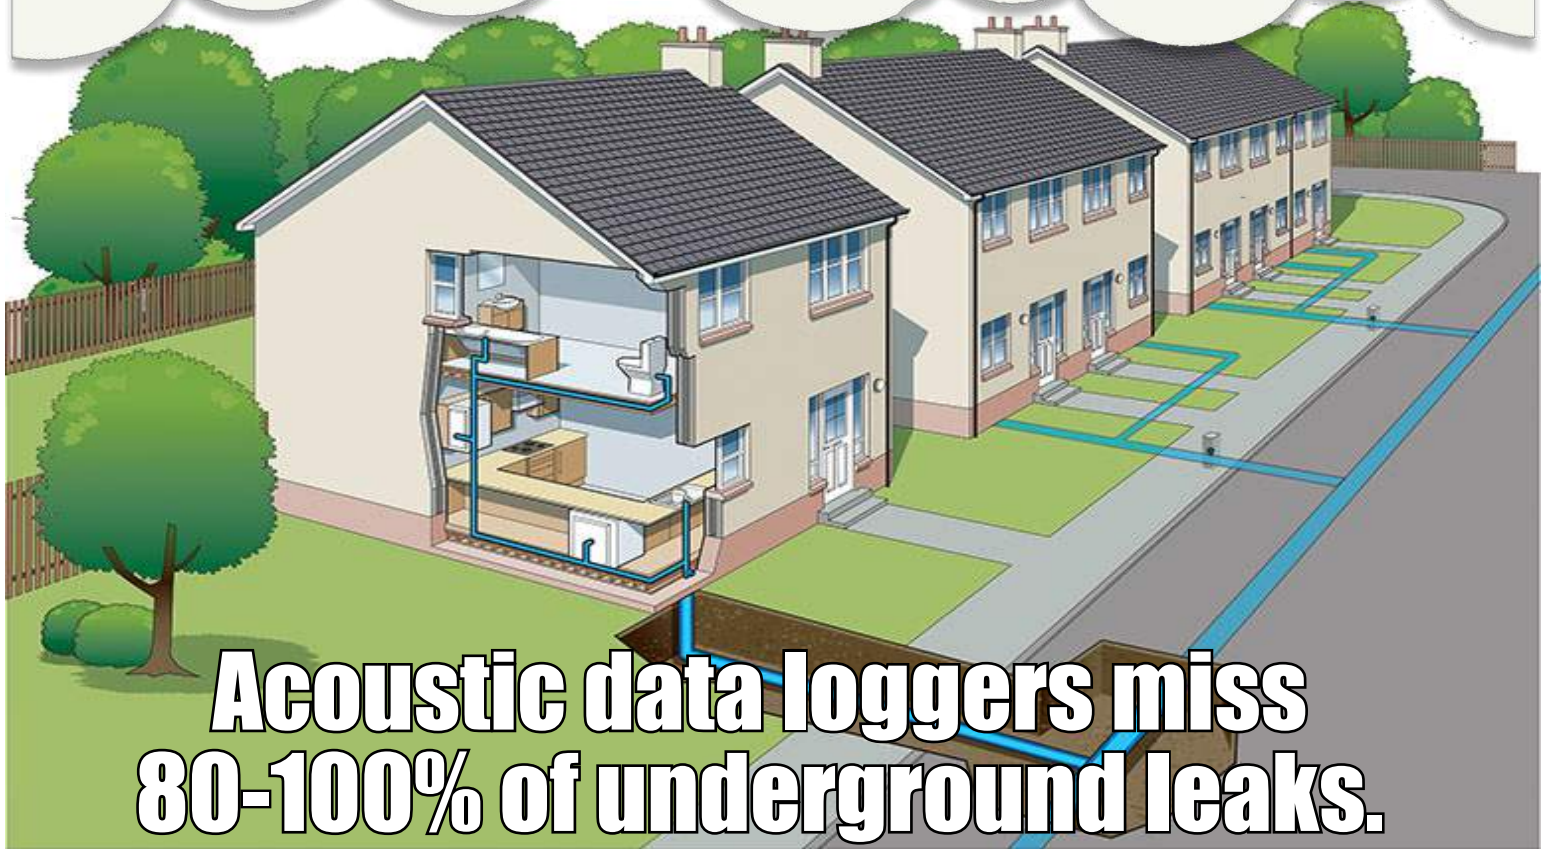
Water Leakage

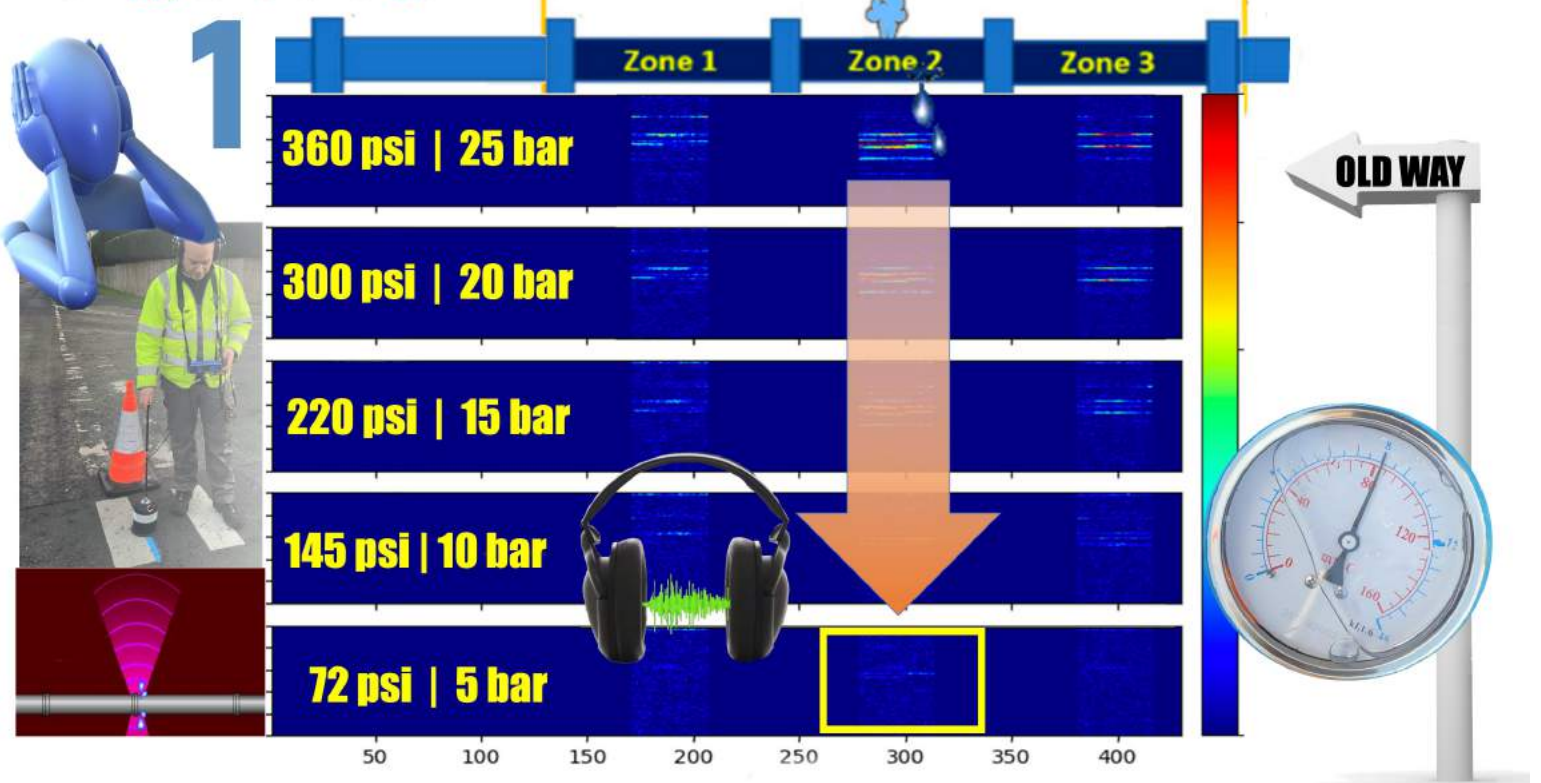
The Biggest Reason That Acoustic Sensors Can't Find or Measure Leaks?

CCTV ONLY 'SEE' 50% OF A PIPE, AND CAN'T TELL WHERE OR HOW MUCH WATER LEAKS INTO OR OUT OF A PIPE.

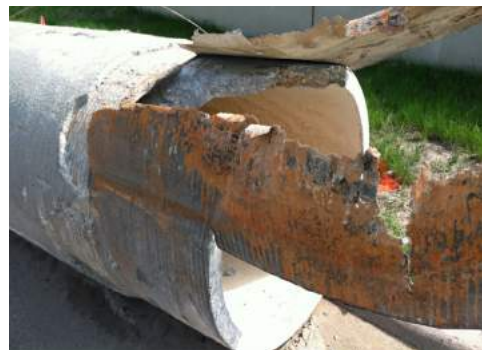
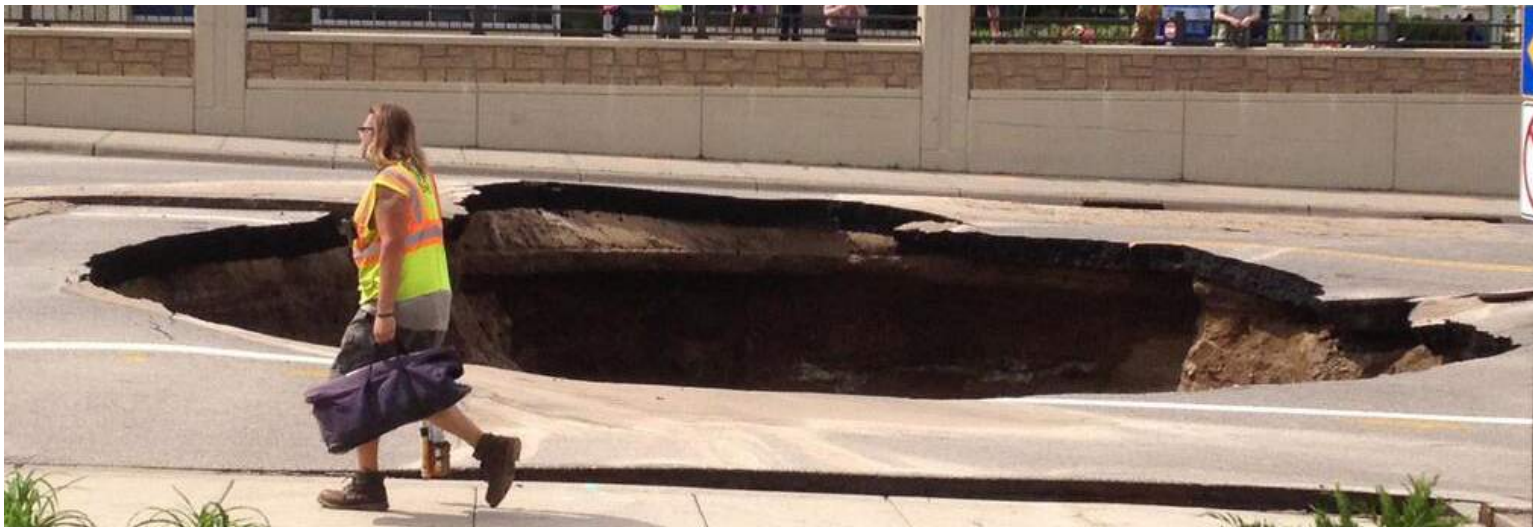
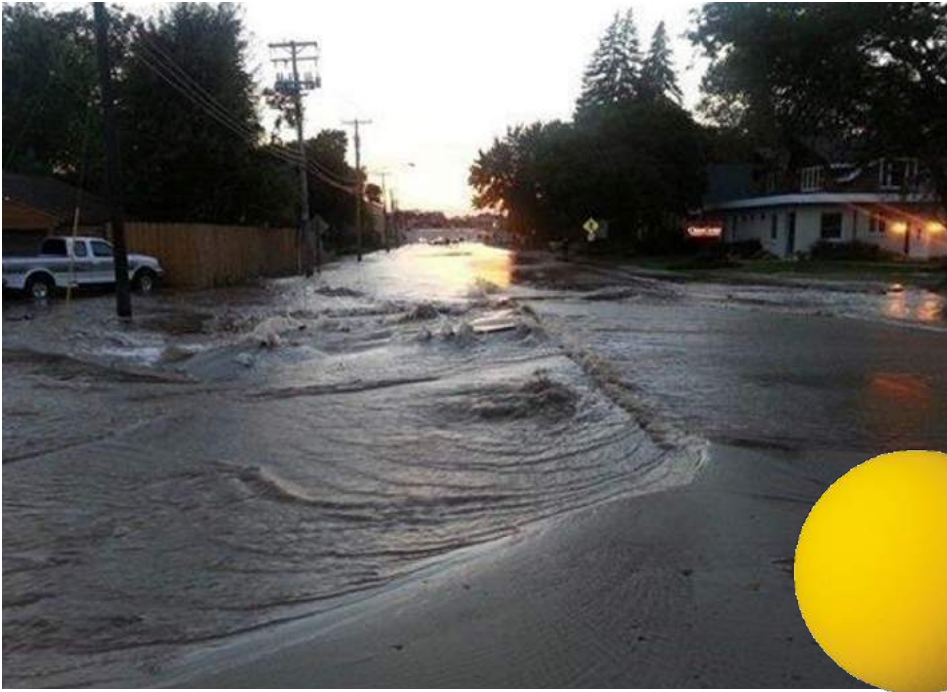
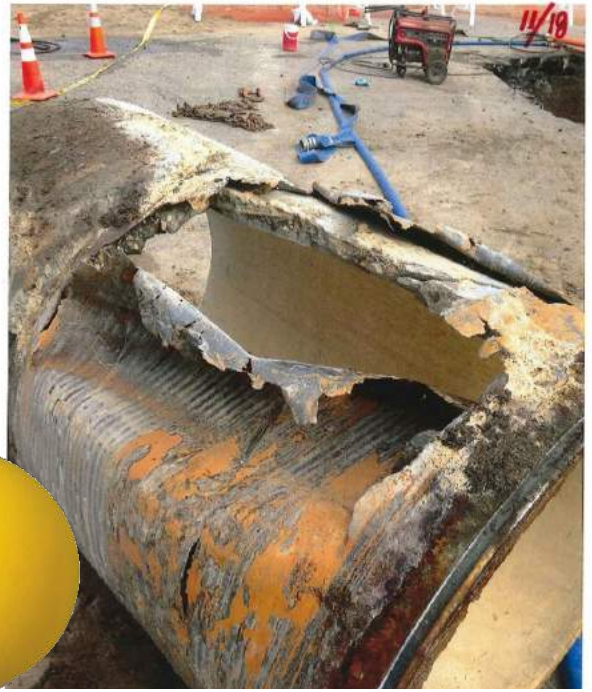
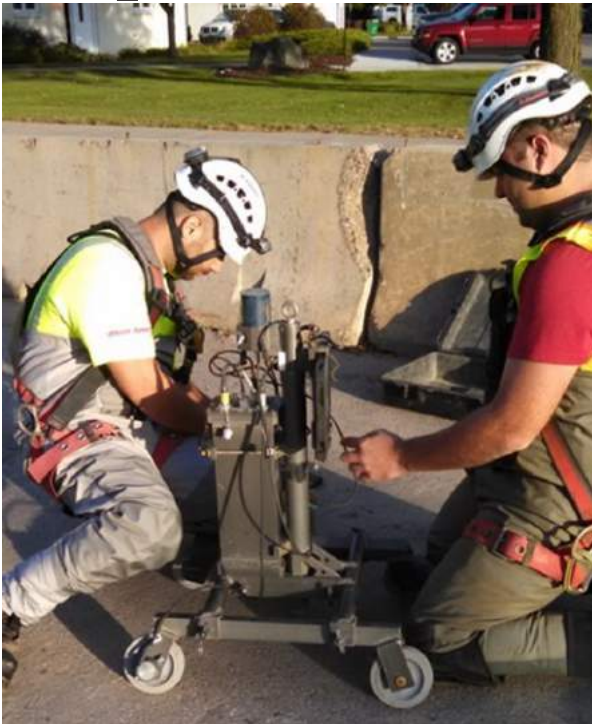
Rupture #1 & #2 – After Acoustic Ball Found No Leaks

Ruptures Cost Over \$2 Million, Each

CCTV of dewatered pipe showed major radial cracks that were not identified as 'LEAKS' using Untethered Acoustic Ball.

Electro Scan automatically identifies & quantifies leaks from cracks, without dependence on pipe pressure or noise.
